# Masonry building behaviors during the February 6–12, 2017 Ayvacik-Çanakkale Earthquakes

Ali Ural\*

Department of Civil Engineering, Aksaray University, 68100, Aksaray, Turkey

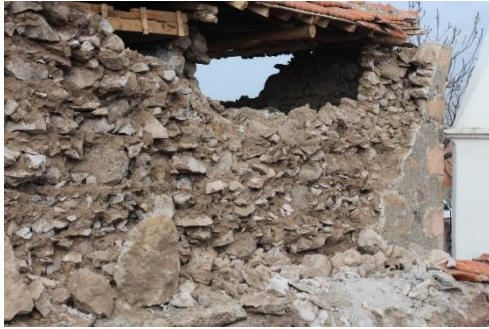
Fig. 6 Joints without binding properties

When looking at the masonry construction that is damaged in the region, the common feature of all is formed from rubble stone walls. The stones used in the load-carrying walls were andesite type, which is abundant in the region. When the collapsed or damaged walls were examined, these stones had no apparent size or shape. Additionally, usually having no binding property to fill the joints between the masonry units, mud was used. Adherence between the masonry units and the mortar layer in the joints is important in masonry wall behaviour. As a result of on-site observations, the author did not find any use of adherence-providing cement or lime-like material on most of the damaged structures. In Fig. 6, a damaged wall from a

masonry building as described above is seen. In this way, the size differences between the masonry units and the state of the mortar joints are clearly visible.

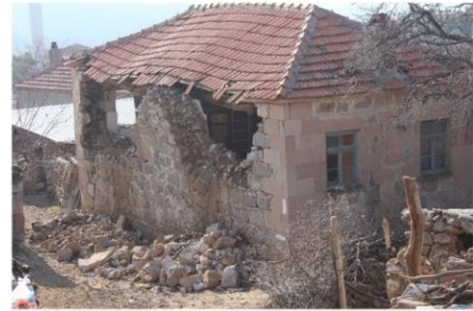
Fig. 7 Use of rubble and cut stone

Wall thicknesses in damaged buildings exceed 50 cm in some places. Although the walls are so thick that they are heat-insulated, this thickness caused the moment of inertia on the walls under the lateral effects. The fact that there is no element inside the wall or corners which provides continuity between the perpendicular walls is also causing damage. A picture of this situation is given in Fig. 7. According to this figure, the damage occurred in the form of out-of-plane overturning. It is also seen that the cut stones are used in the perpendicular wall.

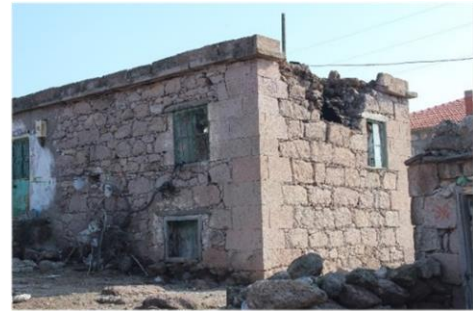
Fig. 8 Use of cut stone around corners and outer parts of the walls

When the walls of some damaged buildings were examined, it was seen that the inner parts of the walls were covered with rubble and the outer parts are covered with cut stone. However, in some buildings, cut stone was only used around the corner points. Photos of damage related to this situation are given in Fig. 8. Cut stone used parts made a positive contribution to the overall behaviour and making the structure survive.

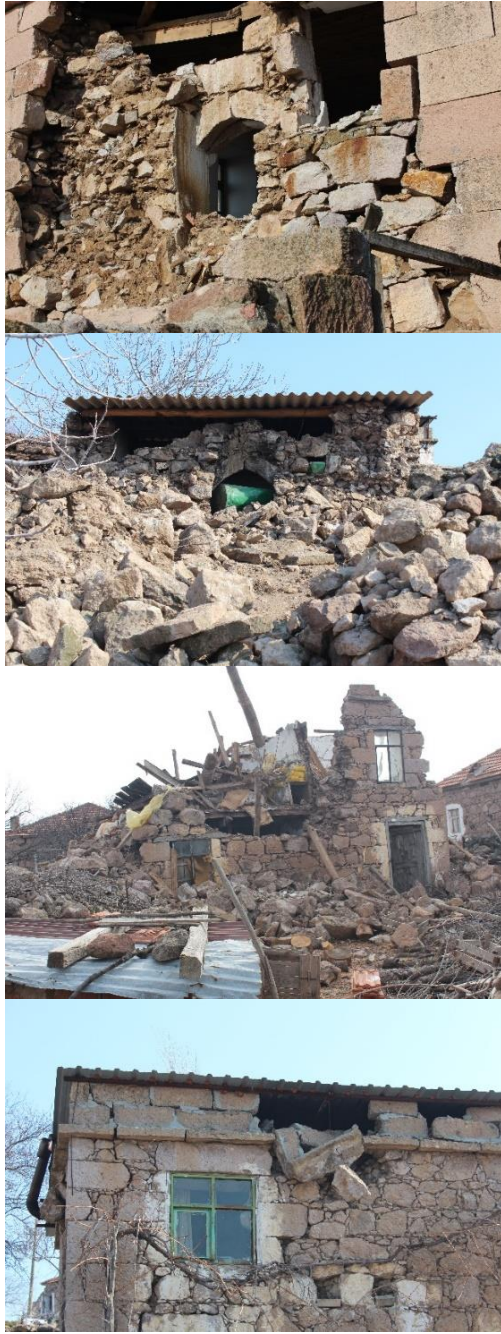
Fig. 10 The effect of door window lintels

The positions of the door and window spaces in the buildings are generally arranged according to the Turkish Earthquake Code. Lintels are often used in these door and window spaces using large stones, and wood. In some structures, these sections have been given arch forms from the stones. This situation has prevented it from being completely destroyed. Fig. 10 shows the effects of the lintels.

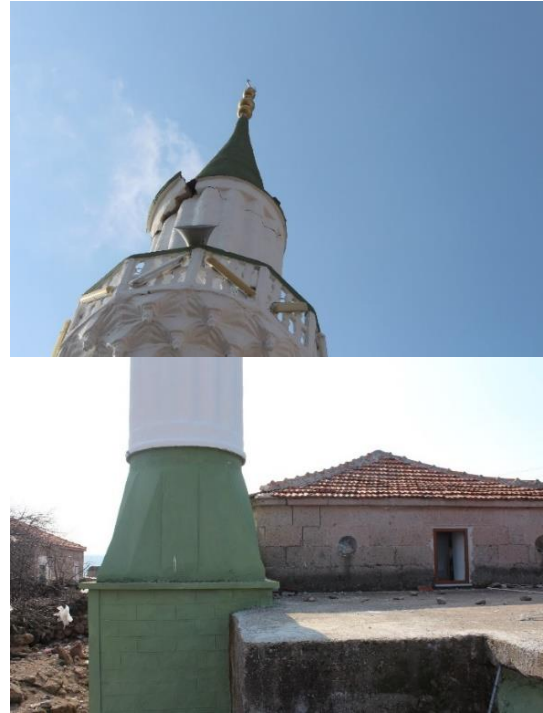
Fig. 11 Mosque and minaret damages

loadings. In the Turkish style, the parts of a minaret are the footing as a base; pulpit, transitional segment, cylindrical or polygonal body as a shaft; a balcony; the upper part of minaret body; cone and flag. The damages caused by an earthquake or wind in the minarets usually occur in the transitional segment or in the cone part. The most important reason for the damage in the transition zone can be explained as the decrease of lateral stiffness due to the sudden decrease of the cross-section. The main reason for the damage that occurs in the cone part is that the upper part of the cone is filled with concrete for the assembly of the flag. For this reason, inertia forces occur at the top of the cone. Many studies have been carried out on minaret damages in earthquakes such as (Doğangün *et al.* 2008, Oliveira *et al.* 2012, Turk and Cosgun 2012, Ural and Firat 2015). It was determined that there was damage in the mosque and the cone of the minaret of the Yukarıköy village during the earthquake region investigation. This damage is given in Fig. 11.
