# Seismic performance of South Nias traditional timber houses: A priority ranking based condition assessment

Mahmoud Sodangi and Zaheer Abbas Kazmi\*

**Keywords:** building defects; condition assessment; defect intensity index; earthquake; seismic shaking; traditional wooden house

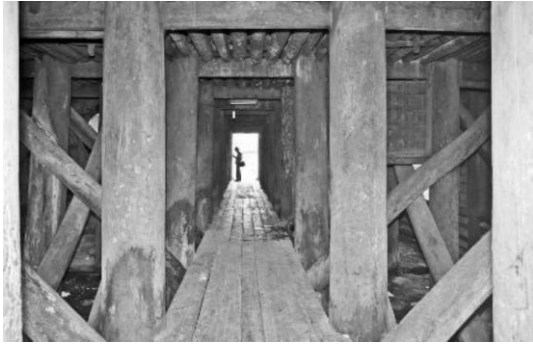
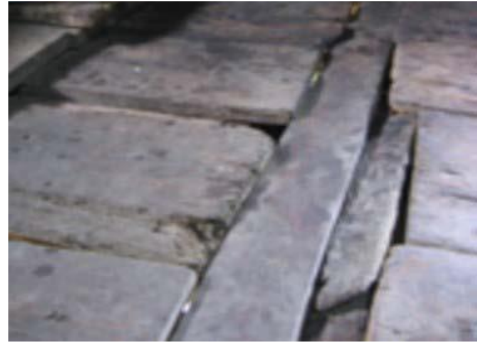
damage of these structural elements. The deteriorations caused by dampness due to humidity is observed in both cross and short pillars in Fig. 5. About 25 short pillars and 10 cross pillars are due for replacement. Similarly, termite attacks have caused serious defects to the columns, beams, and walls as shown in Fig. 6. On the other hand, most of the parts of these elements have decayed due to the termite attack. The defects caused to the roof as seen in Fig. 7 were caused by the rain penetration through the wide gable.

Fig. 5 Dampness on columns and floorboards

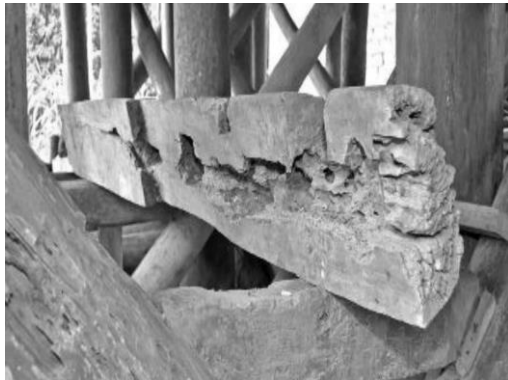
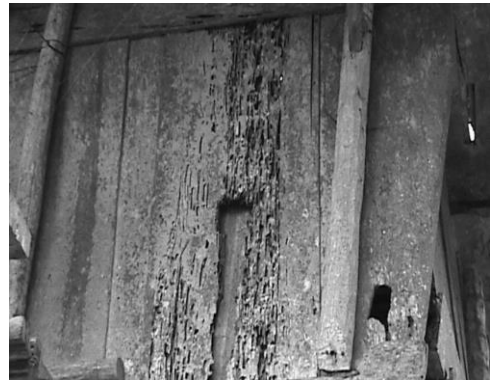
Fig. 6 Termite attack (a) columns and beams, (b) walls

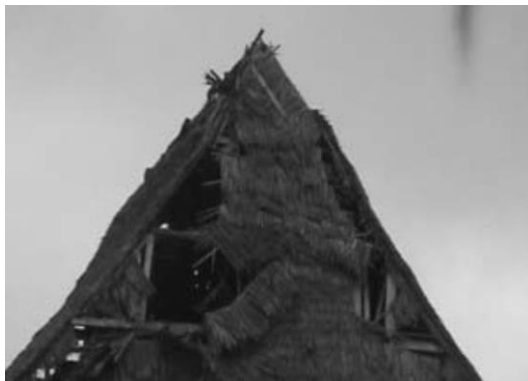
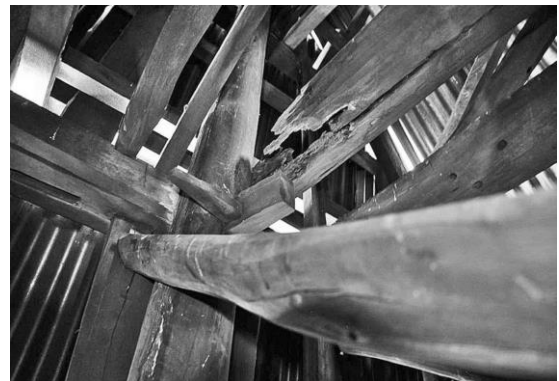
Fig. 7 (a) Leaking roof, (b) Roof frame deterioration due to rain penetration

At the end of the visual survey, the prominent defect observed on elements of the building occurred on the roof structure of the building. As shown in Table 4, the most notable defect is leakage, which resulted to dampness and moisture penetration on other structural elements like beams, columns, walls and floors. The roof was observed to be leaking causing rainwater to penetrate the building. The

leakage was due to old age of the roof and the actions of excessive rainfall and warm sunshine in the area where the building is located. The roof defect is considered serious as the roof cannot function to an acceptable standard. Thus, it needs repair within the period of six months. Despite having a very significant effect on the fabric of the building and the building users; the roof has very high potential risk for structural failure which in turn can lead to death or serious injuries.

The intensity index of the leaking roof in Table 6 shows that the defect has the highest severity index (60.98%). This confirms and justifies the ranking of the roof element as the most serious defective element requiring top priority. The next most intense/severe defect is inclination of column and beams. The columns and beams were observed to be inclining which is quite dangerous to the building users, and the building itself. The probable causes for the inclination could be dislocation of the frame joints during seismic shaking, distortion of the structural members due to prolonged exposure to extreme tropical weather, or a combination of both.

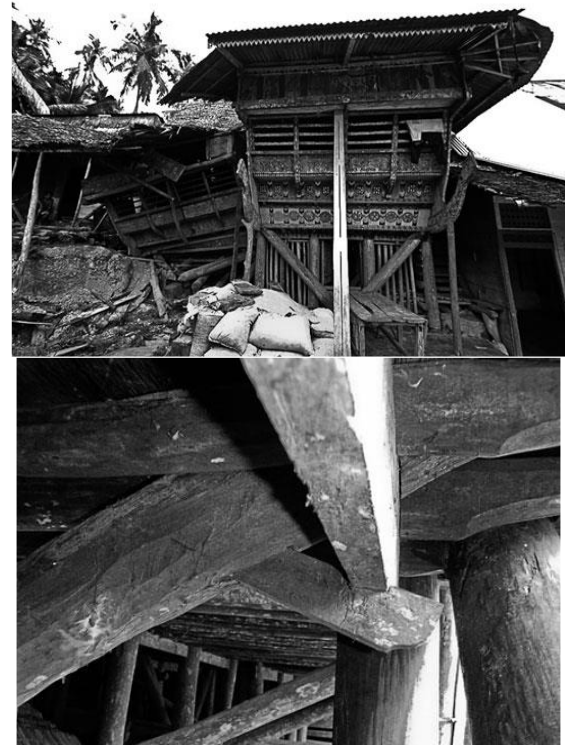
The details of Building B are presented in Table 7. Since the building got severely damaged and collapsed due to seismic shaking (Fig. 8), the main focus of the assessment was to determine its vulnerability and provide strategy for strengthening, maintaining and repairing other valuable Nias traditional timber houses that have survived the previous earthquakes. Solarino *et al.* (2017) and Nitto *et al.* (2016) used visual inspection methods to observe and identify the damages suffered by the structural elements of 'Building B'.

Fig. 8 Damaged Building B (Source: Solarino *et al.* 2017, Nitto *et al.* 2016)

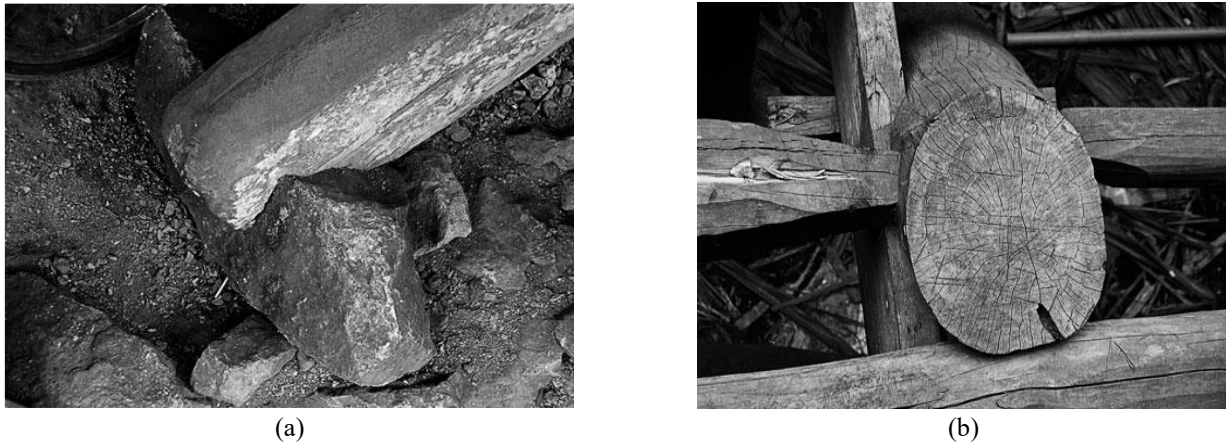
vulnerability. Nitto *et al.* (2016) classified the damages into 2 main categories: 'connection between column & stone base' and 'column & beam connections'. These connections are shown in Fig. 9. As for the 'connection between column & stone base', the tenon at the end point of the column is supposed to secure the position of the columns on the foundation thereby making the structural system strong enough to withstand seismic lateral forces even when the columns are inclined. Solarino *et al.* (2017) observed that some columns did not have the original tenons, thus, the severe damage of the joint between the foundation and column became inevitable. Consequently, columns simply slipped over the stone-base foundation causing serious damages to the structure. Failure of the joint between the foundation and column represents a significant factor with regards to stabilization of a structure after a seismic activity.

Whereas in the 'connection between columns & beams', the mortise and tenon joints of the building provide rotational resistance to lateral forces. The most severe damage was observed at the joint of the column and long

Fig. 9 Connection details (a) between column & stone base, (b) between column & beam

beam, which was due to bending moment as well as shear force inside the mortise. It was also apparent that the severe damage to the building might have occurred due to the number of beams that were inserted into mortise of columns.
