## The M6.4 Lefkada 2003, Greece, earthquake: dynamic response of a 3-storey R/C structure on soft soil

Christos Giarlelis\*, Despina Lekka, George Mylonakis and Dimitris L. Karabalis

*Department of Civil Engineering, University of Patras, 26504 Rio, Greece*

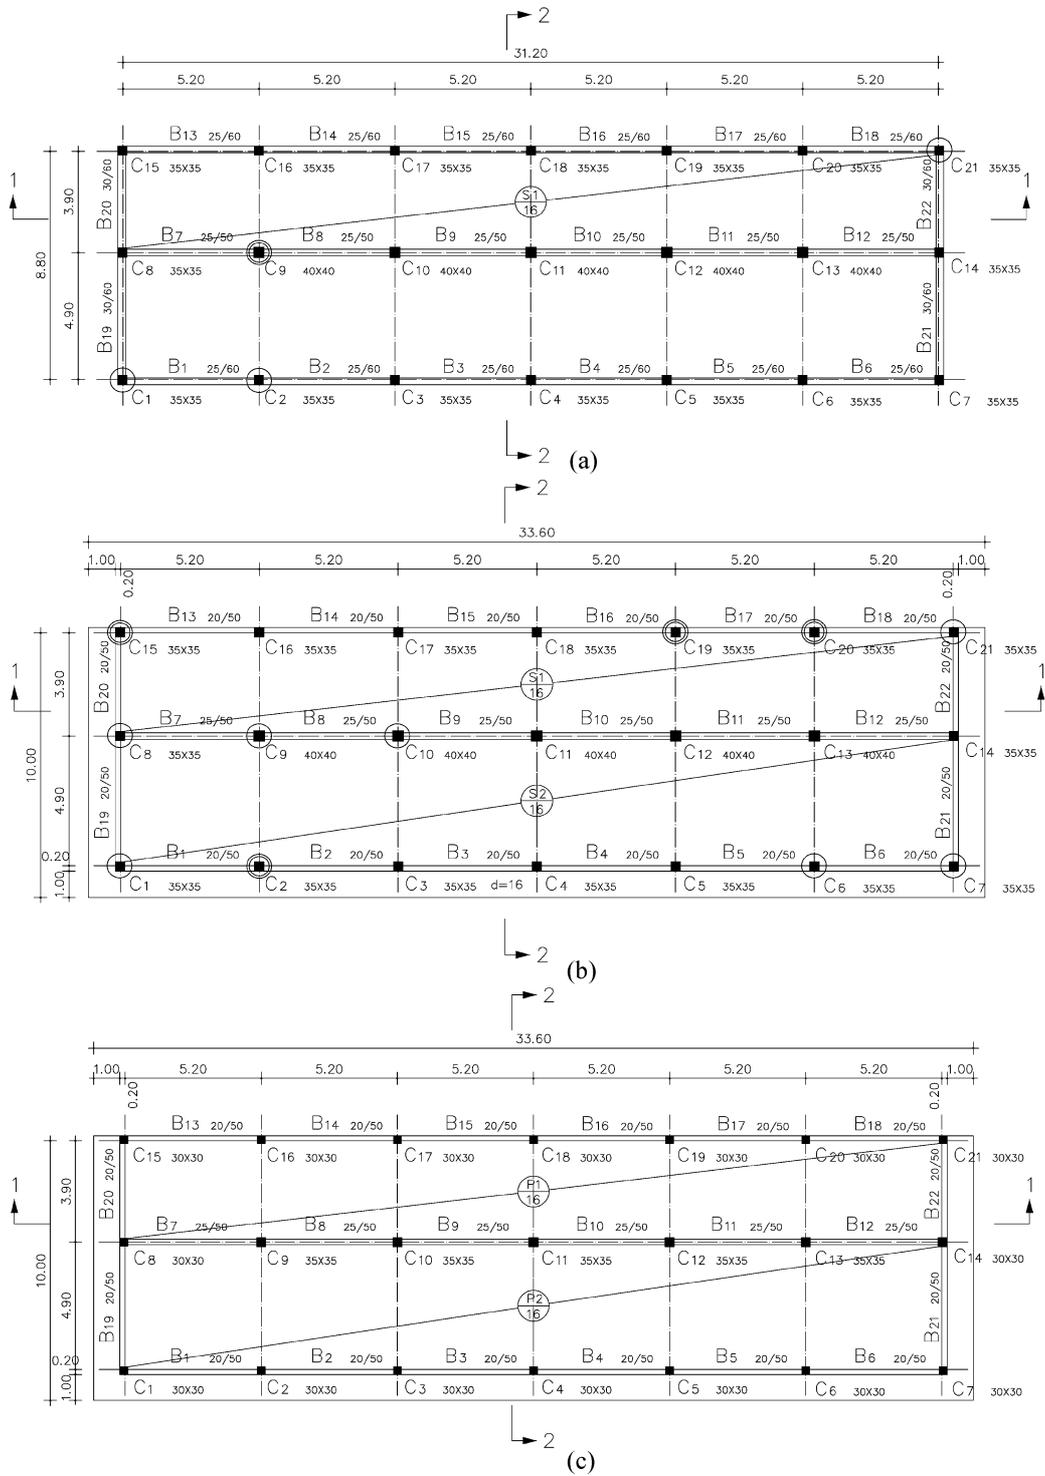
Observed column damage was concentrated at the heads of columns on the first and second floor; severity varies from light (columns C1, C2, C21 of the 1<sup>st</sup> floor and C1, C6, C7, C8, C9, C10, C21 of the 2<sup>nd</sup> floor) to serious (C9, 1<sup>st</sup> floor and C2, C15, C19, C20, 2<sup>nd</sup> floor) as presented in Figs. 7(b), 7(c) (see also Figs. 10(a), 10(b)). Nevertheless no total member failures were observed, which can be attributed to sufficient ductility capacity of the columns versus the ductility demand.

Fig. 7 Plan view: (a) 1st storey, (b) 2nd storey, (c) 3rd storey. Circle denote light cracks, Double circles denote serious cracks

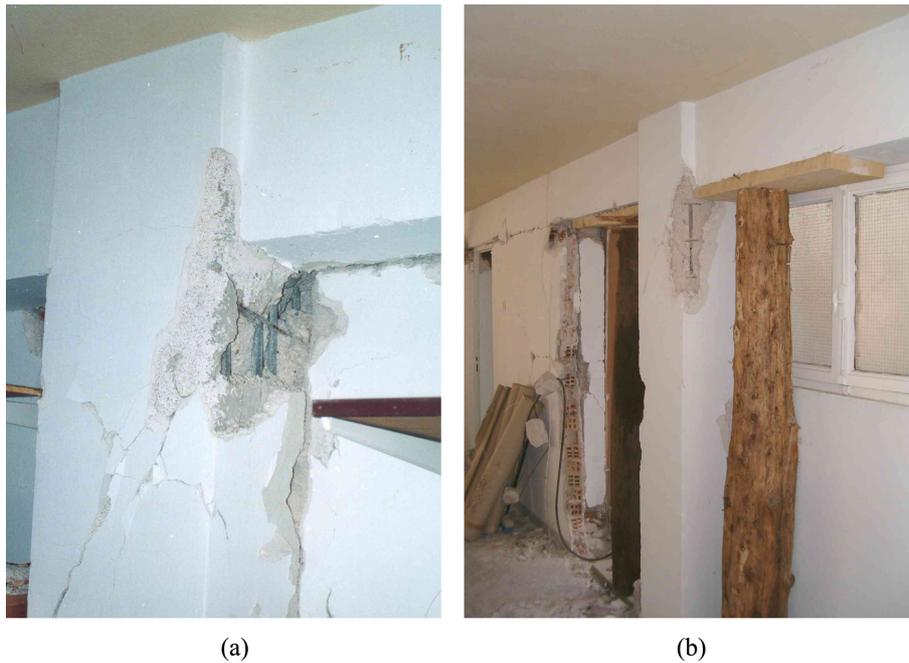
Fig. 10 Serious cracks on columns K19 and K20, 2nd floor
