# Ground response of a gob-side gateroad suffering mining-induced stress in an extra thick coal seam

**Abstract.** This paper presents an investigation of the ground response of a gob-side gateroad suffering mining stress induced by a 21 m-thick coal seam extraction. A field observation, including entry convergence and stress changes monitoring, was first conducted in the tailgate 8209. The observation results of entry convergence showed that, during the adjacent panel 8210 retreating period, the deformation of the gob-side gateroad experienced a continuous increase stage, subsequently, an accelerating increase stage, and finally, a slow increase stage. However, strong ground response, including roof bending deflection, rib extrusion and floor heave, occurred during the current panel 8209 retreating period, and the maximum floor heave reached 1530 mm. The stress changes within coal mass of the two ribs demonstrated that the gateroad was always located in the stress concentrated area, which responsible for the strong response of the tailgate 8209. Subsequently, a hydraulic fracture technique was proposed to pre-fracture the two hard roofs above the tailgate 8209, thus decreasing th

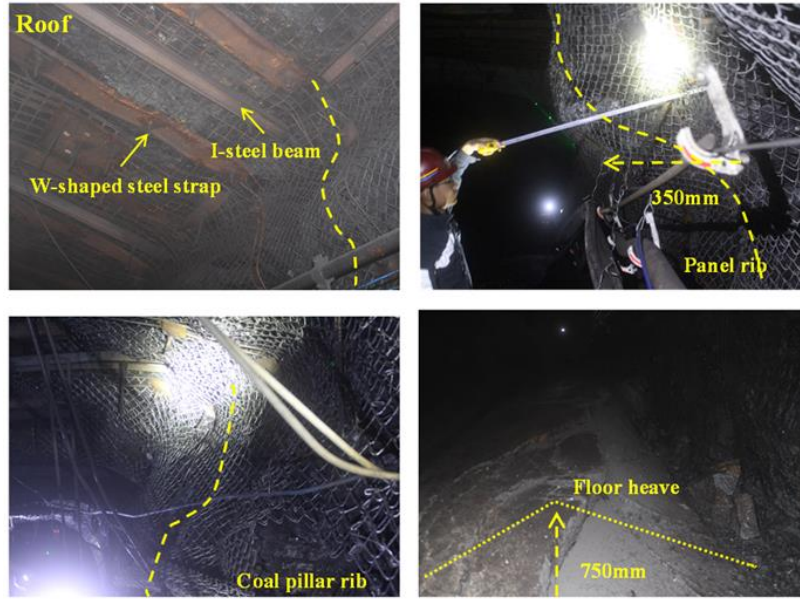
Fig. 6 Ground response of the tailgate 8209 during panel 8210 retreating

Fig. 6 presents the performance of tailgate 8209 during panel 8210 retreating. Field observations revealed the roof-coal mass performed relatively well, and deformations mostly occurred on the two ribs and floor strata. In some areas, the floor heave is significant with a maximum displacement of more than 750 mm, contributing more than 60% of the total roof-to-floor convergence. Overall, deformation and support component failures exist, but drastic failures were infrequently observed during panel 8210 retreat.

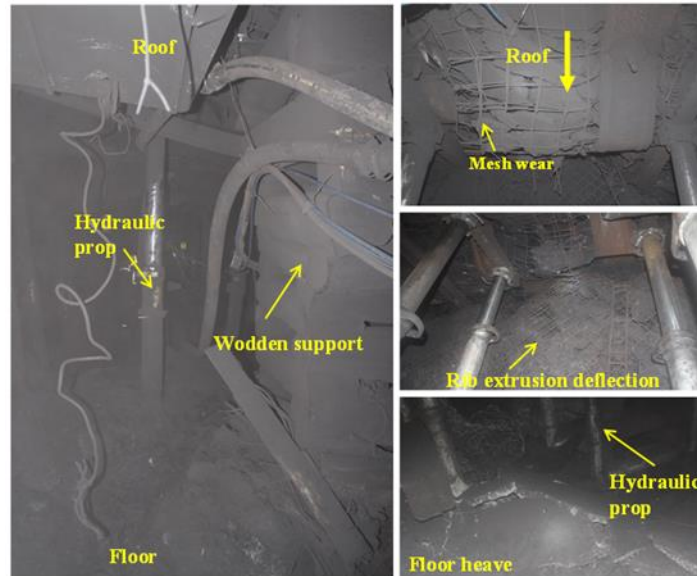
Fig. 7 Performance of the tailgate 8209 during panel 8209 retreating

Fig. 7 presents the performance of the tailgate 8209 during panel 8209 retreating. It should be noted that, for the sake of safety, reinforced support, including hydraulic prop and wooden support, was applied in the field. Despite of this, severe roof sag, rib spalling and floor heave were observed frequently. Roof bending deflection occurred with a maximum displacement of 530 mm, resulting in the I-shaped steel beam or W-shaped steel strap bend. The coal mass of two ribs underwent a prominent extrusion deflection in the field, consequently resulting in the support system failure and rib spalling. The floor heave witnessed a sharply increase, and the maximum floor deformation reached 1530 mm. Due to the large deformation the roof and two ribs, the gateroad cross-section exhibited a tremendous reduction, resulting in a considerable amount of extra labour, financial resources and time loss.

**Stage III** Retreat of the panel 8209. In this stage, the stress field balance was reactivated because of the retreat of panel 8210. Due to the large-area overhangs strata and the mining height nearly 21.1 m, the large impact loads induced by the fracture of the roof strata resulted in a large front abutment stress (Yavuz 2004), see Fig. 10. According to the numerical modelling results, the stress in the coal pillar and the panel rib reached 24.1 MPa and 18.3 MPa (Fig. 8 and 9), which was about 2.3 and 1.7 times the virgin stress, respectively. Affected by the higher stress, the gateroad suffered strong ground response (see Fig. 7).

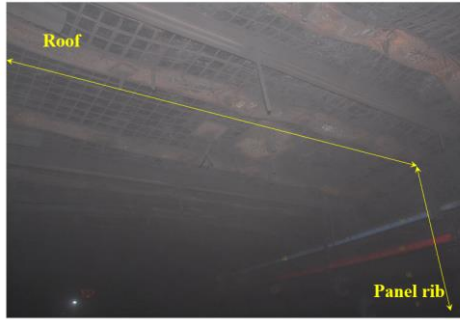
Fig. 14 Gateroad performance with hydraulic fracturing method

Fig. 14 demonstrated that the gateroad performance significantly improved after hydraulic fracturing. The ground pressure was clearly lower than it was before hydraulic fracturing, and no significant rib spalling and floor heave were observed in the field. In total, the maximum convergence values of the entry roof, rib to rib and floor decreased to approximately 160, 230 and 340 mm by 69.81%, 60.85% and 77.2%, respectively. It can be inferred that hydraulic fracturing method can notably decrease the gob-side gateroad deformation.
