A correlation between moisture and compressive strength of a damaged 15-year-old rammed soil house

Abstract. Earthen structures have an excellent bioclimatic performance, but they are vulnerable against earthquakes. In order to investigate the edification process and costs, a full-scale rammed soil house was constructed in 2004. In 2016-2019, it was studied its seismic damage, durability and degradation process. During 2004-2016, the house presented a relatively good seismic performance ($M_w=5.6-6.4$). The damaged cover contributed in the fast deterioration of walls. In 2018 it was observed a partial collapse of one wall due to recent seismicity ($M_w=5.6-6.1$). The 15-year-old samples presented a reduced compressive strength (0.040 MPa) and a minimum moisture (1.38%). It is estimated that the existing house has approximately a remaining 20% of compressive strength with a degradation of about 5.4% (0.0109 MPa) per year (considering a time frame of 15 years) if compared to the new soil samples (0.2028 MPa, 3.52% of moisture). This correlation between moisture and compressive strength degradation was compared with the study of new soil samples at the same construction site and comp

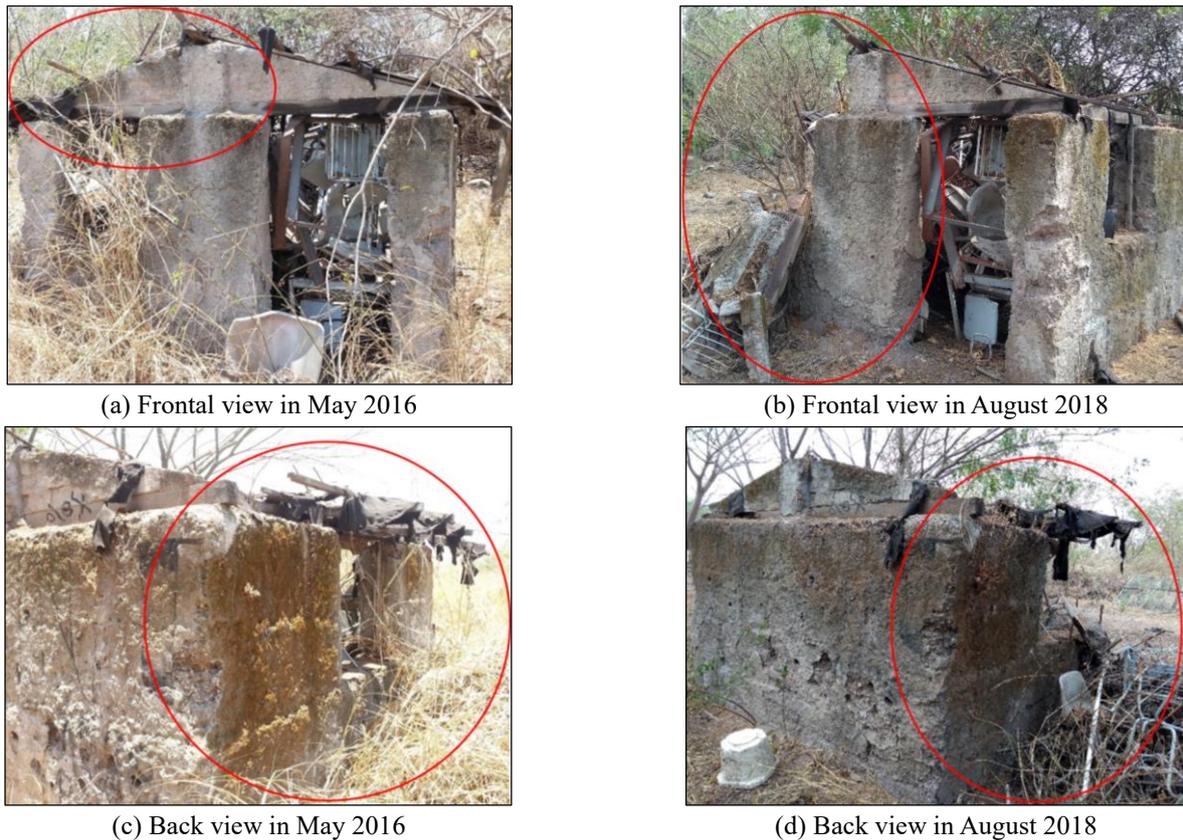
Fig. 9 Actual conservation state of the rammed soil house

Recently, in 2019, it has been 15 years since the construction of the earthen house and has suffered different damages due to the constant seismicity of the region (see Table 3), vandalism, aging, weather degradation, biological attack and lack of maintenance as observed in Fig. 9.

presented a strong damage by aging with the decay of plasters (see that the brick masonry became evident on parapets) due to the heavy rain and weathering, as well as damage of the cover system due to the house was used as a storehouse of scholar furniture and other waste (Fig. 9(a)). The damaged cardboard sheeting of the cover system allowed the entrance of raining water to the interior part of the house and caused damage to the timber elements including the perimetral beam and triangular masonry parapets. The perimetral timber beam is extremely decayed

and also the appearance of the rammed soil walls has changed due to moisture and aging. It was also observed induced moisture to supporting walls at the four façades as illustrated in Fig. 9(c). In May 2016, the supporting walls of the house remained without collapsed parts, just the presence of multiple cracks induced by raining degradation and the presence of biological attack (e.g., cavities generated by insects and invasive plants). In general terms, in the 2016 survey, the seismic performance of the house was considered as relatively satisfactory due to the reduced weight of the cover, great wall thickness and anchorage system between cover and corners of walls (Fig. 9(a) and 9(c)). In August 2018, another in-situ campaign was developed to analyze the decay degradation which considerably increased and it was surprising to observe that the right part of the frontal façade presented an important collapse as shown in Fig. 9b and d. The corner walls collapsed including a half part of the parapet and it was considered that the probable cause was the constant seismicity of the region. Therefore, it was developed an investigation of recent EQs occurred near Colima City. In Table 3 it is shown that after the technical visit developed in May 2016, three important EQs ranging from $M_w=5.6$ to 6.1 (i.e., 2016, 2017 and 2018) have occurred in the surroundings of Colima City.

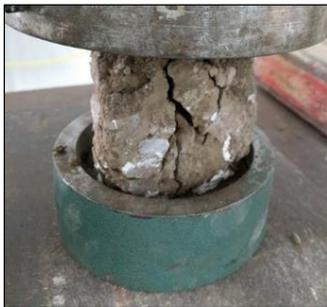
(a) Several vertical/diagonal cracks

Fig. 12 Observed failure mechanisms on existing samples of rammed soil walls M1-M5

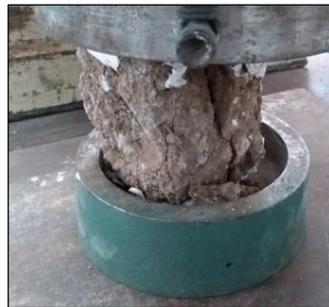
(b) Vertical cracks

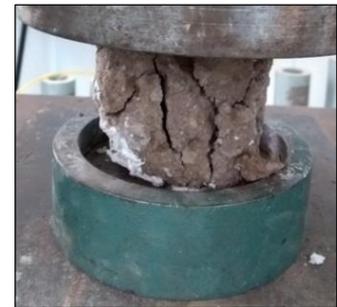
(c) Multiple vertical/diagonal cracks

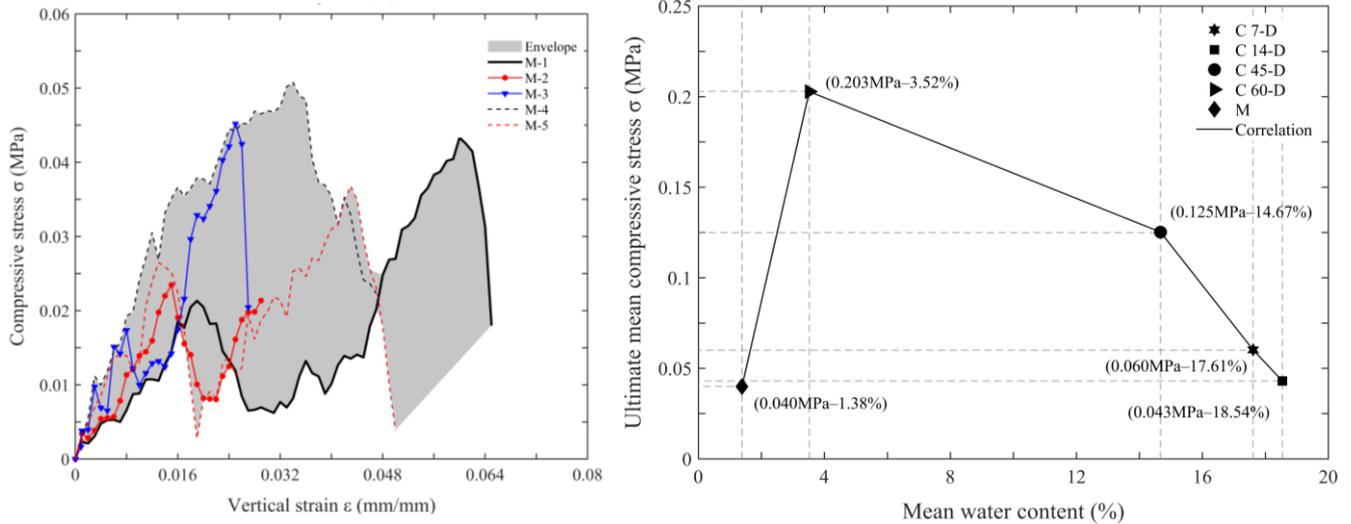
Fig. 13 Summary of results of existing samples M1-M5 of rammed soil walls and new soil cylinders C at different ages under compression

certain sawtooth behavior (see the formed peaks in Fig. 13(a)) due to the interlocking effect by the presence of gravel with a diameter higher than 2.5 cm (see Figs. 11(b), 11(c) and 12). This effect induces micro-cracks inside the samples and hard zones by the interaction of one segment of gravel with another, leading to either, an increasing of strength or its degradation.

Moreover, the samples M1-M5 shown at the day of testing a mean water content of 1.38% (see Table 4 and Fig. 13(b)). The observed mechanical properties are quite below the reported results of new compacted soil samples (Table 1).

13(b) illustrates the correlation between mean compressive strength and water content at ultimate conditions of the existing rammed soil wall samples (M1-M5) with the code M, as well as the results on new soil samples (cylinders) with the code C tested under compression at different ages (i.e., 7, 14, 45 and 60 days). Fig. 13(b) is explained more in detail with the obtained results for new soil samples C in Section 7. Regarding the shear strength of the existing rammed soil house, it was not possible to extract representative samples with enough size (e.g., 30x30 cm) to be transported and tested with the UTM machine due to the brittleness of this material. Hence, the obtained ultimate compressive strength (0.040 MPa) of the existing house (samples M1-M5) may serve as indicator of shear strength by considering an average of 15% (0.006 MPa). This percentage was determined according to the compressive/shear strength properties of rammed soil specimens reported in Table 1, e.g., Silva *et al.* (2014b) (12% of the compressive strength); Afanador-Garcia *et al.* (2013) (13%) and Meli (1998) (10-25%).

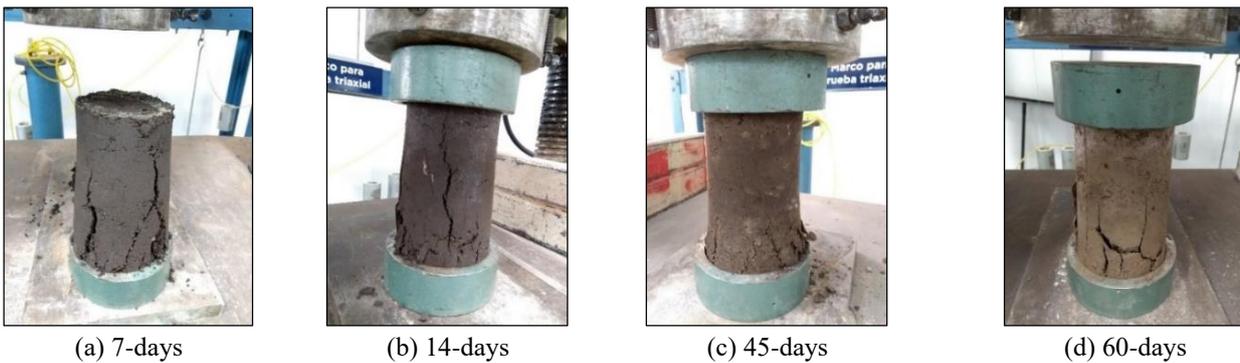
Fig. 16 Observed failure modes under compression in new soil specimens C at different ages

mentioned in the introductory sections of this research paper, as well as the envelope of suitable soils for rammed earth proposed by Houben and Guillaud (2008). In order to compare the plasticity properties of the soil in qualitative terms, it was developed the dropping ball test with an approximated water content of 18%. The samples presented a good plasticity without substantial cracks. Furthermore, the cylinders were filled up in three layers and compacted with a rammer until reaching a visual compaction as the artisanal technique (Fig. 14(b)). The new soil specimens were not capped, instead, it was used neoprene retainers (Fig. 16) to be tested with the UTM at different ages. The failure modes of the new soil samples *C* under compression are shown in Fig. 16. It is worth noting that the level of moisture evidently decreases with age. The correlation between water content and strength is also another relevant contribution of this paper (see Table 5 and Figs. 13(b), 16 and 17). The 7-days samples (moisture 17.61%) (Fig. 16(a)) mainly presented several vertical cracks ending with a semi-diagonal distribution, and the 14-days shown (moisture 18.54%) (Fig. 16(b)) a similar failure but with a combination of vertical cracks and bottom crushing. The 45-days (moisture 14.67%) (Fig. 16(c)) samples exhibited a

failure governed by bottom crushing and the 60-days (moisture 3.52%) (Fig. 16(d)) samples the formation of circular delamination and bottom crushing.

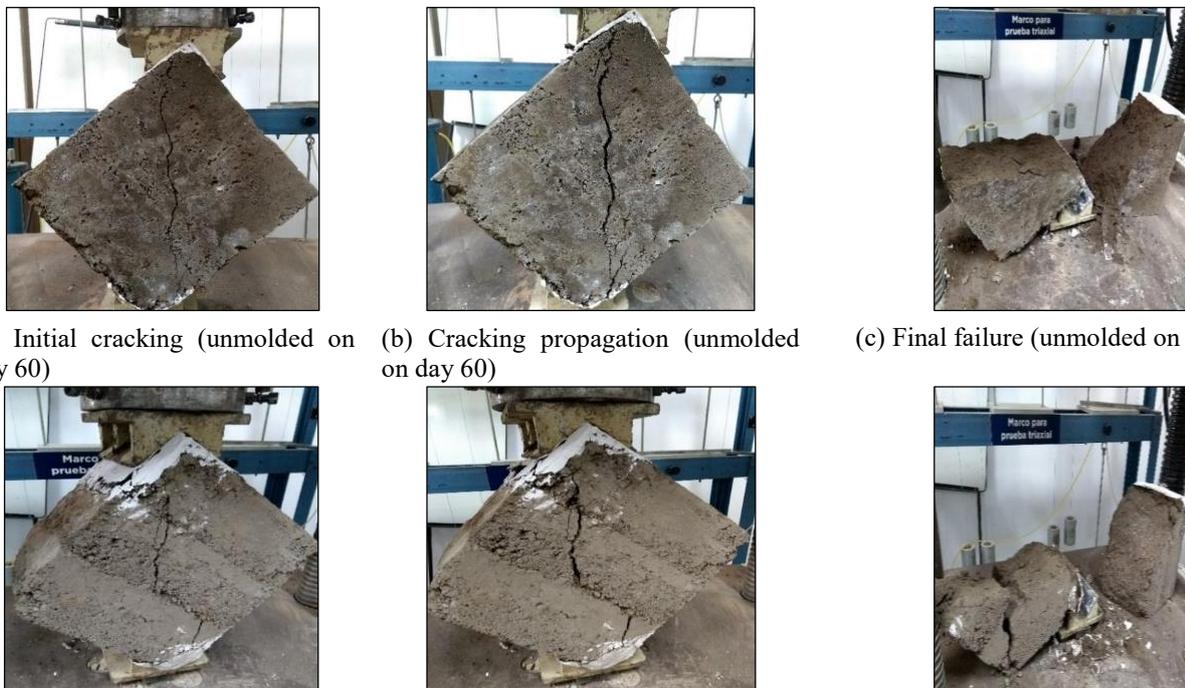
Fig. 18 Observed failure modes under diagonal shear on new compressed soil wallettes unmolded at different stages and variations in water content %

(a) Initial cracking (unmolded on day 60) (b) Cracking propagation (unmolded on day 60) (c) Final failure (unmolded on day 60)

(d) Initial stepped cracking (unmolded on day two) (e) Final cracking (unmolded on day two) (f) Ultimate failure (unmolded on day two)
