Correlation of damage and analysis of R/C building: Experience from the 1995 Kobe earthquake

Taizo Matsumori† and Shunsuke Otani‡

Abstract. During the 1995 Hyogoken-Nanbu Earthquake, a reinforced concrete building, called *Jeunesse Rokko*, suffered intermediate damage by forming a beam-yielding (weak-beam strong-column) mechanism, which has been regarded as the most desirable earthquake resisting mechanism throughout the world. High cost to repair damage at many beam ends and poor appearance expected after the repair work made the owner decide to tear down the building. Nonlinear earthquake response analyses were conducted to simulate the behavior of the building during the earthquake. The influence of non-structural members was considered in the analysis. The calculated results were compared with the observed damage, especially the location of yield hinges and compression failure of spandrel beams, and the degree of cracking in columns and in column-girder connections.

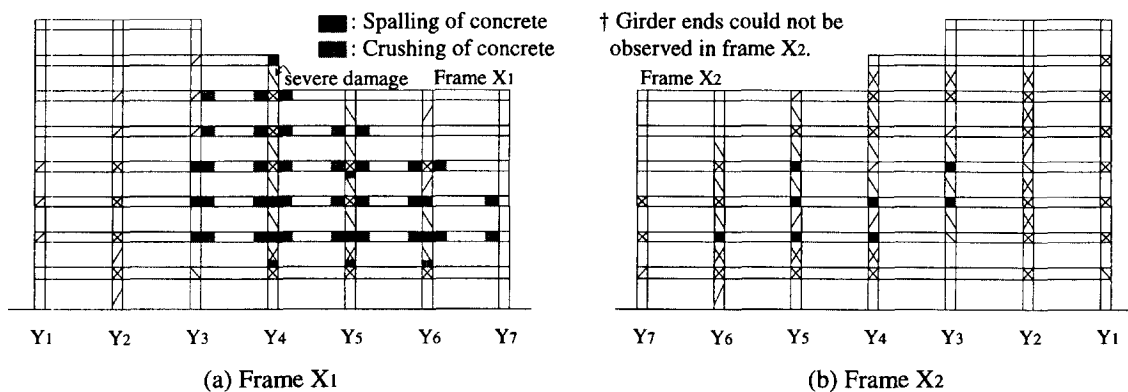
Fig. 3 Distribution of damage in longitudinal frames

Larger damage was observed in the longitudinal direction than in the transverse direction; a typical beam-yielding mechanism was formed with flexural crushing of concrete and wide crack openings at the ends of most girders. Crushing of concrete and buckling of reinforcing bars were observed at the top of spandrel ends. X-shaped shear cracks were observed in many columns and column-girder connections especially on the exterior sides. Outline of the damage is shown in Fig. 3.

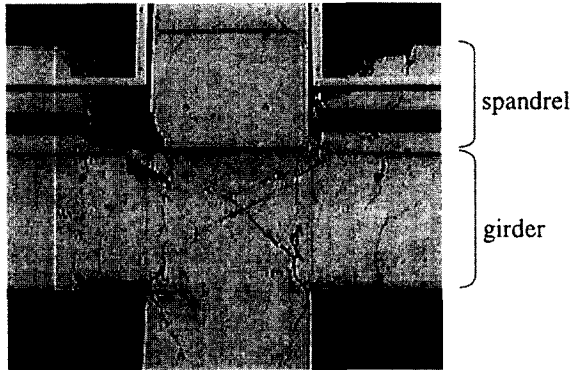
Flexural crushing of concrete and wide crack openings were observed at the ends of most girders at every floor level. Typical damage is shown in Photo. 3. The width of cracks was 0.2 to 1.4 mm at the ends, and 0.2 to 2.0 mm in the mid-span. Flexural cracks narrower than 0.1 mm were also found in transverse beams. All of the reinforced concrete spandrel beams placed on 2nd to 6th-floor girders were crushed at the ends adjacent to the columns; reinforcing bars were exposed and buckled. The spandrel beams on 7th-floor girders, on the other hand, were found to suffer slight damage.

X-shaped shear cracks were observed in many interior girder-column connections in the longitudinal direction (Photos. 3 and 4). The damage was relatively severe between 3rd- and 5th- floor column-girder connections; the width of shear cracks was more than 2 mm, and the spalling of concrete was also observed. The damage was lighter in the connection at X_1/Y_2 than in the other interior connections of the same floor. Shear cracks on the exterior face were wider than those on the interior face; the girders were connected to columns eccentrically at the outer face, and the transverse beams were connected inside of the connections.

Photo. 3 Column-girder connections in frame X_1 Photo. 4 Column-girder connections in frame X_2
