Smart Structures and Systems, Vol. 15, No. 3 (2015) 523-541 DOI: http://dx.doi.org/10.12989/sss.2015.15.3.523

# Effects of local structural damage in a steel truss bridge on internal dynamic coupling and modal damping

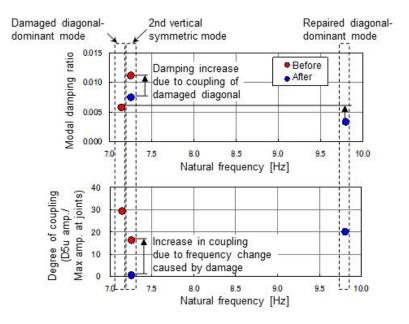
In order to understand coupling between the 2nd vertical symmetric mode and diagonal-dominant mode for D5 with the partial fracture, an additional ERA analysis was conducted with data measured with one sensor at D5 and two at the lower chords. Fig. 15 shows the relation between natural frequency and modal damping ratio for the diagonal-dominant mode and the 2nd vertical symmetric mode, and the relation between natural frequency and degree of dynamic coupling was defined by dividing the component in modal vector for D5 by that at the lower chord. For the 2nd vertical asymmetric mode, although no significant coupling of D5 with the main truss was observed after the repair, D5 diagonal before the repair was coupled clearly due to decrease in natural frequency of diagonal-dominant mode. The coupling of D5 with the main truss caused an increase in modal damping of the 2nd vertical symmetric mode possibly due to damping increase in the damaged diagonal.

Fig. 15 Changes in modal properties of 2nd vertical symmetric mode before and after repair
