Seismic vulnerability and preservation of historical masonry monumental structures

Abstract. Seismic damage and vulnerability of five historical masonry structures surveyed after the 1999 Kocaeli and Duzce, Turkey earthquakes are discussed in this paper. The structures are located in two neighboring cities that have been struck by five very large ($M_s \geq 7.0$) earthquakes during the 20th century alone. Older masonry mosques with arches and domes and their masonry minarets (slender towers) were among the most affected structures in this highly seismic region. While some of the religious and historical structures had virtually no damage, most structures suffered significant damage or collapsed. In the city of Bolu, for example, approximately 600-year-old Imaret, 500-year-old Kadi, 250-year-old Sarachane, and 100-year-old Yildirim Bayezid mosques suffered substantial structural damage after the 1999 earthquakes. Another historical mosque surveyed in Duzce partially collapsed. Most common factors contributing to deterioration of historical structures are also presented. Furthermore, a brief overview of issues associated with analysis and modeling of historical masonry structures is

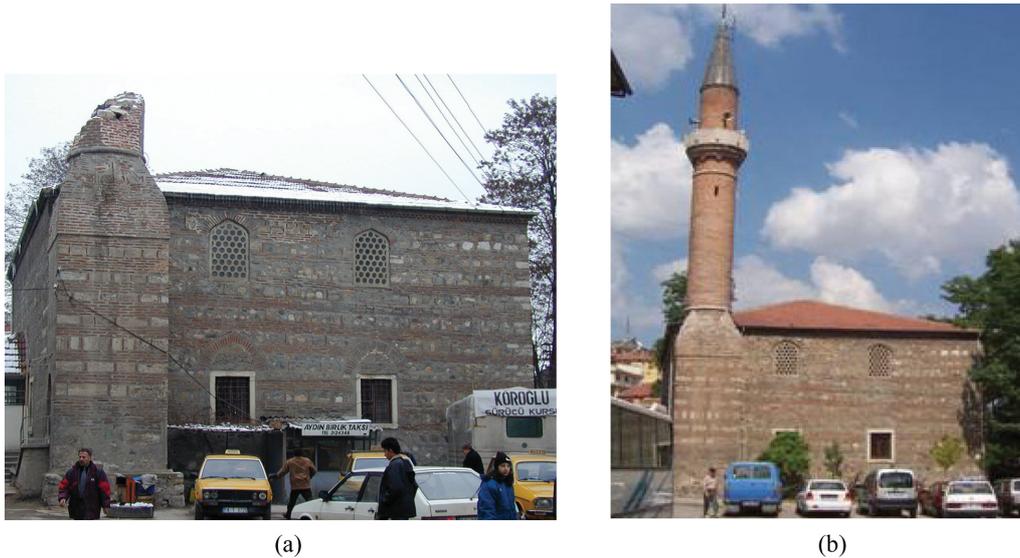
Fig. 1 Imaret mosque: (a) minaret collapsed during the 1999 earthquakes and (b) after the minaret is rebuilt

Old brick masonry minaret collapsed and Imaret mosque was closed after the 1999 earthquakes due to cracks in the walls (Sezen *et al.* 2003). The collapsed unreinforced masonry minaret was rebuilt (Fig. 1) and the large cracks in the walls were repaired by injecting mortar inside the cracks. Some of the vertical and diagonal cracks in the east and north walls were 2 m or longer (Fig. 2).
