24 January 2020 Sivrice (Elazığ) earthquake damages and determination of earthquake parameters in the region

Keywords: Sivrice; earthquake; masonry; reinforced-concrete; structural damages; spectra

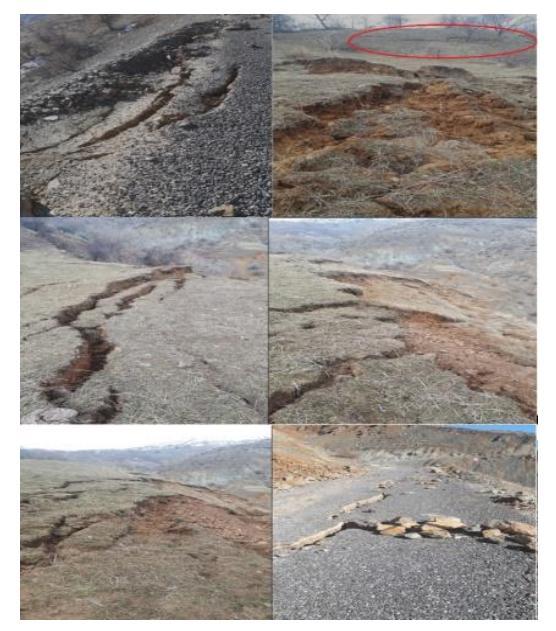
Fig. 12 Ground rupture observed after the earthquake

field and progressed with a definite traceable strike. Fractures and rock fall events were observed on roads in this region. Visual images of these damages were shown in Fig. 12.

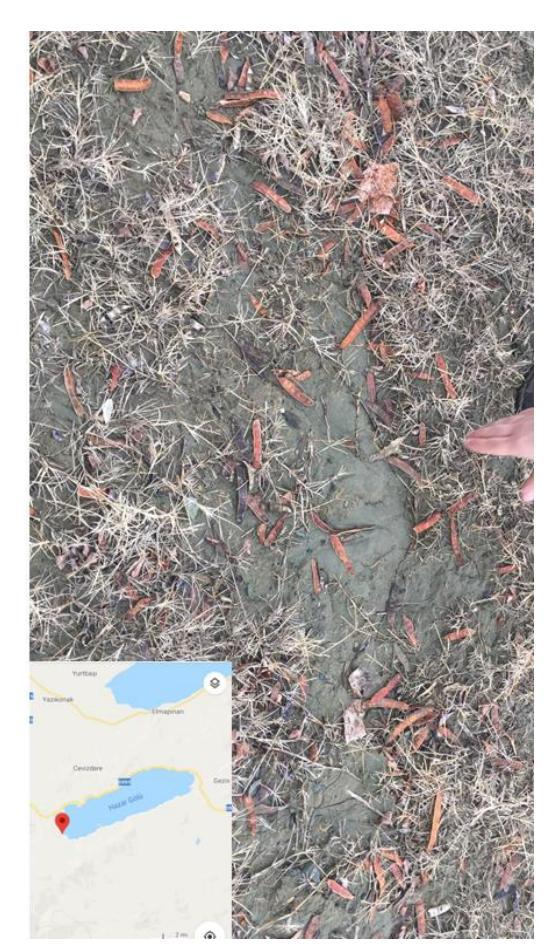
Fig. 13 Local liquefaction traces observed on the shore of Lake Hazar

On the other hand, local liquefaction was observed on the shore of Lake Hazar. However, the fact that liquefaction is at a very low level and not seen in any other area means that this earthquake does not create an acceleration value that exceeds the threshold acceleration value (Fig. 13)

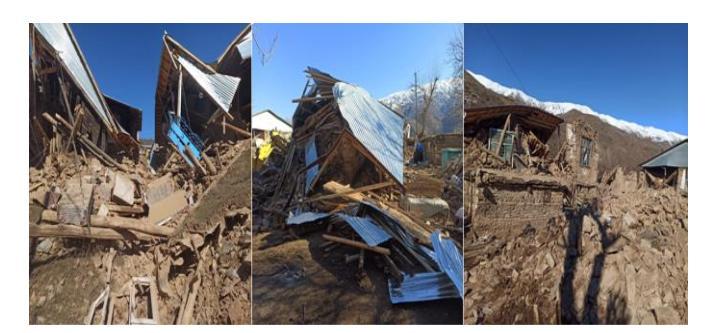
Fig. 14 Completely collapsed masonry structures

bricks and natural stones. Additionally, most traditional and historical structures are constructed of masonry. The reason for choosing masonry structures is that they can be easily made of local material and are economic. These types of structures are generally constructed haphazardly without sufficient engineering knowledge or awareness of standards. As masonry structures consist of loose material like bricks and mortar, they have low ductility. Additionally, they have lower capacity to absorb earthquake energy compared to RC structures. The walls of masonry structures both surround the area of use in the building and act as load-bearing elements. Load transfer is between the material used and the mortar. The elements of the loadbearing system in masonry buildings comprise floors, the walls where they are supported and the foundations of these walls. Damage to masonry structures generally forms as cracks in walls, settling of foundations, and disruption or displacement of material used. Generally, the tensile strength of wall material used in masonry structures and the shear strength of mortar are low. The most important cause of damage is shear strain forming in the walls because of the earthquake causing fractures, separations and displacement due to tensile strain. Additionally, adherence must be provided between material to ensure healthy load transfer (Bilgin and Huta 2018, Çırak 2011, Karaşin *et al.* 2016, Karaşin and Öncü 2009, Korkmaz *et al.* 2016, Hadzima and Nyarko *et al.* 2018b, Özlük *et al.* 2019, Özlük *et al.* 2019, Bilgin and Hysenlliu 2020). Within the scope of this study, the structures in two settlements closest to the epicenter of the Sivrice earthquake of Çevrimtaş and Doğanbağı villages were primarily examined. Fig. 14 shows fully collapsed masonry structures.

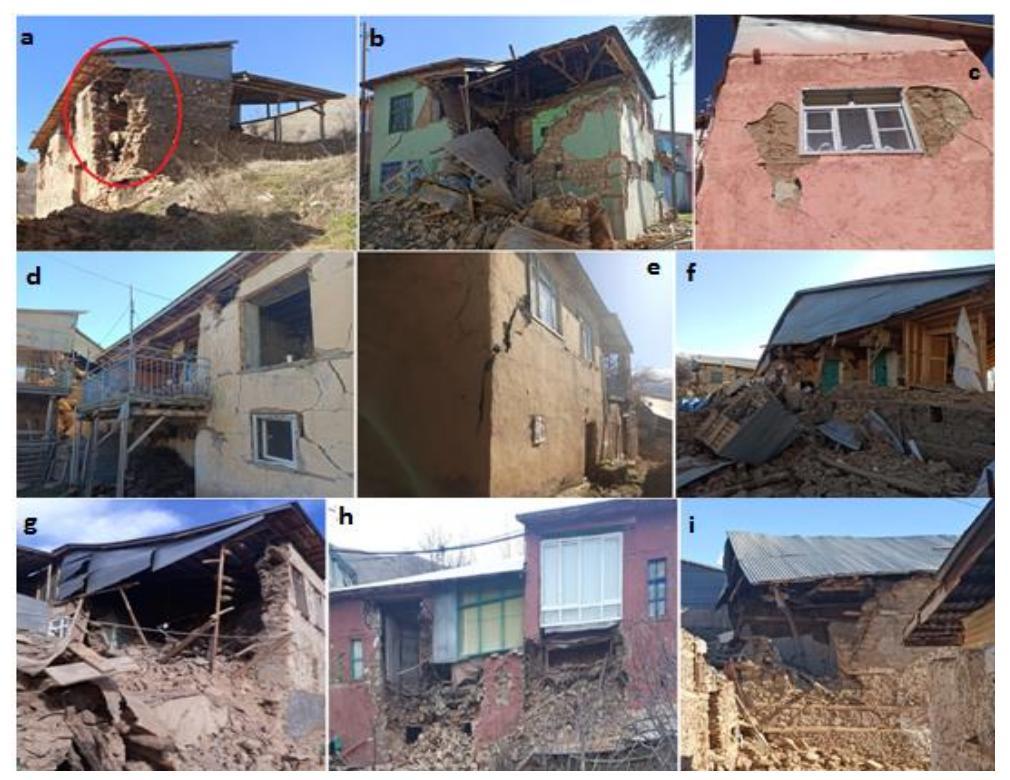
Fig. 15 Damage observed in masonry structures (a) separation at corners, (b) damage to structural wall, (c) damage to nonstructural elements, (d) damage caused by large openings, (e) structural wall damage caused by large window opening, (f) out-of-plane damage to structural wall, (g) out-of-plane damage to structural wall, (h) damage to structural wall by large window openings, (i) earthen roof damage, damage to wooden beams and out-of-plane damage

Fig. 15 shows images of different types of damage commonly observed in masonry structures constructed using local material.

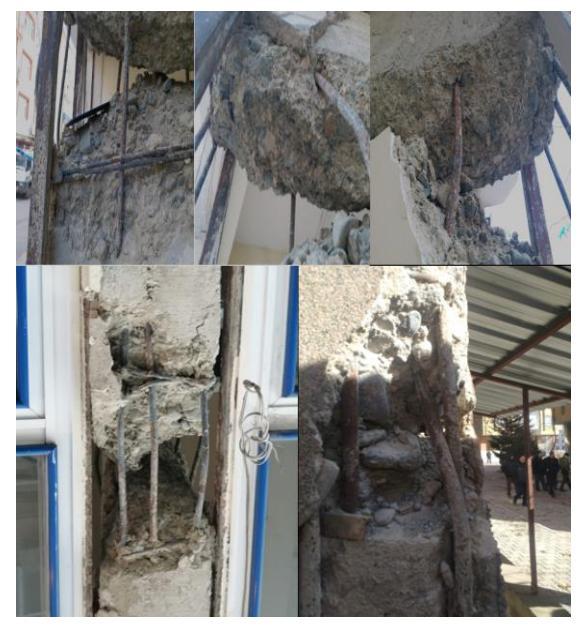
Fig. 16 Damage by poor concrete properties

earthquake. Inappropriate grain distribution and size in aggregate, direct use of aggregate obtained from rivers found in the region and inappropriate concrete compression processes led to concrete with very low strength to segregation. Visual images of low strength concrete are shown in Fig. 16.

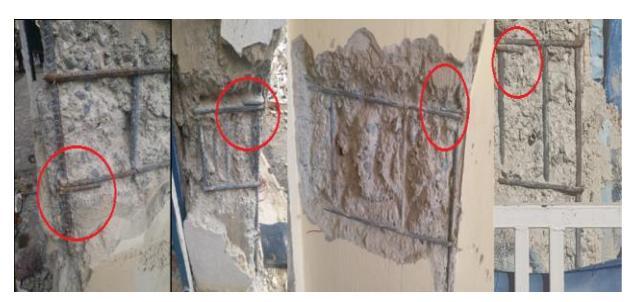
Fig. 17 Improper detailing transverse reinforcement (90° instead of 135°)

While transverse reinforcement used in structural elements in buildings that built in earthquake regions should have 135° , they were bent at 90° . Visual images related to this situation are shown in Fig. 17. Additionally, the lack of use of crossties negatively affected the degree of damage.

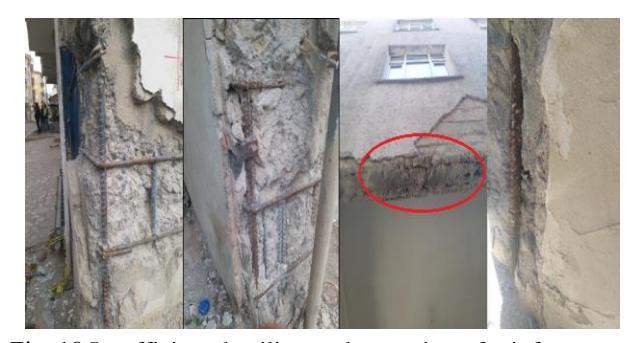
Fig. 18 Insufficient detailing and corrosion of reinforcement

One of the damages observed in damaged structures was insufficient concrete cover layers, removing the adherence between the reinforcement and concrete. This situation also caused corrosion of reinforcement. Reinforcement corrosion was commonly observed due to the content of the aggregate used in the concrete mix. Insufficient fixtures and corrosion are shown in Fig. 18. Corrosion of reinforcement for different reasons reduces the load-bearing capacity.

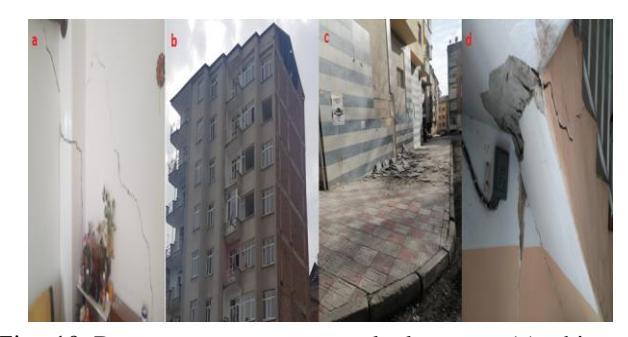
Fig. 19 Damage to non-structural elements, (a) chimney damage, (b)roof gable wall damage, (c)damage to external cladding, (d) stair damage

Damage was observed in non-structural elements also. Damage was observed in roof gable walls, ventilation chimneys, external cladding and stairs. Damage to these elements was shown in Fig. 19.

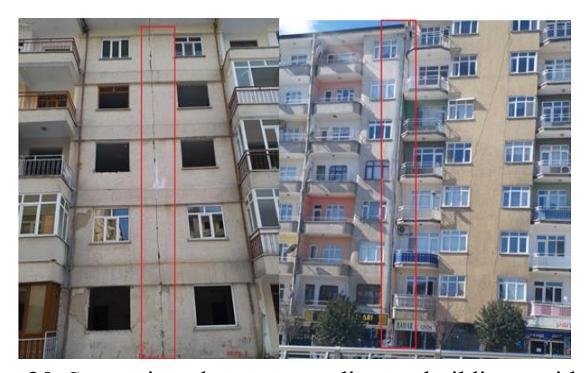
Fig. 20 Separation damage to adjacent buildings without dilatation joints

Though significant structural damage was not observed in relation to not leaving necessary dilatation spaces between adjacent buildings, the expected separation between buildings was observed (Fig. 20).

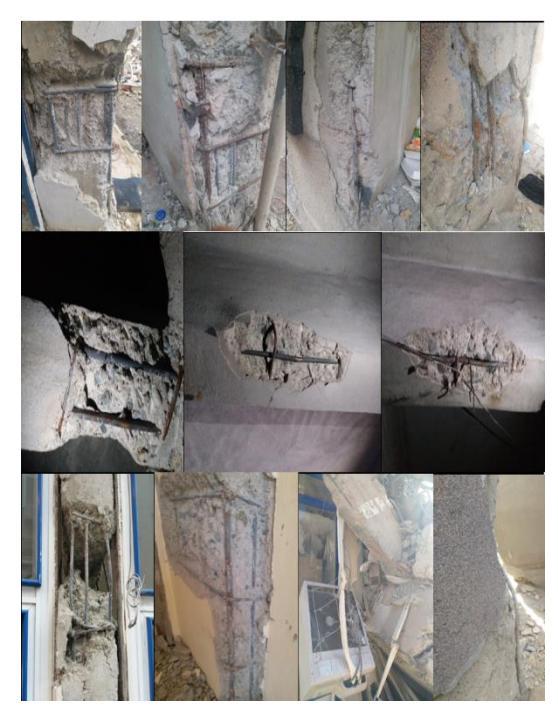
The lack of enough transverse reinforcement caused a variety of damage to structural elements. The clearest form of this damage was buckling of reinforcement longitudinally.

Fig. 21 Insufficient transverse reinforcement intervals and damage

Buckling of longitudinal reinforcement caused direct damage to concrete leading to loss of load-bearing capacity of structural elements. Additionally, improper detailing transverse reinforcement in columns was observed. Visual images related to insufficient transverse reinforcement intervals and damage to columns and beams are shown in Fig. 21.

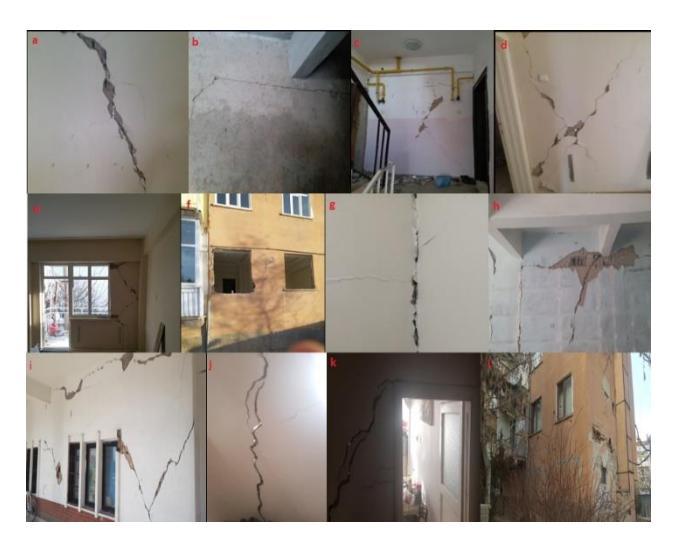
Fig. 22 Different infill wall damages

Infill walls are used to fill the frames in RC structures. At the same time, they limit the movement of the frame contributing to horizontal load carrying. Damage beginning with separations between infill walls and frames later proceeded to cross fractures with X form with higher horizontal load levels in earthquakes. Infill wall damage was commonly observed after the Sivrice (Elazığ) earthquake. This damage was observed as cross fractures, wall separations, frame-wall separations and space wall

damage in many buildings. Separation damage in walls (Fig. 22(a), 22(j)), frame-wall separation (Figs. 22(b) and 22(h)), X form cross fractures (Figs. 22(c), 22(d), 22(f), 22(i) and 22(l)) and damage in wall spaces (Figs. 22(e) and 22(k)) are shown below.

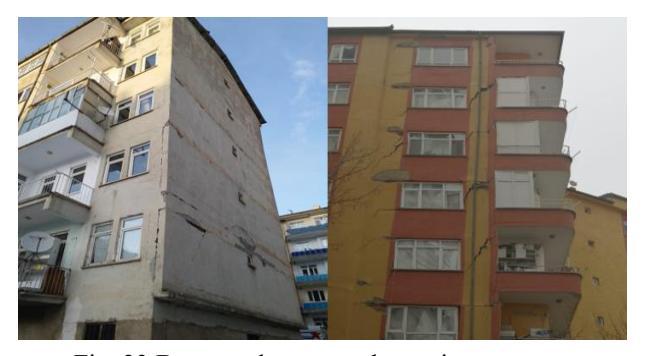
Fig. 23 Damage due to overhangs in structures

Damage of varying types occurred due to overhangs in structures. Design of structures without overhangs is one of the solutions that can be applied to prevent this type of damage. Damage due to overhang is shown in Fig. 23.

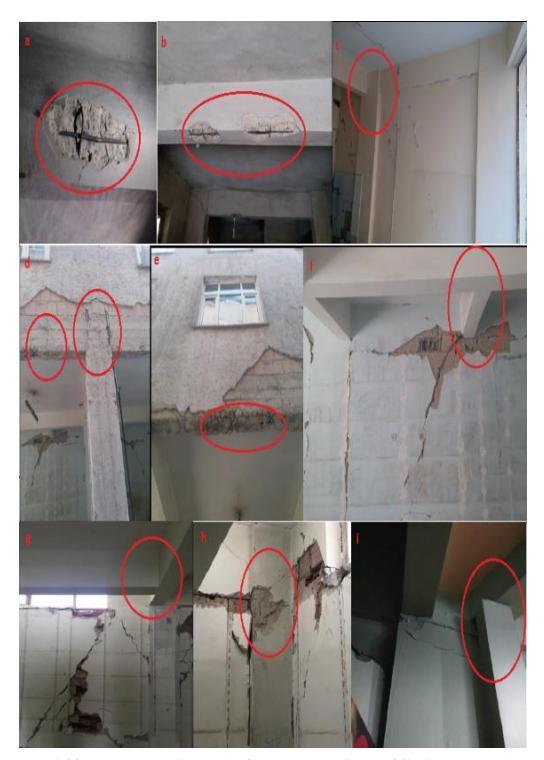
Fig. 24 Different design defects, (a) insufficient and smooth reinforcement use, (b) insufficient reinforcement, (c) column-beam eccentricity, (d) insufficient reinfor-cement where column-beams joint and beams with inappropriate size, (e) Insufficient beam size, (f) stud beam, (g) shear crack on column, (h) no overlap in beam-column joint

In addition to this damage, various types of damage formed in structural elements built without abiding by the rules of earthquake-resistant structural design. This damage is notable including design defencies such as shear damage in columns, insufficient longitudinal reinforcement, use of smooth reinforcement, insufficient reinforcement dimensions, stud beams at connections of beams within the load-bearing system, insufficient reinforcement in beamcolumn regions and eccentricity of column-beam connections. Images related to these design defencies are shown in Fig. 24.
