Strengthening of concrete damaged by mechanical loading and elevated temperature

Hammad Ahmad, Rashid Hameed*, Muhammad Rizwan Riaz and Asad Ali Gillani

Department of Civil Engineering, University of Engineering and Technology, G.T. Road Lahore, Pakistan

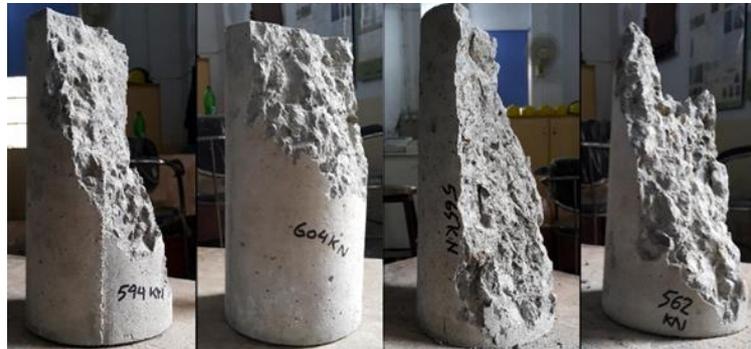
Fig. 1 Intact pieces of specimens fully damaged in compression

Displacement controlled compressive strength tests were performed on cylinders at loading rate of 2 mm/minute. Just after the peak load, the tests were stopped and compressive strength of each tested sample was obtained. The relatively large intact pieces of each failed sample in compression as shown in Fig. 1, were collected for re-casting of cylinder and then strengthening with CFRP. Similarly, split tensile tests were also performed and peak load for each sample was recorded. At failure, cylinders were divided into two pieces as shown in Fig. 2 and for each sample; both half cylindrical pieces were collected and re-joined using rich cement-sand mortar, and then strengthened using CFRP sheet.

The intact pieces of all eight concrete specimens failed in compression (refer to Fig. 1) were placed in steel molds as shown in Fig. 5 for re-concreting using mix having same constituents as that of old concrete. Before pouring concrete in each mold, fractured surface of old concrete was cleaned and moistened for better bond formation with new concrete. Compaction of each mold was done using vibrating table. Finally, the molds were covered by plastic sheets to avoid evaporation of water and de-molding was done after 24 hours of casting. Some of the samples after repair using fresh concrete are shown in Fig. 6. After 28 days of curing, the samples were left for drying. Four re-cast concrete cylinders were strengthened using full CFRP wrapping as shown in Fig. 7 and then testing under compressive loading. The remaining four cylinders were left unwrapped and re-tested in compression to investigate the regain in strength as of result of concrete repairing only.

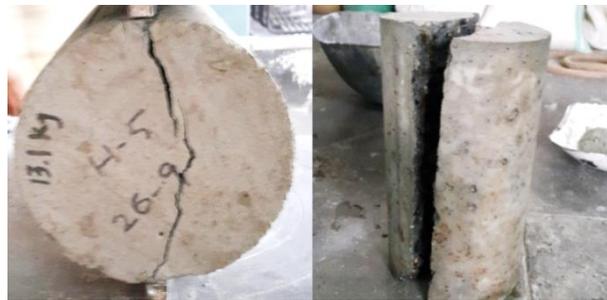
Fig. 2 Cylinder subjected to split tensile loading

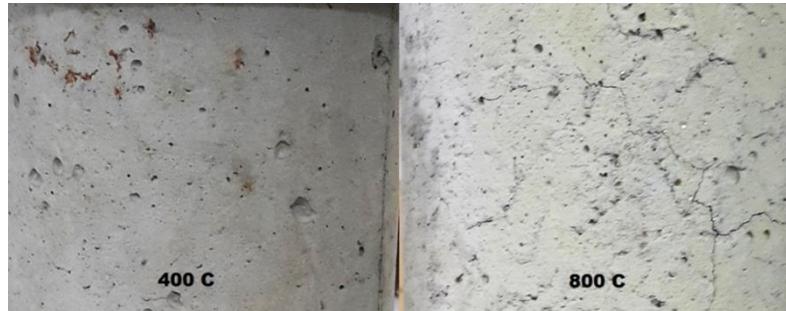
Fig. 4 Surface condition of samples after exposure to elevated temperature

cylinders exposed to 400°C did not show any significant damage whereas the concrete cylinders subjected to 800°C showed visible cracking and slight greenish color was also noticed on their surface as shown in Fig. 4.

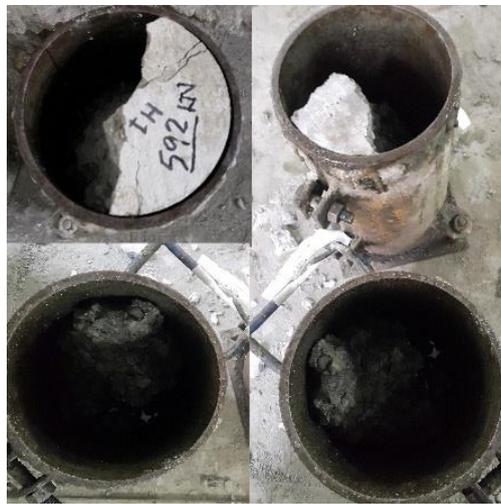
Fig. 5 Intact concrete placed in mold for re-concreting

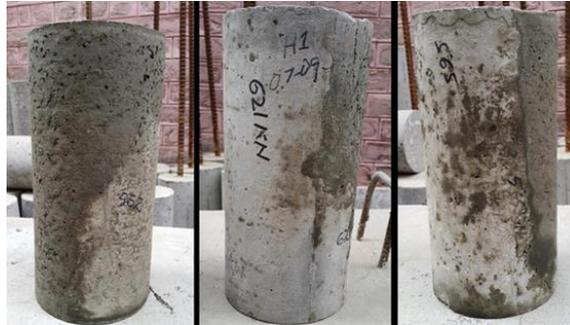
Fig. 6 Re-cast concrete cylinders

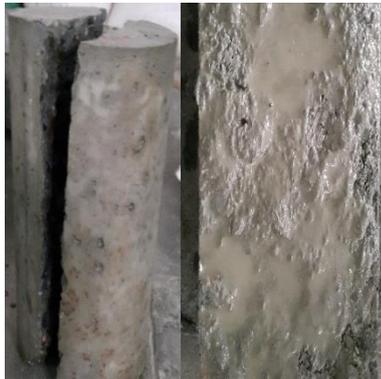
Fig. 8 Cement slurry applied on the inner surfaces of concrete cylinder

Similarly, the samples failed under tensile loading were joined together as shown in Fig. 8 by first applying cement slurry on their surfaces and then using rich cement-sand (c/s) mortar having ratio of 1:1. Moreover, the gaps left at both sides of joined specimens were also filled with c/s mortar. The repaired samples were placed in molds used to cast cylindrical concrete samples and the molds were tightened for adequate bonding of the joined concrete pieces. The specimens were

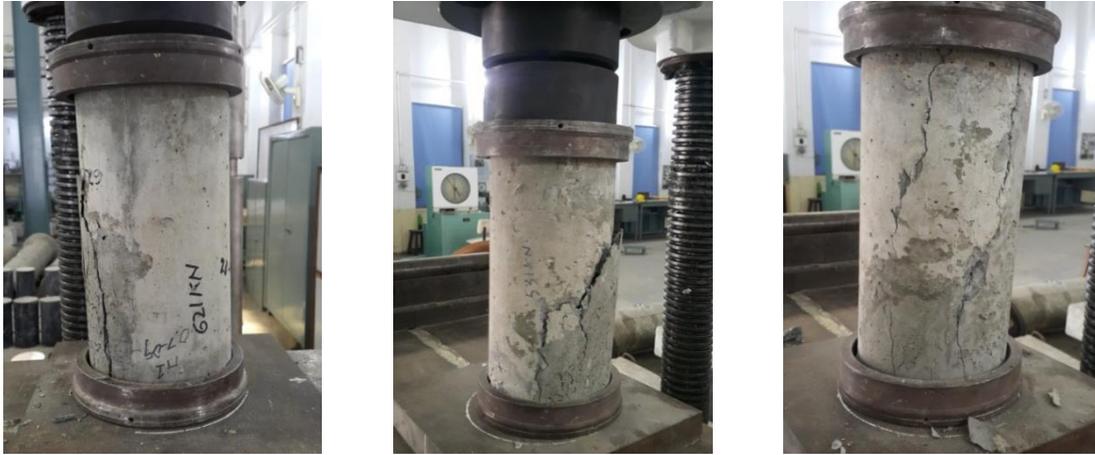
Fig. 14 Failure mode in compression (re-cast samples)

Failure mode of re-cast specimens in compression is shown in Fig. 14, where it is evident that failure was occurred due to separation of old and new concrete (bond failure) under compressive load. In case of strengthened re-cast specimens, highly brittle failure occurred due to the sheet rupture as shown in Fig. 15; this indicates that the CFRP sheet was effectively utilized in enhancing the load carrying capacity of re-cast specimens. Under the application of load, debonding of new and old concrete surfaces resulted into more lateral deformation and consequently, more stress is transferred to CFRP sheet which led to significant enhancement in load carrying capacity of strengthened concrete cylinders. It was further observed that inside concrete was disintegrated into small pieces at final failure stage as evident in Fig. 15. Failure mode of heat damaged specimens in compression is shown in Fig. 16. More severe and distributed damage was observed in concrete cylinders subjected to 800°C temperature which resulted in almost complete disintegration of cylindrical specimen. While in case of concrete cylinders subjected to 400°C temperature, failure in compression was almost similar to that observed in case of control samples; local crushing of concrete at ends or a distinct crack passing throughout the height of cylinder.

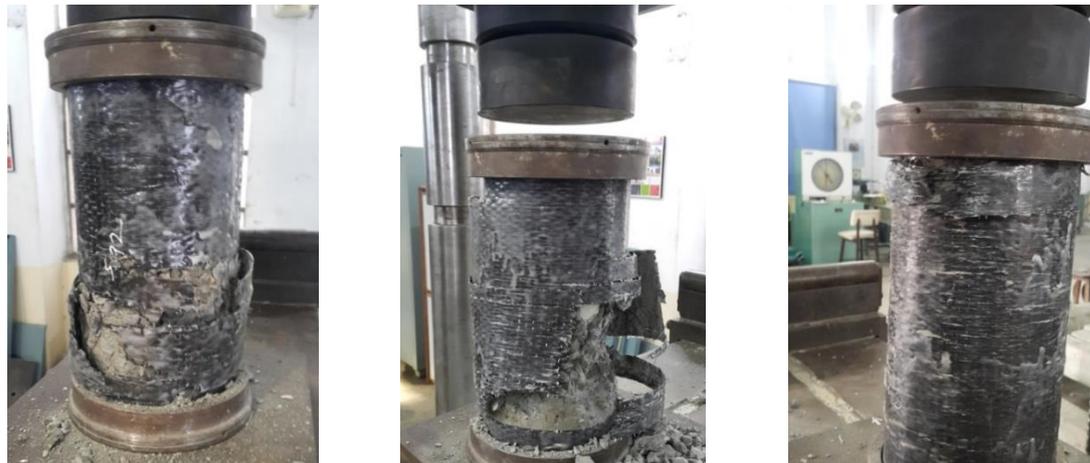
Fig. 15 Failure mode in compression (re-cast & strengthened specimens)

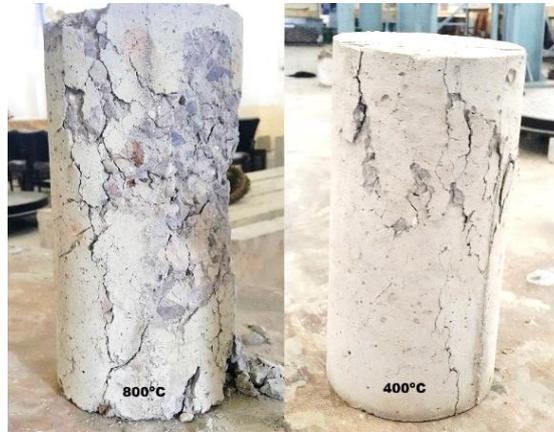
Fig. 16 Failure mode in compression (heated samples)

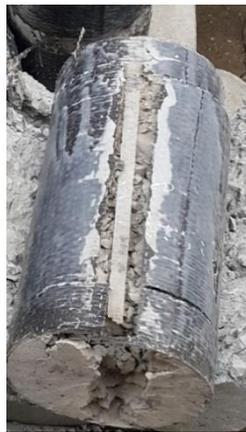
Fig. 19 Failure mode in splitting tensile test

Typical failure mode of strengthened concrete cylinder tested for split tensile strength is shown in Fig. 19 where it is clear that failure occurred due to local crushing of concrete and CFRP sheet under loading line rather than tensile rupture or de-bonding of CFRP sheet. Healthy concrete and un-strengthened heat damaged concrete samples were failed by splitting into two halves.
