Seismic risk investigation for reinforced concrete buildings in Antalya, Turkey

Abstract. Turkey is located in one of the most seismically active regions of in Europe. The majority of the population living in big cities are at high seismic risk due to insufficient structural resistance of the existing buildings. Such a seismic risk brings the need for a comprehensive seismic evaluation based on the risk analysis in Turkey. Determining the seismic resistance level of existing building stock against the earthquakes is the first step to reduce the damages in a possible earthquake. Recently in January 2020, the Elazig earthquake brought the importance of the issue again in the public. However, the excessive amount of building stock, labor, and resource problems made the implementation phase almost impossible and revealed the necessity to carry out alternative studies on this issue. This study aims for a detailed investigation of residential buildings in Antalya, Turkey. The approach proposed here can be considered an improved state of building survey methods previously identified in Turkey's Design Code. Antalya, Turkey's fifth most populous city, with a population over 2.5 Million, w

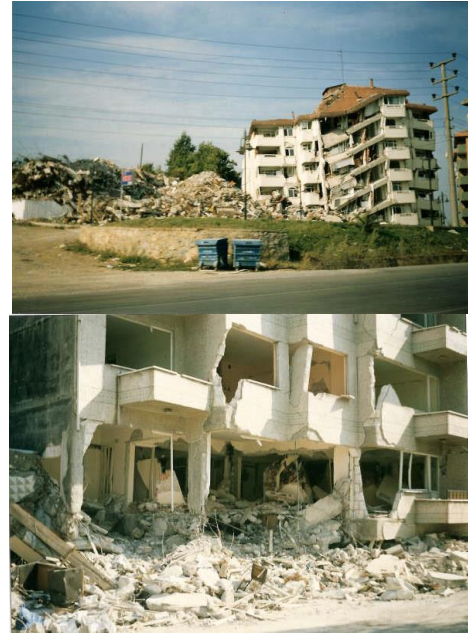
Fig. 2 Typical damages in R/C buildings after 1999 Marmara earthquakes in Turkey

In August and November 1999, two major earthquakes hit the northwestern region of Turkey and resulted in a loss of more than 50,000-property and 20,000-lives. Typical building damages following the 1999 Marmara earthquakes are presented in Fig. 2 (Korkmaz *et al.* 2010). After this countrywide catastrophic experience, researchers focused on existing buildings and carried out various projects. In addition, over the last two decades disaster mitigation programs have gone through a paradigm shift. As a conclusion of the research that was conducted, most of the existing buildings were tagged as suspicious in terms of the structural behavior satisfaction level for future earthquakes. After the 1999 Marmara earthquakes, Turkey has experienced other major earthquakes in 2003 in Bingol and two recent devastating earthquakes in the east part of the country. These include the March 2010 Elazig and the October 2011 Van earthquakes. The results were similar to the 1999 Marmara earthquakes. Structural damage due to the infill walls were typical during these earthquakes (Murty *et al.* 2006).

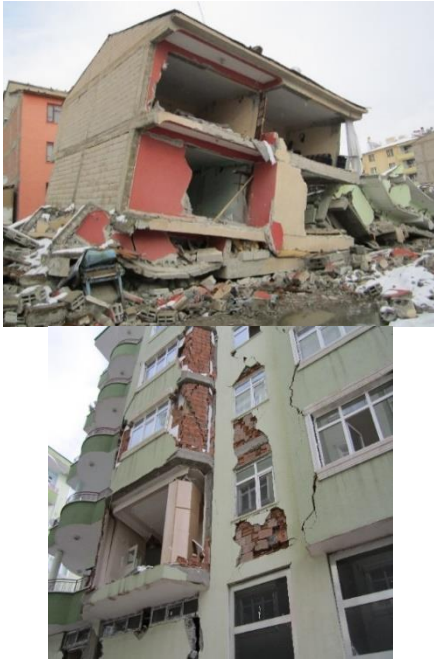
Fig. 3 Typical damages in 2011 Van earthquakes in Turkey

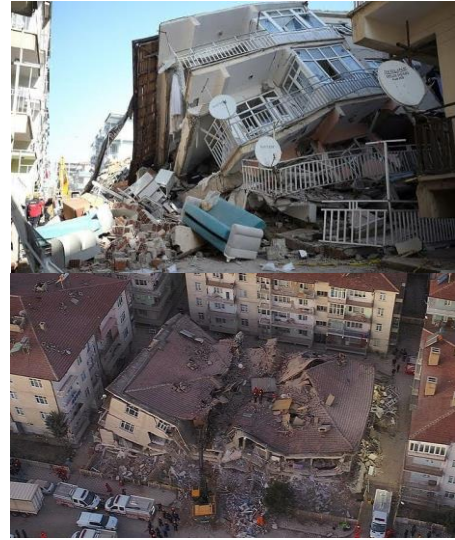
Fig. 4 Typical damages in 2020 Elazig earthquakes in Turkey

building stock in the region is low-story masonry buildings constructed with walls, with low quality mortar. The damage that occurred in infill walls is similar to those observed in previous earthquakes. In the October 23, 2011 Van earthquake ($M_w=7.2$), the disaster was devastating as seen in Fig. 3. The buildings responded insufficiently during the experienced earthquake, even the earthquake was not at a level of a design earthquake defined in Turkish Design Code. After the main earthquake occurred in November 9, 2011, the Van Edremit earthquake ($M_w=5.6$) happened as a following earthquake. In this earthquake, more than 2000 buildings collapsed, and more than 4000 buildings were severely damaged. More than 600 people lost their lives and more than 4000 people were injured. The southeast part of Turkey has experienced a strong earthquake in Elazig ($M_w=6.7$) very recently on Jan 24, 2020. It was the second biggest earthquake in this region after the 2010 earthquake. This earthquake caused significant damage and led to the loss of lives. More than 300 buildings collapsed and 7,500 buildings were damaged. In Fig. 4, the damage that occurred in the region can be seen.
