A new method for repair of fiber reinforced concrete corbels using steel threaded rods

Abstract. The aim of this study is to investigate the efficiency of using threaded rods and steel profiles to produce a steel confining system for rehabilitation of damaged concrete corbels for the first time in literature. Some of the specimens were repaired by crack repair epoxy before being confined for further enhancement. A total of 19 two sided damaged corbels were used in the study with different mechanical properties and parameters but similar dimensions. The differences were in rehabilitation style, shear span, fiber percentage, reinforcement steel diameter, and concrete strength. The rehabilitated specimens were loaded with vertical load until failure. Four different configurations were used in the investigation. Test results show that the proposed rehabilitation technique is effective to enhance the load capacity of the corbels and to improve their ductility. Moreover, new formulations were proposed to calculate the load capacity of the rehabilitated corbels. A good fit was observed between numerical and experimental results.

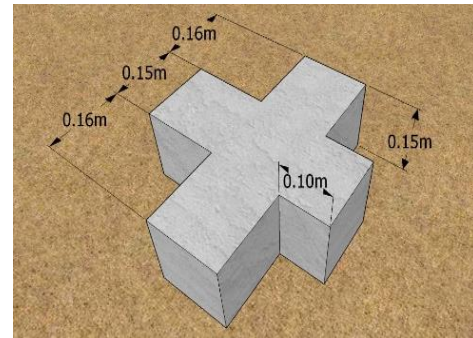
Fig. 1 Dimensions of the specimens

Nineteen two-sided damaged reinforced concrete corbels have been rehabilitated in the experimental study. These corbels had been failed in the studies carried out by Kamil (2016), Hussein (2016). All corbels have the same dimensions. Dimensions of cross sections of corbels are 150×150 mm. The column parts have the same cross sections (150×150 mm). The length of the corbels is 160 mm for both sides. The length of the columns is 160 mm and 100 mm above and below the corbels, respectively. The details of the corbel are shown in Fig. 1.

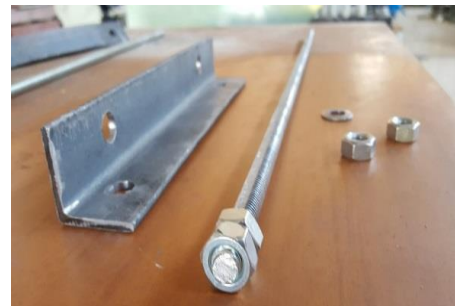
Fig. 2 Steel confining elements

Steel confinement configuration was achieved by 0.2 m and 0.6 m steel threaded rods and 27 cm L-shaped steel profiles (L40×40×4) as shown in Fig. 2.

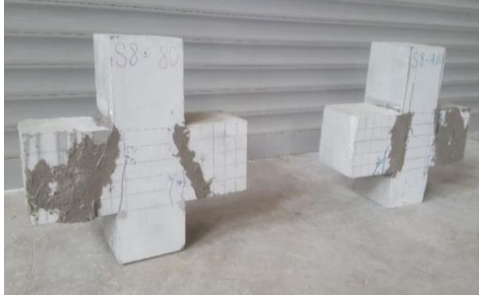
Fig. 3 Corbel coated with high viscosity epoxy

externally to prevent leaking of the very low viscosity epoxy, Fig. 3. Very small cracks (smaller than 5 mm) were filled with repairing epoxy using the “Gravity Feed” method to rehabilitate them, Fig. 4. Before injecting the epoxy, cracks were cleaned by compressed air to get rid of loose particles inside that can negatively affect the bonding performance of epoxy.

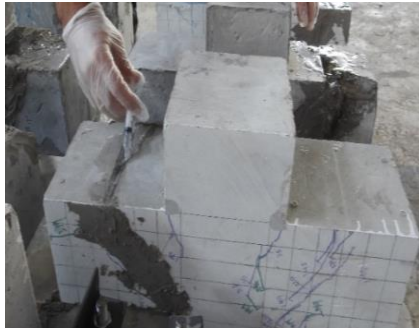
Fig. 4 Filling small cracks with repairing epoxy

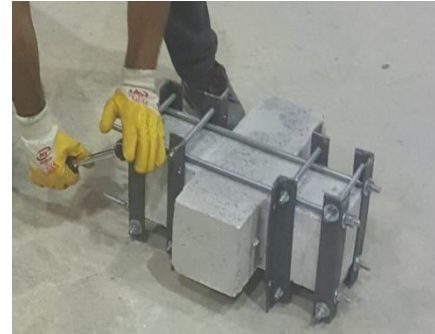
Fig. 5 Installing the steel confinement

12 mm diameter steel threaded rods were cut into 0.6 m and 0.2 m pieces. Then, L-shaped (L40×40×4) steel profiles were cut into 27 cm pieces, and holes were prepared in L-shaped pieces by steel drilling machine. All the pieces were

combined and tightened by using nut keys (Fig. 5).

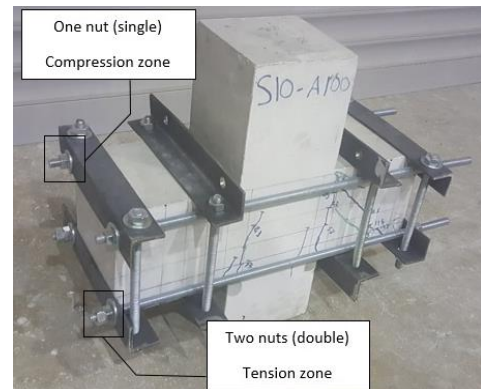
Fig. 6 Doubling nuts

Threaded rods that exist in the tension zones were connected to the steel sections with double nuts because of the expected high tensile stress. Since ductility of the new composite system-the confined concrete- will be very high, the nuts will be under higher strength for a long time. Therefore, the safety of the system was increased by doubling the nuts in the tension zones (Fig. 6).

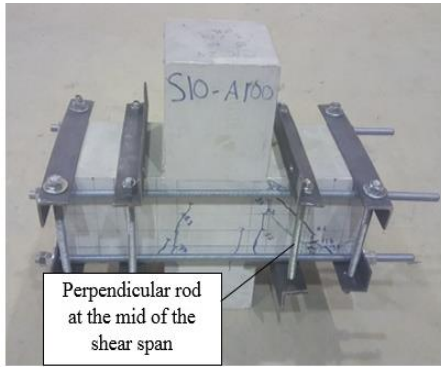
Fig. 7 Place of the middle steel rods

corresponding shear spans. The distance of the center of the outer steel profiles is 140 mm from the column face for all corbel specimens. The centers of the perpendicular threaded rods were placed parallel to the middle of the shear span to achieve the most effective performance against shear cracks (Fig. 7).

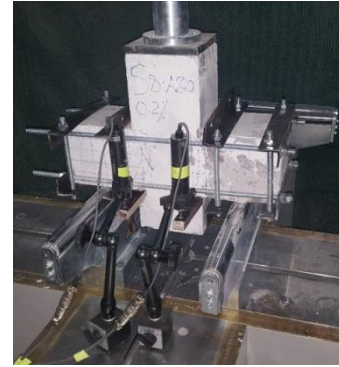
Fig. 8 A prepared specimen to be tested

Loading tests of corbels were carried out via 500 kN capacity displacement controlled loading machine. The load is transferred from the machine to the top of the upper column by a square shaped steel transmission plate in order to distribute the load to the column homogeneously. The loading tests were carried out in a displacement controlled mode with a rate of 0.2 mm/minute. Deflections of corbels were measured via two linear variable displacement transducers (LVDTs). LVDTs were placed at the junction of the bottom of the corbel and column face for each corbel side (Fig. 8), since the highest deflections occur in this region.

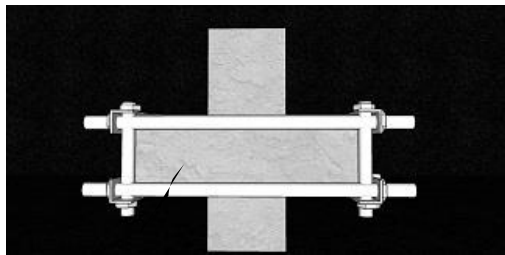
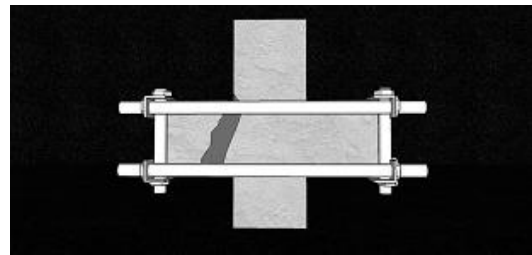
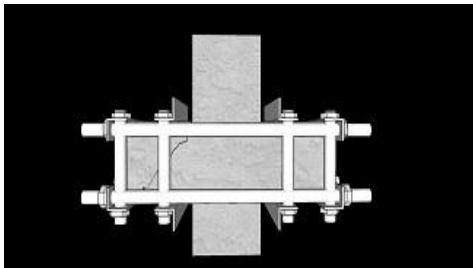
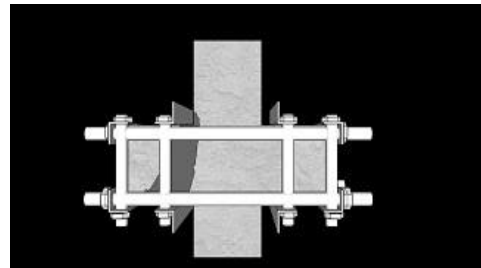
(a) Configuration -1 (Control)

(b) Configuration -2

(c) Configuration -3

(d) Configuration -4

Fig. 9 Schemes of rehabilitation configurations

Configuration	Steel Profiles	Horizontal Rods	Vertical Rods	Epoxy Details
Configuration -1	4 rods	4	4	No
Configuration -2	4 rods	4	4	Yes
Configuration -3	8 rods	4	8	No
Configuration -4	8 rods	4	8	Yes

pieces of horizontal and 8 pieces of perpendicular threaded rods and 8 pieces of steel profiles in addition to repairing with the epoxy. Details and schemes of the configurations are shown in Table 4, and Fig. 9. The resulting load-deflection graphs of the 19 tested corbels are shown in Figs. 10, 11(a) and (b), 12(a)-(e), and 13(a)-(k).

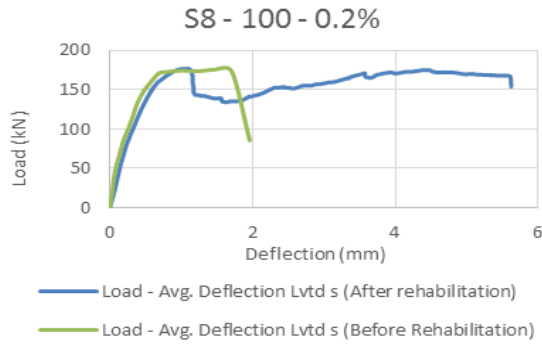
Fig. 10 Configuration -1 result (Control specimen)

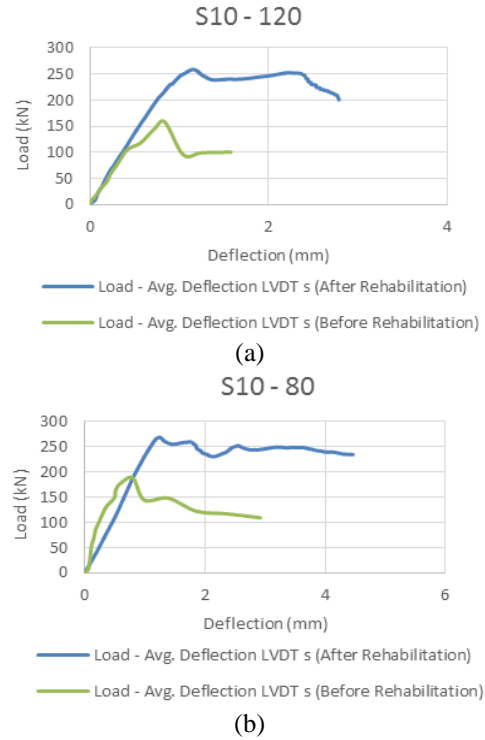
Fig. 11 Configuration -2 results

In configuration-2 the concrete failed earlier as compared to configuration 4 because of the lower number of perpendicular pieces of threaded rods. These pieces let the repaired concrete resist the load. So, the steel system did not work directly till the repaired concrete failed. Therefore, the high amount of ductility was achieved after the concrete failed. It was noticed that once the epoxy failed, it caused a semi-sudden loading of the steel system, and this load affected the performance of the steel slightly. However, the

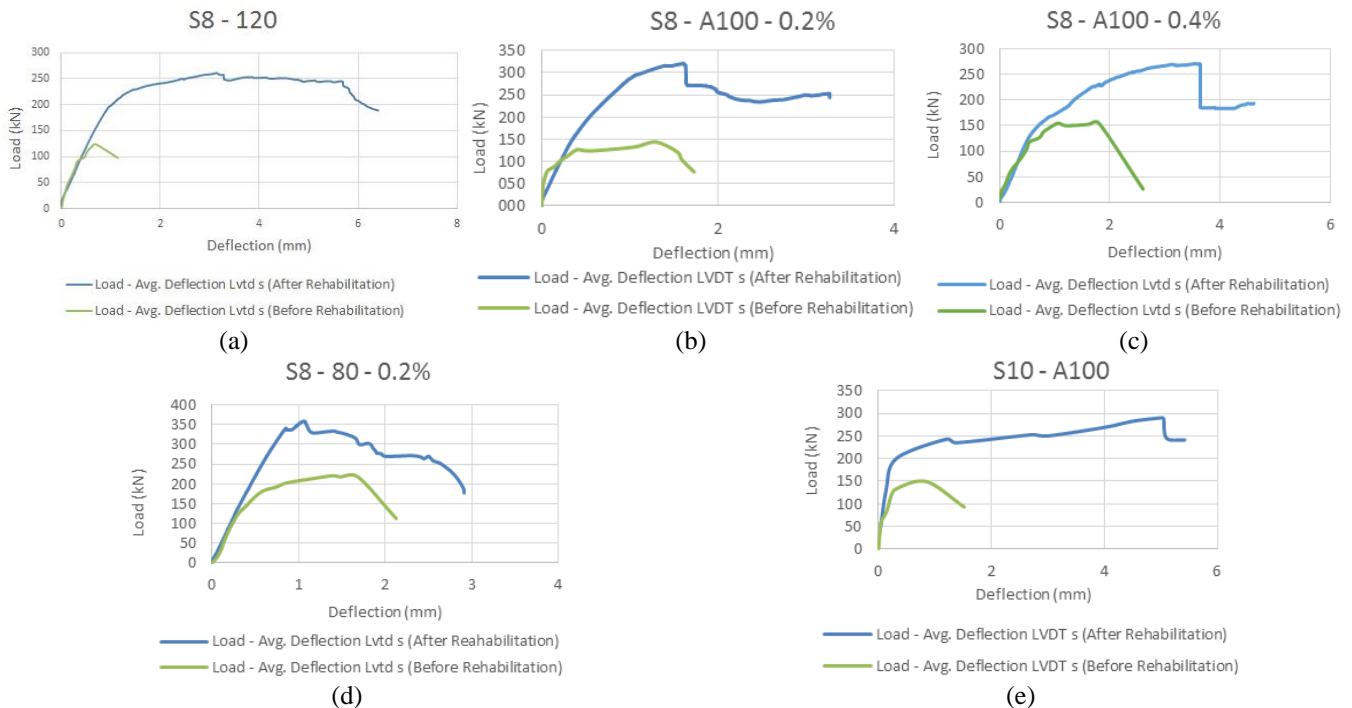
Fig. 12 Configuration -3 results

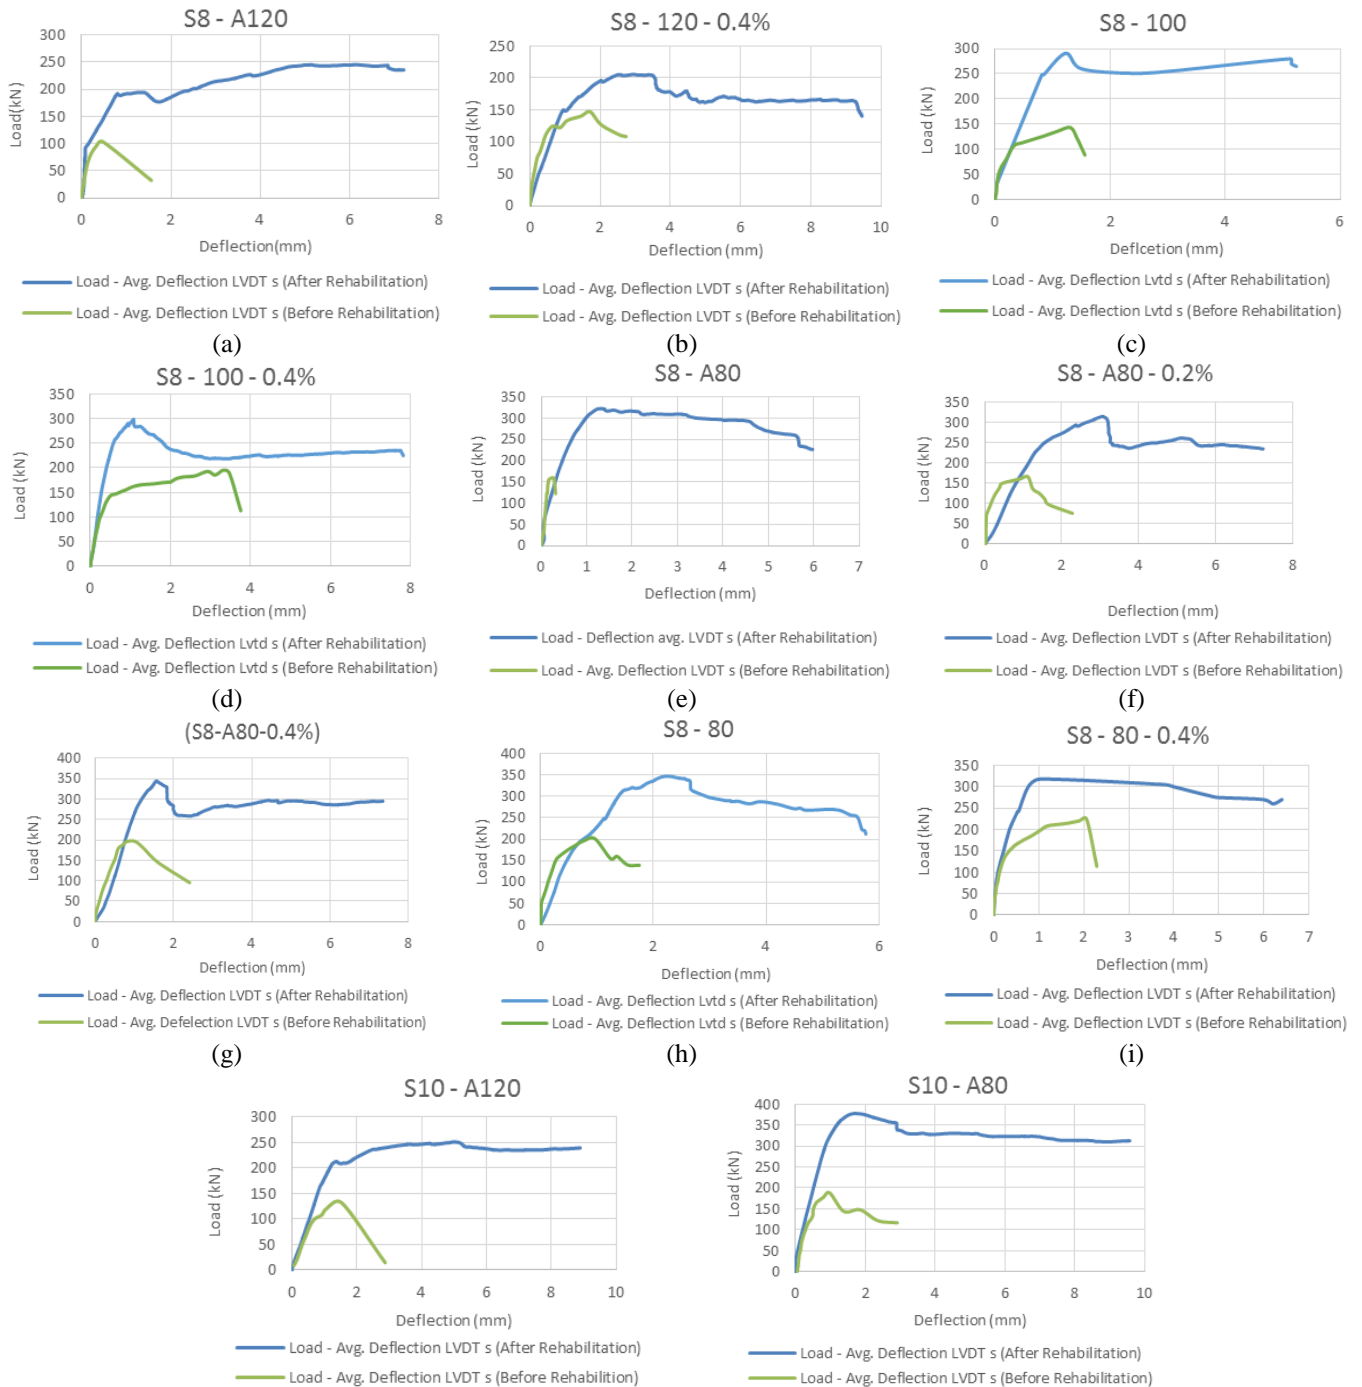
Fig. 13 Configuration -4 results

It was observed that the improvement of samples containing less glass fibers was higher than those with more glass fibers. In Fig. 13 (e-g), we can see the results of specimens (S8-A80), (S8-A80-0.2%), and (S8-A80-0.4%), which have been rehabilitated by configuration -4. Their load capacities have been increased to 201%, 189% and 173% respectively.

The results of the two specimens (S8-A120) and (S10-A120) are shown in Fig. 13 (a, and i). The two specimens were rehabilitated by configuration-4 and had different diameters of the steel reinforcement (ϕ). Their responses to the rehabilitation were different. Their load capacities were increased to 234% and 189% respectively. Their ductility enhancement are as shown in Fig. 16. These results indicated that the ductility of the corbels with a smaller reinforcement ratio was higher than bigger ones. This result was mostly because of the response of the pre-deformed steel. The larger diameter means stiffer steel, and stiffer

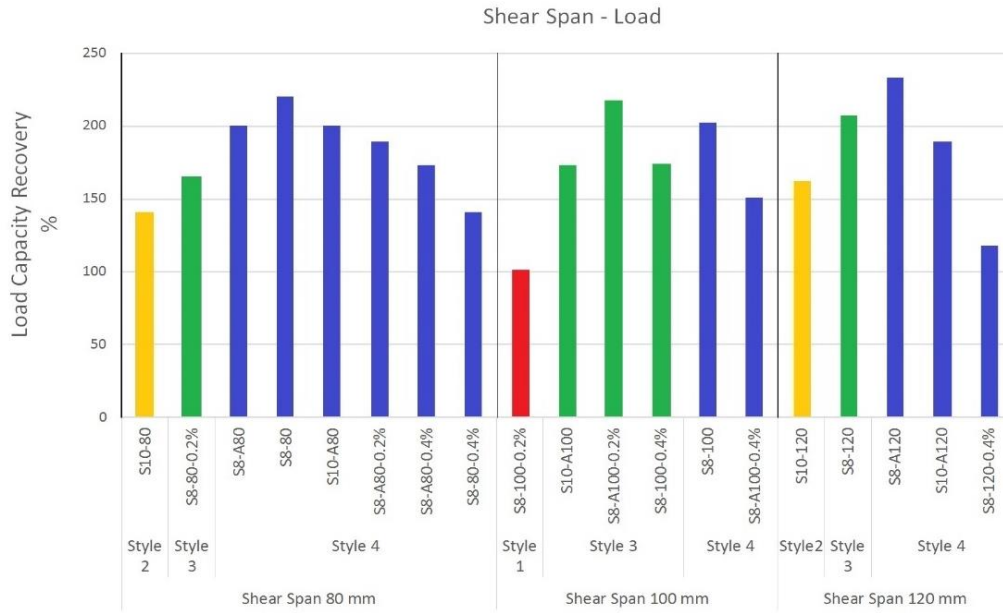
Fig. 14 Load capacity recovery according to shear span

When the results are examined, it is observed that shear span affects the rehabilitation efficiency, Fig. 14. Specimens with larger shear span were recovered better than those with smaller shear spans. This remark was obvious especially in configurations 2, and 3. This is mostly for two reasons. The first reason, the activity of the steel confinement system starts earlier, since the epoxies have no serious effect in large spans and fail early. The second reason, the old performances were different, while the new performances

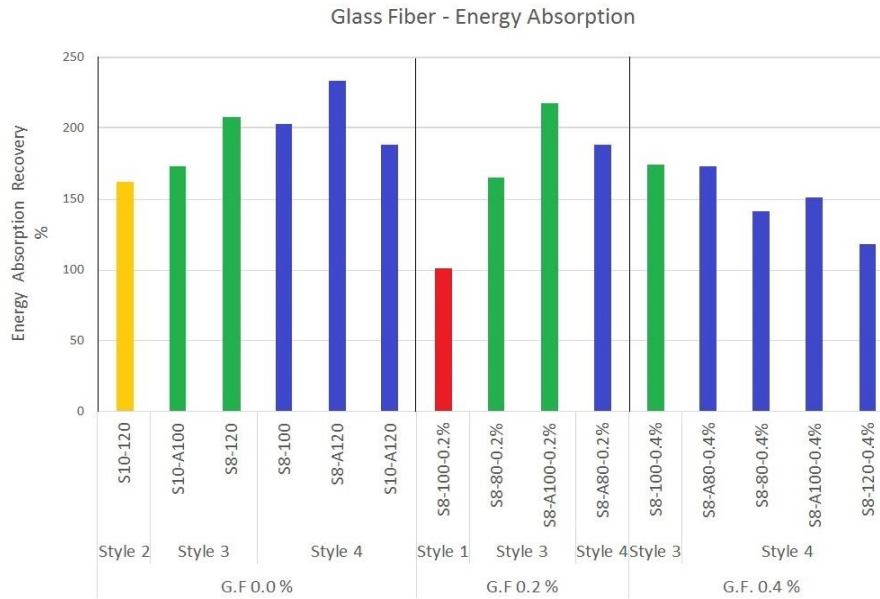
Fig. 15 Ductility recovery according to glass fiber content

The ductility for specimens (S8-A80-0.2%), and (S8-A80-0.4%) were increased perfectly (Fig. 15). While, the recovery percentage of specimen with span of 80 mm (S8-80) are not shown in Fig. 15, since their failure mode had been sudden before rehabilitation.

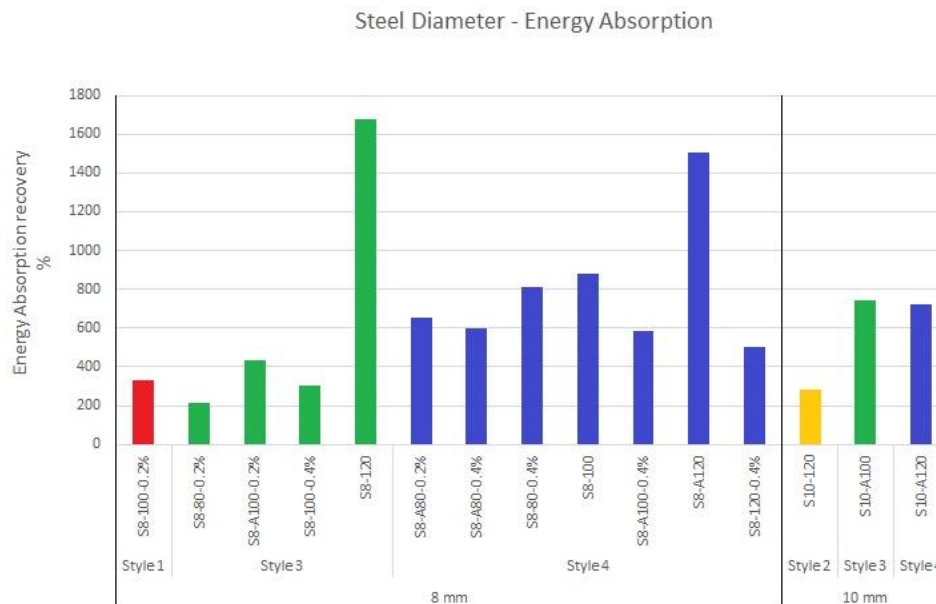
Fig. 16 Ductility recovery according to reinforcement steel diameter

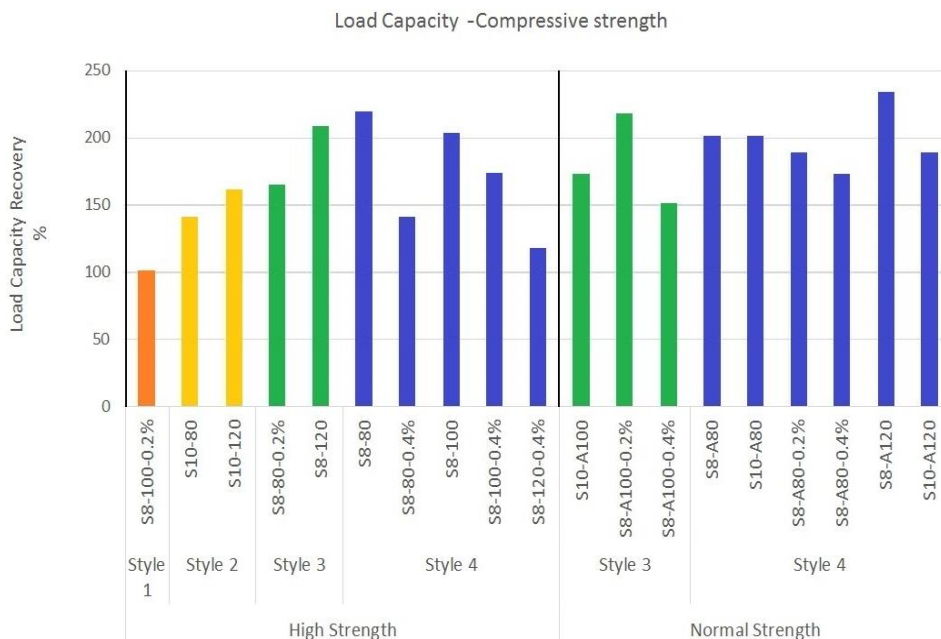
Fig. 17 Load capacity recovery according to compressive strength

The results stated in Table 7 are close to each other. These results show that the proposed rehabilitation system has a noticeable effect on the load capacity and the ductility of the member, while; the compressive strength of the concrete has no obvious effect.

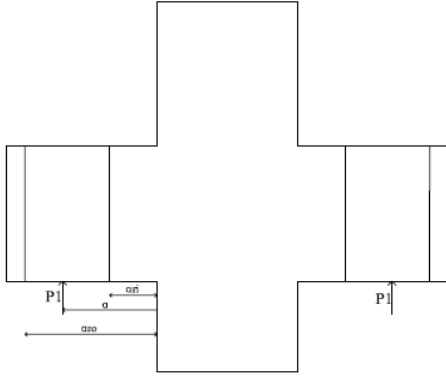
Fig. 18 Representation of P_1 , a , a_{si} , a_{so}

Where a_{si} is distance of the center of inner steel profile from the column face. P_1 is calculated by taking the smaller value from the Eq. (5) and equating it to P_3 (Eq. (3)). P_1 , a , a_{si} and a_{so} are shown in Fig. 18.
