## Self-healing and leakage performance of cracks in the wall of a reinforced concrete water tank

**Abstract.** A reinforced concrete water tank is a typical functional liquid storage structure and cracks are the greatest threat to the liquid storage structure. Tanks are readily cracked due to seismic activity, thereby leading to the leakage of the stored liquid and a loss of function. In order to study the effect of cracks on liquid storage tanks, self-healing and leakage tests for bending cracks and through cracks in the walls of a reinforced concrete water tank were conducted. Material performance tests were also performed. The self-healing performance of bending cracks in a lentic environment and through cracks in a lotic environment were tested, thereby the self-healing width of bending micro-cracks in the lentic environment in the short term were determined. The through cracks had the capacity for self-healing in the lotic environment was found. The leakage characteristics of the bending cracks and through cracks were tested with the actual water head on the crack. The effects on liquid leakage of the width of bending cracks, the depth of the compression zone, and the acting

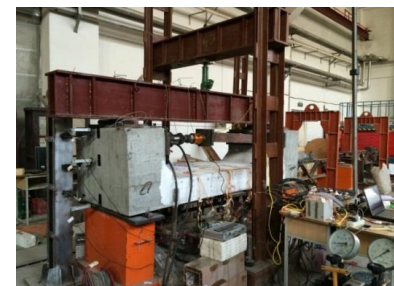
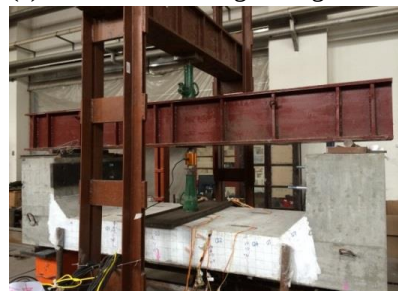
Fig. 8 Testing device for specimen 2

(a) Horizontal loading testing device

(b) Vertical loading testing device

was used to apply a vertical upward load at the vertical mid-span of the bottom slab. The vertical load and horizontal load at the mid-span were applied at the same time and the value was maintained at 1:5.

A steel beam was placed at the top of two vertical rigid ends to provide the support for the endpoint of the vertical load at the mid-span. The steel beam and top beam of the steel frame were connected tightly by a jack. Therefore, a high shear force could develop in the concrete slab (Fig. 8(a)). First, a bending crack formed on the upper surface of

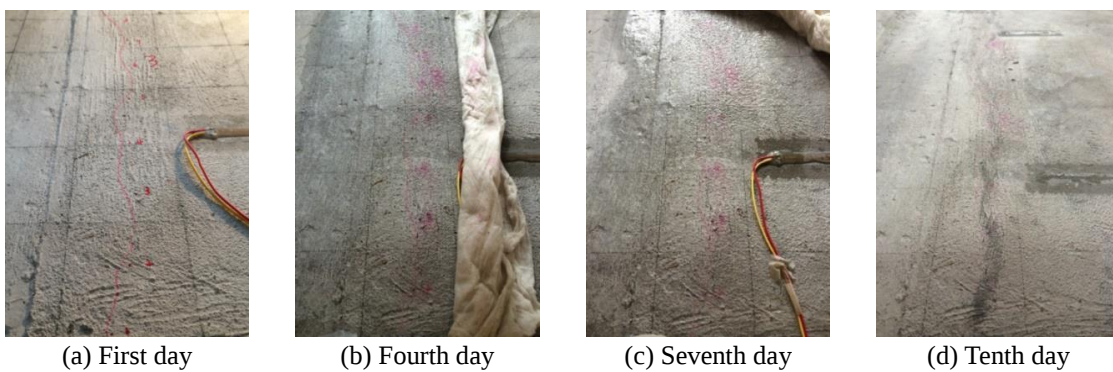
Fig. 10 Self-healing at the measurement points h1-1→h1-7 for crack 1

Fig. 11 Self-healing at the measurement points 1-1→1-19 for crack 1

Fig. 12 Self-healing at the measurement points q1-1→q1-4 for crack 1

Fig. 13 Self-healing at the measurement points q2-1→q2-5 for crack 2

Fig. 14 Self-healing at the measurement points h3-1→h3-7 for crack 3

Fig. 15 Self-healing at the measurement points 3-1→3-16 for crack 3

Fig. 16 Self-healing at the measurement points q3-1→q3-5 for crack 3

thereby ensuring that the crack remained continuously in a wet environment, as shown in Fig. 7(a). During the micro-crack self-healing test, the crack width was measured and recorded in real time. In addition, the degree of crack self-healing was compared based on photographs. The self-healing test for the micro-crack was conducted after maintaining the specimen in a lentic environment for 21 days. The number of test days was used to replace the test date to represent the test result in order to understand the degree of self-healing of bending crack in a convenient and intuitive manner. The crack widths after self-healing are listed in Table 2. Photographs of the self-healed crack in some positions are shown in Figs. 10 to 16.

According to the descriptions in Table 2 and the photographs of crack self-healing, the bending micro-cracks in solid concrete self-healed in the lentic environment were observed. According to the self-healing test for the bending micro-cracks, the relationship between the crack self-healing width [W] and healing phase under the test conditions were determined, as shown in Table 3. The variation in the crack width was equal to the ratio of the difference between the crack width and the minimum crack width relative to the minimum crack width. The change in the crack width was greater when the value was higher.

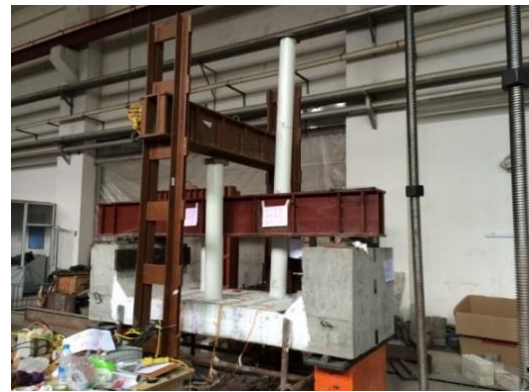
Fig. 18 Self-healing and leakage test devices for the through cracks

(a) Locations of through cracks and water heads

(b) Testing device

After the formation of the bending crack, vertical force was applied to the concrete slab and bending cracks 1, 2, and 3 formed through cracks 1, 2, and 3 along the direction of the slab thickness. The strain value of the rebar strain gauge was monitored continuously when the through cracks appeared. After the strain value of the rebar stabilized completely, the self-healing and leakage tests were performed for the through crack, while avoiding the effects of steel and concrete retraction on the follow-up test results after unloading. The through cracks and location of the water head are shown in Fig. 18(a). The self-healing and leakage test devices used for assessing the through cracks
