Earthquake-resistant rehabilitation of existing RC structures using high-strength steel fiber-reinforced concrete jackets

Abstract. The effectiveness of an innovative method for the earthquake-resistant rehabilitation of existing poorly detailed reinforced concrete (RC) structures is experimentally investigated herein. Eight column subassemblages were subjected to earthquake-type loading and their hysteretic behaviour was evaluated. Four of the specimens were identical and representative of columns found in RC structures designed in the 1950s-70s period for gravity load only. These original specimens were subjected to cyclic lateral deformations and developed brittle failure mechanisms. Three of the damaged specimens were subsequently retrofitted with innovative high-strength steel fiber-reinforced concrete (HSSFC) jackets. The main variables examined were the jacket width and the contribution of mesh steel reinforcement in the seismic performance of the enhanced columns. The influence of steel fiber volume fraction was also examined using test results of a previous work of Tsonos *et al.* (2017). The fourth earthquake damaged subassemblage was strengthened with a conventional RC

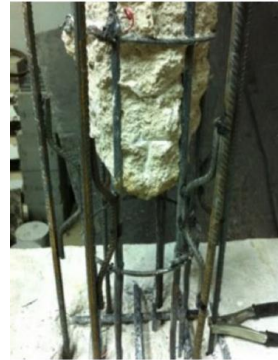
(b) The longitudinal bars of the RC jacket were anchored in the foundation block. The holes were filled with epoxy resin

Fig. 3 Strengthening interventions applied to column subassemblage CV_5

4. The retrofit process of the damaged original specimen V_5 included the construction of a RC jacket, designed according to the recommendations of modern design codes, EC2 and EC8 (2004). The post-earthquake strengthened column was designated CV_5 . Six holes of diameter equal to 12mm were drilled in the foundation block of the specimen (see Figs. 3(a)-(b)). The holes were subsequently cleaned with air pressure. Thereupon, six longitudinal B500C steel bars of 10mm diameter each were inserted in the holes and anchored in the foundation block of the subassemblages. The anchorage of the bars was achieved by inserting epoxy resin into the holes with a syringe. The control of the concrete compression strut adequacy was made according to equation Eq. (2). In Table 2 the Eurocode provisions for the shear reinforcement are presented. The transverse reinforcement demand was finally calculated according to the expression Eq. (3), where it is recommended that $V_{Rd,s} \geq V_{sd}$. In Eqs. (1)-(3) $A_{s,ex}$ is the cross-section area of the existing column; $A_{s,j}$ is the cross-section area of the RC jacket; $f_{ck,ex}$ is the concrete characteristic strength of the existing column; $f_{ck,j}$ is the concrete characteristic strength of the RC jacket; f'_{ck} is the equivalent concrete characteristic strength of the retrofitted column; $V_{Rd,max}$ is the strength of the concrete compression struts; $V_{Rd,s}$ is the shear force resisted by the hoops; A_{sw} is the cross-section area of the transverse reinforcement; s is the spacing of the stirrups; f_{ywd} is the yield strength of the transverse reinforcement; b_w is the cross-sectional depth of the column; $z = 0.9 \cdot d$; a_{cw} is a coefficient taking account of the state of the stress in the compression strut; v_1 is the strength reduction factor for concrete cracked in shear with recommended value of $1 - f_{ck}(MPa)/250$ and θ is the angle between the concrete compression strut and the member axis perpendicular to the shear force ($\theta = 22^\circ$). Ultimately, the transverse reinforcement of the RC jacket consisted of an 8 mm diameter B500C spiral with 80mm pitch along the critical column height, while C25/30 concrete was used for the construction of the RC jacket. The strengthened specimen was designated CV_5 . The retrofitting interventions applied to CV_5 are shown in Fig. 3. Connection between the reinforcing bars of the RC jacket and the bars of the existing column was achieved using s-shaped (\sim) segments welded to the reinforcement. The welding was made according to Code for Steel

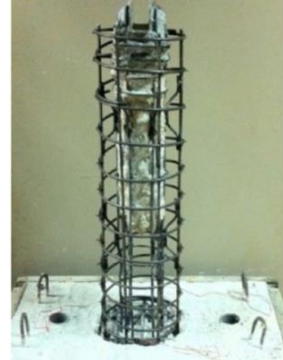
(c) S-shaped (\sim) segments were used to connect the longitudinal reinforcement of the RC jacket with the bars of the existing column

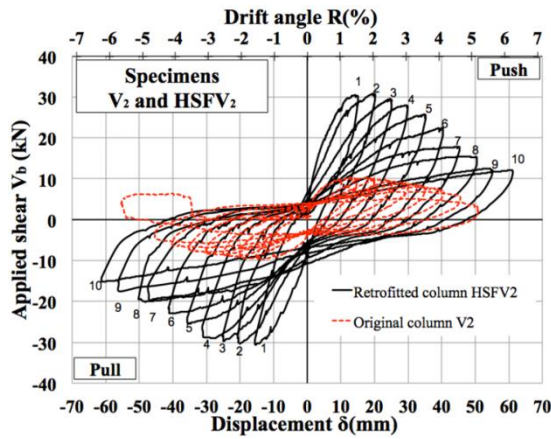
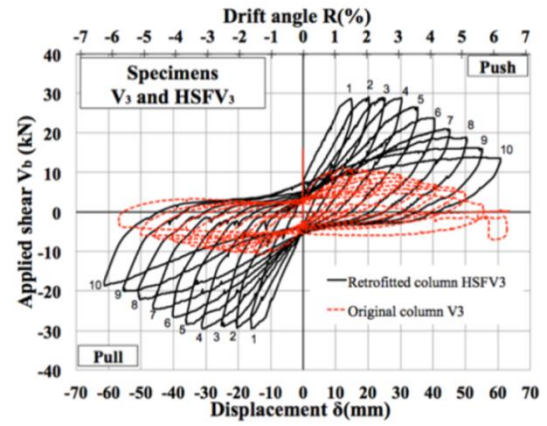
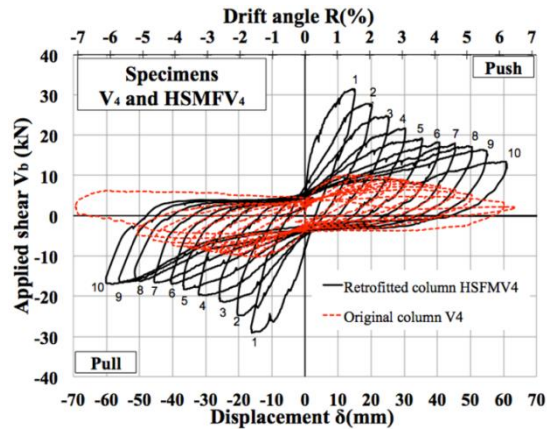
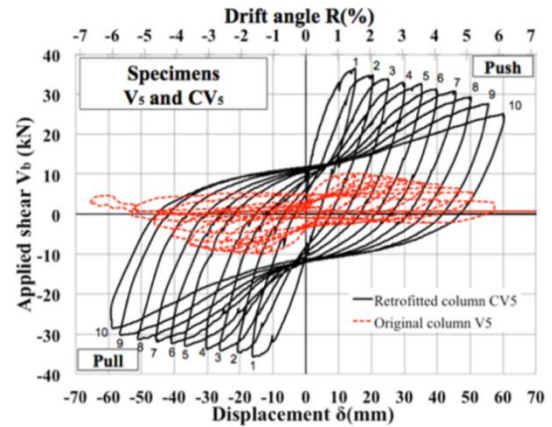
(a) Hysteresis loops of specimens V_2 and $HSFV_2$

(b) Hysteresis loops of specimens V_3 and $HSFV_3$

(c) Hysteresis loops of specimens V_4 and $HSFV_4$

(d) Hysteresis loops of specimens V_5 and CV_5

Fig. 6 (a-d) Plots of applied shear-versus-displacement of the original and the strengthened subassemblages

stiffness and energy dissipation capacity. Thus, the efficiency and suitability of the innovative retrofit scheme in improving the hysteretic behavior of the strengthened subassemblages are evaluated. Moreover, the influence of the jacket width and the contribution of the mesh reinforcement in the column cyclic lateral response were investigated. Furthermore, in order to investigate the influence of the steel fiber volume fraction in the column seismic performance, the experimental results of Tsonos *et al.* (2017) are also discussed and compared herein. The seismic behaviour of the subassemblages is clearly reflected in the hysteresis loops, illustrated in Fig. 6.

The strengthened subassemblage CV_5 showed a ductile behavior. This is clearly reflected in the spindle-shaped hysteresis loops illustrated in Fig. 6(d). The overall seismic performance of the column was substantially improved with respect to that of the original specimen V_5 , due to the additional longitudinal (six $\varnothing 10$ mm B500C bars) and transverse reinforcement ($\varnothing 8/80$ mm B500C spiral) of the RC jacket. Nevertheless, the lateral strength and peak-to-peak stiffness values of columns $HSFV_1$, $HSFV_2$, $HSFV_3$ and $HSFMV_4$ (which were strengthened with a HSSFC jacket) and the corresponding values of CV_5 (which was strengthened with a conventional RC jacket) are comparable. During the first cycle of the earthquake-type loading the strength ratio values $CV_5/HSFV_1$, $CV_5/HSFV_2$, $CV_5/HSFV_3$ equaled to 1.19/1.29, 1.20/1.16 and 1.27/1.21 (push/pull half cycles), respectively, while for

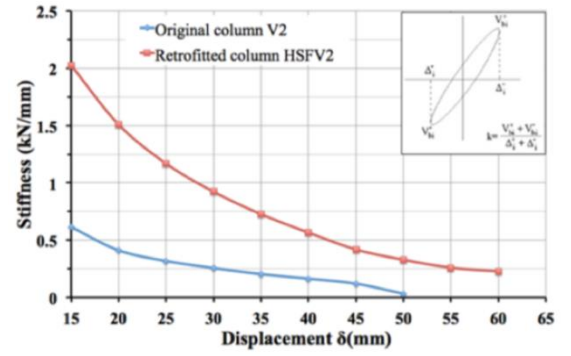
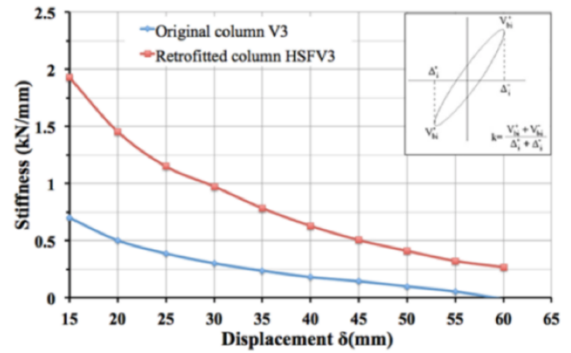
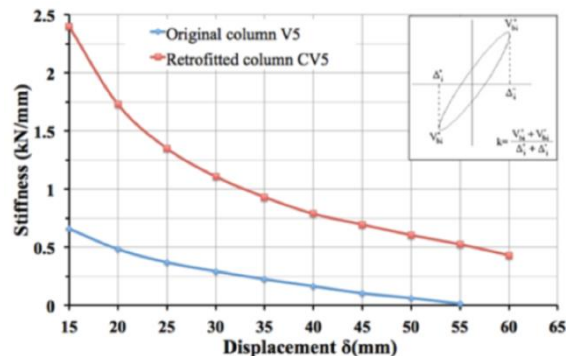
(a) Specimens V_2 and $HSFV_2$

(b) Specimens V_3 and $HSFV_3$

(c) Specimens V_4 and $HSFMV_4$

(d) Specimens V_5 and CV_5

Fig. 7 Peak-to-peak stiffness of the column specimens

The increase in column dimensions resulted in a significant increase of the peak-to-peak stiffness of the post-earthquake strengthened column subassemblies, with respect to that of the original ones. During the first cycle of the seismic loading $HSFV_1$, $HSFV_2$, $HSFV_3$, $HSFMV_4$ and CV_5 showed 2.75, 3.31, 2.77, 2.94 and 3.64 times higher

peak-to-peak stiffness values than the corresponding original columns (see Fig. 7). Furthermore, the enhanced specimens maintained 21.47, 16.30, 14.02, 16.60 and 21.79 percent of their initial stiffness value (during the first cycle) for the same lateral displacement for which the original subassemblies collapsed, due to the loss of axial load carrying capacity. The peak-to-peak stiffness values of the retrofitted columns were similar for both the subassemblies strengthened with the HSSFC jackets and the specimen enhanced with the conventional RC jacket.

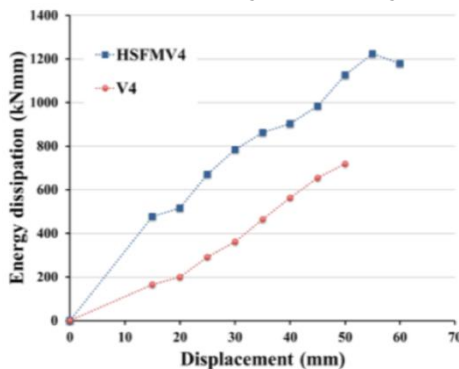
(a) Specimens V_2 and $HSFV_2$

(c) Specimens V_3 and $HSFV_3$

(c) Specimens V_4 and $HSFMV_4$

(d) Specimens V_5 and CV_5

Fig. 8 Energy dissipation capacity of the specimens

the energy dissipation capacity with respect to that of the corresponding original columns. During the first cycle subassemblages $HSFV_1$, $HSFV_2$, $HSFV_3$, $HSFMV_4$ and CV_5 dissipated 2.13, 2.29, 1.56, 2.87 and 3.21 times the

energy which was dissipated by the columns V_1 , V_2 , V_3 , V_4 και V_5 , respectively (see Fig. 8). Moreover, for lateral displacement equal to 45mm the values of energy dissipated by the strengthened columns showed 60.16, 106.28, 72.28, 50.19 and 208.23 percent increase with respect to the corresponding values of the original columns. At the end of the seismic loading sequence, the strengthened subassemblages achieved 195.48, 220.44, 348.78, 146.82 and 393.90 percent increase in energy dissipation values with respect to the first cycle of loading. Due to the additional reinforcement of the RC jacket, specimen CV_5 showed a substantial improvement in the energy dissipation capacity with respect to the original column V_5 , while also dissipated higher values of energy compared to the columns that were retrofitted with the innovative HSSFC jackets. Thus, during the first cycle CV_5 dissipated 10.81, 21.55 and 42.11 percent increased values of energy compared to $HSFV_1$, $HSFV_2$, $HSFV_3$, respectively. After seven cycles of loading these values equaled 43.36, 33.22, 40.39 percent. However, the proposed innovative retrofit scheme was indisputably satisfactory in remarkably improving the energy dissipation capacity, peak-to-peak stiffness and lateral strength of $HSFV_1$, $HSFV_2$, $HSFV_3$ and $HSFMV_4$ with respect to the original specimens V_1 , V_2 , V_3 and V_4 , without the use of conventional steel reinforcement and with significantly less labour demand with respect to the RC jacket. Moreover, the effectiveness of the innovative retrofit scheme proposed herein is further substantiated by the overall ductile hysteresis behaviour and the failure mode of the enhanced columns (see Fig. 10).

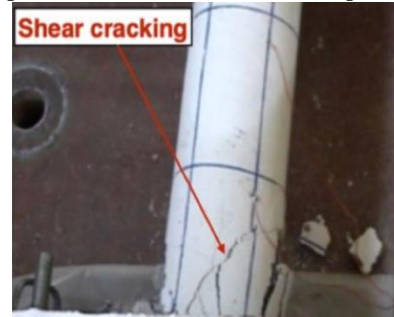
(b) The dilation of shear cracks results in gradual disintegration of the core concrete

Fig. 9 Cracking propagation - original column specimens

confined with hoops spaced at 250mm, the specimens exhibited brittle shear failure and loss of axial load carrying capacity. The original columns collapsed under gravity loads and buckling of the longitudinal reinforcement occurred (see Figs. 10 (a), (c), (e), (g)). The longitudinal steel bars of the original columns were continuous and well anchored in the foundation block of the specimens. Thus, the columns developed their flexural nominal moment capacity, while significant post-yield strain values of the longitudinal steel bars were measured using electrical resistant strain gages (see Fig. 12).

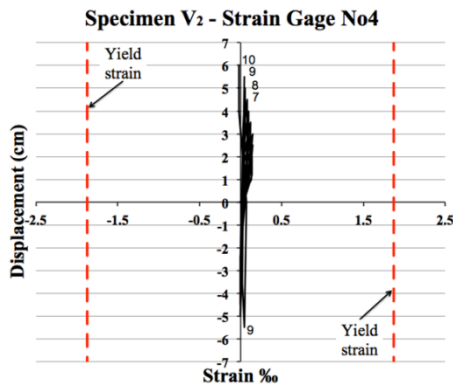
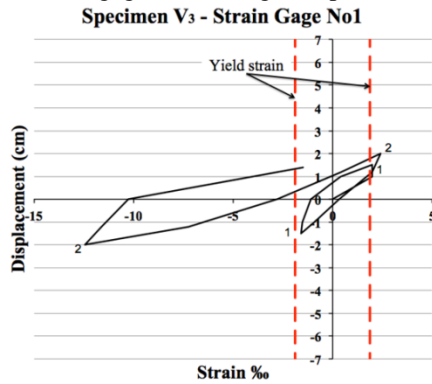
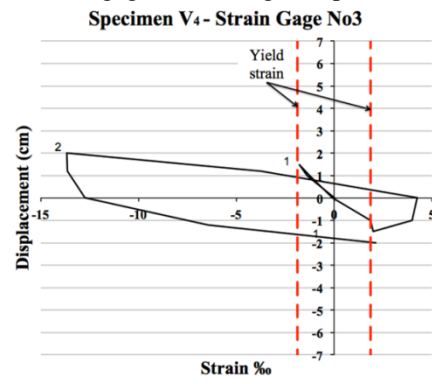
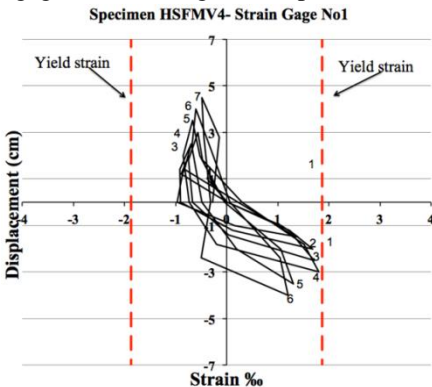
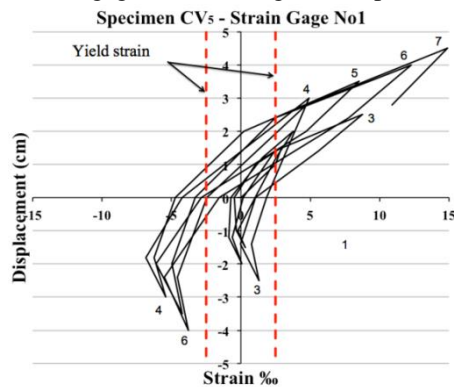
(a) Strain gage No4 - Original specimen V_2

(b) Strain gage No2 - Original specimen V_2

(c) Strain gage No1 - Original specimen V_3

(d) Strain gage No3 - Original specimen V_4

(e) Strain gage No3 - Strengthened specimen $HSFV_2$

(f) Strain gage No1 - Strengthened specimen $HSFV_3$

(g) Strain gage No1 - Strengthened specimen $HSFMV_4$

(h) Strain gage No1 - Strengthened specimen CV_5

Fig. 12 Plots of displacement-versus-strain of the longitudinal and transverse reinforcement of the original and the strengthened column subassemblages

HSSFRC or RC jacket. The exact location of each strain gage is presented in Fig. 13, while in Fig. 12 the plots of the load

point displacement-versus-strain of reinforcement are illustrated. As a result, critical information for the seismic performance of the original and strengthened column subassemblages, was provided. For instance, given that the longitudinal reinforcement of the subassemblages was continuous and sufficiently anchored in the foundation block, a continuous increase in maximum steel strain to post-yield values was observed during the consecutive cycles of loading. According to Ehsani and Whight (1985) the latter indicates the absence of bar slipping and the ductile lateral response of the columns, while stable or decreasing strain values reflect hysteresis deterioration due to the slippage of the bars, as long as buckling has not taken place. In particular, strain values significantly higher than yield strain (1.87‰) were observed during the tests (2.74‰ Fig. 12(b), 12.33‰ Fig. 12(c), 13.82‰ Fig. 12(d), 1.91‰ Fig. 12(e), 4.46‰ Fig. 12(f), 1.87‰ Fig. 12(g) and 14.90‰ Fig. 12(h)). The yielding of the longitudinal bars demonstrates that the columns developed their nominal flexural strength. Moreover, all the retrofitted specimens performed in a ductile manner, since both the HSSFC jacket system and the conventional RC jacket system adequately confined the potential plastic hinge region and prevented seismic damage of the post-earthquake strengthened columns. It is noteworthy that the strengthened subassemblages showed yielding of the longitudinal bars (see Figs. 12(e)-(h)), which had also yielded previously during the seismic tests of the original columns and had subsequently been straightened during the retrofit process.

In the case of the original specimens, the concrete at the lower part of each column, where the plastic hinge was formed, was unconfined between the ties over a height of 250 mm. This resulted in the early formation of hairline shear cracks, which gradually dilated with the increase of the lateral drift angle. Afterwards, the rupture of the concrete in the compression zones and the exhaustion of both the aggregate interlock shear transfer capacity and the dowel action of reinforcement, resulted in the brittle shear failure and collapse of the original columns under the axial load. This explains the minimum strain values of the ties (see Fig. 12(a)), which were located above the plastic hinge region of the columns.
