Seismic analysis of a masonry cross vault through shaking table tests: the case study of the Dey Mosque in Algiers

Abstract. This paper presents the results of a monodirectional shaking table test on a full-scale unreinforced masonry cross vault characterized by asymmetric boundary conditions. The specimen represents a vault of the mosque of Dey in Algiers (Algeria), reproducing in detail the mechanical characteristics of masonry, and the constructive details including the presence of some peculiar wooden logs placed within the vault's abutments. The vault was tested with and without the presence of two steel bars which connect two opposite sides of the vault. The dynamic behaviour of both the vault's configurations were studied by using an incremental dynamic analysis up to the collapse of the vault without the steel bars. The use of an innovative high-resolution 3D optical system allowed measure displacement data of the cross vault during the shake table tests. The experimental results were analysed in terms of evolution of damage mechanisms, and in-plane and out-of-plane deformations. Moreover, the dynamic properties of the structure were investigated by means of an experimenta

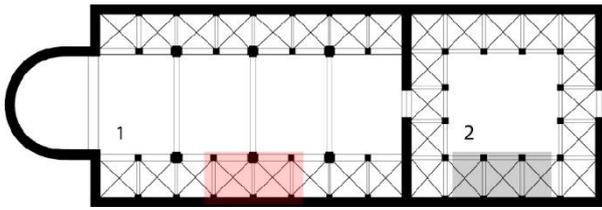
Fig. 1 Example of a typical case of cross vaults with asymmetric boundary conditions in a three naves church (1) with an annexed cloister (2)

This paper focuses on the study of the seismic behaviour of unreinforced masonry cross vaults, which are typical covering of churches aisles, and floors of porticos. The plan in Fig. 1 shows two typical examples of cross vaults found in churches aisles and porticos. In this context, cross vaults are frequently characterized by asymmetric boundary conditions and a relevant difference in stiffness between the supports, which are walls on one side, and arcades on the other side. The general purposes of the paper are to study the dynamic behaviour of masonry cross vaults with asymmetric boundary conditions and to identify their main collapse mechanism. The study was carried out by testing a full-scale model of a masonry cross vault on a shaking table. The mock-up represented a vault of the Mosque of Dey in the Citadel of Algiers.

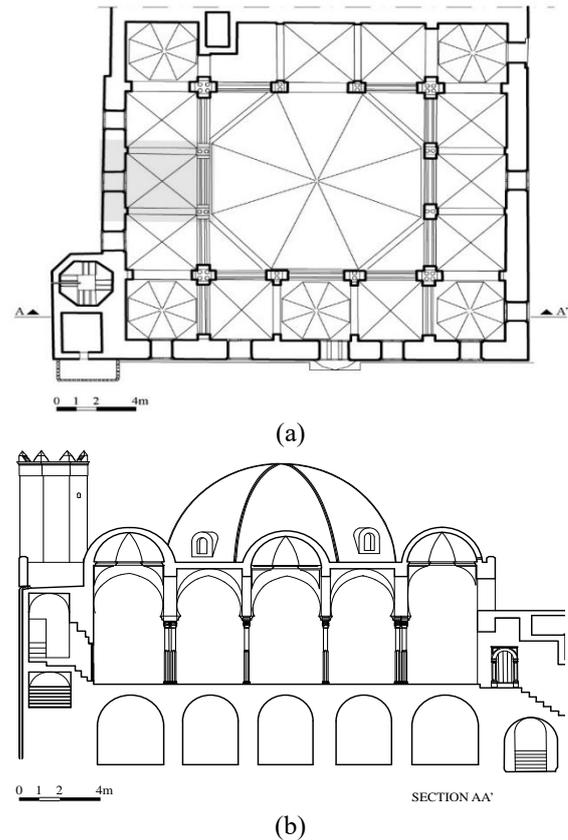
Fig. 2 Plan (a) and section AA' (b) of the Mosque of Dey. In grey, the vault's prototype considered for the design of the full-scale mock-up

The plan and the section of the mosque are shown in Figs. 2(a)-(b), respectively. Ten cross vaults and five small

The cross vault prototype taken as reference for designing the full-scale model is that indicated in grey in Fig. 2(a). A picture of the structure is shown in Fig. 3(a). The plan and the sections of the prototype are illustrated in Figs. 3(b)-(d). The cross vault is one brick layer in thickness. It has an almost square plan ($3.50 \times 3.60 \text{ m}^2$) and a semicircular directrix. Its total height is around 5.65 m. The pointed arch is reinforced by a couple of wooden ties, shown in Fig. 4(a). An interesting constructive detail is the insertion of wood logs of *Thuya*, a typical wood of the Atlas mountain region, between the vault's springing and the column. As shown in Fig. 4(b), the wood elements are arranged in three layers perpendicular to each other and each made of three logs. Some studies (Abdessemed-Foufa 2012, Abdessemed-Foufa *et al.* 2015) mention that this constructive technique was used as a seismic isolator system during post-earthquakes reconstructions of historical buildings in various Algerian cities. The same system was used beneath columns of other buildings of the Citadel, as shown in Fig. 4(c).

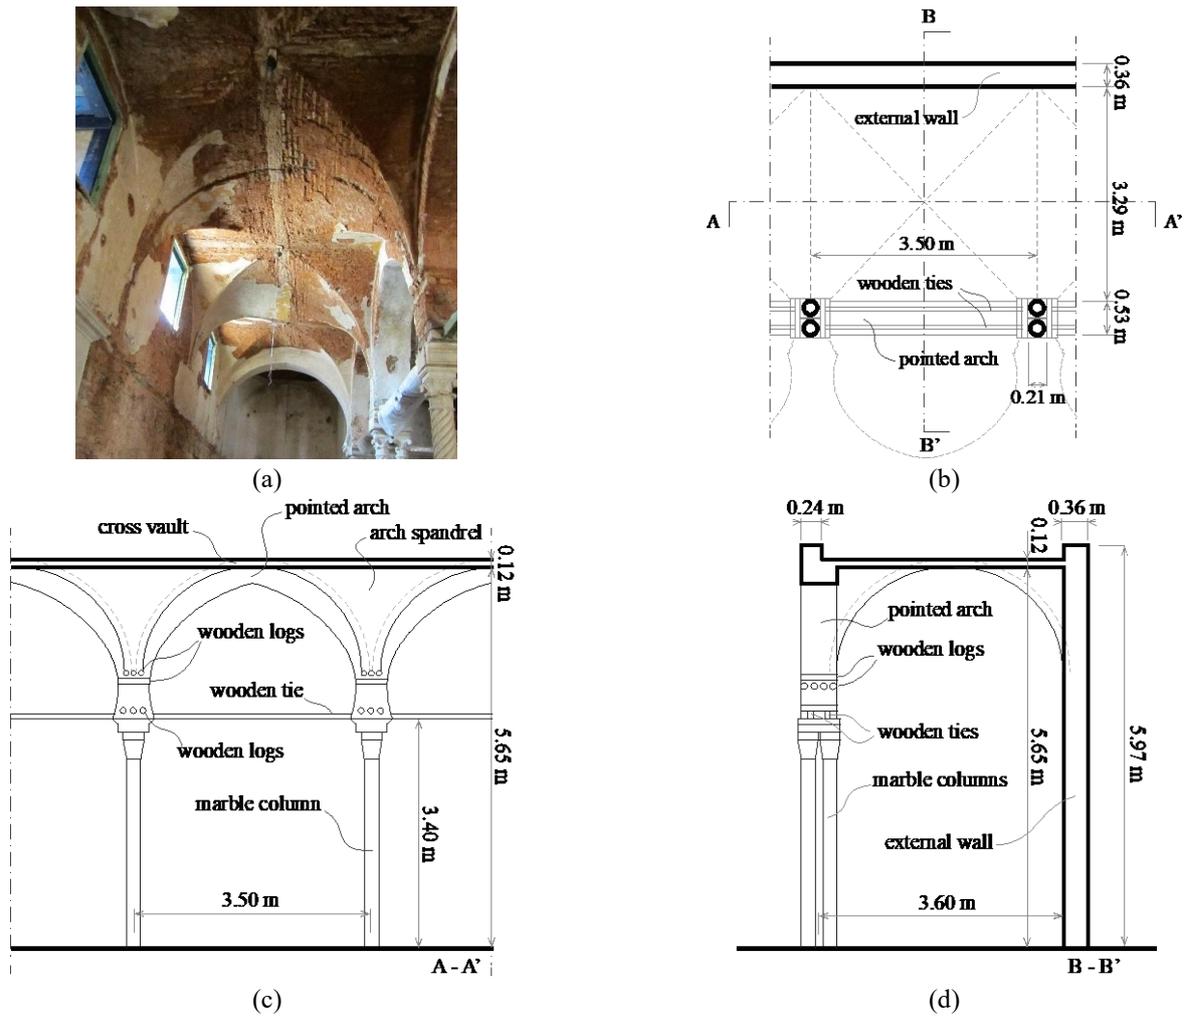
Fig. 3 Vault's prototype for designing the full-scale mock-up (a); plan (b), sections A-A' (c) and B-B' (d) of the cross vault's prototype

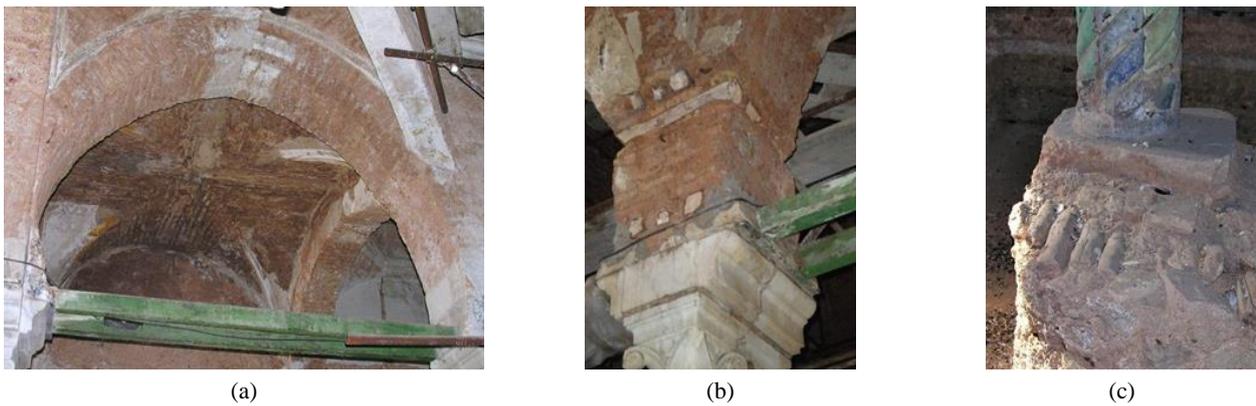
Fig. 4 Pointed arch reinforced with a couple of wooden tie (a); constructive technique of the wooden logs at the arches springing (b); wooden logs at the base of a column of one building of the Citadel (c)

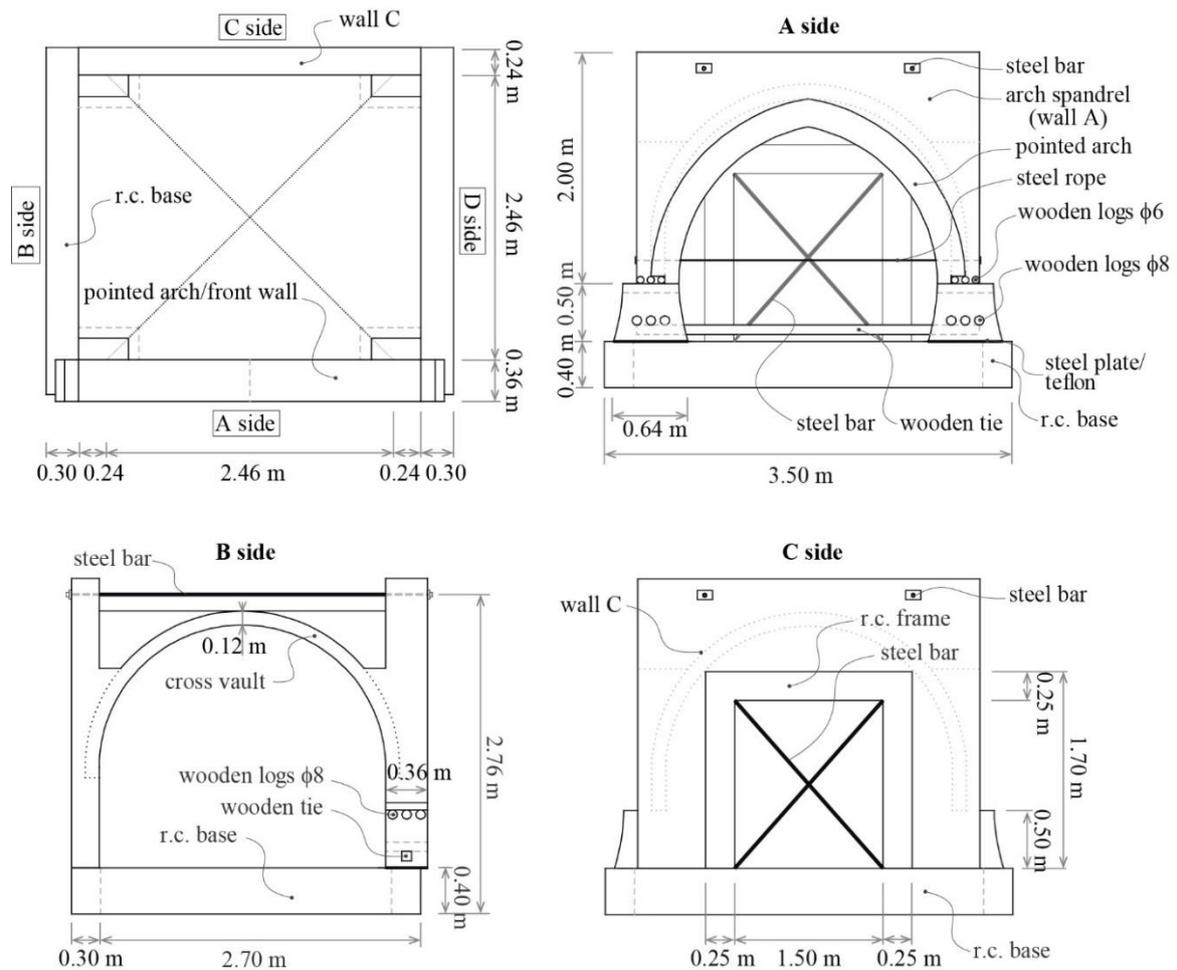
Fig. 5 Design of the full-scale mock-up: plan and elevations

some changes of the geometry had to be done on the basis of technical limitations of the experimental setup and of the shaking table characteristics. Compared to the vault's prototype, the plan of the physical model was smaller ($3.00 \times 3.00 \text{ m}^2$) and it was 2.20 m in height. The mock-up was built over a reinforced concrete frame $3.50 \times 3.00 \text{ m}^2$ in plan. The frame aimed to move more easily the vault from the place where it was built over the shaking table. Fig. 5 shows the plan and the elevations of the 0.12 m thick vault.

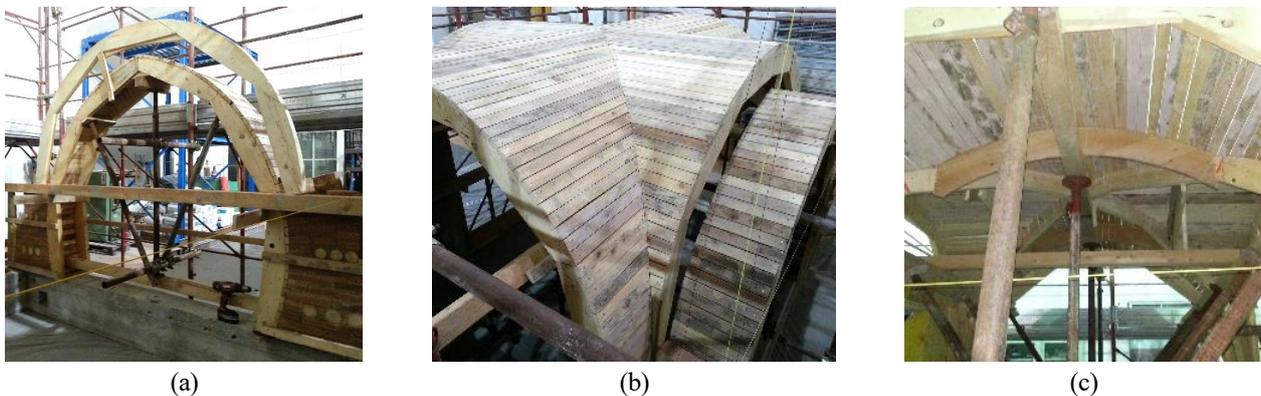
Fig. 6 Wooden scaffolding of the pointed arch (a); view of the masonry cross vault's scaffolding from the top (b) and bottom (c)

The supporting structure used to build the pointed arch is shown in Fig. 6(a), while Figs. 6(b)-(c) illustrate the cross vault's scaffolding from the top and the bottom, respectively. Fig. 7(a) shows the building process of the

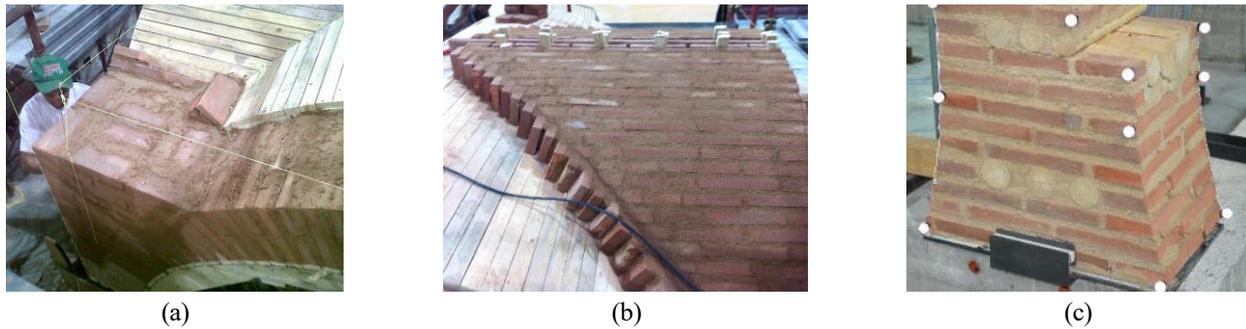
Fig. 7 Building of the vault's support within the thickness of the arch spandrel (a); detail of the bricks arrangement along the cross vault's diagonals (b); detail of the abutment (c)

vault's supports that consisted in building them within the thickness of the arch spandrel. The same thing was done in the opposite side where the supports were built within the walls thickness. On the contrary, the rest of the vault (from the springing to the key) was completely disconnected from both the wall and the arch spandrel, being simply built close to each other. Particularly attention was paid in arranging bricks along the diagonals. Bricks were cut appropriately, studying ancient master builders' solutions observed in historical cross vaults and described in previous works (Gurrieri 1999, Cangi 2005), to allow the interlocking between the vault's webs (Fig. 7(b)). Fig. 7(c) shows the

abutment with the wooden logs. The abutments were built on Teflon sheets so that they could slide in y , while their x displacement was prevented by a steel element. On the opposite side, the reinforced concrete frame was built and the masonry wall erected. The final building step was the "locking" of the vault with key blocks (Figs. 8(a)-(c)). The key bricks were placed in the middle of each vault's webs and then, they were stressed by means of wooden shims, as shown in Fig. 8(b). After this, a liquid mortar was poured through the joints (Fig. 8(c)). Once the mortar dried, the vault acquired its stability and it could transfer loads to its supports. Two steel longitudinal bars not pre-tightened were

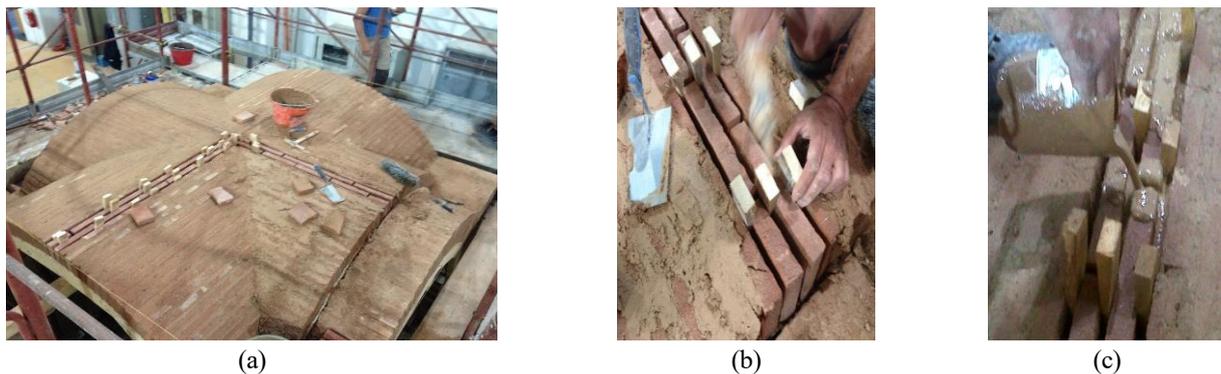
Fig. 8 Positioning of the last bricks in the key of the vault's web (a); stressing of the key bricks using wooden shims (b); pouring of the space between bricks with liquid mortar (c)

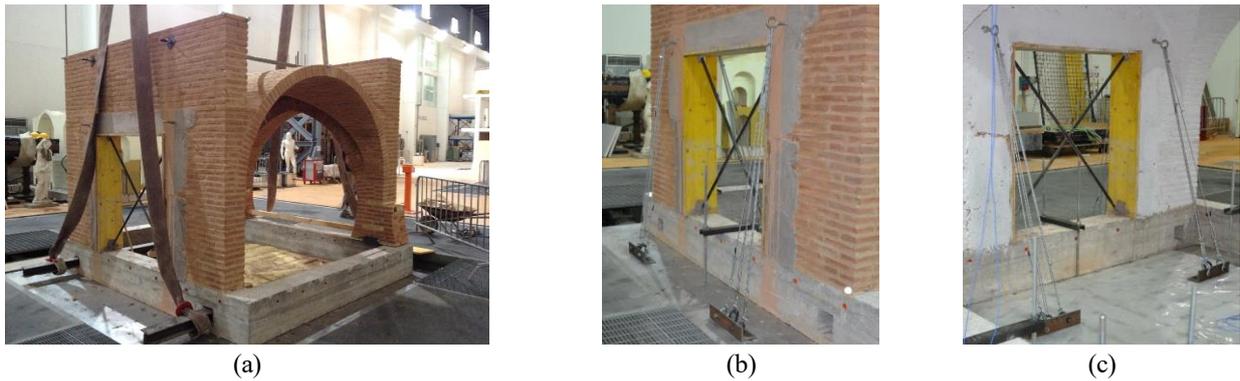
Fig. 9 Moving of the vaulted structure from the building place to the shaking table (a); steel strand cables placed at both sides of the r.c. frame built within the wall C

The vault's mock-up was later moved from the place where it was built to the shaking table using a harness system, as shown in Fig. 9(a). In order to prevent deformations of the wall C (and consequently of the whole structure) in x, a system of steel strand cables was anchored to the ground on both side of the masonry wall C (Figs. 9(b)-(c)).

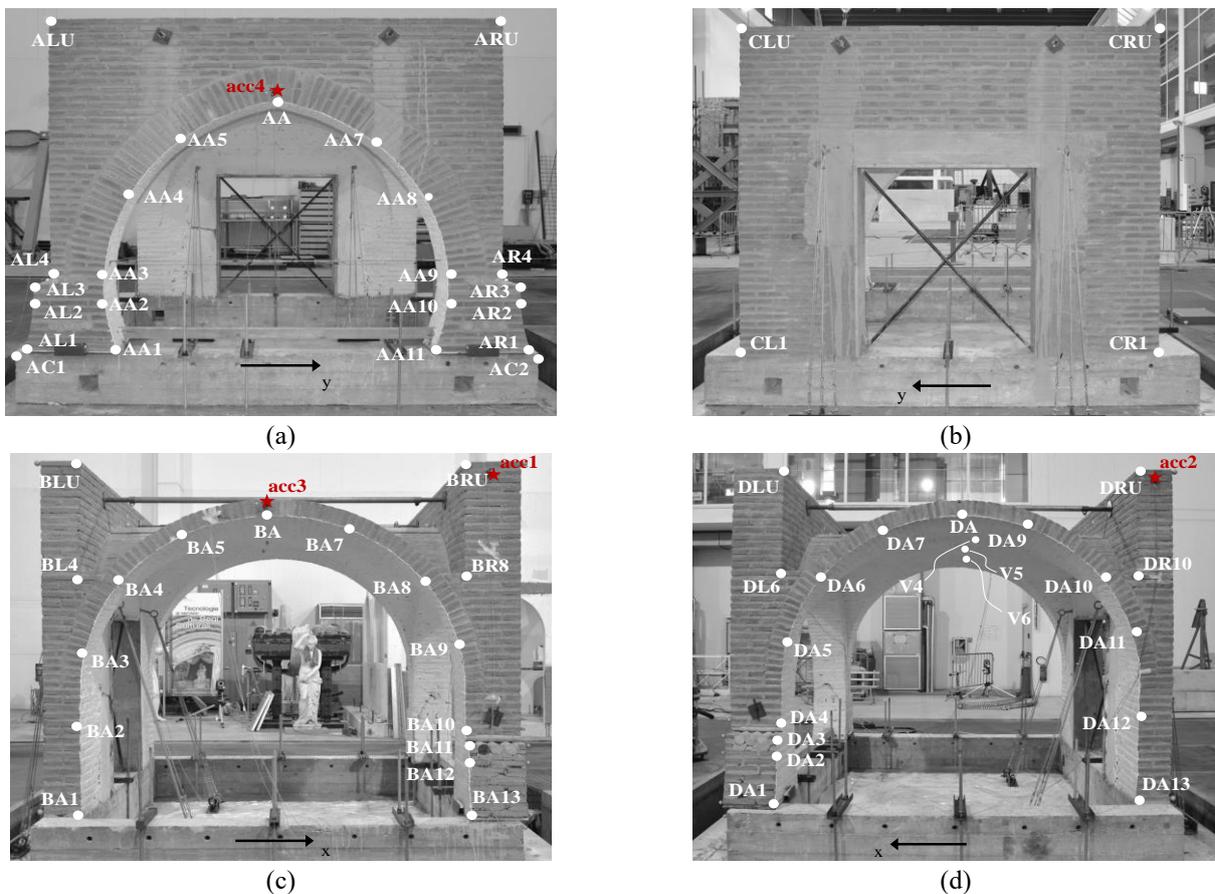
Fig. 10 Identification of the markers and the accelerometers in (a) side A, (b) side C, (c) side B and (d) side D

The shaking table was equipped with a 3-axial accelerometer (acc0) to measure the actual input applied to the table. Further 3-axial accelerometers were placed at the top of the wall A (acc1, Fig. 10(c)), at the top of the wall (acc2 in Fig. 10(d)), at the key of the arch of the side B (acc3, in Fig. 10(c)), and at the key of the pointed arch (acc4, in Fig. 10(a)).

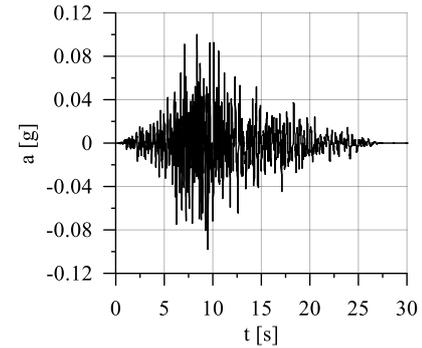
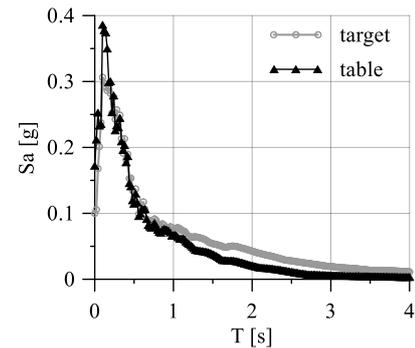
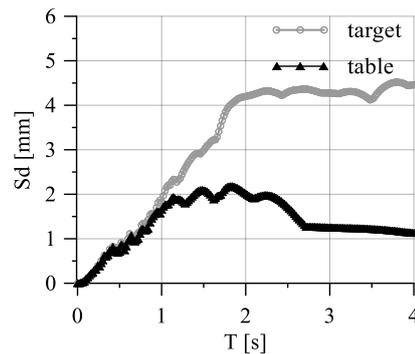
Fig. 11 Target acceleration time history (a); comparison between the acceleration (b) and displacement response spectra (c) of the target input and the input actually measured on the table on sequence Rnd_1

Tests were performed by applying the North-South component of the ground motion registered during the 21 May 2003 Keddara earthquake (ked_NS) along y direction. The target acceleration time history is shown in Fig. 11(a). Figs. 11(b)-(c) show the target acceleration and the displacement response spectra, respectively, compared with the response spectra of the input actually measured on the table. The signal was normalised and rescaled to the site of the Citadel of Algiers according to the uniform hazard response spectrum (UHRS). Tests were performed at increasing value of Peak Ground Acceleration (PGA) of 0.05 g. The actual acceleration applied to the table, named Peak Table Acceleration (PTA), was measured with the accelerator acc0.

The target acceleration time history is shown in Fig. 11(a). Figs. 11(b)-(c) show the target acceleration and the displacement response spectra, respectively, compared with the response spectra of the input actually measured on the table. The signal was normalised and rescaled to the site of the Citadel of Algiers according to the uniform hazard response spectrum (UHRS). Tests were performed at increasing value of Peak Ground Acceleration (PGA) of 0.05 g. The actual acceleration applied to the table, named Peak Table Acceleration (PTA), was measured with the accelerometer acc0. Besides the real history accelerogram, a signal obtained from a multiple-frequency random excitation was given to the table (Rnd).

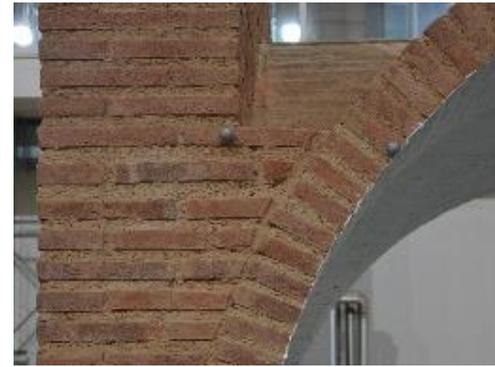
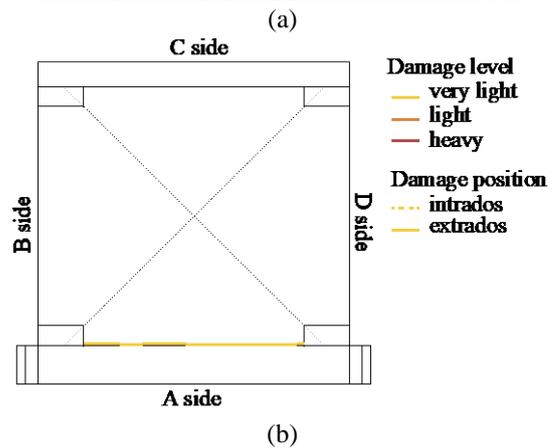
Fig. 12 Very light damage detected after the last test (PTA=0.262 g) on the vault WT: detailed view of the intersection between the vault and the wall A (a); top view of the crack pattern (b)

The development of damage was detected through qualitative visual inspections after each sequence of tests on both the configurations, WT and NT. It is worth to be noted that, the damage detected after the sequence of tests on the vault WT was very light (see Table 2) and in most of the case cracks were almost invisible to naked eyes. After the test ked_NS_0.15 (PTA = 0.262g), a very thin crack at the extrados of the vault WT, along the intersection between the vault profile and the arch spandrel on side A was just barely visible (Fig. 12(a)). A map of the detected crack pattern is shown in Fig. 12(b).

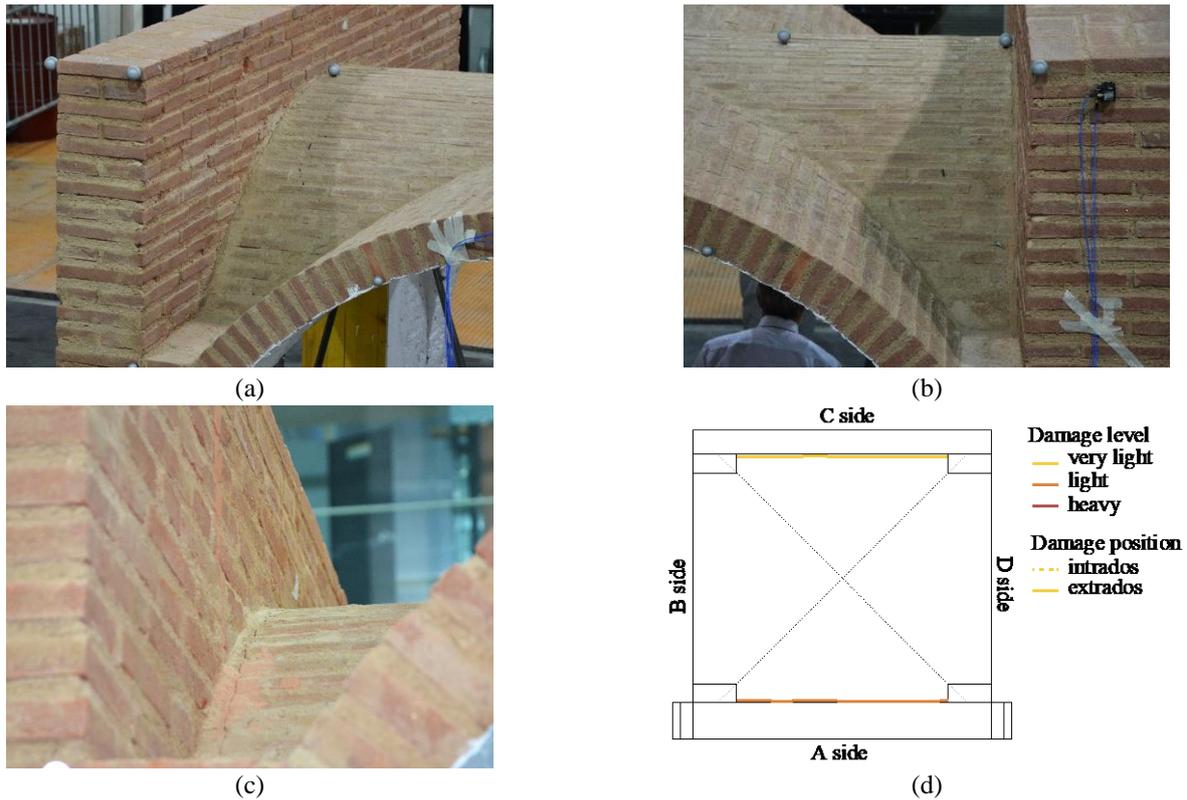
Fig. 13 Damage detected after the test *ked_NS_0.15* (PTA = 0.226g) on the vault NT: detailed views of the intersection between the vault and the wall C (a); the wall A (view from side B) (b); the wall A (view from side D) (c); and top view of the crack pattern (d)

Concerning the tests on the vault NT, after the test ked_NS_0.10 (PTA = 0.173g), no damage was detected, excepting the very thin crack already identified after the previous tests on the vault WT. The damage slightly worsened during the test ked_NS_0.15 (PTA = 0.226g), with the development of a thin crack along the intersection between the vault and the wall C (Fig. 13(a)) and the widening of the crack between the vault and the arch spandrel (Fig. 13(b)-(c)). The damage level was light and caused by a physiological detachment between the vault and the walls that, as explained in Section 3.3, were not built together as a whole, but they were just juxtaposed. No damage, indeed, were detected at the level of the vault's supports, as illustrated in Fig. 13(d). After the following test sequence, ked_NS_0.20 (PTA=0.318 g), the gravity of damage increased (Fig. 14(a)-(b)) and a new very thin

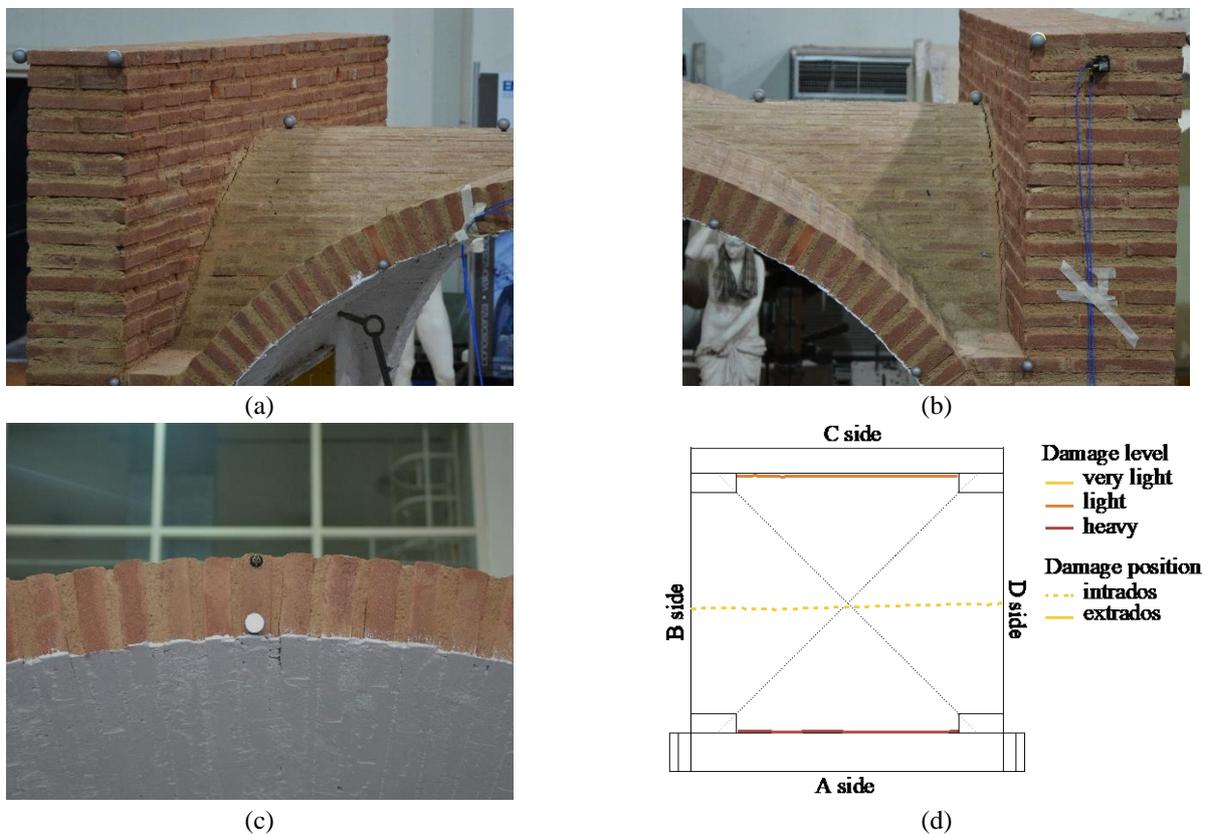
Fig. 14 Damage detected after the test *ked_NS_0.20* (PTA = 0.318g) on the vault NT: detailed views of the intersection between the vault and the wall C (a); the wall A (view from side B) (b); the middle of the vault's profile from side D (c); and top view of the crack pattern (d)

crack, parallel to the other two and passing through the vault's key, was detected (even though scarcely visible at naked eyes) at the intrados (Fig. 14(c)). This crack pattern revealed the activation of a three hinges mechanism of the vault. However, no damage was surveyed at the level of the vault's supports, as shown in Fig. 14(d). The collapse of the vault occurred abruptly during the test *ked_NS_0.25* (PTA=0.398 g). The failure mechanism was characterized by the overturning of the side A and the development of four hinges mechanism (three hinge on the vault and one hinge at the base of the abutments) along the x direction, as shown in Fig. 15. A sequence of images of the failure up to collapse is illustrated in Fig. 16.

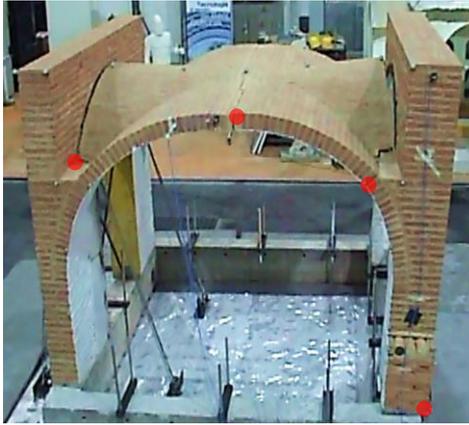
Fig. 15 Four-hinge collapse mechanism of the vault during the test *ked_NS_0.25* (PTA = 0.398g)

- The vault NT collapsed during the last test with a PGA equal to 0.25 g corresponding to a peak table acceleration equal to 0.398 g. The main mechanism of collapse was the out-of-plane response of the side A of the model (wall A overturning) and the development of a four-hinge mechanism of the vault.
- In the vault WT, the maximum cumulative MRD were measured between markers BA10 and BA12 above the abutments (0.79 mm) and between markers BLU and BRU at the top of the wall A and the wall C (0.81 mm).
- In the vault NT, the maximum cumulative MRD (excluding the test at collapse) were measured between markers BA7 and BA8 at the level of the formation of an arch's hinge (2.44 mm) and between markers BLU and BRU at the top of the wall A and the wall C (5.96 mm).

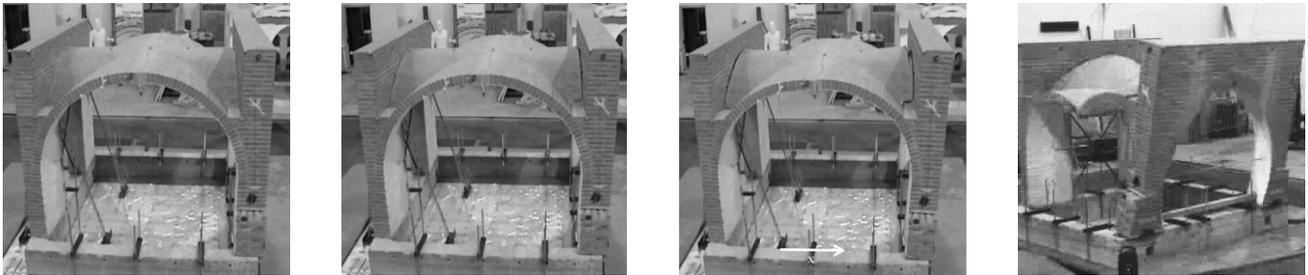
Fig. 16 Collapse mechanism of the vault NT for the seismic input of PTA=0.398 g, with the overturning of the side A and the development of a four-hinge mechanism on the vault

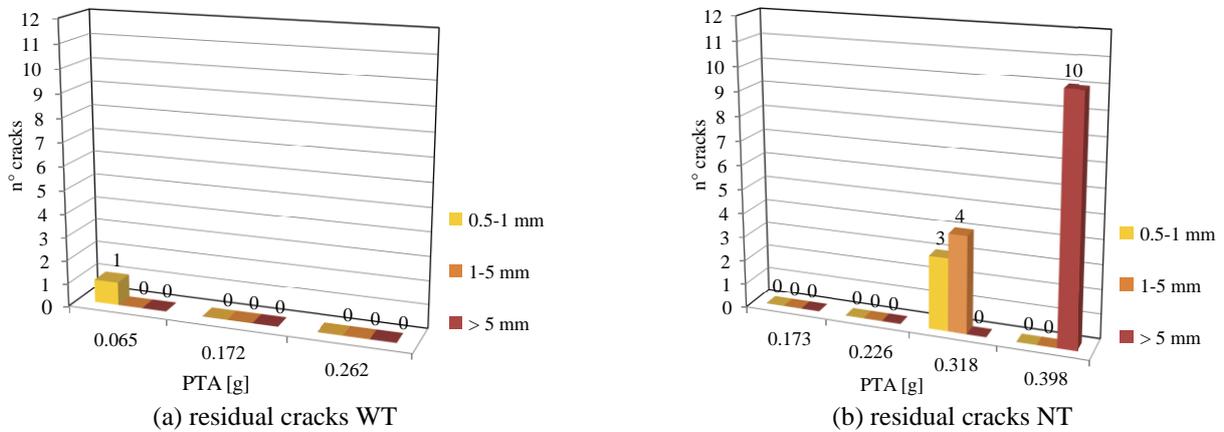
Fig. 17 Maximum number of cracks detected at the end of each test sequence in the vault WT (a) and NT (b)

The number of residual cracks (openings) after each test sequence are shown in Figs. 17(a)-(b) for the vault WT and the vault NT, respectively. The maximum numbers of cracks that occurred throughout tests (dynamic cracks) are shown in Fig. 18(a) (vault WT) and Fig. 18(b) (vault NT).

For the vault WT, a light damage occurred as early as in the ked_NS_0.05 test. After the application of the input of PTA equal to 0.065 g, one crack 0.5-1 mm thick developed (Fig. 17(a)). However, in dynamic conditions, more than one crack (two openings 0.5-1 mm thick and five openings 1-5 mm thick) developed throughout the test, as shown in Fig. 18(a). With increasing the PTA (ked_NS_0.10 and ked_NS_0.15), no residual cracks were measured at the end of each test, while in dynamic conditions, there were two openings 0.5-1 mm thick and four openings 1-5 mm thick.

For the vault NT, no residual cracks were recorded up to the test with PTA equal to 0.318 g (ked_NS_0.20), when three openings 0.5-1 mm thick and four openings 1-5 mm thick occurred (Fig. 18(b)). Despite the lack of residual cracks, five cracks of thickness 0.5-1 mm opened during the test ked_NS_0.10 (PTA = 0.173 g), while three cracks of thickness 0.5-1 mm and three of thickness 1-5 mm opened during the test ked_NS_0.15 (PTA = 0.226 g). During the test of PTA equal to 0.318 g, two cracks of thickness 0.5-1 mm and six of thickness 1-5 mm developed.

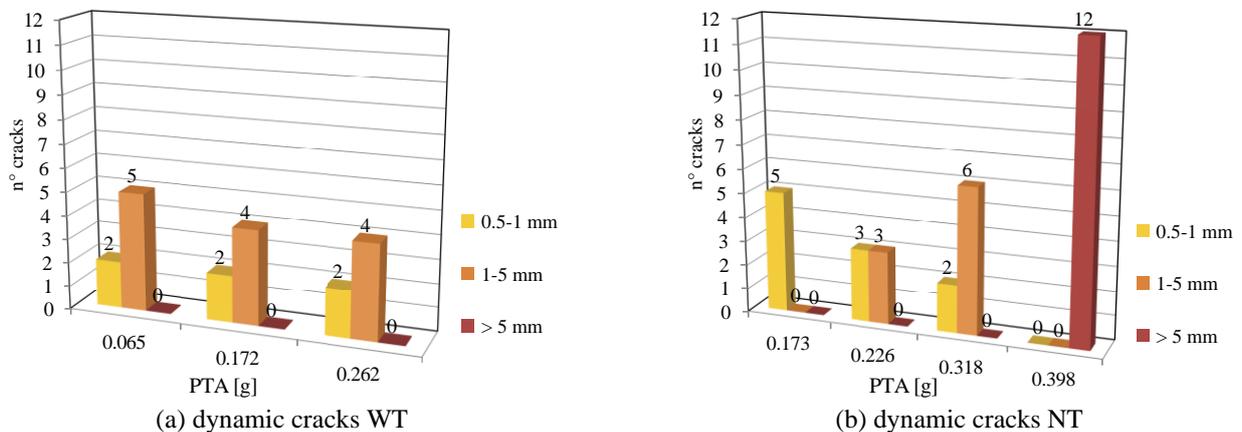
Fig. 18 Maximum number of cracks detected in dynamic condition in the vault WT (a) and NT (b)

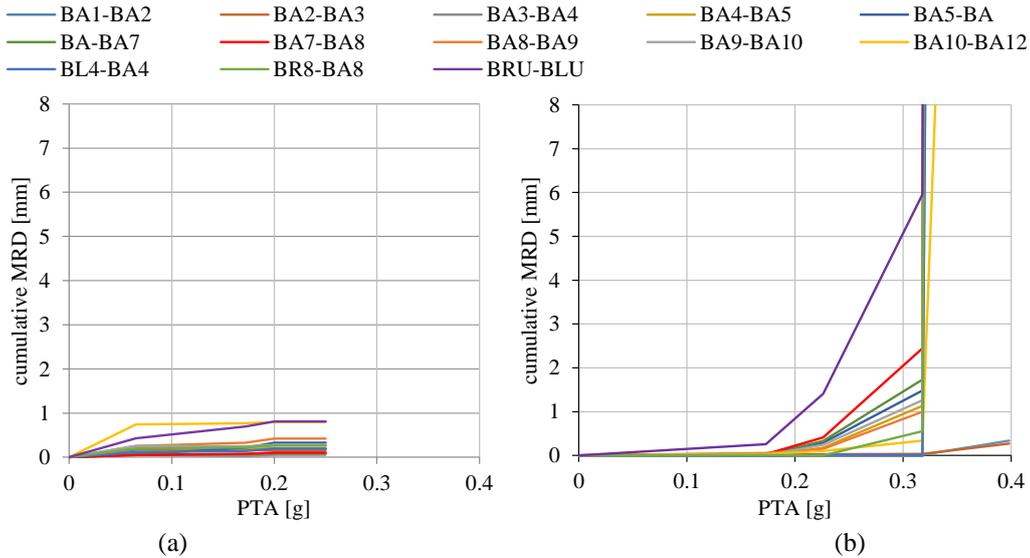
Fig. 19 Cumulative MRD results of tests in the vault WT (a) and NT (b)

Figs. 19(a)-(b) illustrate the cumulative MRDs, which provides the incremental growth of permanent deformations throughout the tests. In general, it can be observed that the vault WT was subjected to initial deformations, mainly localized at the level of the wooden logs (Fig. 19(a), BA10-BA12) and associated to an outward movements of the wall

A (Fig. 19(a), BRU-BLU). These small deformations occurred from the first test of PTA=0.065 g and remained basically constant throughout the three tests.

On the contrary, the vault NT exhibited the main deformations starting from the tests of PTA 0.226 g. As shown in Fig. 19(b), displacements are mainly associated to the increasing outward movement of wall A (BRU-BLU) and to the development of the hinges on the vault, in particular: BA7-BA8 (hinge at the level of one springing), BA-B A7 (hinge on the vault's crown), and BA4-BL4 (hinge at the level of the other springing).

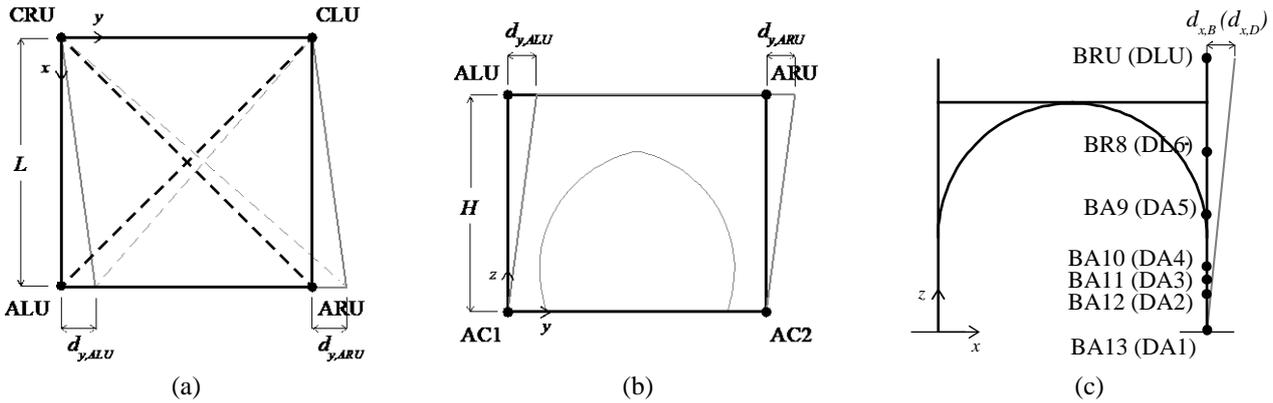
Fig. 20 (a) Horizontal in-plane deformation of the vault (xy plane, top view), (b) vertical in-plane shear of the wall A (yz plane), and (c) out-of-plane mechanism of the wall A (xz plane)

The markers displacement data provided by the 3D Vision system were used to calculate: i) the deformation of the vault in the xy plane (in-plane horizontal drift, Fig. 20(a)); ii) the in-plane shear deformation of the wall A in the yz plane (in-plane vertical drift, Fig. 20(b)); and iii) the displacement profile of the wall A in the xz plane (Fig. 20(c)).

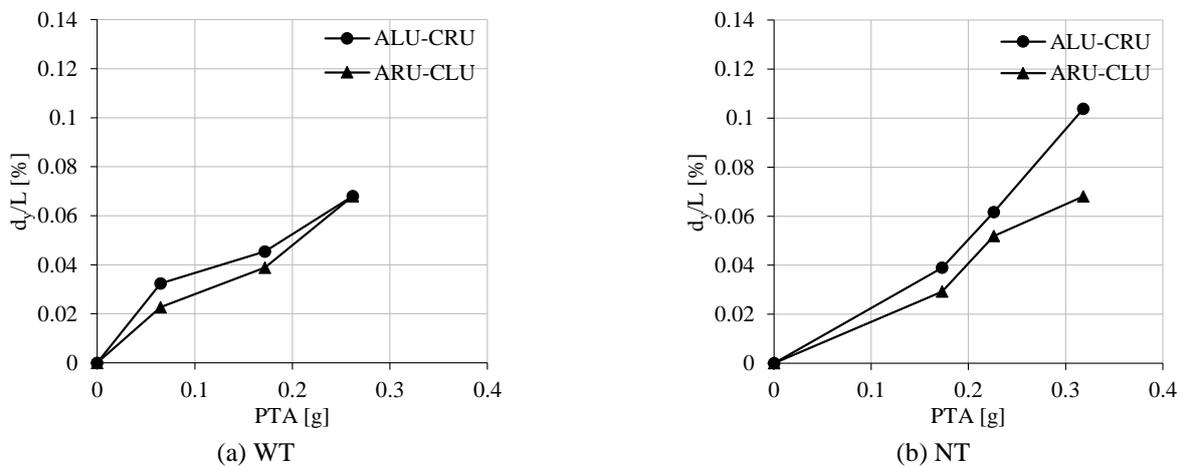
Fig. 21 Horizontal in-plane shear of the vault expressed in terms of displacement/vault's span ratio

The vault's in-plane shear deformation was analysed by calculating the relative displacements dy between the markers ALU-CRU (side B), and ARU-CLU (side D), as shown in Fig. 20(a). The trends of the drift dy/L , with L equal to the distance between the mid plane of the wall C and of the wall A are illustrated in Figs. 21(a)-(b) for the vault WT and NT, respectively.

In the model WT, the drift of side B was slightly bigger than of side D for the first two tests (PTA equal to 0.065 g and 0.172 g). In the last tests (PTA=0.262g), the in-plane response of the vault was almost symmetric, with a drift value of 0.07% in both sides. The same behaviour is observable in Fig. 22(a) that shows the vertical in-plane deformation of the wall A expressed in terms of the vertical drift dy/H , with H the distance between the markers ALU and AL1. The response was modestly asymmetric for the first two tests and symmetric for the last test. This small asymmetry was ascribable to local movements at the level of the abutments caused by settlements of the wooden logs,

The model NT exhibited a higher asymmetry of the response between the sides B and D. During the test of $PTA=0.318$ g, the in-plane horizontal drift of side B (0.104%) was 50% bigger than the drift of side D (0.068%), as shown in Fig. 21(b). However, considering the in-plane vertical drift, the drift of side B was similar to the drift of side D for the first test, and it was smaller during the following tests, as shown in Fig. 22(b). The main reason was that the horizontal in-plane deformation was also affected by some torsional behaviour that increased the drift between ALU and CRU.

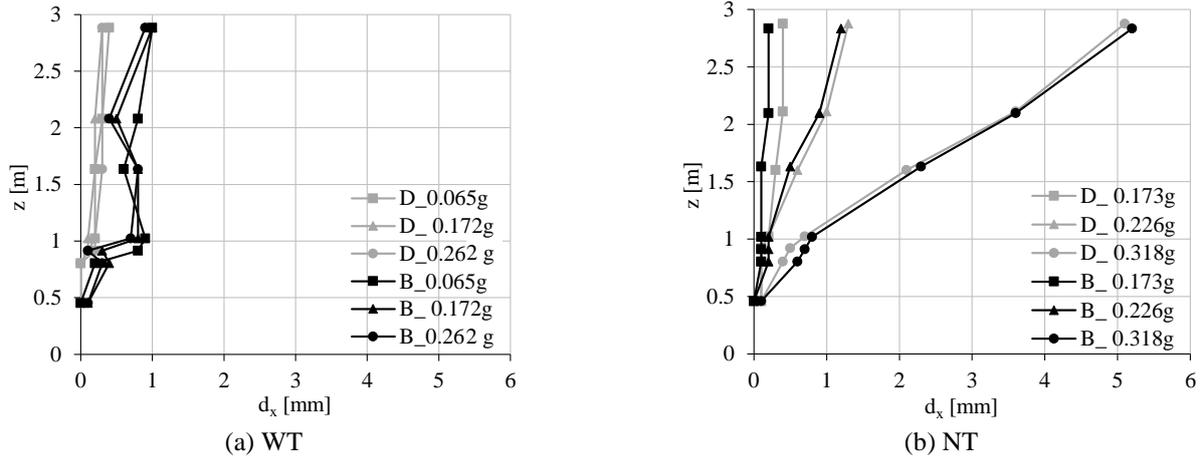
Fig. 23 Displacement profiles of the wall A on both sides B and D

The displacement profiles of the wall A were created based on the relative displacement in x of the markers indicated in Fig. 22(c). Figs. 23(a)-(b) illustrate the displacement profiles for each test of the vault WT and the vault NT, respectively. The black curves indicate the displacement profile of side B, while the grey curves represent the displacement profile of side D.

The vault WT (Fig. 23(a)) exhibited an asymmetric response. In particular, the displacement measured on side B were higher than those on side D. It is worth noting that, however, this difference in drift is related to relatively small deformations produced by low PTA and may be affected by

On side D, displacements show a more regular profile, increasing with the markers' coordinate z and with the seismic input.

The displacement profiles obtained by the three tests of the vault NT (Fig. 23(b)) present a symmetric behaviour on average. The maximum displacement achieved before the collapse ($PTA=0.318$ g) was of 5.2 mm and measured in BLU. This value was four times higher than that measured in the previous test ($PTA=0.226$ g).

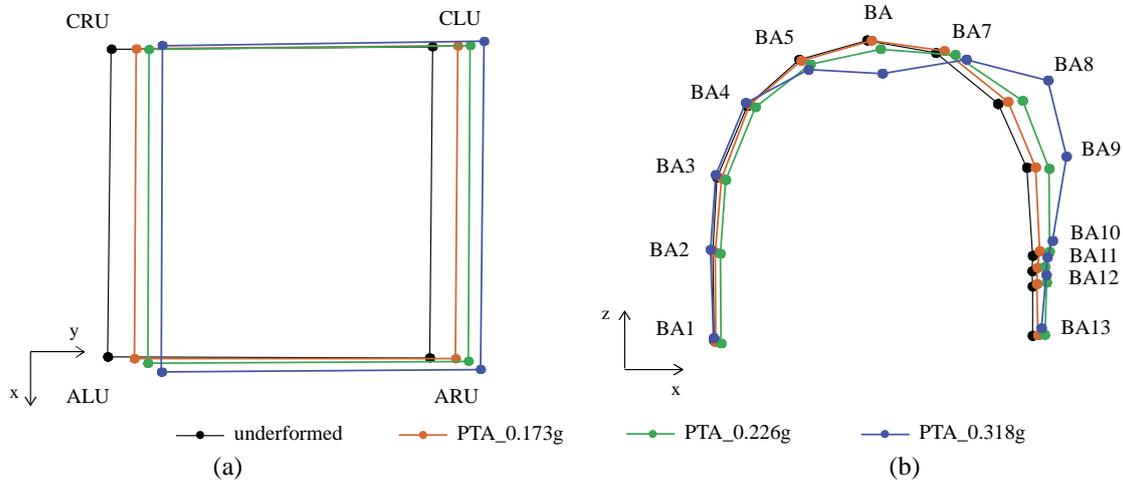
Fig. 24 Deformed shapes of the vault NT: (a) horizontal in-plane deformed shapes from the vault's top view and (b) deformed shapes of the vault from side B

The deformed shapes of the vault NT in both the xy and the xz plane are shown in Figs. 24(a)-(b), respectively.

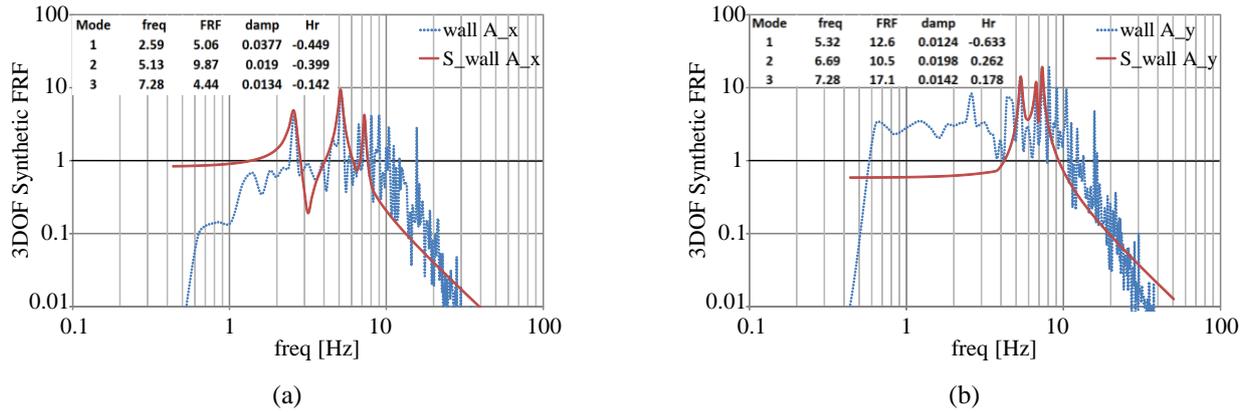
Fig. 25 Test Rnd_1 in the vault WT, Displacement input-Displacement Output Transmissibility function (FRF)_{d-d} of the wall A in (a) x and (b) y direction

The graphs in Fig. 25 show the Transmissibility Function (FRF)d-d of the markers at the points ALU and ARU (top of the wall A), in the x and y direction, during the

Considering the FRF results of the vault WT (see Fig. 25), the first and the second modes correspond to the modes 1 and 2 in x, with a frequency of 2.59 Hz and 5.13 Hz, respectively. The second mode's frequency value was close to the frequency of the mode 1 in y, equal to 5.32 Hz.

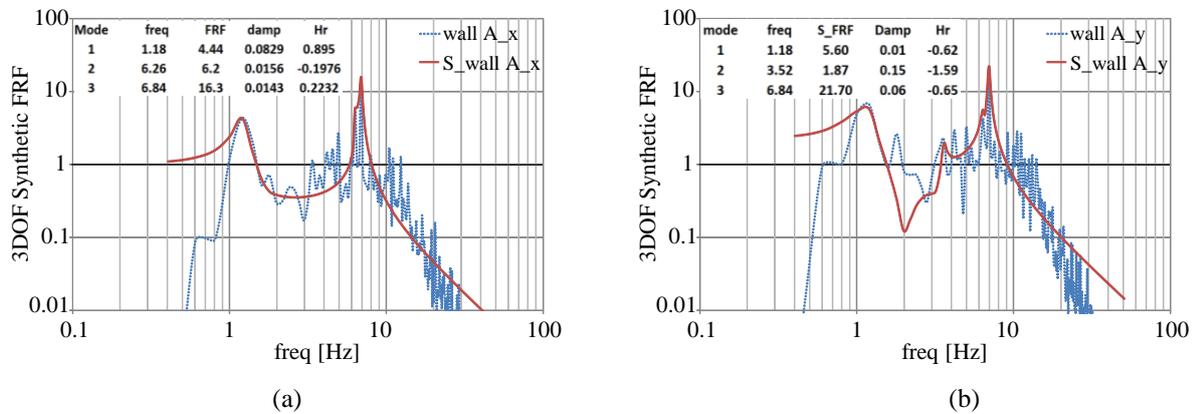
Fig. 26 Test Rnd_4 in the vault NT, Displacement input-Displacement Output Transmissibility function (FRF)_{d-d} of the wall A in (a) x and (b) y direction

test Rnd_1 (vault WT). The graphs in Fig. 26 show the (FRF)d-d at the same markers during the test Rnd_4 (vault NT). The graphs show also the Synthetic FRF (S_FRF) obtained using a 3DOF modal model, calculated as Eq. (1).

The highest frequency had an equivalent value (7.28 Hz) in both the directions. Analysing the FRF results of the vault NT (see Fig. 26), it can be observed that the first mode frequency of 1.18 Hz is equal in both directions. The second mode was the mode 2 in y (3.52 Hz) and the third mode is the mode 2 in x (6.26 Hz).

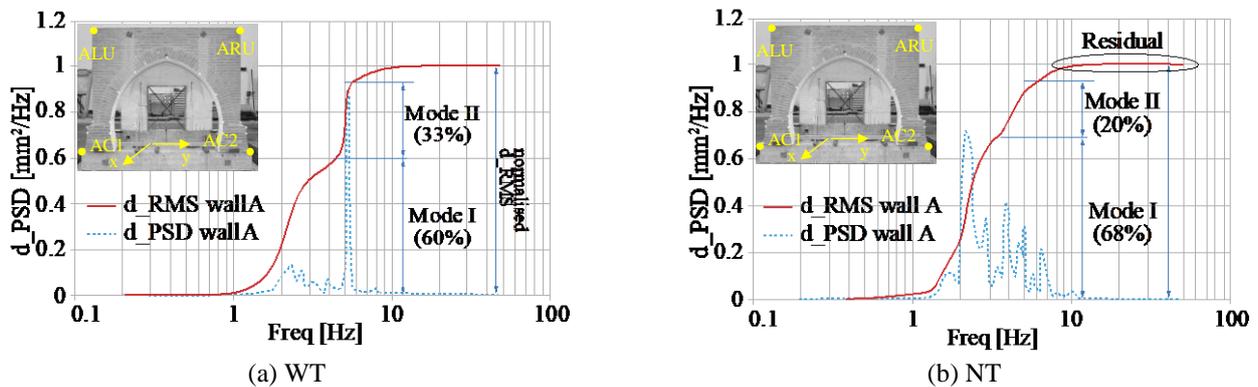
Fig. 27 Power Spectral Density of the displacement at the wall A Control Points and associated frequency contribution to the Root Main Square displacement calculated for (a) test Rnd_1 (WT) and (b) Test Rnd_4 (NT)

to the modal participation coefficients. Figs. 27(a)-(b) show the PSD of the displacements at the wall A control points (ALU and ARU at the top, AC1 and AC2 at the bottom) and the associated frequency contributions to the RMS value of the displacement time histories. This allows estimating the modal participation factors, and consequently the modal mass participation to calculate the spectral acceleration activating the collapse kinematics of the wall (De Canio *et al.* 2015).
