# Structural health monitoring of seismically vulnerable RC frames under lateral cyclic loading

**Abstract.** The effectiveness and the sensitivity of a Wireless impedance/Admittance Monitoring System (WiAMS) for the prompt damage diagnosis of two single-storey single-span Reinforced Concrete (RC) frames under cyclic loading is experimentally investigated. The geometrical and the reinforcement characteristics of the RC structural members of the frames represent typical old RC frame structure without consideration of seismic design criteria. The columns of the frames are vulnerable to shear failure under lateral load due to their low height-to-depth ratio and insufficient transverse reinforcement. The proposed Structural Health Monitoring (SHM) system comprises of specially manufactured autonomous portable devices that acquire the in-situ voltage frequency responses of a network of twenty piezoelectric transducers mounted to the RC frames. Measurements of external and internal small-sized piezoelectric patches are utilized for damage localization and assessment at various and increased damage levels as the magnitude of the imposed lateral cycle deformations increases. A bare RC fra

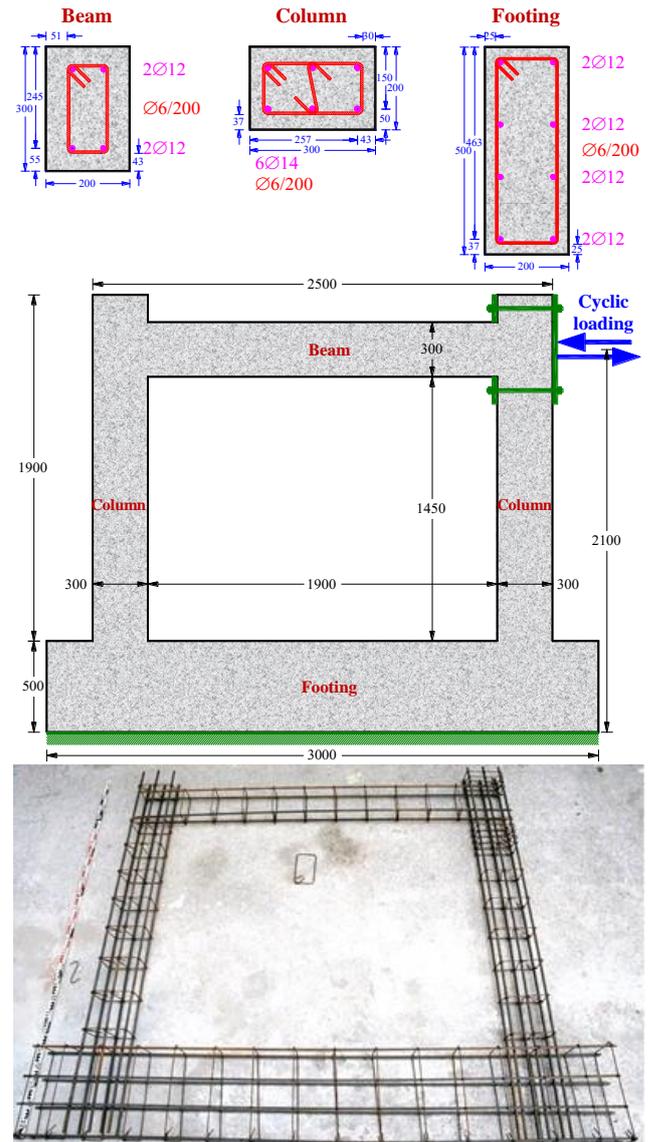
Fig. 1 Dimensions and reinforcement configuration of the structural members of the RC frames

The geometrical and the reinforcement characteristics of the RC structural members of the frames are the same and represent a typical old RC moment-resisting frame structure in Greece that has been designed and constructed using past Code provisions without proper seismic requirements. The cross-sectional dimensions of the beam and the columns of the frames are  $200 \times 300$  mm. The longitudinal reinforcing bars of the beam and the columns are  $4\text{Ø}12$  and  $6\text{Ø}14$  (deformed steel bars, diameters in mm), respectively. The transverse reinforcement of all structural members consists of mild steel closed stirrups of 6 mm diameter uniformly distributed throughout their total length and 200 mm spacing ( $\text{Ø}6/200$  mm). Dimensions and reinforcement configuration of the RC structural members that compose both frames are illustrated in Fig. 1.

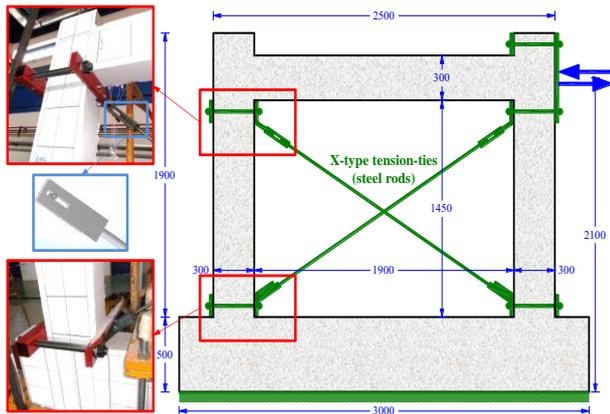
(a) Characteristics of the X-braced RC frame

diameter of 16 mm that have placed diagonally inside the RC frame in X-type arrangement as shown in Fig. 2(a). These rods have been connected to the columns of the RC frame very close to the upper and lower joints of the frame using steel brackets and have been installed in order to operate only in tension (see also the detail in Fig. 2(a)).

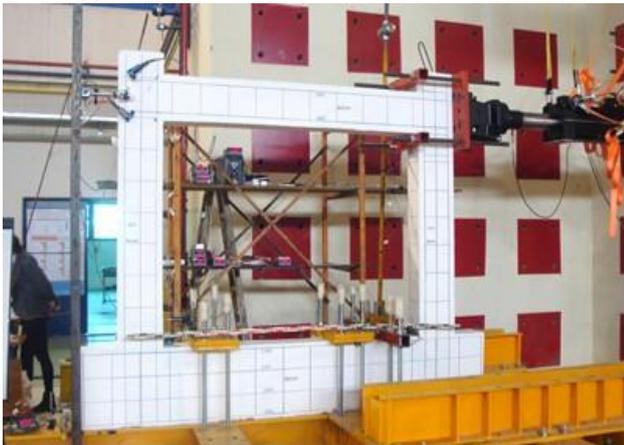
(b) Test rig and instrumentation of the cyclic test  
Fig. 2. X-braced RC frame and experimental setup

The RC frames have been subjected to the same lateral cyclic in-plane displacement-control loading in a rigid RC floor - wall testing area. Test rig and instrumentation are demonstrated in Fig. 2b. The footing of the RC frames was properly fixed to the rigid floor by bolts and nuts in order to prevent slip of the specimen. The load was imposed to the top corner of the RC frames using a double acting servo-controlled hydraulic actuator fixed to the rigid wall of the laboratory with maximum capacity of 500 kN and 500 mm total stroke connected to an intermediate hydraulic control unit to ensure its smooth operation (Liolios *et al.* 2017).

Displacements were measured via a number of digital strain gauges, positioned at different locations on the frame. Linear Variable Differential Transformers (LVDTs) and String Displacement Transducers (SDTs) were used. LVDTs were positioned on the top and bottom corners of the frames to measure the net in-plane horizontal displacements of the frame and on the opposite faces to measure any possible twisting or out-of-plane deformation of each frame. SDTs were positioned on the internal diagonals of the frames to measure the diagonal deformations. SDTs were also diagonally positioned on the upper beam-column joints of the frames to measure the shear deformations of the joint area. All measuring devices were placed in appropriate locations and connected to data logger for digital recording.

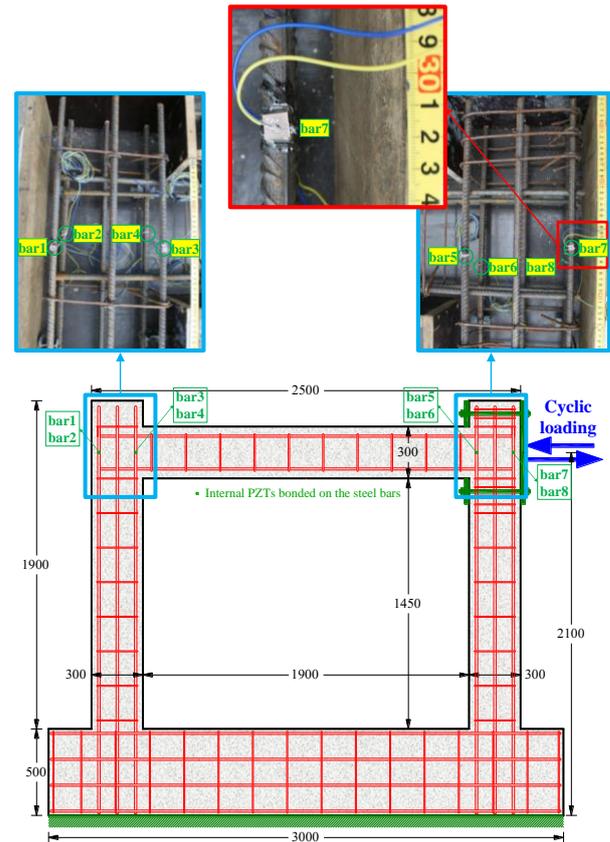
Fig. 3. Locations and installation of the epoxy bonded PZTs on the steel longitudinal reinforcing bars of the columns of the tested RC bare frame

- Eight (8) PZTs (denoted as “bar1”, “bar2”, etc.) have been epoxy bonded on the surface of the steel reinforcing bars of the columns at locations shown in Figs. 3 and 6(a) for the bare and the X-braced frame, respectively.
- Six (6) PZTs (denoted as “SA1”, “SA2”, etc.) have been embedded inside the concrete mass of each frame specimen as “Smart Aggregates” at locations shown in Figs. 4 and 6(a) for the bare and the X-braced frame, respectively.
- Six (6) PZTs (denoted as “X1”, “X2”, etc.) have been externally epoxy bonded to the concrete surface at the back face of the RC frames at locations shown in Figs. 5

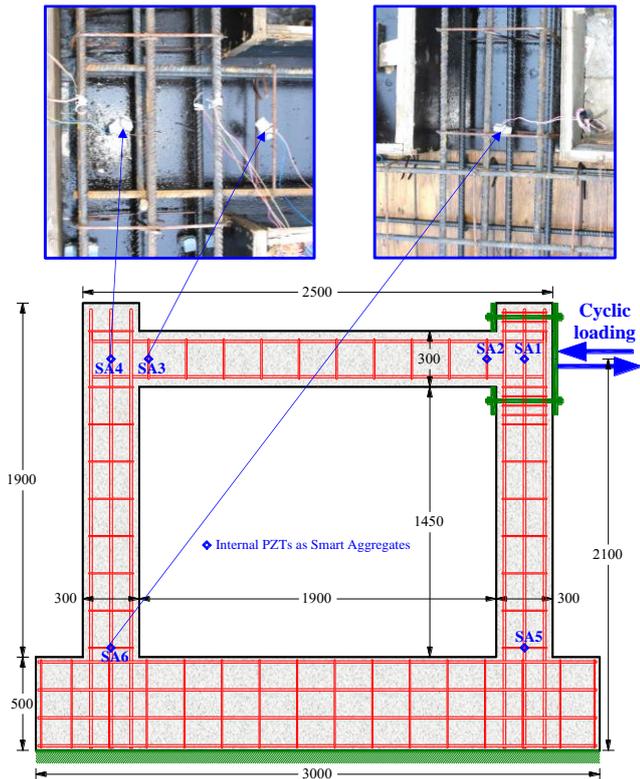
Fig. 4. Locations and installation of the embedded PZTs inside the concrete mass of the RC bare frame as “Smart Aggregates” (SA)

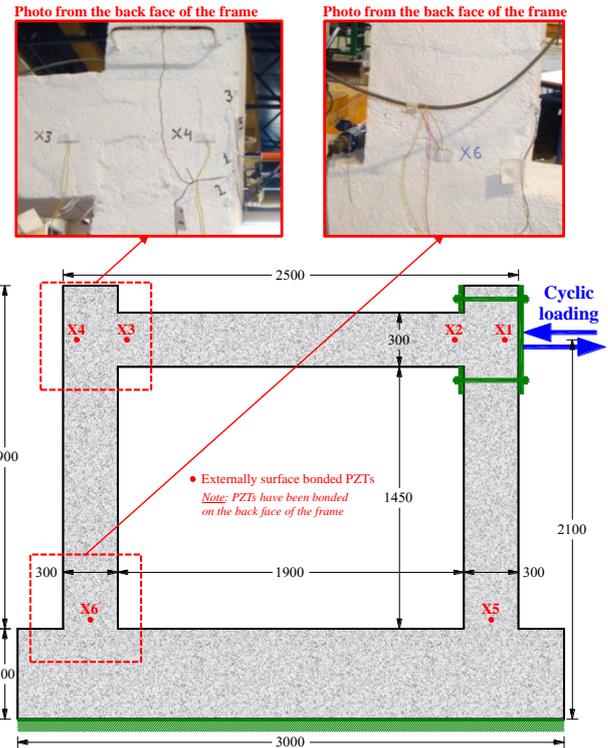
Fig. 5. Locations of the externally epoxy bonded PZTs at the back face of the RC bare frame surface

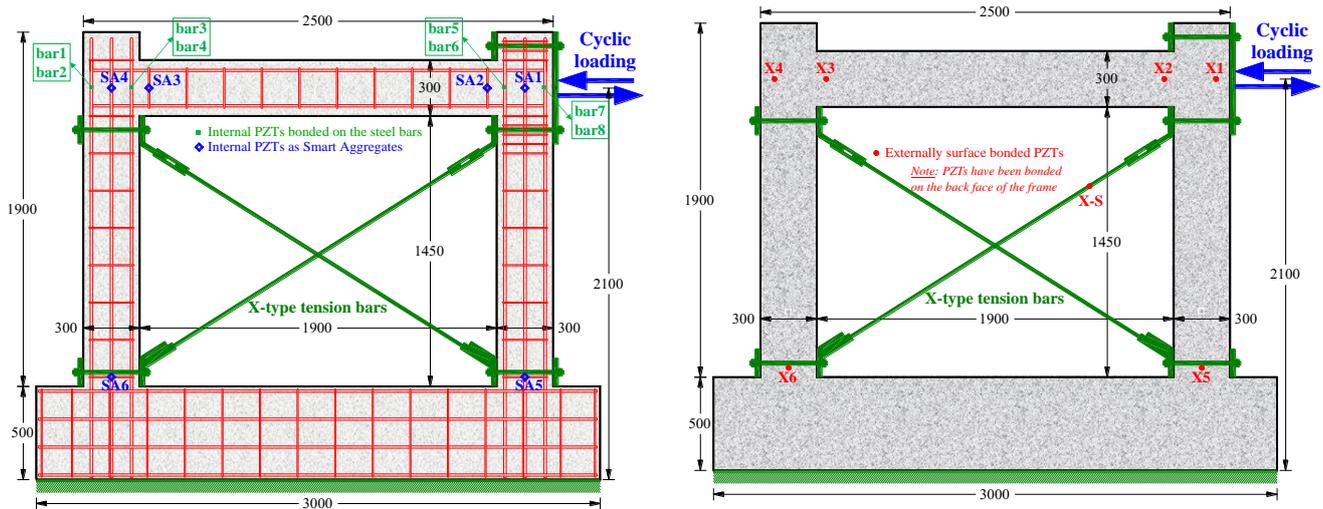
(a) Internal PZTs: Epoxy bonded on the steel longitudinal reinforcing bars of the columns and embedded inside the concrete mass as “Smart Aggregates” (SA)

(b) External PZTs: Epoxy bonded on the concrete surface

Fig. 6. Locations of the PZTs of the RC X-braced frame

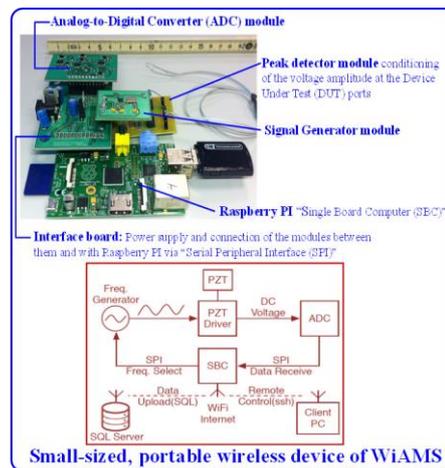
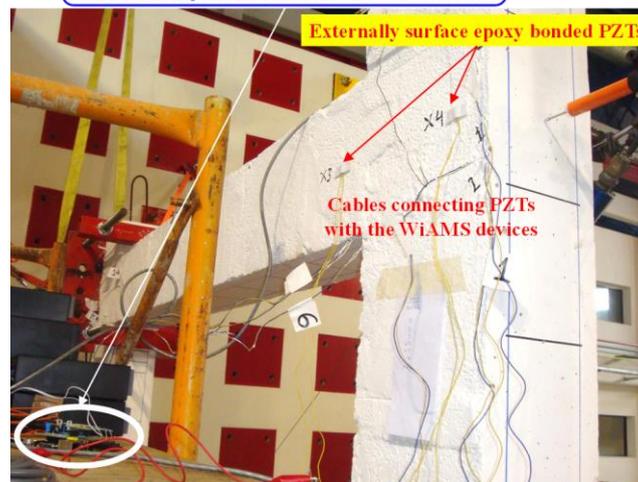
Fig. 7. Test setup of the used SHM system during the cyclic loading procedure of the examined RC frames (view from the top back face of the frame)

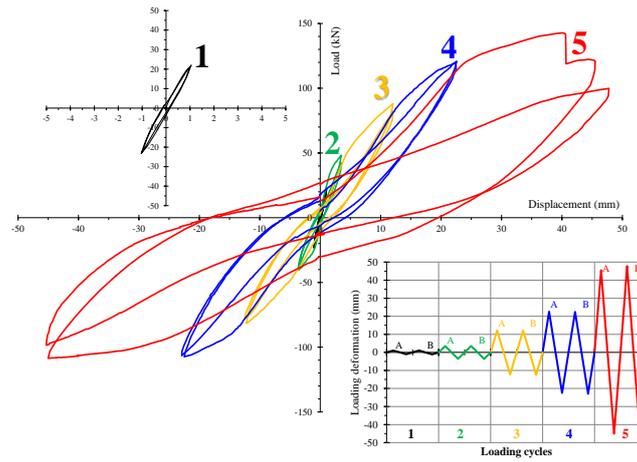
Fig. 8. Hysteretic response of the RC bare frame

The hysteretic response of the RC bare frame is presented in Fig. 8 in terms of imposed load versus horizontal displacement. Fig. 9 illustrates four photographs with the cracking patterns of the frame at the end of the 2nd, 3rd, 4th and 5th loading step, which are the examined damage levels. It is noted that the first two loading cycles of the first (1st) loading step developed low stresses, very close to the elastic region of the structural members and therefore the bare frame remained practically undamaged.

RC bare frame, as shown in the hysteretic response of the frame in Fig. 8. It is obvious that this failure occurred due to the combination of the low height-to-depth ratio of the column that corresponds to a rather short RC structural member and the inadequate transverse reinforcement, which results to low shear resistance, insufficient confinement and low ductility (Armaghani *et al.* 2019).

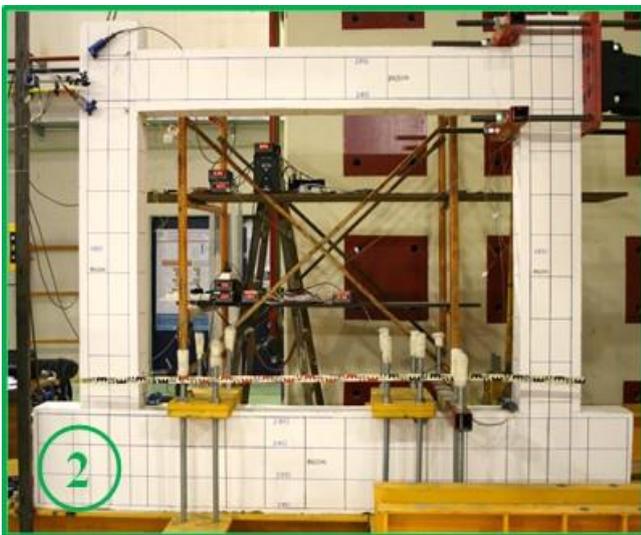
(a) End of loading step 2: Hairline flexural cracks at the beam and conjunctions of the beam and the columns

At the end of the 2nd loading step only slight and hairline flexural cracks occurred at the conjunctions of the beam and the columns. These cracks formed during loading and closed when unloading (see also Fig. 9(a)). When the RC frame subjected to the 3rd loading step more flexural cracks were propagated from the tip of the existing cracks and several new flexural cracks were generated at new locations and for both lateral loading directions. At the end of the 3rd loading step hairline diagonal cracks observed at both upper beam-column joints area (see also Fig. 9(b)). During the 4th loading step, as the applied load increased new flexural cracks developed, whereas the existing flexural cracks became wider (see also Fig. 9(c)).

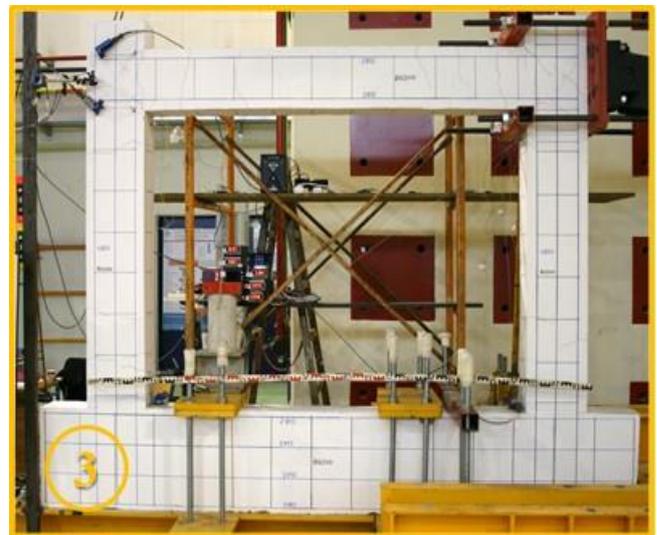
(b) End of loading step 3: Flexural cracks in beam and columns and hairline diagonal cracks in joints

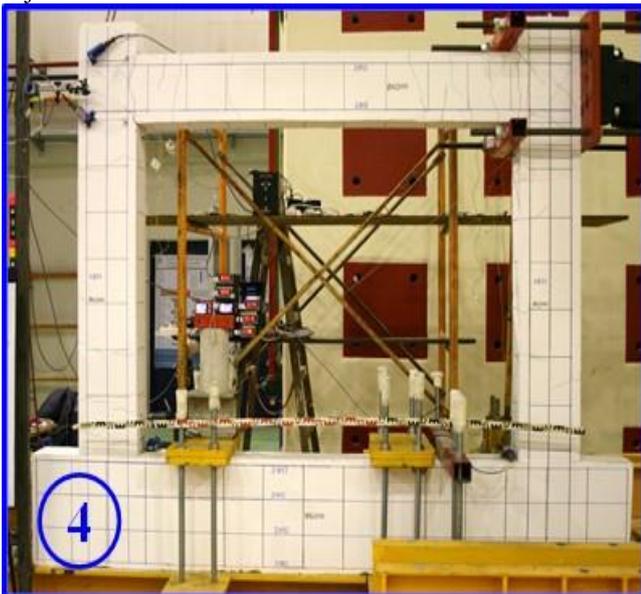
(c) End of loading step 4: Increased flexural cracking and slight diagonal cracks

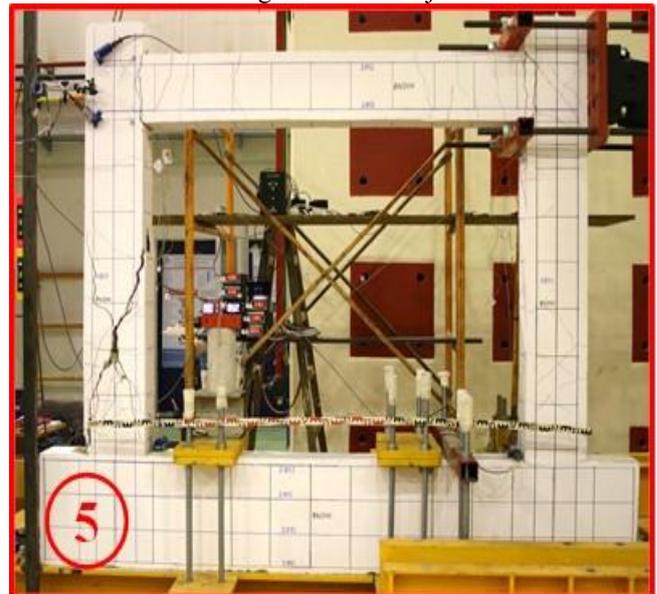
(d) End of loading step 5: Failure due to the brittle diagonal cracking of the left column

displacement approximately 40 mm of the first positive cycle of the 5th loading step due to the development of a severe diagonal crack of the left column that caused brittle

shear failure (see also Fig. 9(d)). It is noted that diagonal cracking was only visible immediately prior to fatal failure which caused a sudden reduction of the load capacity of the

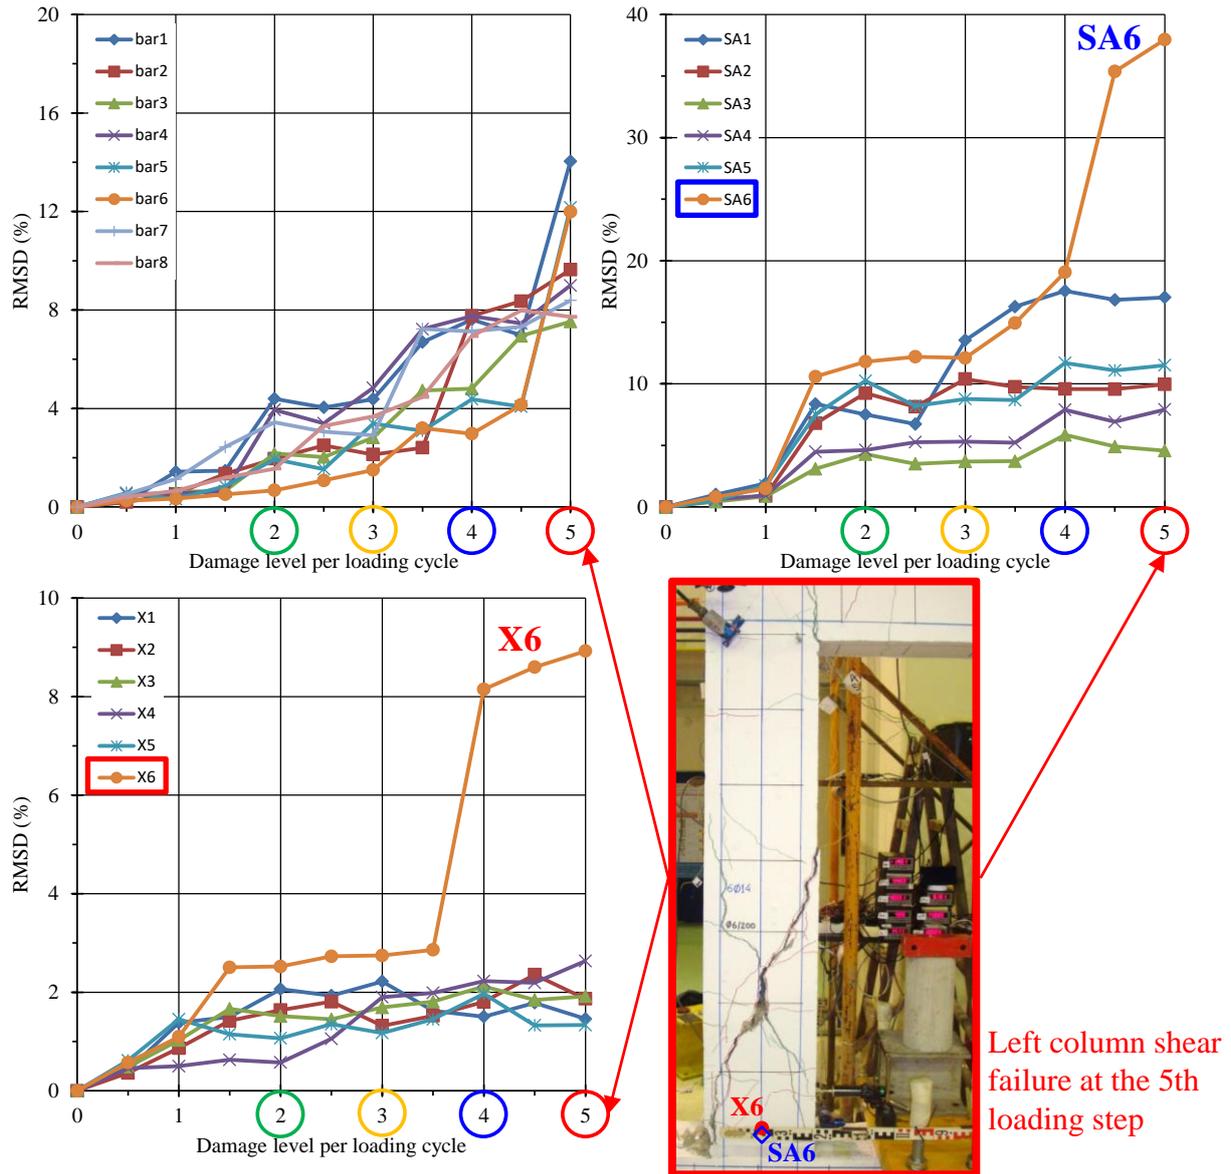
Fig. 10. Values of RMSD index evaluated from the voltage frequency response signals of the PZTs for different level of loading/damage of the RC bare frame

Fig. 10 presents the results derived from the applied damage detection SHM procedure that is based on the voltage frequency response of the attached PZTs measured by the WiAMS devices during the cyclic test of the bare RC frame. The comparisons of the response of each PZT at the initial healthy state (baseline signal) with the corresponding response at every examined loading level (increasing loading step) that cause an increased damage level provide useful information concerning the structural integrity condition of the examined RC bare frame.

The RMSD values of every PZT at each loading step - cycle are presented in the curves of Fig. 10. Any damage occurred in the tested RC bare frame due to concrete cracking or/and steel yielding causes a change to the voltage signal measurements of the PZTs mounted to the region of the structural member close to the damage. The greater the damage, the greater the change in the voltage signals and, consequently, the greater the absolute value of the RMSD index. This way, RMSD value is used as a feasible damage index that provides a real-time quantitative assessment of damage during a seismic excitation.

The values of RMSD calculated from the voltage frequency response signals of all the twenty (20) PZTs for the five (5) different levels of loading/damage shown in Fig. 10 indicate a consistent increase. This trend confirms the increase of the damage due to the increase of the imposed lateral cyclic deformations (see also the cracking patterns of the RC bare frame in the photographs in Fig. 9).

It is emphasized that the RMSD values of (a) the internally embedded PZT aggregate "SA6" and (b) the externally bonded PZT "X6", which have been installed at the base of the left column (see also Fig. 10) exhibited maximum values and much higher values from the other PZTs during the 5th loading step, right after the development of the fatal shear diagonal cracking that has also been occurred at the base of the left column.

Further, promising early warnings of the forthcoming brittle failure are indicated from the high RMSD values of the external PZT "X6" at the 4th loading step, before there is any visible diagonal crack in the base of the left column and before the formation of the critical shear crack during the 5th loading step (see also Figs. 8, 9 and 10).

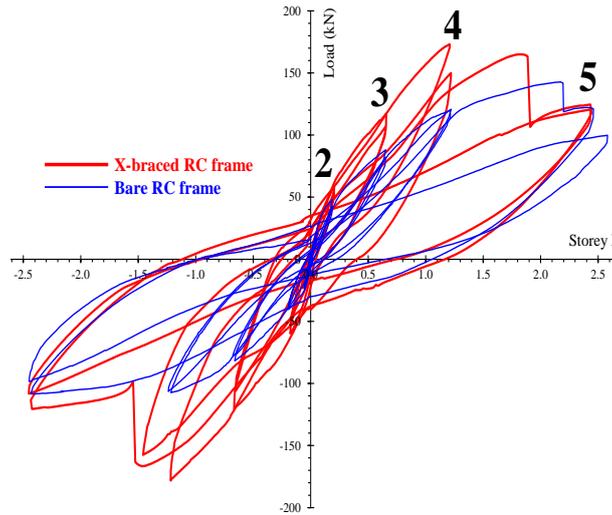
Fig. 11. Comparison of the hysteretic responses of the tested RC frames in terms of load versus storey drift

The hysteretic response of the X-braced RC frame is presented and compared with the response of the bare one in Fig. 11 in terms of load versus storey drift ratio. Fig. 12 illustrates four photographs with the cracking patterns of the X-braced frame at the end of the 2nd, 3rd, 4th and 5th loading step. The response in the first two loading cycles of the first (1st) loading step was nearly linearly elastic and the members of the frame remained practically undamaged.

extensive shear cracking in the columns of the frame and caused a substantial increase of the loading bearing capacity of the strengthened specimen with regard to the cracking and lateral response of the bare one (see also Fig. 11).

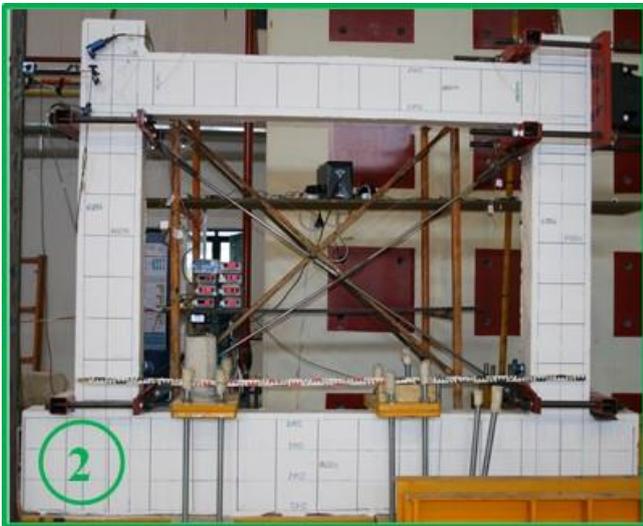
(a) End of loading step 2: Slight hairline flexural cracks in beam

At the end of the 2nd loading step only slight and hairline flexural cracks occurred at the conjunctions of the beam. These hairline cracks formed during loading and closed when unloading (see also Fig. 12(a)). When the RC frame subjected to the 3rd loading step more flexural cracks were propagated from the tip of the existing cracks and several new flexural cracks were generated at new locations and for both lateral loading directions. Further, hairline diagonal cracks observed at both upper beam-column joints area (see also Fig. 12(b)). During the 4th loading step, as the applied load increased new flexural cracks developed, whereas the existing flexural cracks in the beam became wider (see also Fig. 12(c)). It is noted that the application of the steel crossed tension-ties prevented the development of

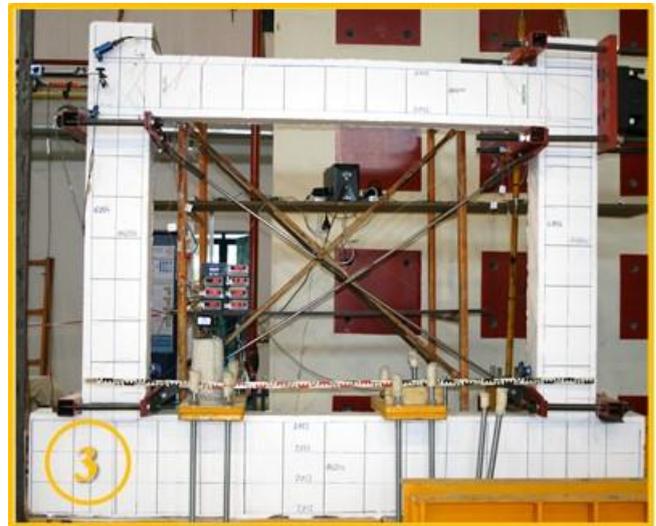
(b) End of loading step 3: Flexural cracks in beam and columns and hairline diagonal cracks in joints

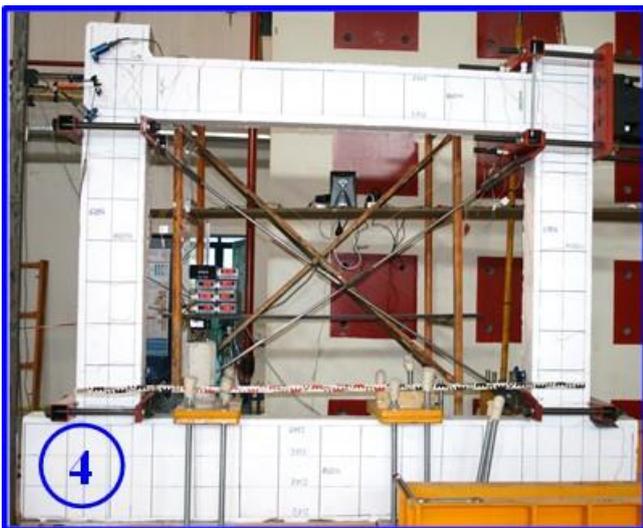
(c) End of loading step 4: Increased flexural cracking mainly in beam

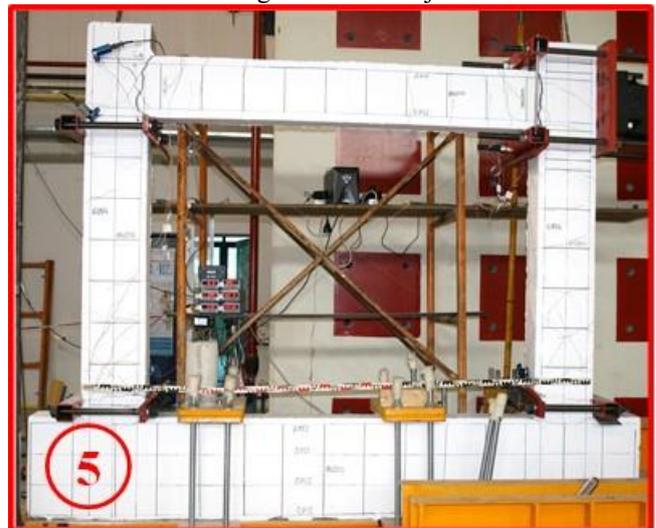
(d) End of loading step 5: Fracture of the steel X-braced rods, hairline diagonal cracks in columns and development of plastic hinges in the beam

The critical damage of the X-braced frame occurred at displacement equal to approximately 35 mm of the first positive cycle of the 5th loading step due to the fracture of the first steel tension tie that caused a sudden reduction of the load (see also Fig. 11). The second tension tie fractured at the right next opposite loading direction of the same cycle. During the 5th loading step two distinct plastic hinges have also been formed in both end regions of the beam, very close to the beam-columns conjunction (see also Fig. 12d). The quite different failure mode of the X-braced frame with regard to the failure of the bare one reveals that the use of the strengthening system succeeded to improve the response by preventing the shear failure of the column.

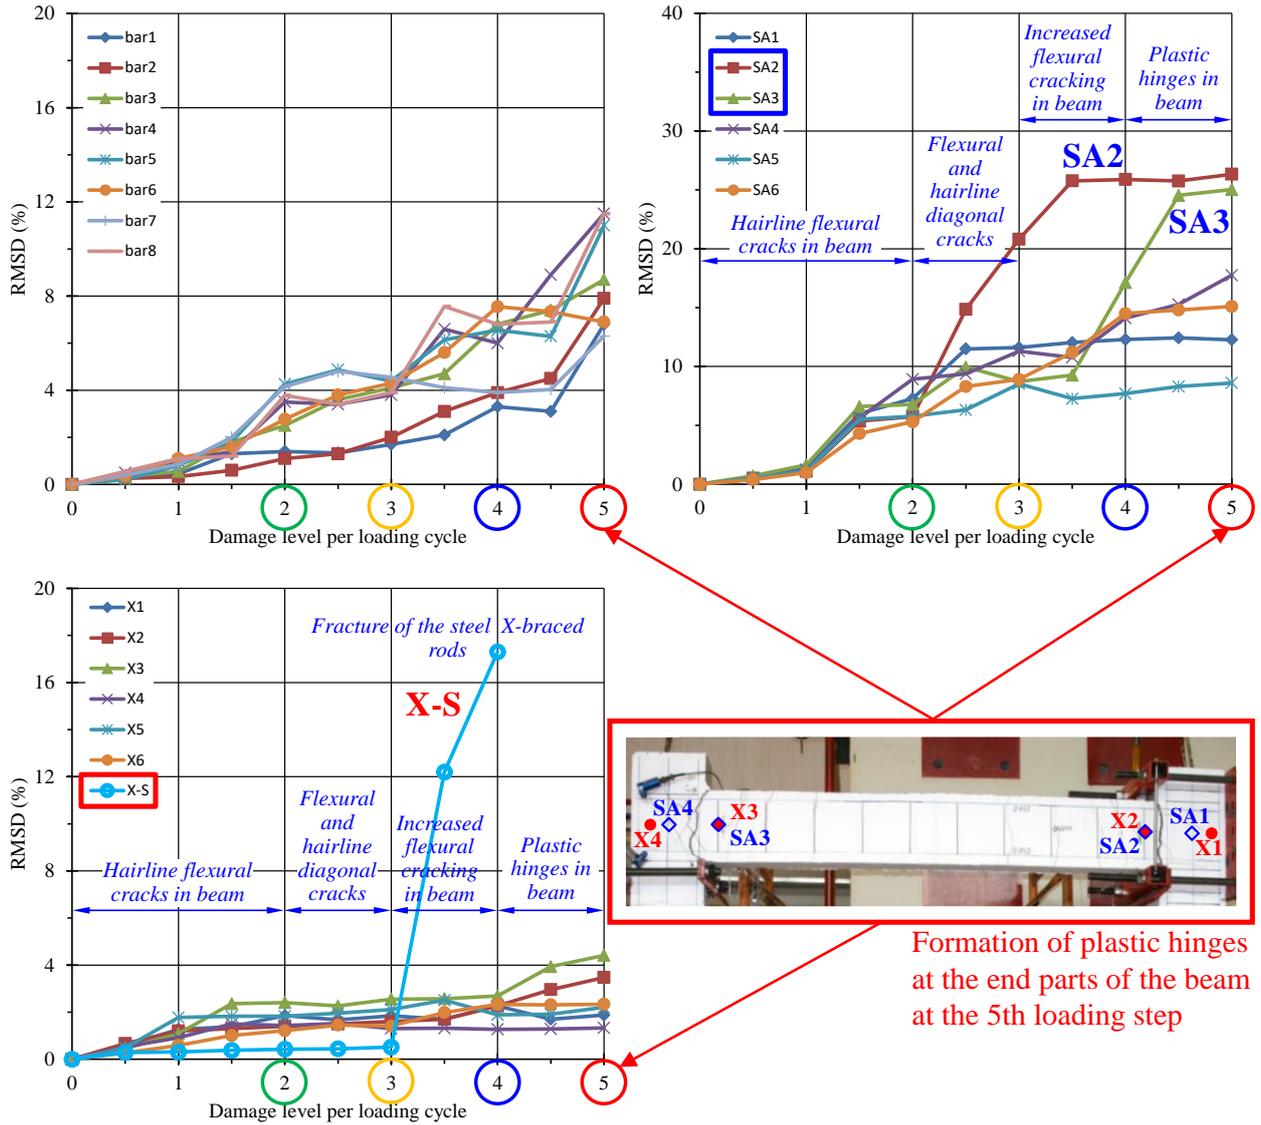
Fig. 13. Values of RMSD index evaluated from the voltage frequency response signals of the PZTs for different level of loading/damage of the RC X-braced frame

Fig. 13 presents the values of the RMSD damage index of every PZT at each loading step - cycle. The RMSD values have been calculated from the voltage frequency signals of all the twenty-one (21) PZTs mounted to the X-braced RC frame for the five (5) examined damage levels.

The curves of Fig. 13 indicate that the RMSD index can reflect the damage deterioration quantitatively since RMSD values increase gradually as the damage of the tested frame grows. Further, the RMSD values of the embedded smart piezoelectric aggregates "SA2" and "SA3" which have been installed at the end regions of the beam, very close to the beam-columns conjunction (see also Fig. 10) exhibited higher values from the other PZTs during the 3rd and the 4th loading step, respectively. It is noted that during these loading steps extensive flexural cracking has been developed in these areas and two plastic hinges have finally been formed in both end regions of the beam. Thus, it is concluded that the PZTs located in the vicinity of the severe cracks are more sensitive and register greater changes, or else higher RMSD values, compared to the distant PZTs. Similar remarks are also derived from the results of the PZT "X-S" that has been externally bonded to the diagonal steel tension-tie. The fracture of the tension-tie has been observed at the first cycle of the 5th loading step, whereas steel yield occurred at the 4th loading step. The significant increase of the RMSD value of the PZT "X-S" at this loading step reveals the damage occurred in the steel due to yielding and can be used as a warning of the forthcoming fracture.
