# Seismic performance of non-ductile detailing RC frames: An experimental investigation

**Abstract.** Non-ductile detailing of Reinforced Concrete (RC) frames may lead to structural failure when the structure is subjected to earthquake response. These designs are generally encountered in older RC frames constructed prior to the introduction of the ductility aspect. The failure observed in the beam–column joints (BCJs) and accompanied by excessive column damage. This work examines the seismic performance and failure mode of non-ductile designed RC columns and exterior BCJs. The design was based on the actual building in Tainan City, Taiwan, that collapsed due to the 2016 Meinong earthquake. Hence, an experimental investigation using cyclic testing was performed on two columns and two BCJ specimens scaled down to 50%. The experiment resulted in a poor response in both specimens. Excessive cracks and their propagation due to the incursion of the lateral loads could be observed close to the top and bottom of the specimens. Joint shear failure appeared in the joints. The ductility of the member was below the desired value of 4. This is the minimum number required to survive an earthqua

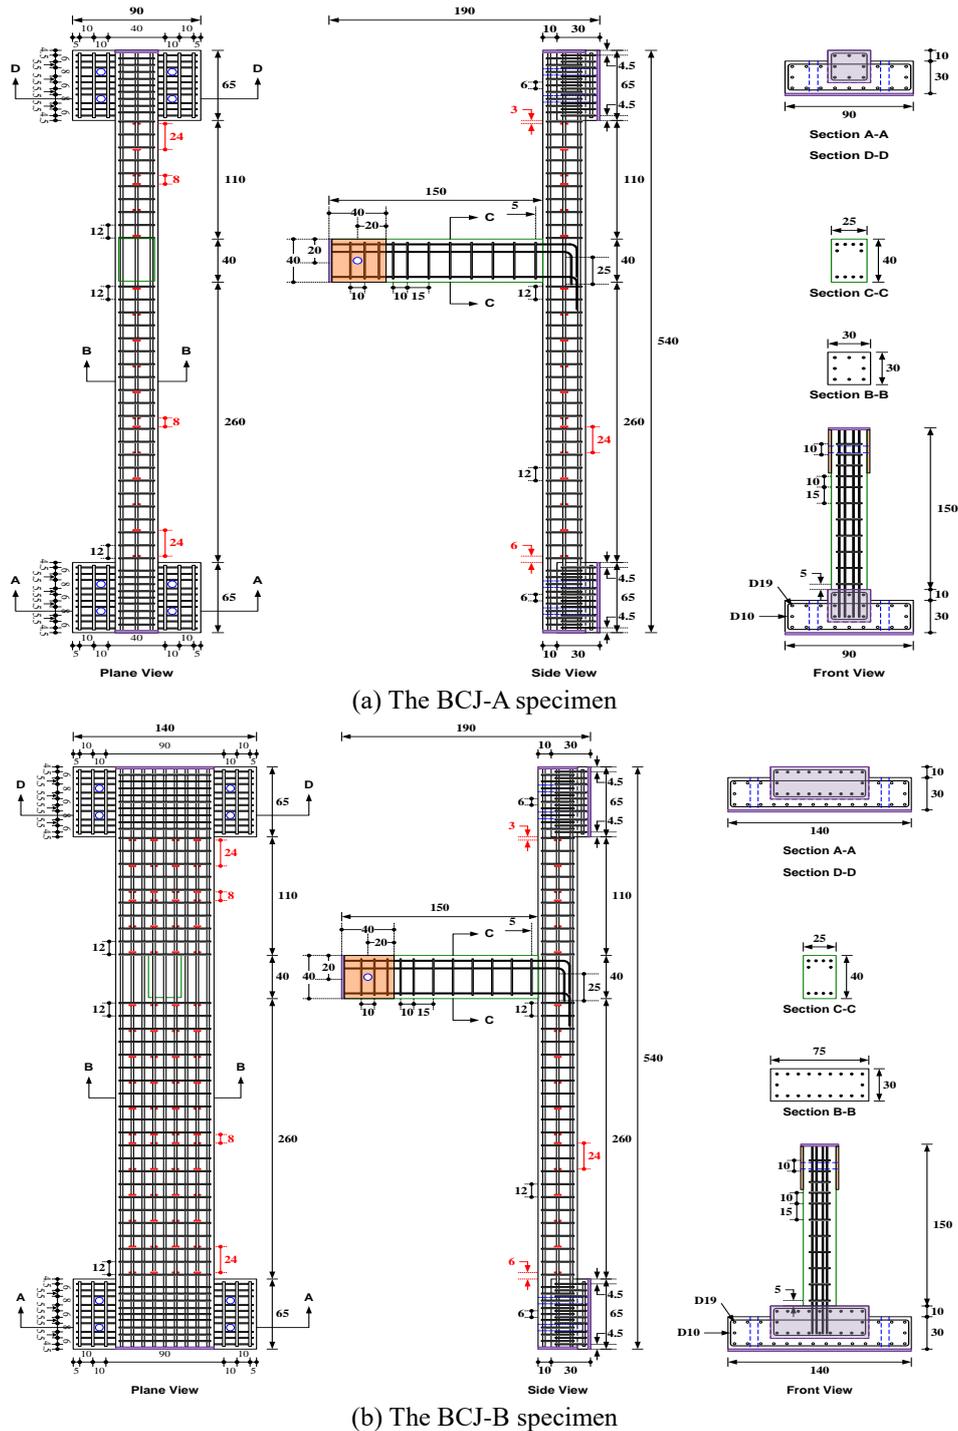
Fig. 1 The reinforcement configuration of the BCJ specimens for the quasi-static test (units: cm)

mm for the small column denoted as C-A and  $300 \times 750$  mm for C-B symbolized the large column. For the BCJ specimens, two columns with lengths of 4,100 mm were connected to the beam, which had an area of  $250 \times 400$  mm and 1,500 mm length, and were denoted as BCJ-A and BCJ-B, respectively. Table 1 and also Fig. 1 show the details and configurations of longitudinal and transversal reinforcement of the RC specimens for the quasi-static test. The compressive strength of the concrete, following ASTM-C39 (2020) testing, was 21.96 MPa at 28-day. Fig. 2 illustrates

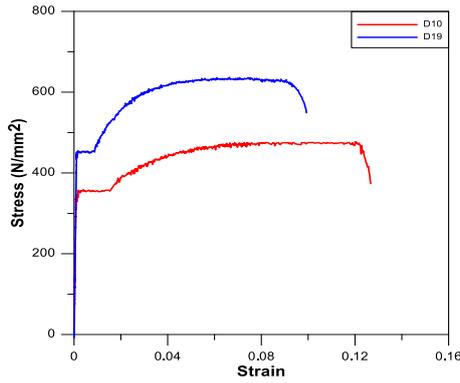
Fig. 2 Tensile test result of steel reinforcement

that the reinforcements were tested and the obtained elastic modulus, yield strength, and ultimate strength were found to be 355.45 GPa, 450 MPa, and 634 MPa for the 19-mm-diameter bar and 208.77 GPa, 355 MPa, and 471 MPa for the 10-mm-diameter bar, respectively. This value can be considered as a low grade for the steel reinforcement. The schematic configuration of the MATS was displayed in Fig. 3.

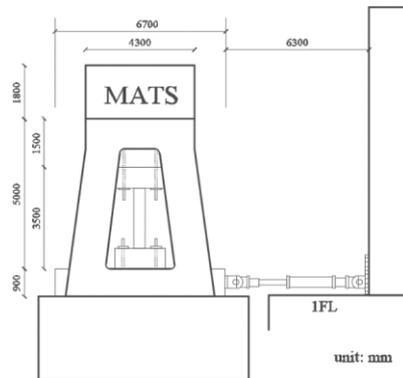
Fig. 3 Schematic figure of MATS in NCREE Laboratory

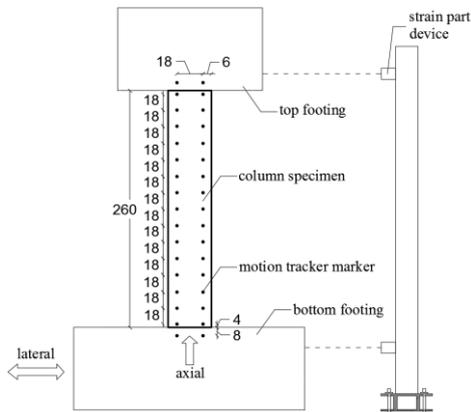
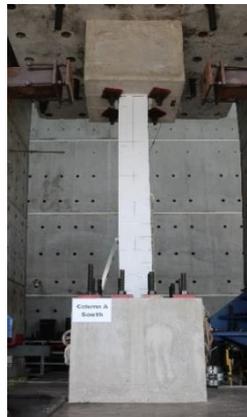
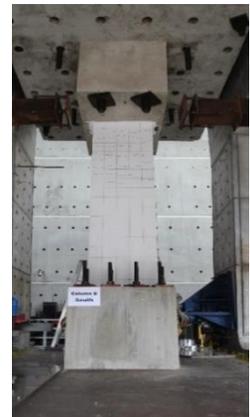
Fig. 4 Column test setup using MATS

(a) Schematic test setup for the column (units: cm)

(b) C-A specimen

(c) C-B specimen

The columns were tested in a vertical position inside the MATS to investigate the cyclic behavior, as displayed in Fig. 4, respectively for C-A and C-B. During the test, the deformations of the column are monitored by a variety of advanced optical measurement sensor systems, including 30 motion tracker devices to measure the deformation of the column near the bases and two strain part devices which were installed at both column ends to measure the column displacement.

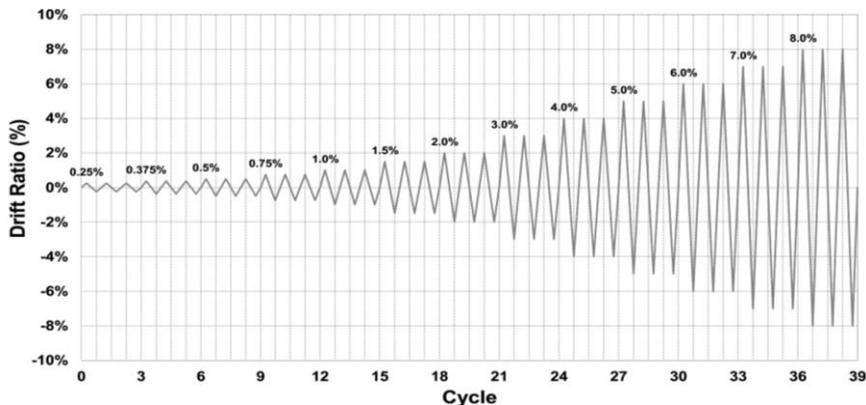
Fig. 5 Loading protocol applied to both column specimens

374.1-05 code (2019). As stated in Fig. 5, three fully reversed cycles were added at each loading stage.

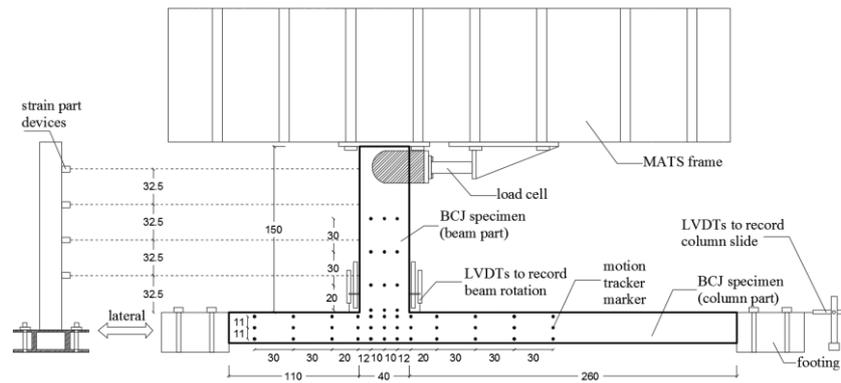
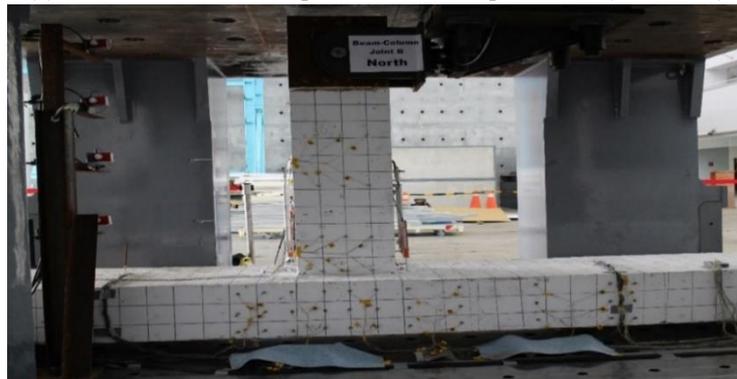
Fig. 6 Test setup for the BCJ specimens using MATS

(a) Schematic test set up for the BCJ specimens (units: cm)

(b) Side view of the BCJ specimen

Both BCJ specimens, as shown in Fig. 6, were examined in the MATS with the column sitting horizontally and the beam was in the vertical position. In order to simulate support conditions on the beam and both ends of the columns, the hinge was constructed as a swivel connector on the beam positioned 1,300 mm from the column surface and was linked to a load cell. The footing was designed to allow the column to display vertical deformation, and both joints were also designed with hinge mechanisms to account for the rotation effect. The lateral load of the machine is placed in the bottom part of the specimen.

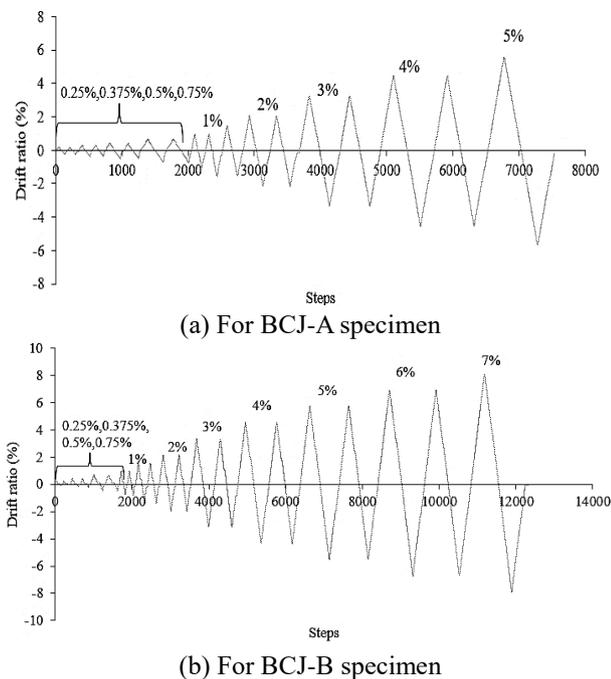
Fig. 7 Loading protocol applied to both BCJ specimens

with ACI 374.2R-13 (2013), consisting of displacement-controlled steps starting at 0.25, 0.375, 0.5, 0.75, 1, 1.5, 2, 3, 4, 5, 6, and 7%. However, the loading protocol on the BCJ-A specimen ended at a drift ratio of 5%, when failure occurred. The loading test for both specimens can be viewed in Fig. 7.

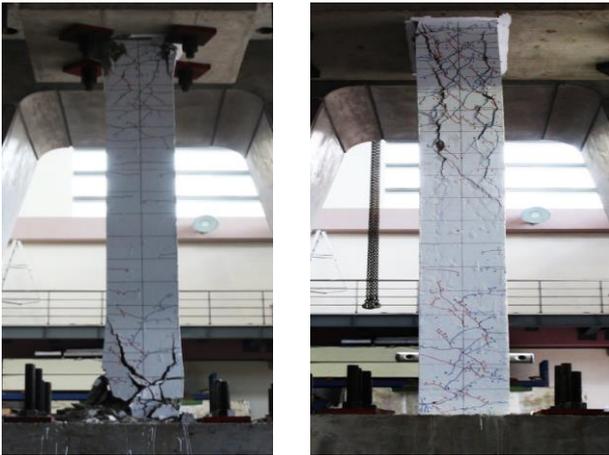
Fig. 8 Final crack patterns of the column specimens

(a) C-A specimen at an 8% drift ratio (b) C-B specimen at a 4% drift ratio

The crack propagation for the C-A and C-B specimens started from the appearance of minor flexural cracks at the bottom end of specimens, which occurred slowly at 0.5 and 0.25% drift ratios, respectively, and then continued with diagonal cracks at drift ratios of 1 and 0.5%, respectively. The width of the existing cracks became larger, as the drift ratio increased. The two specimens reached their maximum lateral loads of 96.86 kN for C-A and 225.24 kN for C-B, respectively, at a 3% drift ratio. However, the experiment was continued at drift ratios of 8 and 4% for each column specimen. The test ended more quickly for C-B due to rapid propagation and increases in crack width, indicating an inability to control cracks.

When the test of the C-A specimen ended, the widest crack existed at the intersection between the column and the bottom base, indicating that the longitudinal bars slip occurred. In addition, for the C-B specimens, the widest crack occurred near to the top in the form of splitting cracks. The C-A specimen failed in the axial flexural mode, whereas the C-B specimen was governed by shear failure. The final crack patterns of the two column specimens are exhibited in Fig. 8. The C-A specimen responded in a ductile manner compared to the C-B specimen.

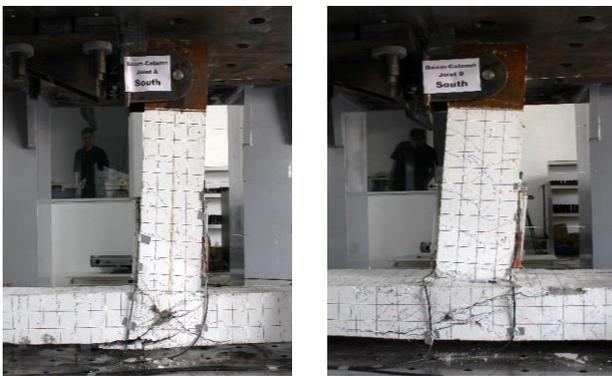
Fig. 9 Final crack pattern of the beam-column joint

(a) BCJ-A specimen at a 5% drift ratio (b) BCJ-B specimen at a 7% drift ratio

However, in both BCJ specimens, the first cracks formed in the joint area of the BCJ-A specimen and on the column face 700 mm from the joint zone of the BCJ-B specimen at a drift ratio of 0.25%. This was in the form of 0.25 mm wide flexural cracks. There was opening of the diagonal cracks due to concrete crushing, bonding deterioration of the beam bottom reinforcement, and the lateral ultimate load degradation. The splitting cracks around the joint region through the column caused the anchorage length of the beam near the column face to become inadequate. The wider diagonal cracks at the bottom of the joint area indicates the degradation of the joint stiffness and moment resisting capacity. As the drift ratio gradually increased, the inelastic rotation from the beam to the joint made the condition of the joints become more and more disrupted due to the existing cracks.

The BCJ-A reached the maximum load of 100.40 kN, corresponding to a drift ratio of 2% along the positive direction, which continued until the test terminated at a 5% drift ratio. Moreover, the maximum lateral load of the BCJ-B was 157.57 kN, associated to a drift ratio of 3% in the positive direction, and the test finished at a drift ratio of 7%. The primary failure mode of both specimens was driven by diagonal shear cracking in the joint zone, due to an insufficient number of joint shear reinforcements. The final

crack development of the BCJ-A and BCJ-B specimens is shown in Fig. 9.

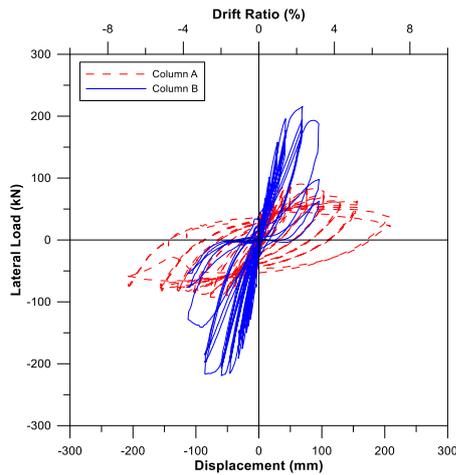
Fig. 10 Lateral load versus displacement with corresponding drift ratio hysteretic response of the C-A and C-B specimens

The hysteretic curve pattern for the C-A and C-B specimens, as shown in Fig. 10, has a different behavior response. Column C-B has lower lateral drift and higher strength than the C-A specimen. In addition, the C-A specimen exhibited a more ductile hysteretic loop with flexural failure, indicated by a gradual 12% drop in strength when the maximum load was reached. In contrast, the C-B specimen showed a 48% drop in strength when it passed beyond the maximum load. This 48% strength drop condition was quite tremendous due to a considerable degradation amount of stiffness and strength as the displacement increased, which was mainly associated to shear failure.

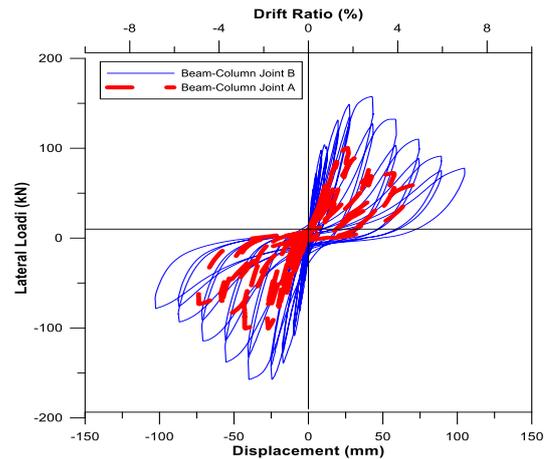
Fig. 11 Lateral load versus displacement with corresponding drift ratio hysteretic response of the BCJ-A and BCJ-B specimens

As for the BCJ-A and BCJ-B specimens, the hysteretic curves behaved similarly in response, as shown in Fig. 11. However, both specimens exhibited a minor stiffness and strength deterioration, indicated by the load drop when the maximum load was reached. This degradation occurred continuously as the input displacement increased until the specimen failed in flexural shear in the joint region.

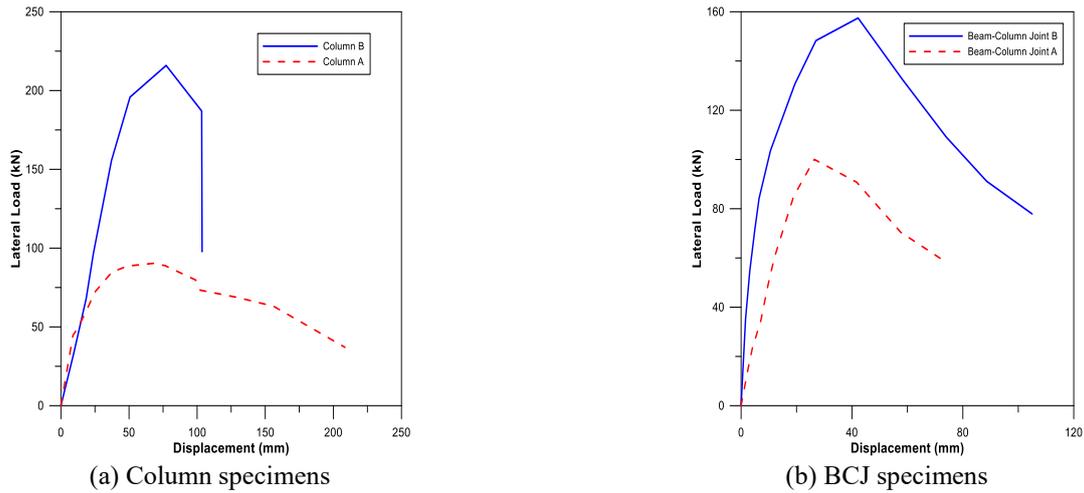
Fig. 12 The load–displacement responses comparison for the column and BCJ specimens

The ductility factor can be determined from the envelope curve of load–displacement response by using this method. Fig. 12 shows the curve of the load–displacement relation along the positive direction in the column and BCJ specimens, respectively. In addition, the calculation of the ductility factor is shown in Table 2.

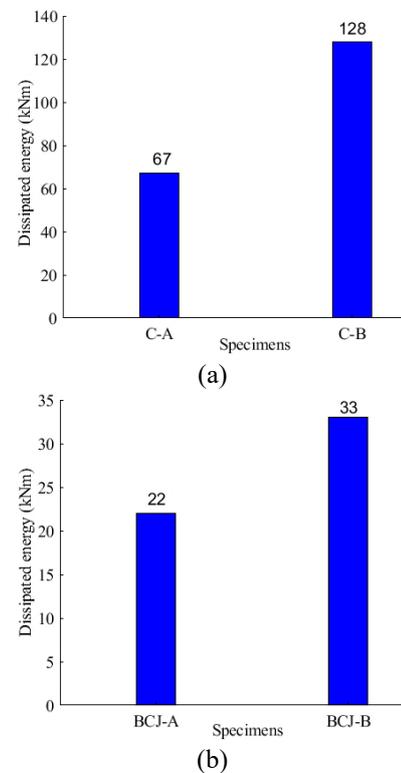
Fig. 13 Dissipated energy response for (a) column and (b) beam–column joint specimens

However, among the BCJ specimens, the BCJ-B specimen showed 30% higher dissipated energy compared to the BCJ-A specimen, as shown in Fig. 13(b). This further proved the concept suggesting that a strong column with a weak beam mechanism, as in the BCJ-B specimen, is more effective due to the ability to resist more lateral movement under seismic loading. The increase in dissipated energy is marked by the delay in crack propagation and the yield and

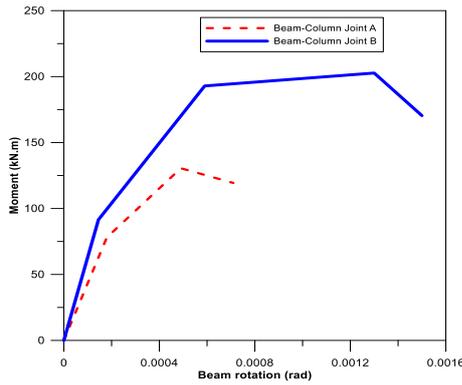
Fig. 14 The curve of beam moment versus beam rotation for the BCJ specimens

The results obtained from Fig. 14 indicated a high amount of beam rotation for the BCJ-A specimen, due to the weak column with a strong beam mechanism. This induces lower stiffness in BCJ-A compared with BCJ-B. In addition, both specimens yield about the same rotation at 0.0002 rad with different applied moments of 70 and 90 kNm for BCJ-A and BCJ-B, respectively.

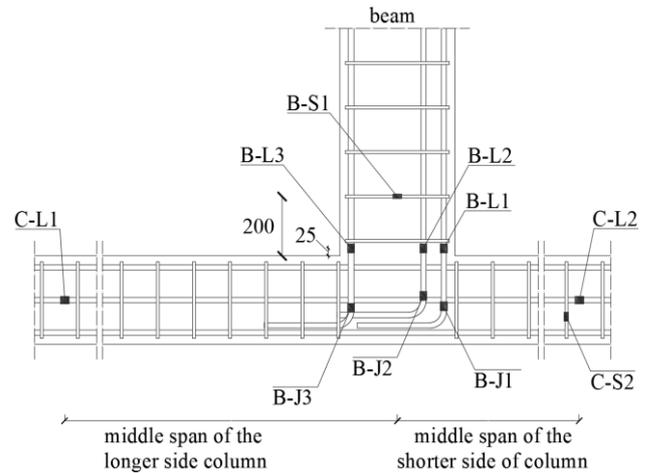
Fig. 15 The location of strain gauge used in the analysis (units: mm)

Forty-six electrical resistance strain gauges were installed to the BCJ specimens, distributed at the top and bottom of the longitudinal and transversal bars of the beam, shear reinforcement at the inside of the joint core, and the column's longitudinal and transverse bars. The strain gauges were fitted to calculate the local strain on reinforcement during cyclic loading and were compared with yield strains of approximately 1,270 and 1,710 micro-strains, for the longitudinal and transversal bars, respectively. The placement of the strain gauges used in this section is depicted in Fig. 15.

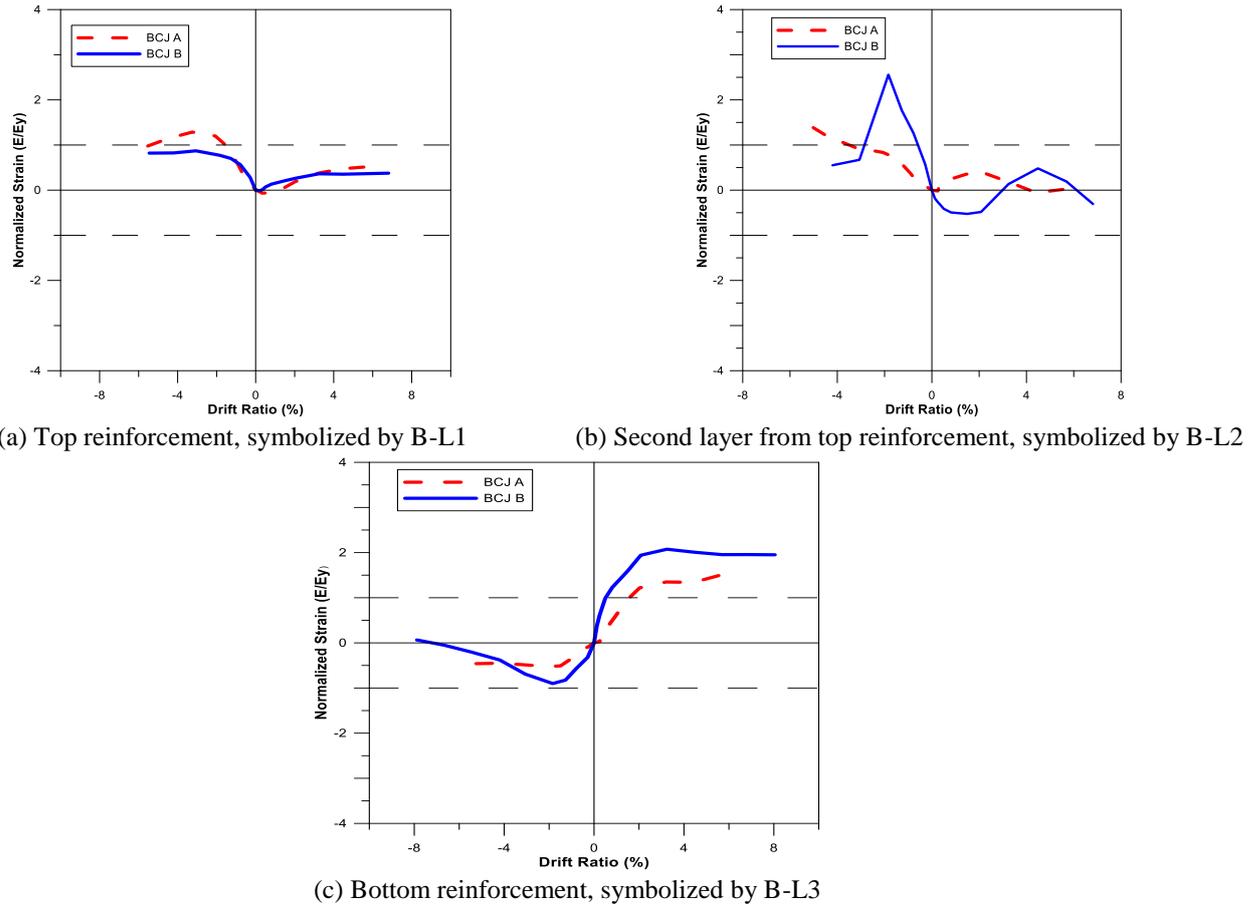
Fig. 16 Normalized strain for the beam's longitudinal bars for BCJ-A and BCJ-B specimens, located 25 mm from the column

Fig. 16 displays the measured normalized strains in the beam's longitudinal rebar in the plastic hinge region, located 25 mm from the column face. Both top beam reinforcements yielded during the negative cyclic loading and gradually decreased to a positive cyclic loading at a specific drift ratio, due to the loss of tensile strength, as presented in Figs. 16(a) and 16(b). In addition, the bottom beam reinforcement had yielded during the negative cyclic loading, and the magnitude of the compressive strain gradually increased and became tensile due to the local interface of a pull-out crack, as shown in Fig. 16(c).

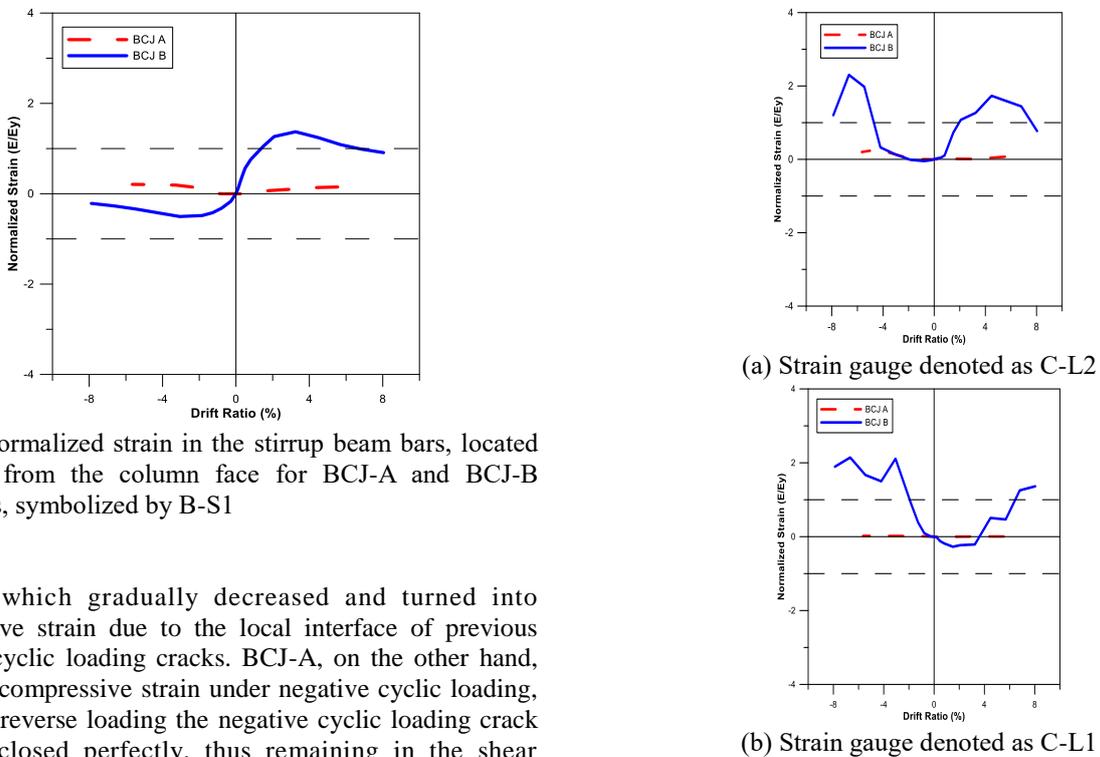
Fig. 17 Normalized strain in the stirrup beam bars, located 200 mm from the column face for BCJ-A and BCJ-B specimens, symbolized by B-S1

The normalized strain of the beam stirrup located 200 mm from the column face is shown in Fig. 17. The result displays that the stirrup at the plastic hinge of the BCJ-B specimen yielded during positive cyclic loading, whereas BCJ-A did not yield due to immediate joint failure of the

beam stirrups. The BCJ-B specimen showed a gradual increase in compressive strain, which became tensile and reached a yielding point at a positive drift ratio of 2%. It was indicated by the residual plastic strain that developed, which gradually decreased after passing a positive drift ratio of approximately 3%. The strain reduction corresponds to a peak reduction in the cyclic load.

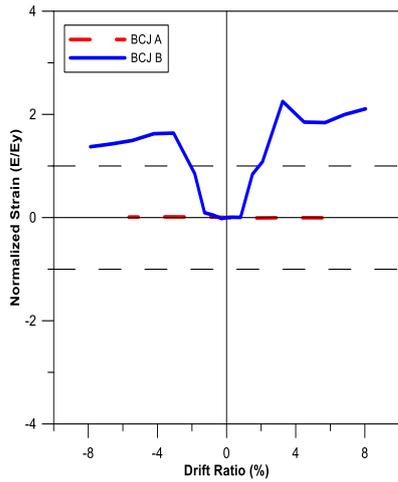
Fig. 19 Normalized strains in the stirrup column for BCJ specimens at the plastic hinge, located on the shorter side of the column, symbolized by C-S2

Fig. 19 indicates that the measured strain of BCJ-B was symmetrical for negative and positive drift ratios. However, the behavior of column stirrups at the plastic hinge located on the column's longer span was less than yield point for both specimens. This could be due to the fact that no plastic strain experienced in both specimens at that particular location of strain for both specimens, or splitting crack occurred causing loss of concrete at longer span of column, leading to shear failure.

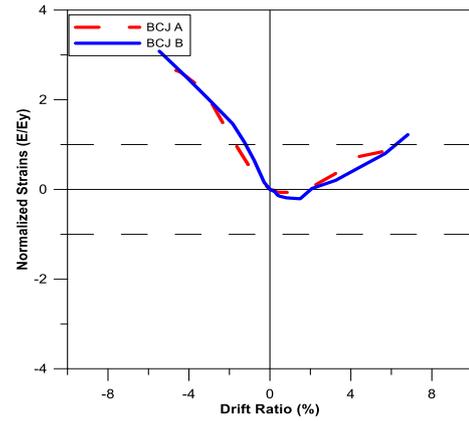
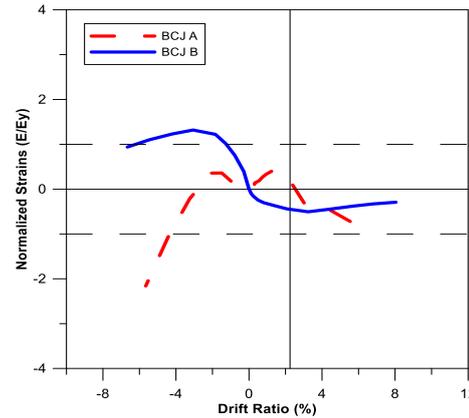
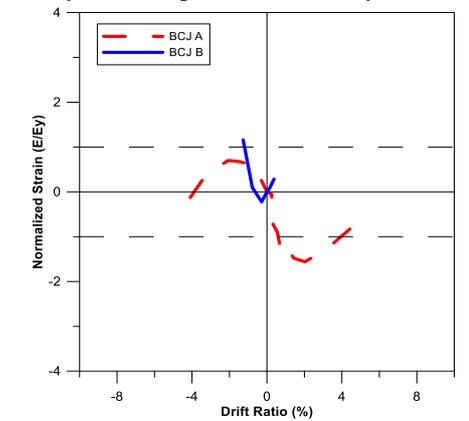
Fig. 20 Normalized strain in beam longitudinal reinforcement within the joint zone

(a) Top reinforcement, symbolized by B-J1

(b) Second layer from top reinforcement, symbolized by B-J2

(c) Bottom reinforcement, symbolized by B-J3

The top shear reinforcement rebar within the joint zone, as shown in Fig. 20(a), displayed the tensile strain was yielded under negative cyclic loading. In addition, the magnitude gradually decreased linearly as the negative drift ratio decreased, until the top shear reinforcement behavior increased linearly after achieving a positive drift ratio of 2%. However, for the BCJ-A and BCJ-B specimens, the normalized strain for the second layer from the top of the shear rebar within the joint behave differently in Fig. 20(b). BCJ-B exhibited tensile strain under negative cyclic

loading, which gradually decreased and turned into compressive strain due to the local interface of previous negative cyclic loading cracks. BCJ-A, on the other hand, exhibited compressive strain under negative cyclic loading, and upon reverse loading the negative cyclic loading crack was not closed perfectly, thus remaining in the shear reinforcement bar. Fig. 20(c) shows that the bottom shear reinforcement within the joint exhibited tensile strain below the yield point in the BCJ-B specimen, which gradually decreased and turned into compressive strain as it reached

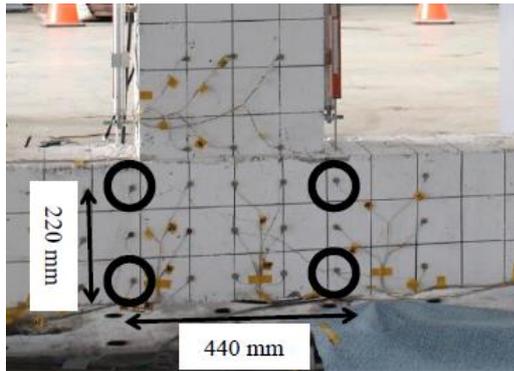
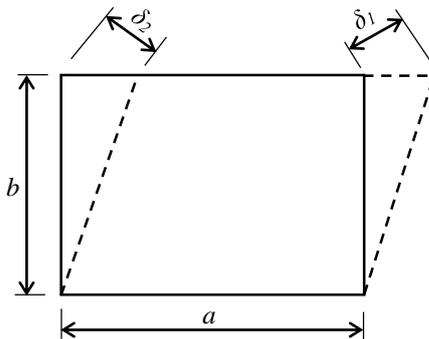
Fig. 21 The calculation of the beam-column joint shear deformation

(a) The location of the measurement of joint shear deformation

(b) The illustration of geometrical compatibility of the joint shear deformation

The joint shear deformation signifies the nature of the damage induced in the joint based on the increase in cyclic loading, measured in terms of the drift ratio. The shear deformation was determined by selecting four markers of motion tracker devices installed over the joint zone, as displayed in Fig. 21(a). Through geometrical compatibility as illustrated in Fig. 21(b), it was calculated from the measured coordinates position of these markers during the increase in the drift ratio. The shear deformation, denoted as  $\gamma$ , is expressed by Eq. (3), where  $\delta_1$  and  $\delta_2$  are the change in deformation, and  $a$  and  $b$  are the shear element width and height, respectively.

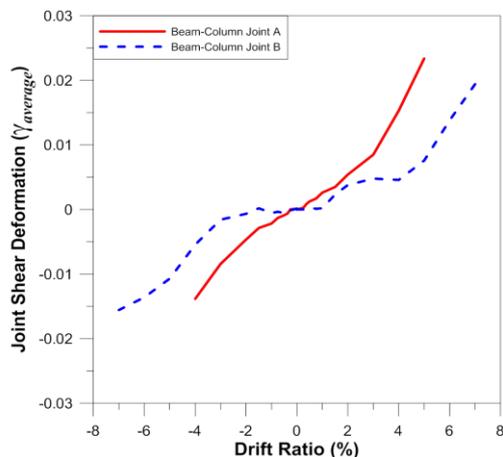
Fig. 22 Curves of joint shear deformation versus drift ratio for the beam-column joint

The curve of shear deformation, calculated using Eq. (3) with respect to drift ratio, is shown in Fig. 22. It is clear that the joint shear deformation enhanced with the increment in the drift ratio. The BCJ-A specimen showed a much more substantial shear deformation when the drift ratio was increased compared to the BCJ-B specimen. This is because BCJ-A had a smaller beam–column depth ratio, where failure occurred instantly in the column rather than in the beam, whereas BCJ-B, due to its larger column area, experienced joint failure at a larger drift ratio of 7%. This occurred because there were no stirrups to resist the induced joint force that occurred within the specimen.
