# Seismic analysis and performance for stone pagoda structure under Gyeongju earthquake in Korea

**Abstract.** Analytical models were developed and seismic behaviors were analyzed for a three-story stone pagoda at the Cheollyongsa temple site, which was damaged by the Gyeongju earthquake of 2016. Both finite and discrete element modeling were used and the analysis results were compared to the actual earthquake damage. Vulnerable parts of stone pagoda structure were identified and their seismic behaviors via sliding, rocking, and risk analyses were verified. In finite and discrete element analyses, the 3F main body stone was displaced uniaxially by 60 and 80 mm, respectively, similar to the actual displacement of 90 mm resulting from the earthquake. Considering various input conditions such as uniaxial excitation and soil-structure interaction, as well as seismic components and the distance from the epicenter, both models yielded reasonable and applicable results. The Gyeongju earthquake exhibited extreme short-period characteristics; thus, short-period structures such as stone pagodas were seriously damaged. In addition, we found that sliding occurred in the upper parts because th

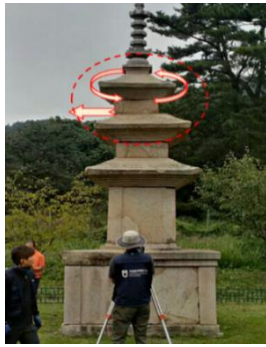
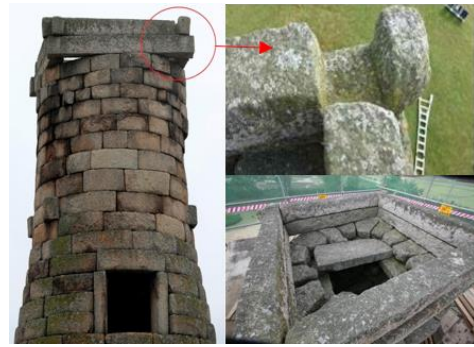
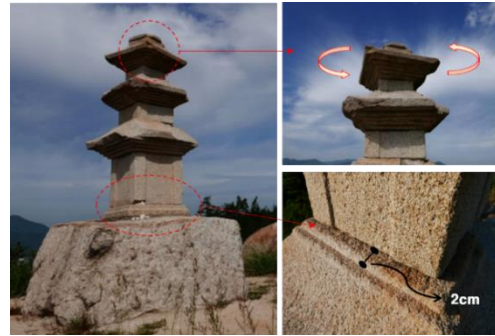
Fig. 3 Stone pagoda damage caused by the Gyeongju earthquake

(a) Three-story stone pagoda at Cheollyongsa temple site

(b) Cheomseongdae observatory

(d) Three-story stone pagoda at the third temple site in Jiamgok valley on Mt Namsan

Name	Damage
Stone brick pagoda of Bunhwangsa temple	<ul style="list-style-type: none"> <li>Some cracks and exterior wall flaking</li> <li>Inclination (2 cm)</li> </ul>
Cheomseongdae observatory	Separation of the southeast contact of an upper member (5cm) (Fig. 3(b))
Five-story stone pagoda in Nawon-ri	South upper member deformed to the north direction (3.8 cm)
East and west three-story stone pagodas in Cheongun-dong	<ul style="list-style-type: none"> <li>Joint crack in the 1F main body stone</li> <li>Breakage of upper regions</li> <li>Breakage of roofing tiles</li> </ul>
Three-story stone pagoda of Pyochungsa temple	<ul style="list-style-type: none"> <li>East pagoda: Collapse of upper member</li> <li>West pagoda: Tilting</li> </ul>
East and west three-story stone pagodas of Unmunsa temple	<ul style="list-style-type: none"> <li>Protrusion of the upper region</li> <li>Westward deformation 9 cm to the west of the third floor (3F) main body and roof stones (Fig. 3(a))</li> <li>Separation of 2F roof stones</li> </ul>

Three-story stone pagoda in Yongmyeong-ri	<ul style="list-style-type: none"> <li>Breakage of the roof stone edge of the east-facing pagoda</li> <li>Breakage of roof stone</li> </ul>
Three-story stone pagoda at Cheollyongsa temple site	<ul style="list-style-type: none"> <li>Counterclockwise rotation and westward deformation of the decorative top</li> <li>Sliding of the 3F main body stone</li> </ul>
East and west three-story stone pagodas at Wonwonsa temple site	<ul style="list-style-type: none"> <li>Separation of the 3F main body stone</li> <li>Breakage of the lime bonding agent</li> </ul>
Three-story stone pagoda at Changnimsa temple site	Counterclockwise rotation of the main body and roof stones of the first to the third story (Fig. 3(c))
Three-story stone pagoda at the third temple site in Namsan mountain	<ul style="list-style-type: none"> <li>Southward sliding 2 cm of the 3F main body and roof stones</li> <li>Southward sliding 5 cm and counterclockwise rotation of the decorative top (Fig. 3(d))</li> </ul>

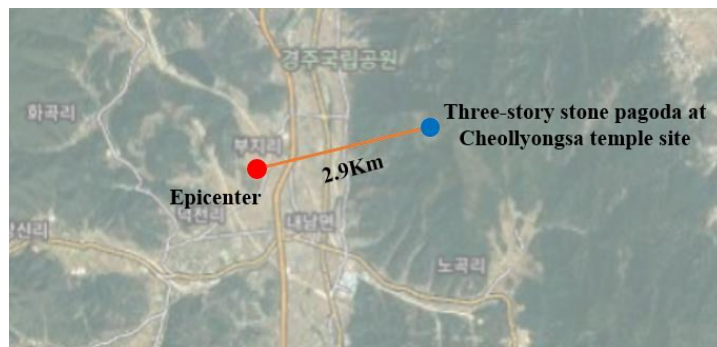
Fig. 6 Distance between the Cheollyongsa temple site and the epicenter

earthquake caused significant damage, as shown in Fig. 5. Fig. 6 shows the distance between the Cheollyongsa temple site and the epicenter.

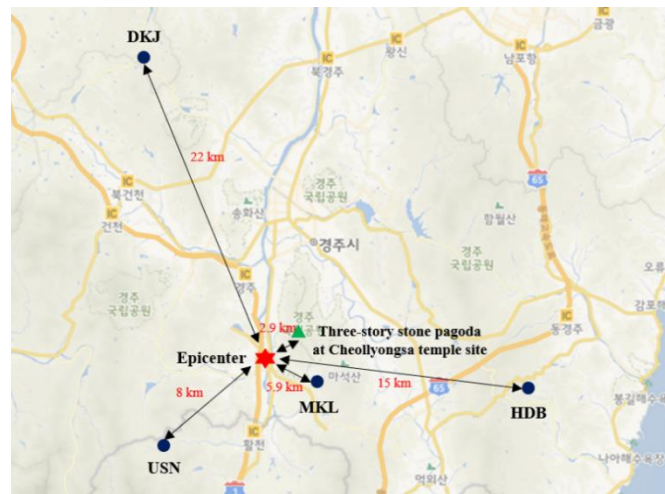
Fig. 7 The epicenter and nearby observatories

USN station 8.0 km from the epicenter; the distances of various stations from the epicenter are shown in Fig. 7. Although the MKL observatory was located only 5.9 km from the epicenter, the USN station record reflects the effect of the  $S_4$  ground type, which was considered suitable for the construction of a three-story stone pagoda at

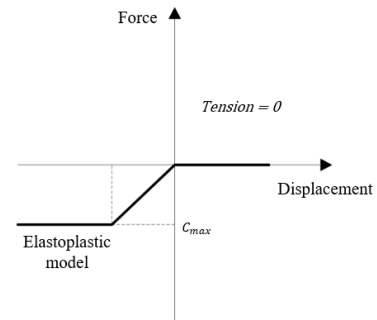
Fig. 9 Modeling of discontinuous surface boundaries

(a) Boundary elements

(b) Vertical and horizontal boundary elements

(c) Nonlinear characteristics of vertical boundary elements

We used the OPENSEES program to perform nonlinear structural analysis of the stone pagoda and obtained its nonlinear properties based on a comparison with actual damage (OpenSees 2020). In addition, we carefully analyzed the behavior of the structure at the discontinuous surface between stones undergoing rigid body motion to reflect this aspect in the analytical model. Boundary modeling of discontinuities requires that transmission of only the compressive force between two stones is permitted and tensile force transmission is prohibited. Here, each boundary surface can be modeled by a zero-length element and applied to a vertical boundary element.
