Experimental investigation of existing R/C frames strengthened by high dissipation steel link elements

Apostolos A. Karalis^{*} and Kosmas C. Stylianidis^a

*Aristotle University of Thessaloniki, Faculty of Engineering, School of Civil Engineering
Laboratory of R/C and Masonry Structures, Thessaloniki, 54124, Greece*

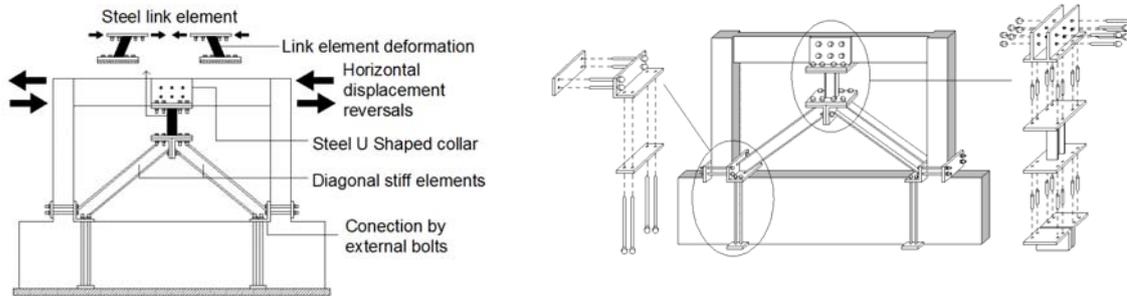
As shown in Fig. 1, the bracing system is composed by two steel elements that are connected to each other at their top. At this point there is a steel plate on which the shear - flexural link element

Fig. 1 Strengthening layout

is welded. The top of the link element is connected to the midpoint of the beam through a steel U shaped collar which surrounds the beam. The collar element is connected to the top beam by six bolts from side to side of the beam. The diagonal elements of the bracing system are connected at their bottom with the column base and the foundation beam of the specimens by external bolts. The elements of the bracing system, the collar and the connections to the beams and the columns were not considered as parameters under investigation in the present study. Therefore they were oversized in order to avoid local failures at these elements. Consequently, the inelastic deformation of the strengthened specimens is expected to be concentrated mainly at the link element. This type of link elements are expected to significantly increase the strength and stiffness of the strengthened frame, but the most important advantage of these systems is the drastic reduction of the strength demand of the strengthened R/C elements against seismic actions due to their high energy dissipation capacity.

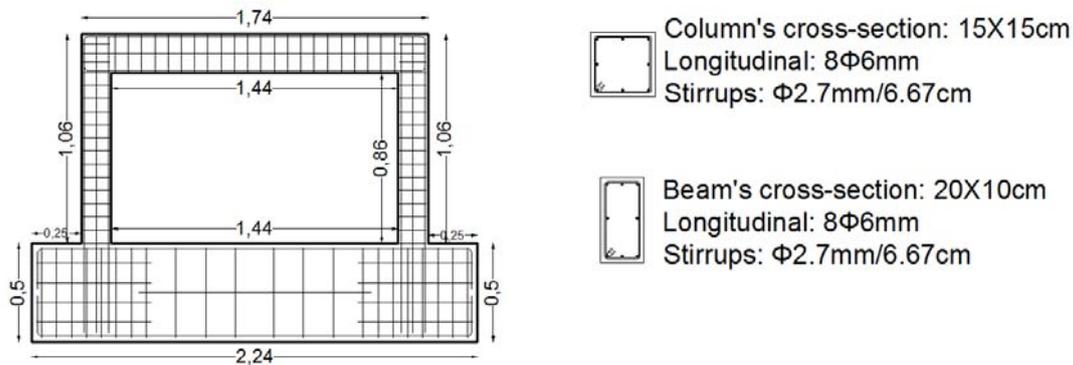
Fig. 2 Geometry (m) and reinforcement arrangement of the specimens

The tests were carried out at the Laboratory of Concrete and Masonry Structures, Civil Engineering Department, Aristotle University of Thessaloniki. In this work results are given from the tests of five specimens constructed in 1:3 scale. The specimens represent a single storey one bay frame rigidly based on a strong foundation. The five R/C specimens are identical to each other. The geometry and the reinforcement arrangement of the specimens are shown in Fig. 2.

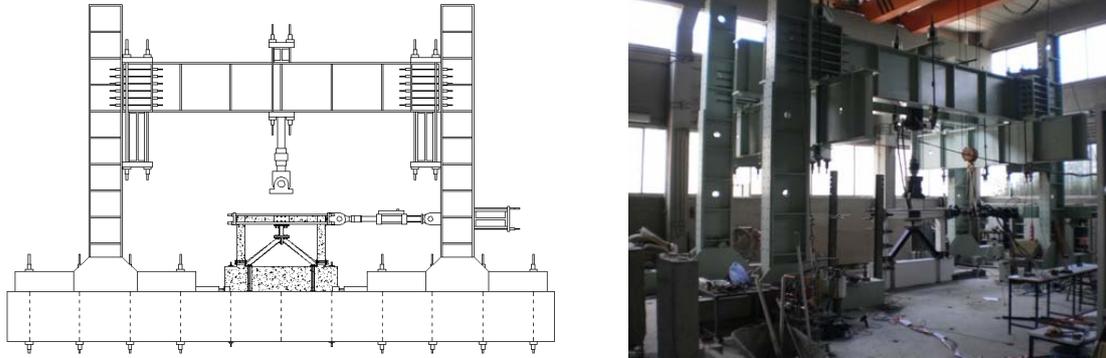
Fig. 3 Test setup

For the tests, the facilities of the Laboratory of Concrete and Masonry Structures, Aristotle University of Thessaloniki, were used (Fig. 3). The reaction frame consists of steel beams and columns connected to each other by prestressed bolts. One double acting actuator is connected at the top beam of the specimens applying horizontal displacement reversals. Another actuator can also be connected to the system to apply vertical axial loads on the columns through a top steel beam in a load control mode. This option was not activated for the present study.

in combination with vertical prestressed anchored bolts. The test specimens were also connected to the floor by the same technique. It is worth mentioning that during the tests no slip was recorded between the specimens and the laboratory floor. The horizontal actuator was connected to the top of the specimens by a system of two stiff steel plates at the vertical outer sides of the beam - column joints, connected to each other by four long bolts. In order to provide rotational degree at the connection points, beyond the 3D rotational hinges of the actuator at the ends of its length, two more rotational hinges were provided between the steel plates and the two top beam - column joints of each specimen.

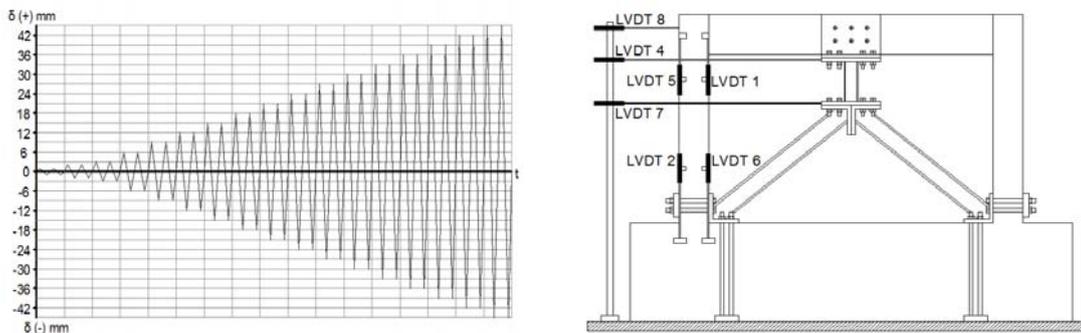
Fig. 4 Horizontal loading history and LVDT arrangement on the specimens

The horizontal loads were imposed in a displacement control mode. The displacement history is composed of 17 levels of displacement (Fig. 4). Due to the extended damage that developed, some tests were terminated earlier but the maximum strength had already been developed. For each displacement level, two full cycles were imposed.

The specimens were instrumented by the use of seven LVDTs. The layout of these instruments is shown in Fig. 4. LVDTs 1, 5, 2, 6 were used for the measurement of the shortening and the elongation of the outer fibers at the ends of the left column. LVDT 8 was used for the measurement of the top horizontal displacement of the specimen and was compared with the measurements of the internal LVDT of the horizontal actuator. LVDTs 4 and 7 were used for the measurement of the net horizontal displacement at the top and bottom ends of the steel link element. Some differences between instruments 8 and 4 occurred because the top collar of the shear - flexural element could not be completely horizontally restrained at the midpoint of the top

The displacement mentioned corresponds to the clear beam horizontal displacement (LVDT 8, Fig. 4). Note that, since the height of the specimens is almost 100cm, a displacement of 1cm corresponds almost to 1% storey drift.

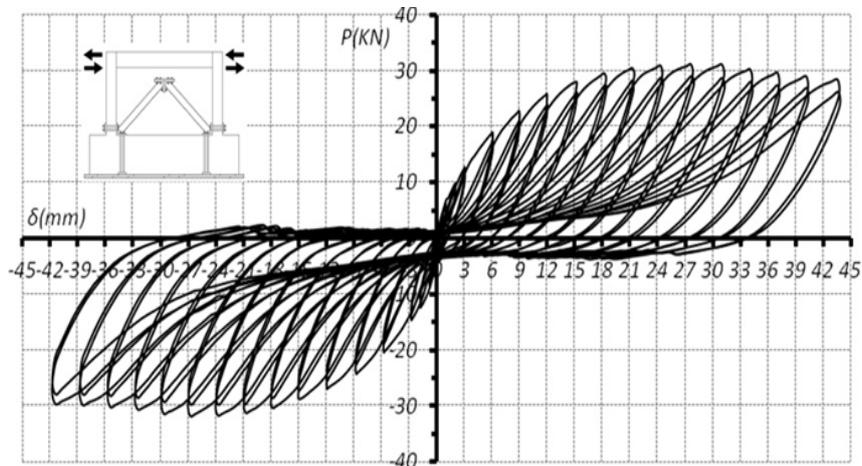
Fig. 5 Load - displacement (P - δ) curves of the frame F1

At early stages, during the first imposed cyclic displacements, horizontal or inclined cracks appeared, initially at the base and later at the top of the columns. The cracks at the base of the columns were formed just over the connection point of the bracing system to the columns (Figs. 10-11). Under high level of imposed displacements, plastic hinges were formed at the ends of the columns of the specimens. Although no specific measures were taken, such as local confinement, the strength of the specimen was slightly increased even for drifts close to 3% (Figs. 5-6). For higher levels of the imposed inelastic deformation, the strength degradation was very low. This

response is attributed to the prevailing flexural type of failure that was observed and measured during the tests. Taking into account the poor detailing of the specimen, although pinching is evident under reversals, the load - displacement hysteresis loops are rather rich. This is a characteristic of the relatively high energy dissipation capacity of the system (Fig. 7). During the second cycles at each displacement level, only a small reduction of the strength and the dissipation

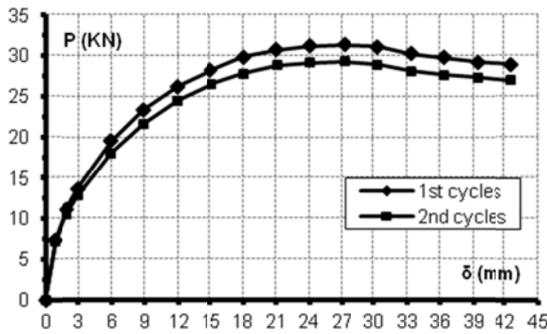
Fig. 6 Load - displacement ($P - \delta$) envelopes (F1)

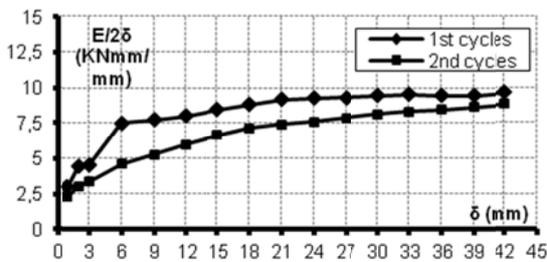
Fig. 8 Normalized energy dissipation - displacement ($E/2\delta - \delta$) envelopes (F1)

A rapid increase of the normalized energy dissipation is observed until the displacement of 6mm at the first cycles, and consequently the curve tends to stabilize at 10KNmm/mm in the maximum displacement 42mm. During the second cycles the curve is similar to the one of the first cycles but the values are lower (Fig. 8).

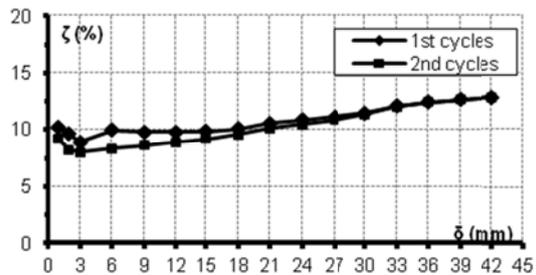
Fig. 9 Equivalent viscous damping - displacement ($\zeta - \delta$) envelopes (F1)

During the three firsts displacement levels, only a small reduction of the equivalent viscous damping is observed in both cycles and then, with a soft increase, stabilizes at the maximum value 13% (Fig. 9). From the displacement of 27mm and then the curve variation is exactly the same in both cycles.

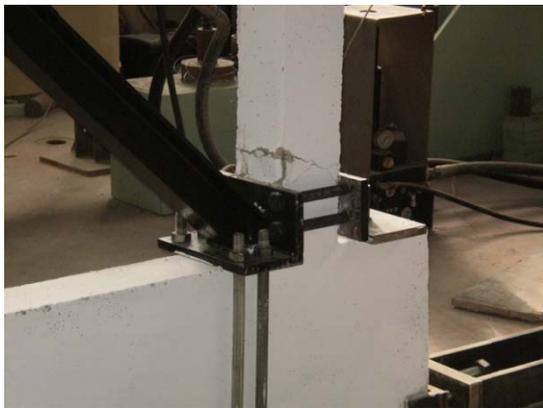
Fig. 10 Plastic hinge at the bottom of the column (F1)

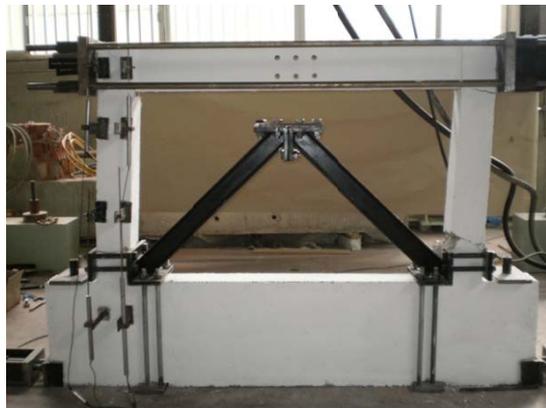
Fig. 11 Specimen F1 at the end of the test

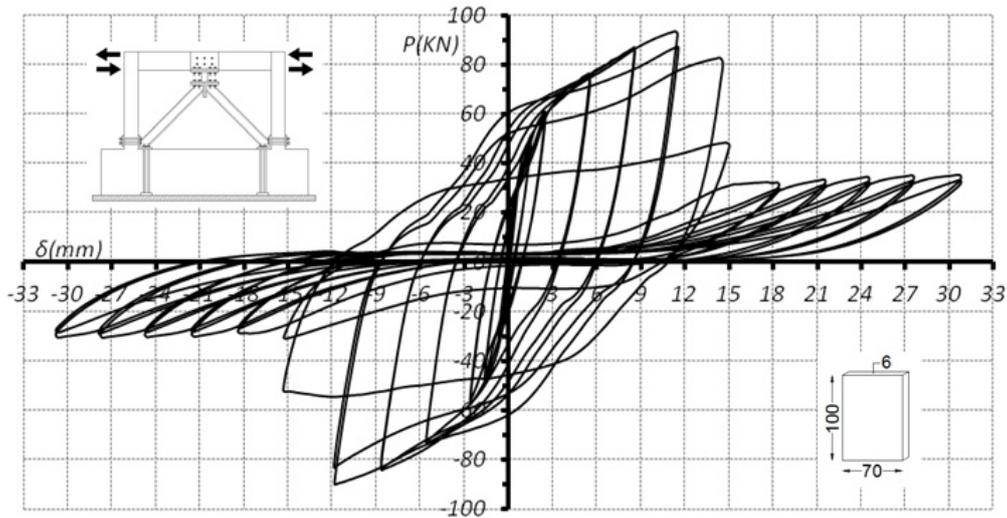
Fig. 12 Load - displacement (P- δ) curves of the frame F2

This specimen presents an excellent behavior up to a drift of 12‰ (Figs. 12 and 13). The load carrying capacity is three times higher than that of the reference specimen F1, the hysteresis loops are very rich, no pinching is traced. The failure mode of the R/C frame is the same as in F1, since plastic hinges are formed again at the top and the bottom of the columns. The midpoint of the beam suffers some local cracking, but the cracking is not significant enough to alter the failure mode (Fig. 17). When the drift reaches about 12‰, the steel link element reveals a failure of a rather shear type, with a side to side horizontal crack at the top and the bottom ends (Fig. 18). After the complete detachment of the link element, the overall behavior, concerning strength and energy dissipation capacity, drops to the behavior of the reference specimen (Figs. 13-15). It is worth mentioning that no signs of unfavorable phenomena, such as considerable drop of strength during imposed reversals and pinching, are traced.

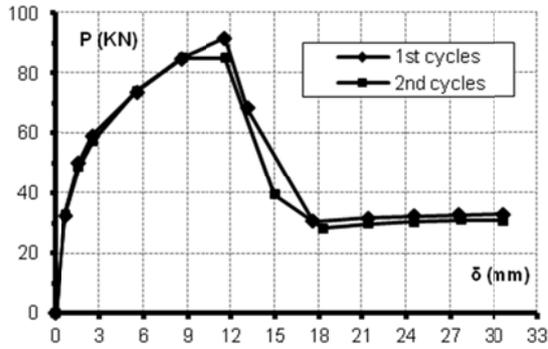
Fig. 13 Load - displacement ($P - \delta$) envelopes (F2)

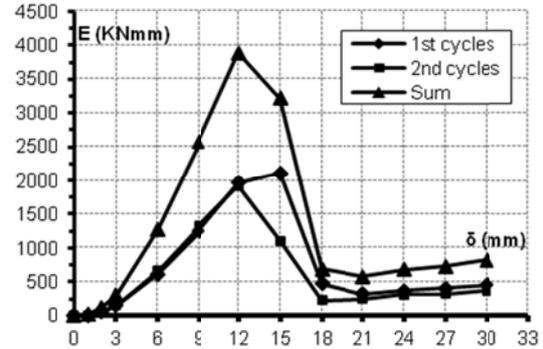
Fig. 14 Energy dissipation displacement ($E - \delta$) envelopes (F2)

A significant increase at the energy dissipation capacity is observed before the link element failure (drift 12%), which is about ten times higher than that of the reference specimen F1 (Figs. 14 and 15). The equivalent viscous damping presents an excellent behavior. When the drift reaches

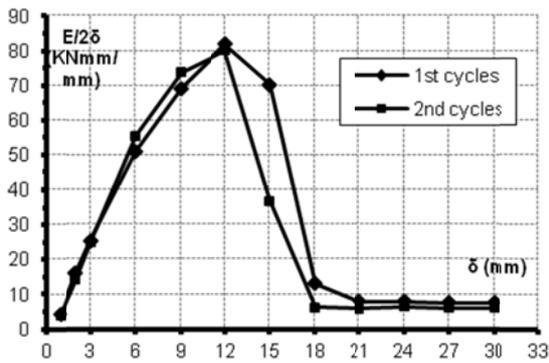
Fig. 15 Normalized energy dissipation - displacement ($E/2\delta - \delta$) envelopes (F2)

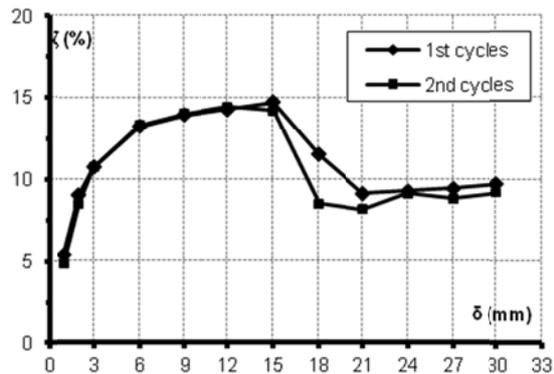
Fig. 16 Equivalent viscous damping - displacement ($\zeta - \delta$) envelopes (F2)

15‰, the equivalent viscous damping is almost 15% (Fig. 16). This percentage is very close to the perfect plastic behavior ($\zeta=1/2\pi=15,92\%$). After the failure of the link element this percentage drops to the behavior of the reference specimen.

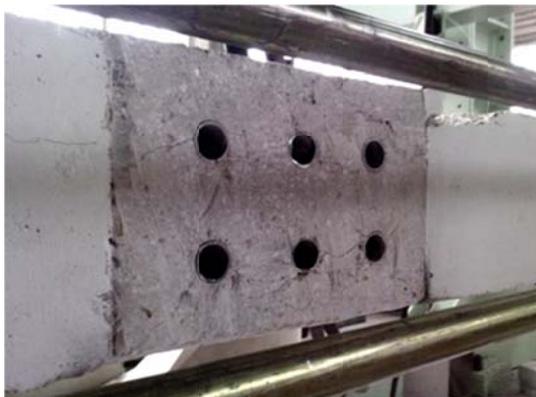
Fig. 17 Cracking at the middle of the beam (F2)

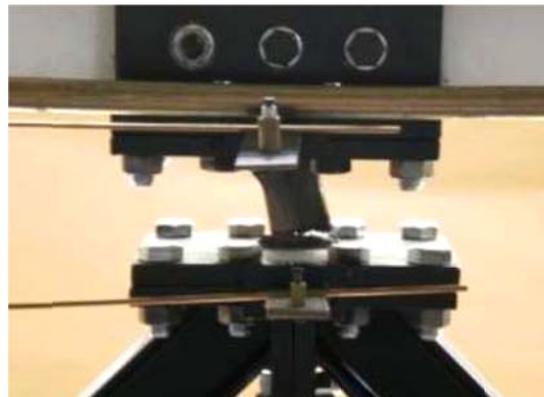
Fig. 18 Failure mode of the link element (F2)

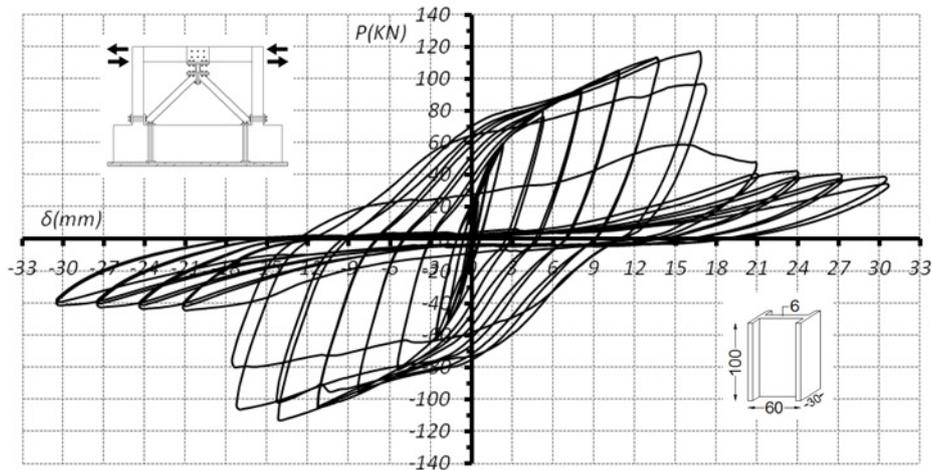
Fig. 19 Load - displacement (P - δ) curves of the frame F3

Specimen F3 reveals an even better behaviour compared to F2. Failure occurs at a drift of 18‰ (Figs. 19 and 20). The load carrying capacity is almost four times higher than that of the reference specimen F1, the hysteresis loops are also very rich, again no pinching is traced. At that level of drift the steel link element reveals a rather bending type of failure (Fig. 25). For a small amount of further displacements, the link element, although practically inactive, is not completely detached from the plates, still offering some strength and energy dissipation capacity before the full detachment occurs (Figs. 20-22). Again, no unfavorable phenomena are evident.

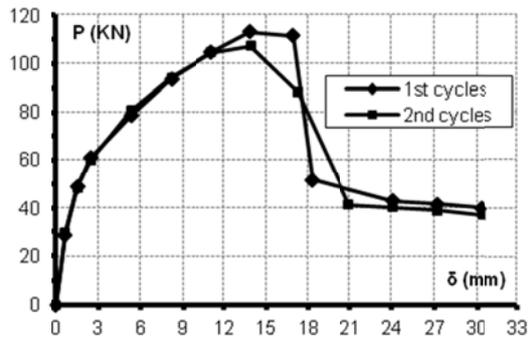
Fig. 20 Load - displacement ($P - \delta$) envelopes (F3)

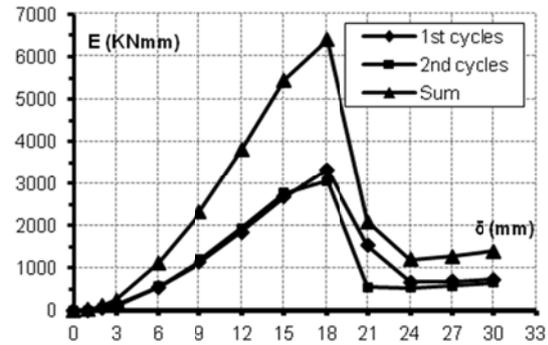
Fig. 21 Energy dissipation - displacement ($E - \delta$) envelopes (F3)

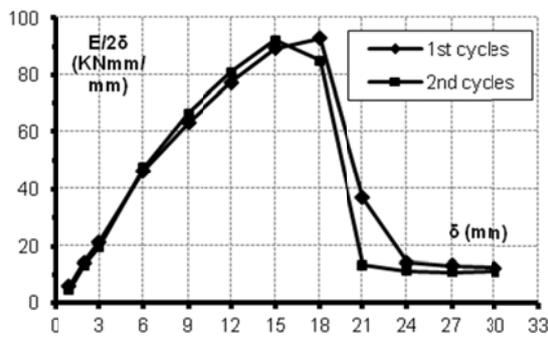
Fig. 22 Normalized energy dissipation - displacement ($E/2\delta - \delta$) envelopes (F3)

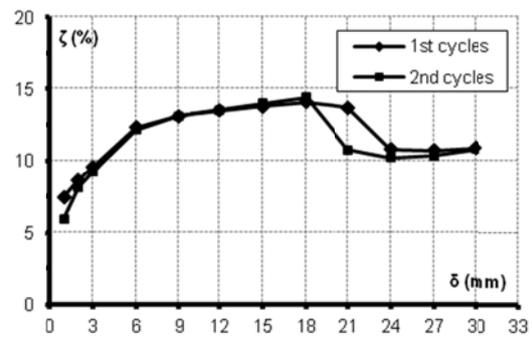
Fig. 23 Equivalent viscous damping - displacement ($\zeta - \delta$) envelopes (F3)

The equivalent viscous damping presents similar behavior with that of the specimen F2. The maximum percentage (~14%) is observed before the link element failure (Fig. 23). The difference is that the maximum percentage is observed for a 18‰ drift, when the equivalent drift for the specimen F2 is 15‰.

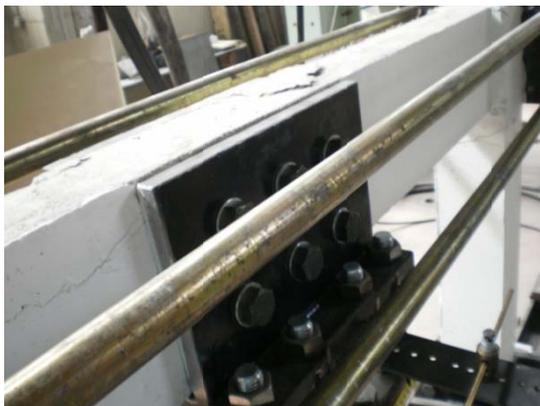
Fig. 24 Cracking at the middle of the beam (F3)

The failure mode of the R/C frame is the same as in the previous specimens, since plastic hinges are formed again at the top and the bottom of the columns. Once more time the midpoint of the beam suffers some local cracking (Fig. 24).

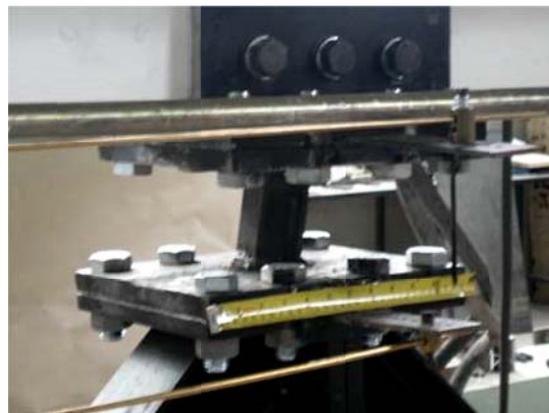
Fig. 25 Failure mode of the link element (F3)

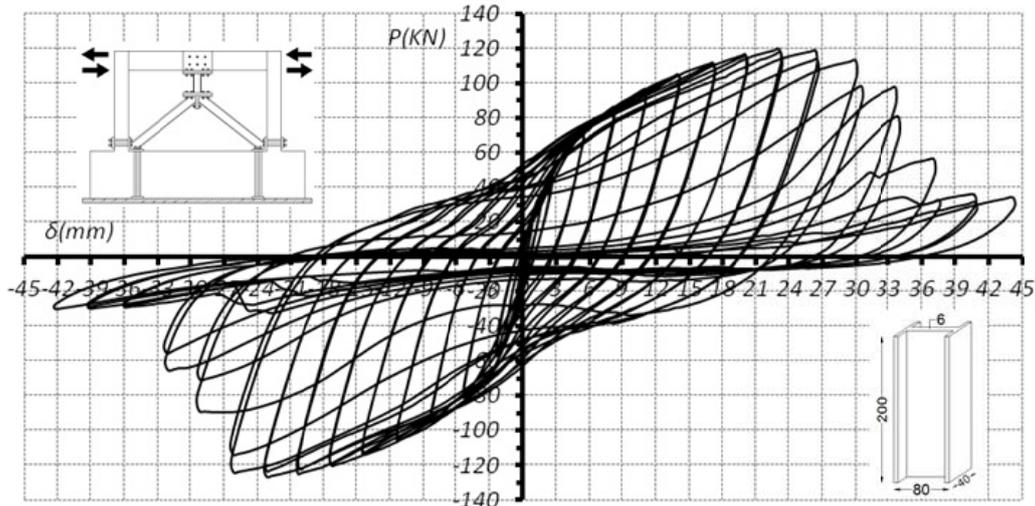
Fig. 26 Load - displacement (P-δ) curves of the frame F4

to lower stiffness compared to the link of the specimen F3. However, the ultimate strength for this specimen is slightly higher than that of specimen F3. The main improvement for the present specimen is that the strength was increased without reduction until a drift of 27%, thus, improving the ductility of the strengthened frame (Figs. 26 and 27).

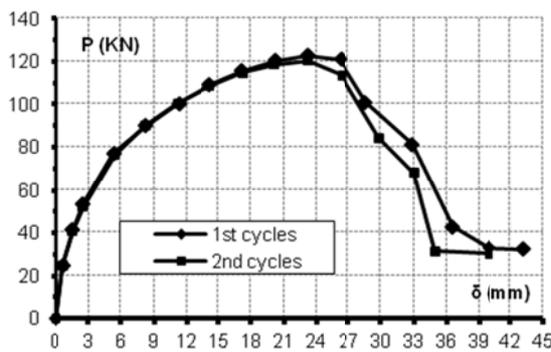
Fig. 27 Load - displacement (P - δ) envelopes (F4)

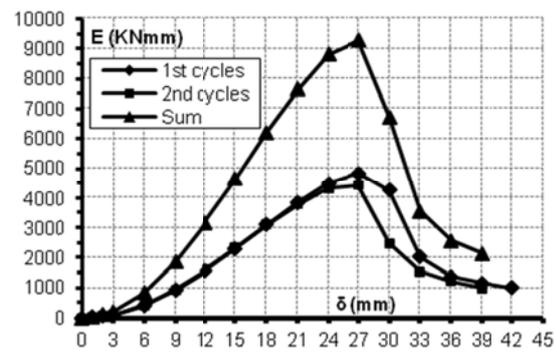
Fig. 28 Energy dissipation - displacement (E - δ) envelopes (F4)

The energy dissipation capacity (Figs. 28 and 29) was increased until the failure of the link

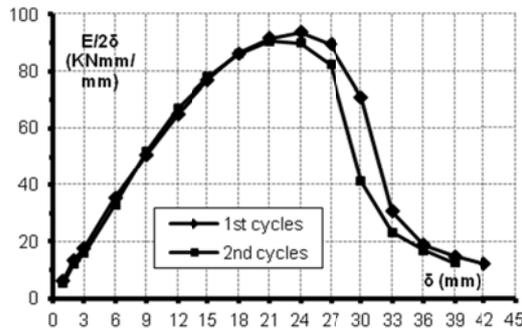
Fig. 29 Normalized energy dissipation - displacement ($E/2\delta - \delta$) envelopes (F4)

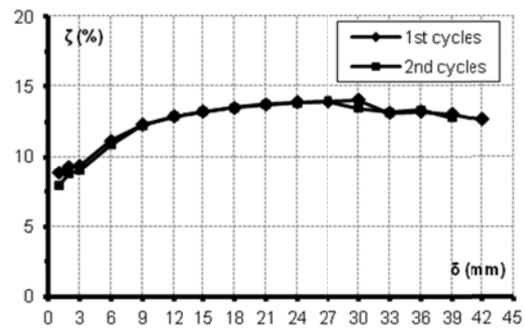
Fig. 30 Equivalent viscous damping - displacement ($\zeta - \delta$) envelopes (F4)

element. The equivalent viscous damping (Fig. 30) was also increased slightly until a drift close to 21%, remained constant without reduction until a drift of 27% and then dropped due to the link element failure.

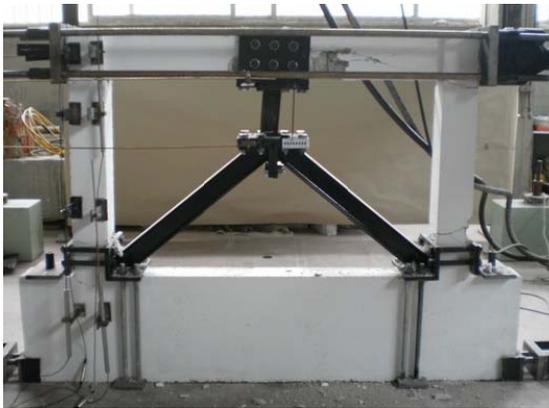
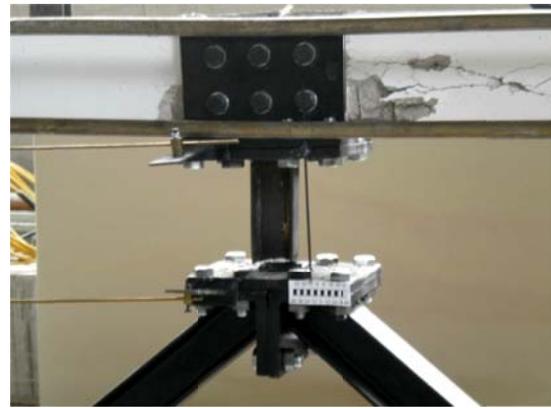
Fig. 31 Cracks at the middle of the top beam and failure mode of the link element (F4)

The failure of the link element started at a drift of 27% and was completed at a drift of 36%. After that point, the specimen dropped to the response of the unstrengthened specimen F1. This high ductility of the specimen is attributed to the higher rotational capacity of the link element. Due to the higher forces and the significant inelastic deformations that were developed, the U-shaped collar at the middle of the top beam caused local damage to the frame (Fig. 31). Moreover, the bending moment that developed at the mid-span of the beam due to the eccentricity of the horizontal force undertaken by the link, led to the development of high shear forces along the two parts of the beam and resulted to the bidiagonal shear cracks at the left and right parts of the top beam (Fig. 31). Plastic hinges were also formed at both ends of the columns.

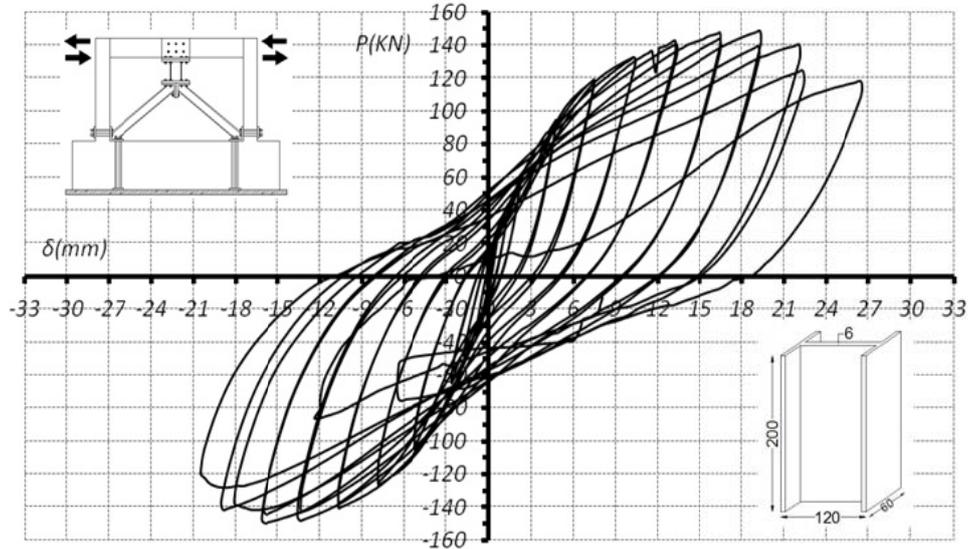
Fig. 32 Load - displacement (P- δ) curves of the frame F5

During the test the strength and the stiffness of the frame was quite higher compared to the other specimens. The maximum strength of 150kN was five times higher than the reference specimen (F1) and was observed at a drift of ~18% (Figs. 32 and 33).

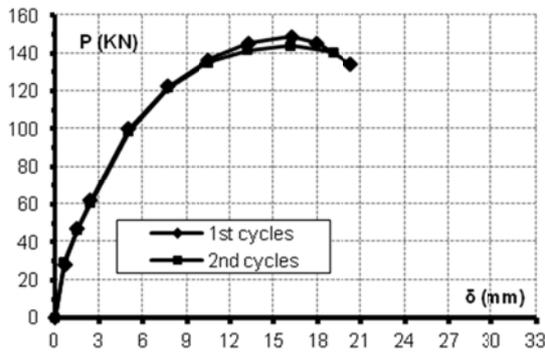
Fig. 33 Load - displacement (P - δ) envelopes (F5)

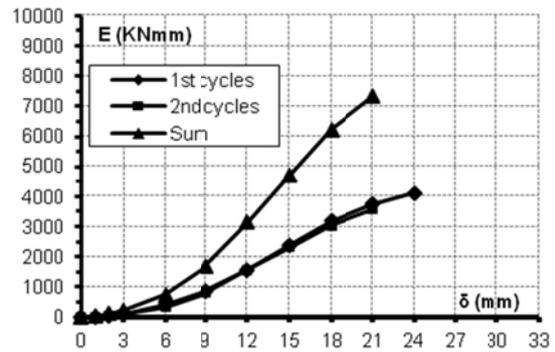
Fig. 34 Energy dissipation displacement (E - δ) envelopes (F5)

failure (Figs. 34 and 35). The equivalent viscous damping was also slightly increased until the end of the test with the maximum percentage at ~14% for drift of 24% (Fig. 36).

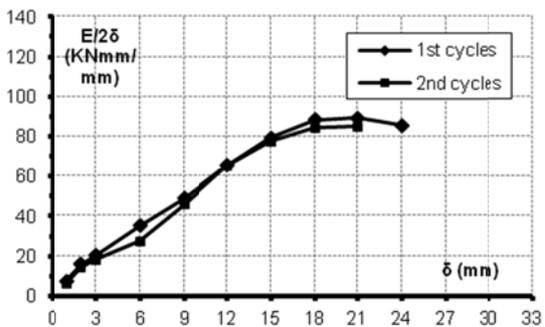
Fig. 35 Normalized energy dissipation – displacement (E/2 δ - δ) envelopes (F5)

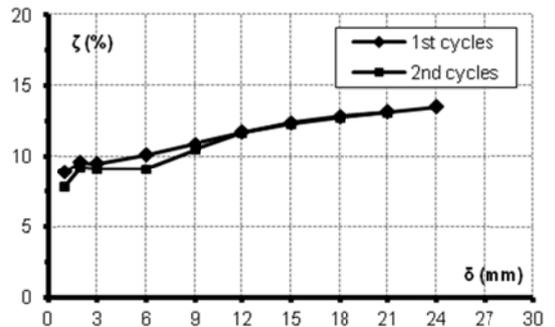
Fig. 36 Equivalent viscous damping - displacement (ζ - δ) envelopes (F5)

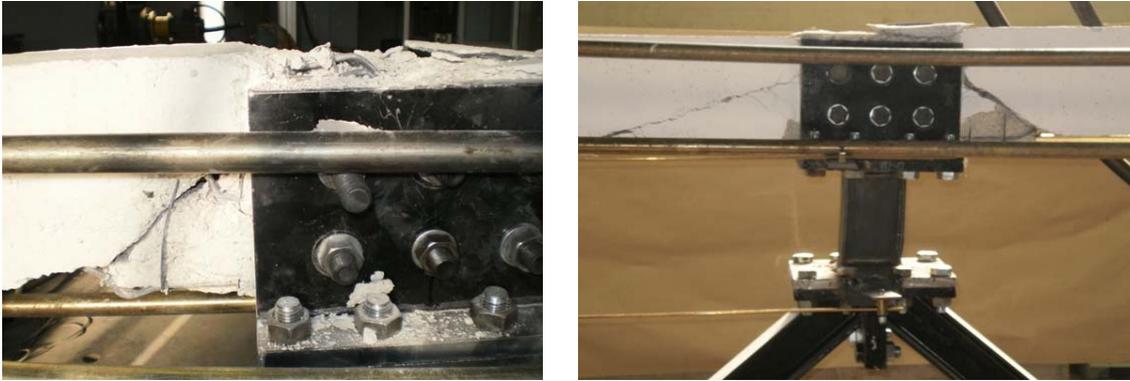
Fig. 37 Extended damage at the middle of the top beam (F5). The link did not fail

At early stages, during the first imposed cyclic displacements horizontal cracks appeared initially at the base and the top of the columns. By imposing displacement reversals, the U-shaped jacket at the middle of the top beam progressively caused extended damage due to the relatively high force induced by the link element. At the end of the test, extended damage was observed in the R/C beam (Fig. 37). For this reason the test was terminated earlier in comparison to the other specimens. The link element suffered inelastic deformation but it was not detached from the plates.

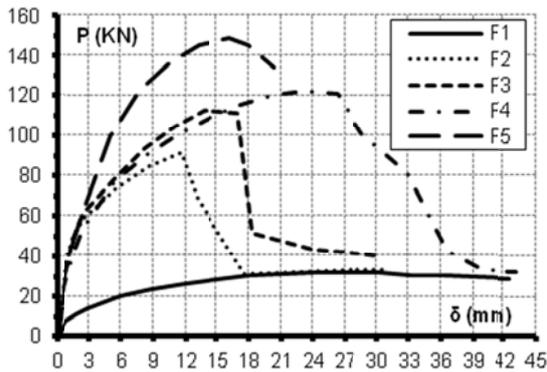
Fig. 38 Load - displacement ($P - \delta$) envelopes (F1-F5)

In Fig. 38 the loads are calculated as the mean of the absolute values of the positive and negative load carrying capacity at each displacement level. It is apparent that the strengthened specimens F2 and F3 are stiffer and stronger, about three and almost four times respectively in comparison to the reference specimen F1. The specimen F3 appears to behave better than the specimen F2 since it reveals higher strength and deformation capacity. The curve of specimen F4 is very close to the curves of specimens F2 and F3, before the failure of their link elements. The link element failure of specimen F4 was delayed due to the link element longer length. So the strength was increased even for drifts close to 21%. This type of link element increased drastically the ductility of the system. After the link element failure of specimens F2 - F4, the strength drops to the strength of the reference specimen F1. Specimen F5 presents a rapid increase of the strength but the higher forces due to the strong link element caused extended damage at the middle in the top beam and the strength of the frame drop earlier than in specimen F4.

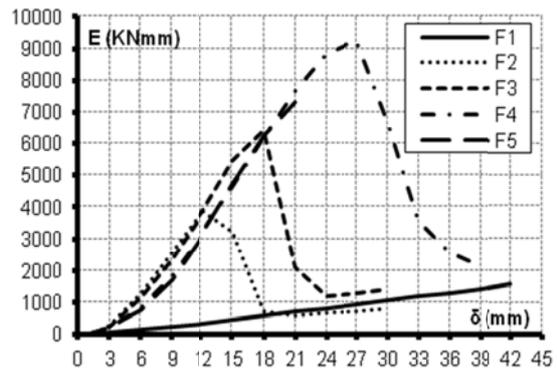
Fig. 39 Energy dissipation - displacement ($E - \delta$) envelopes (F1-F5)

From Figs. 39-40 it is evident that, at the displacement levels where the links are active, the strengthened specimens can dissipate energy about ten times than that of the reference specimen. Again, specimen F3 seems to behave better than the specimen F2. Specimen F4 dissipates more energy since its link element did not fail soon. The hysteresis loops for the specimen F5, despite its higher strength, are not richer. Again, after the link elements failure, the energy dissipation drops to the reference specimen behavior. In Fig. 40 the normalized energy dissipation shows that the maximum value was almost the same for all strengthened specimens and appeared just before the link element failure.

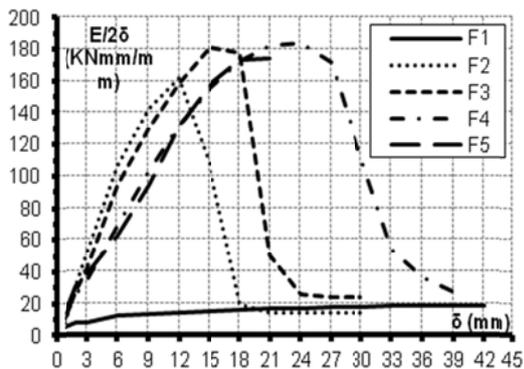
Fig. 40 Normalized energy dissipation - displacement ($E/2\delta - \delta$) envelopes (F1-F5)

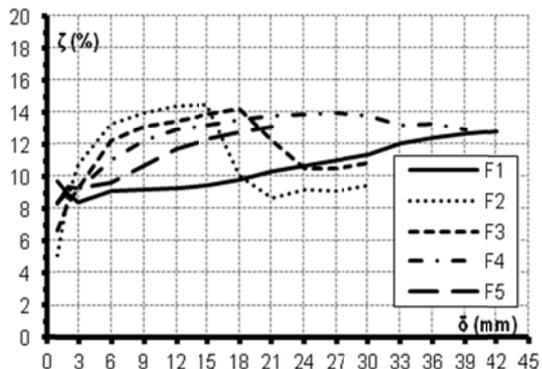
Fig. 41 Equivalent viscous damping - displacement ($\zeta - \delta$) envelopes (F1-F5)

The equivalent viscous damping (Fig. 41) for the reference specimen (F1) presents an almost linear increase from 8% to 13% during the test. It is clear that all the curves of the strengthened specimens tend to reach the perfect plastic behavior ($1/2\pi=15,92\%$) at early stages of displacement.

It is significant to observe that equivalent viscous damping of the strengthened specimens is about 50% greater than that of the reference frame in the range of accepted drifts 5 to 15%. For one more time, the curves of the strengthened specimens after their link element failure drop to the reference specimen curve.
