## Seismic retrofitting of Fragavilla Monastery

Fillitsa V. Karantoni\*

*Department of Civil Engineering, University of Patras, Greece*

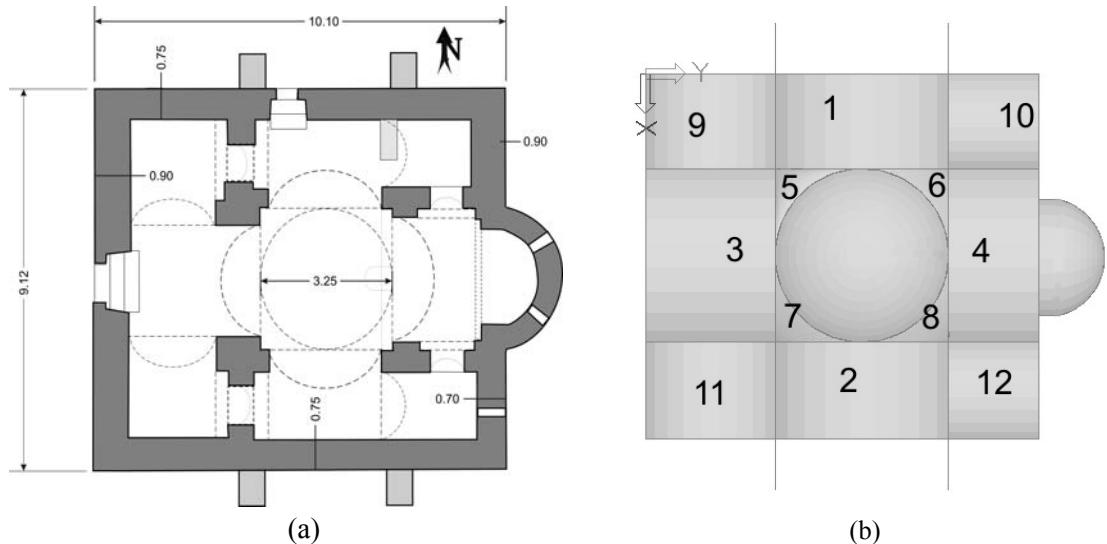
Fig. 1 The Fragavilla Monastery church, (a) floor plan, and (b) nomenclature of the architectural features

The church is of the "cross-in-square" type; the cylindrical drum is based at the crossing of longitudinal and transept barrel vaults. The drum supports the dome, which is also carried by pendentives (Fig. 1(b), parts 5-8). The four "corner bays" transform the plan into an orthogonal of dimensions  $10.10 \times 9.10$  m, as shown in Fig. 1(a). During the long life of the monument, the main vaults, identified with numbers 1 to 4 in Fig. 1(b), as well as parts of the vaults of the corner bays were covered with layers of normal and lightweight gravel. For this reason, the walls which support the vaults were built up higher than the level of their extrados as illustrated in the perspective drawing of Fig. 2(a). Because of this intervention, the lower half part of the cylindrical drum which supports the dome was buried, effectively confined by the gravel pressures through the depth of the gravel fill. The two pairs of buttresses placed transversely to the external aisle walls are also interventions of an earlier period with an obvious intention to prevent the outwards movements of the north and south walls due to the thrust imparted by the dome. The thicker west

The existence of frescos in the church interior prohibits any intervention at the intrados except the sealing of cracks which has already been taken in consideration during modelling where an un-cracked structure was supposed. Considering the critical cracking, it is reasonable not to reject any of the so called modern retrofitting techniques such as confinement through externally bonded FRP sheets (EBR-FRPs), if the interior appearance of the church must remain unaffected after the implementation. Note that the tile roofing may completely cover the intended external intervention at the extrados of the vaults (Mazzolani & Mandara 2002, Valluzzi & Modena 2001, Tararu *et al.* 2010). In this section, strengthening the vaults 1 to 8 (as illustrated in Fig. 1(b)), through externally

In order to investigate the probable additional benefits from bonding AFRPs at all the vaults, the vaults 1 to 12 in Fig. 1(b) were modelled assuming a two layer material, with the properties mentioned in Section 6.2. The structural model obtained in this manner is referred to hereon as ExFRP2. The effected reduction in  $\sigma^*$  relative to that of the original structure is listed in Table 5 as a percentage of the associated OC value. The mean value for the maximum  $\sigma^*$  over the two faces of masonry is reduced to 1.36, 1.60 and 0.28 which represent a percent reduction of  $\sigma^*$  by 56%, 67% and 82% on average for all eight seismic combinations, for the main vaults, the pendentives and the vaults of corner bays, respectively. It is noteworthy that when compared to

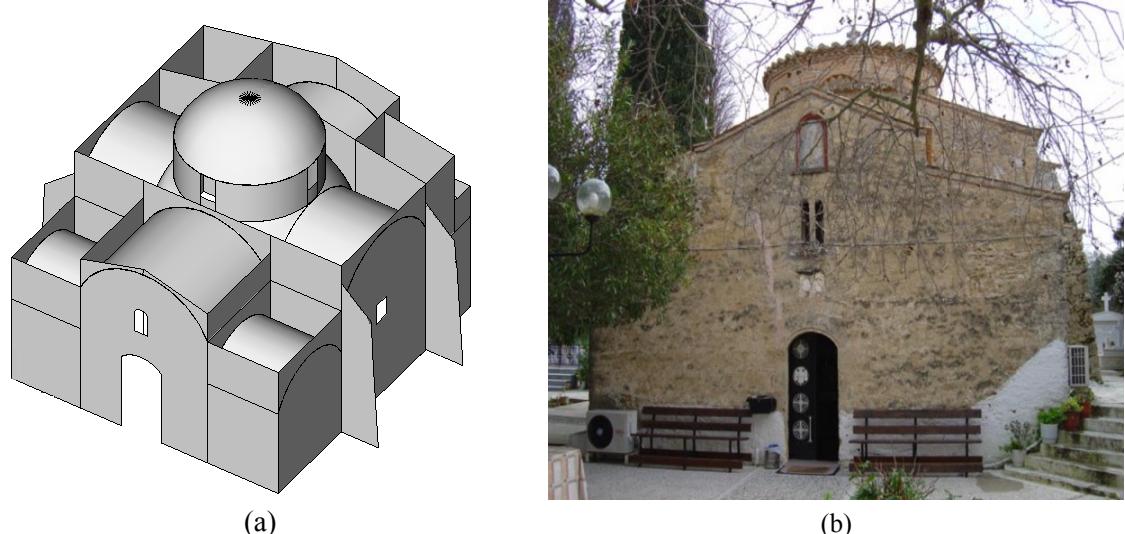
Fig. 2 (a) Perspective drawing of the church "as was" (IS Model) during the earthquake, and (b) a picture taken from west before the 1993 earthquake

Old sealed cracks on the north and west external walls reveal the earlier presence of differential settlements of the walls, which are believed to have occurred in an unknown past, the most severe damage being on the west façade wall Fig. 2(b). A relevant geotechnical study confirmed that the stiff clay under the stone foundation provided adequate load bearing capacity, a finding inconsistent with the inference that attributed cracking to differential settlement. Note however

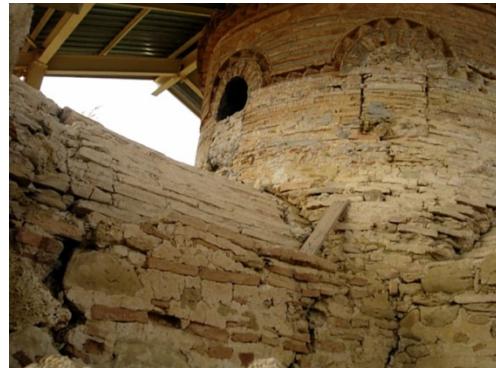
Fig. 3 The South East pendentive (part 8 - the light-coloured region was buried by the infill)

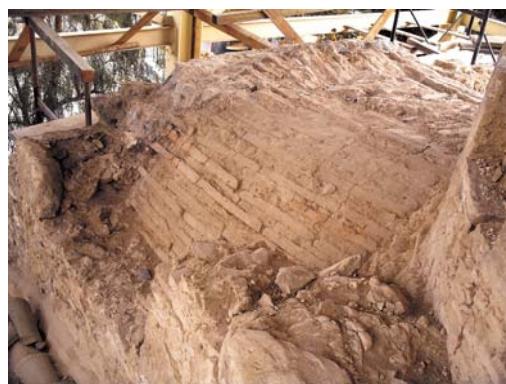
Fig. 4 The north main vault (part 1)

The interventions at the top of the vaults as well as the addition of the buttresses are signs that damage had developed over the centuries of the monument's life and they were intended to prevent the church from further devastation. In 1988, the Vartholomio earthquake of  $Ms = 5.9$  with an epicentre of about 40 km away from the monastery's location, caused some cracking but did not disturb the integrity of the structure. However, in the earlier event of the 1993 the Pyrgos earthquake critical damage had occurred in the monument and shoring had been required to prevent it from collapse. All structural members of the monument, except the stiff external walls, had developed cracking. The most important damage observed was the downwards and southwards movement of the south transept which was manifested by, (a) detachment from the dome and the south wall, as illustrated on the left of Fig. 3 and, (b) eastwards movement of the eastern vault which created a crack of about 10cm. Longitudinal cracks developed also in the vaults of the east-corner bays, which were overburdened by the gravel fill. Due to this deformation, minor cracks had been formed in the internal walls that connect the piers but also in the four central piers that support the dome. The recorded damage of the north main vault (vault 1 in Fig. 1(b)) is shown in Fig. 4. Detailed drawings of the cracking patterns of the vaults are provided in Karantoni (2010).

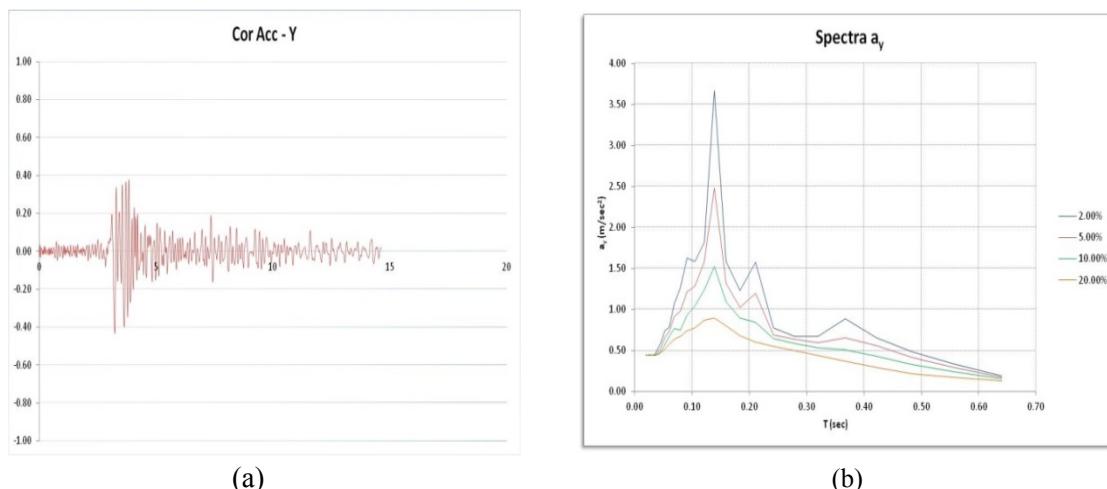
Fig. 5 The y- component of the corrected acceleration time history recorded nearby the Monastery (a); and the corresponding elastic response spectrum (b) (Data from National Observatory of Athens)

The seismic excitation of March 26 1993 consisted of three strong ground motions with epicenters located  $5 \div 20 \text{ km}$  away from the Monastery of Fragavilla (near fault ground motions). The critical shock at the site of the monument was the seismic event at 12:56 on the 26<sup>th</sup> of March ( $M = 5.1$ ) recorded at AMAL station, 2 km to the NW from the church location, with a ground peak acceleration in the NW-SE of 0.46 g according to Stavrakakis (1996). From the ground motion record in the transverse direction which is presented in Fig.5 (see (ISESD) archives, <http://www.iseds.cv.ic.ac.uk>), the demand in terms of spectral total acceleration was found to be 0.12 g for the fundamental period of the church,  $T = 0.09 \text{ sec}$  (Karantoni 2002) and damping 20% which is reasonable for masonry structures. Linear equivalent static analyses were performed for gravity loads and eight seismic load combinations;  $G \pm E_x \pm 0.30E_y$  and  $G \pm 0.30E_x \pm E_y$  with the seismic loads  $E_x$  and  $E_y$  representing the horizontal seismic forces taken equal to 0.12g the mass of the structure, distributed along the height of the structure according with an inverse triangular pattern. The triangular distribution was chosen so as to be consistent to seismic codes in force, since the distribution according to modal shape is not representative because minor part of mass is vibrating, especially after the strengthening measures, as it is mentioned in the next.

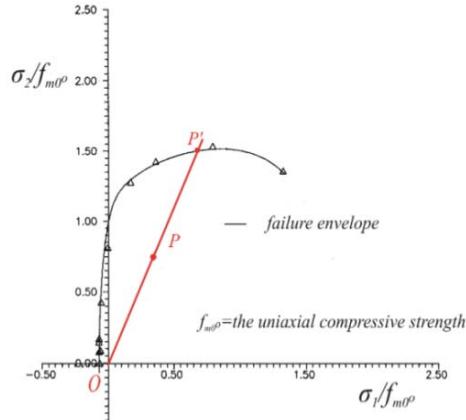
Fig. 6 The proposed failure envelope

In the stress space defined by the two orthogonal principal stress axes, an arbitrary stress state having stress coordinates  $\sigma_1, \sigma_2$ , is represented by the point P (Fig. 6). This stress state is evaluated with respect the failure envelope by considering the length of the radius OP', going through P, to the failure envelope to point P'. If the ratio OP/OP' is denoted by  $\sigma^*$ , then, normalizing the stresses by  $\sigma^*$  would produce a stress state,  $\sigma_1/\sigma^*, \sigma_2/\sigma^*$  that lies exactly on the failure envelope. (Thus, the pair  $(\sigma_1/\sigma^*, \sigma_2/\sigma^*)$  satisfies the equation of the criterion). In this light, practically  $\sigma^*$  is a safety factor: stress combinations values with  $\sigma^* < 1$  lie inside the failure envelope, whereas cases having  $\sigma^* > 1$  have reached plastification, which, in masonry is associated conceptually with failure due to the apparent brittleness of the material.

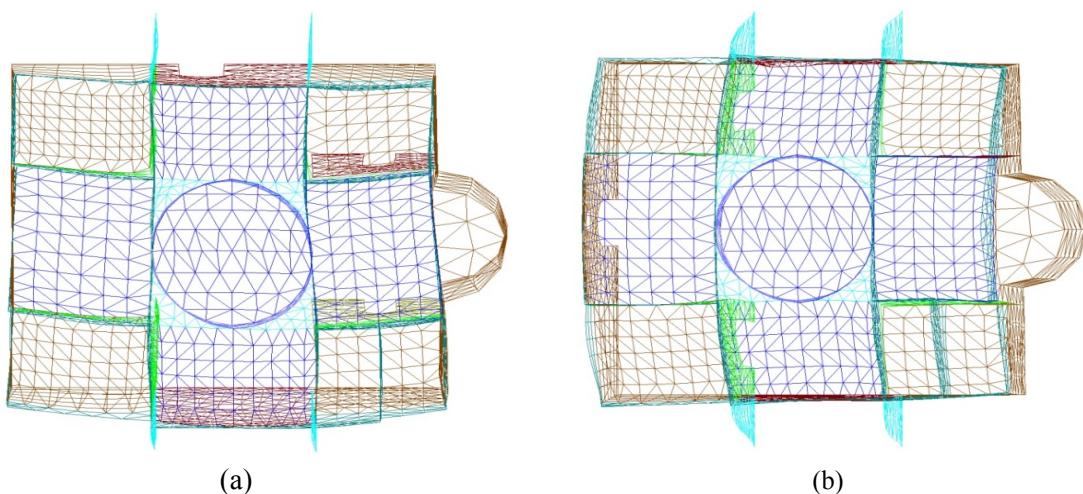
Fig. 7 The fundamental eigenmodes obtained from the IS Model for translation in a) the x, and b) the y axis, respectively

The finite element model representing the church “as was” when struck by the 1993 earthquake comprised 4355 finite elements and 2340 nodes – it is referred to hereon, as model IS (initial state). Modal and equivalent static analyses were performed according with the assumptions outlined in the previous section. Modal analysis revealed higher deformations when the structure is vibrating along the x axis. Furthermore, it was shown that 67% of the mass participates in the fundamental modes along the x and y axes; these modes are strongly marked by out of plane bending deformation components; the two translational fundamental modes in the x and y directions are shown in Fig.7. Upon comprehensive evaluation of the results of linear equivalent static analysis it was concluded that the analytical estimations were consistent with the observed damage. No damage was anticipated in the external walls under any of the eight different seismic load combinations considered in the analysis, consistently with the field observations. Field reports of damage in the vaults were in agreement with the findings of the analysis. Actually, the analytical estimates successfully identified not only the location but the orientation of cracking as well (Karantoni 2008, 2010). This is illustrated when comparing the damage pattern of the south-east pendentive shown in Fig.3 with the estimated contours of  $\sigma^*$  for the loading combination G-0.30E<sub>x</sub>-E<sub>y</sub> as depicted in Fig.8 (a). Table 2 lists the value for the peak equivalent stress  $\sigma^*$  calculated over either of the two faces of the masonry wall, i.e. either on the extrados or the

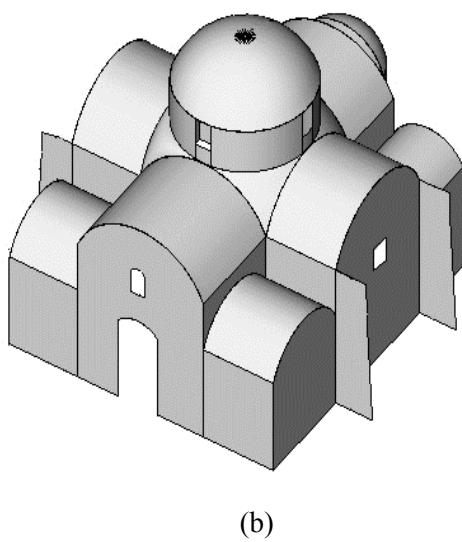
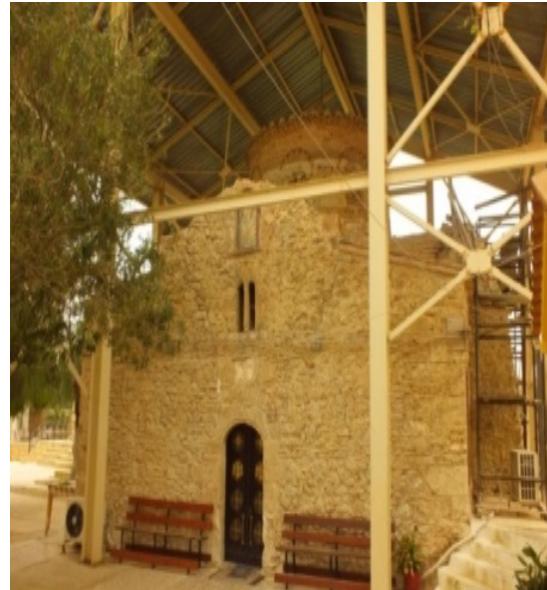
Fig. 9 Perspective drawing of the “original” church (OC Model) (a), and a recent picture of the church which is protected from the rainfall by an external steel structure (b)

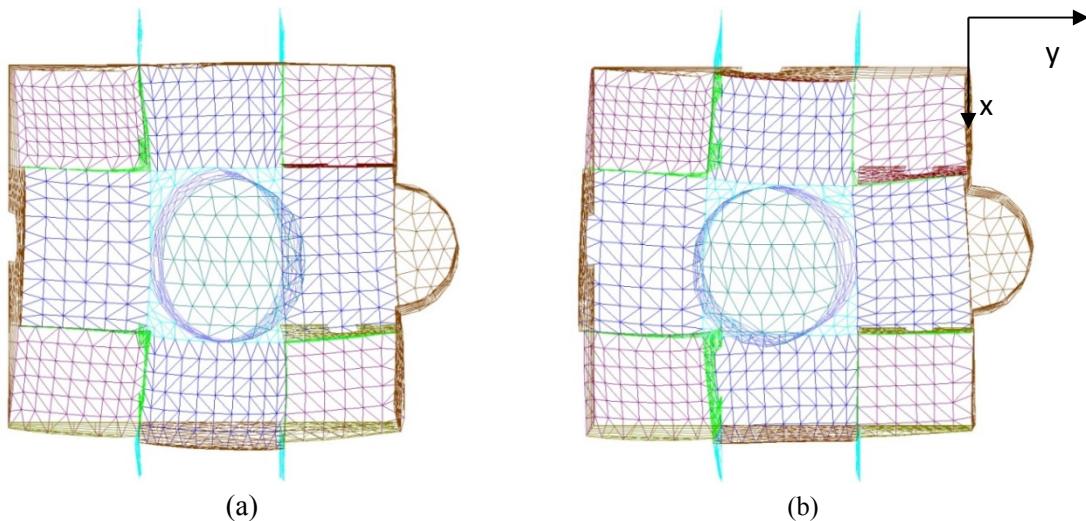
Fig. 10. The fundamental eigenmodes of the OC Model along a) the x and b) the y axis, respectively

The implications of the model alterations may be gauged immediately from the effected differences in the fundamental modes of vibration and the distribution and magnitudes of the equivalent stresses  $\sigma^*$ . The fundamental lateral translational modes in the two orthogonal directions of the plan are depicted in Fig. 10; these are compared with their counterparts shown in Fig. 7. The structure responds uniformly, regardless of the direction of excitation. The first mode in the x direction has the highest degree of mass participation (24% of the total translational mass);

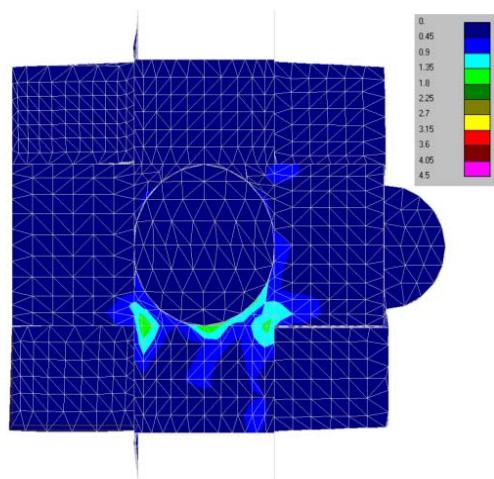
Fig. 12 Contours of  $\sigma^*$  for load combination G-0.30Ex-Ey at intrados of the ExFRP2 Model (AFRP bonding on all vaults)

the previous case, this extra cost in the intervention, as expected, is rather effective in protecting the vaults of the corner bays, but provides little benefit for the other parts (see also Fig. 12). Taking into account that the mean value of max  $\sigma^*$  over the corner bays for all the eight seismic combinations is reduced from 0.60 to 0.28 one may conclude that bonding of ExFRPs at the external surface of vaults of corner bays would not be essential for improving the overall response.
