## Seismic improvement of infilled nonductile RC frames with external mesh reinforcement and plaster composite

**Abstract.** The objective of this paper is to report the result of an experimental program conducted on the strengthening of nonductile RC frames by using external mesh reinforcement and plaster application. The main objective was to test an alternative strengthening technique for reinforced concrete buildings, which could be applied with minimum disturbance to the occupants. Generic specimen is two floors and one bay RC frame in 1/2 scales. The basic aim of tested strengthening techniques is to upgrade strength, ductility and stiffness of the member and/or the structural system. Six specimens, two of which were reference specimens and the remaining four of which had deficient steel detailing and poor concrete quality were strengthened and tested in an experimental program under cyclic loading. The parameters of the experimental study are mesh reinforcement ratio and plaster thickness of the infilled wall. The effects of the mesh reinforced plaster application for strengthening on behavior, strength, stiffness, failure mode and ductility of the specimens were investigat

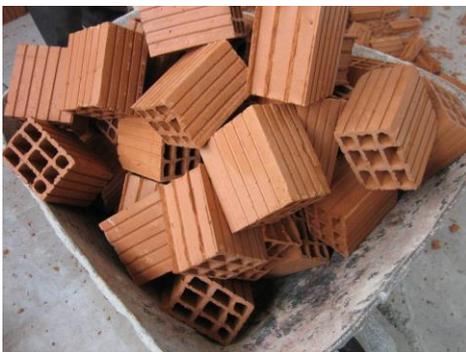
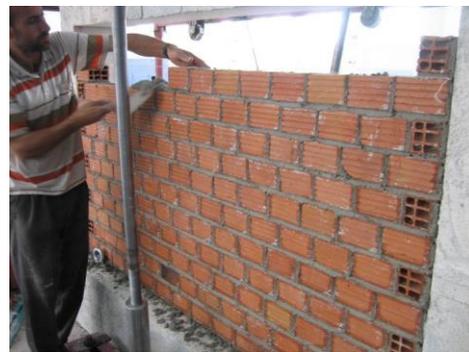
Fig. 7  $\frac{1}{2}$  scaled bricks were used with ordinary mortar

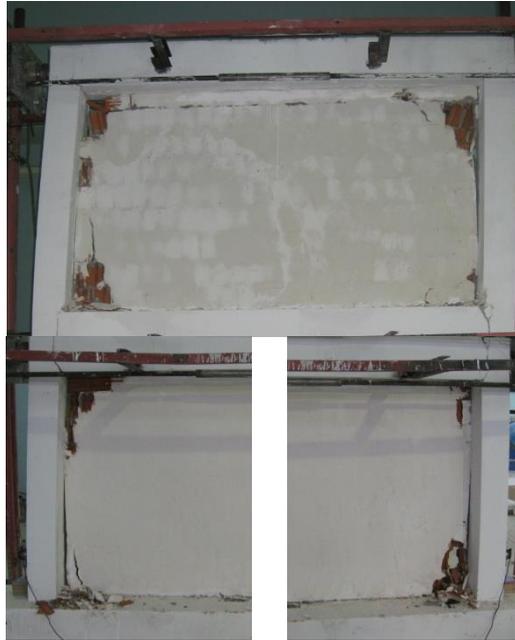
Fig. 8 Failure modes of the wall portions (Korkmaz *et al.* 2010)

The failure mode of the infill wall was the corner damage and crushing of the wall panel. Bottom storey wall panel damaged more than the upper one. After the infill was crushed at the upper corners due to diagonal compression, the specimen lost its lateral load carrying capacity and thus, failed. The representation of the failure mode of the wall is given in Fig. 8.

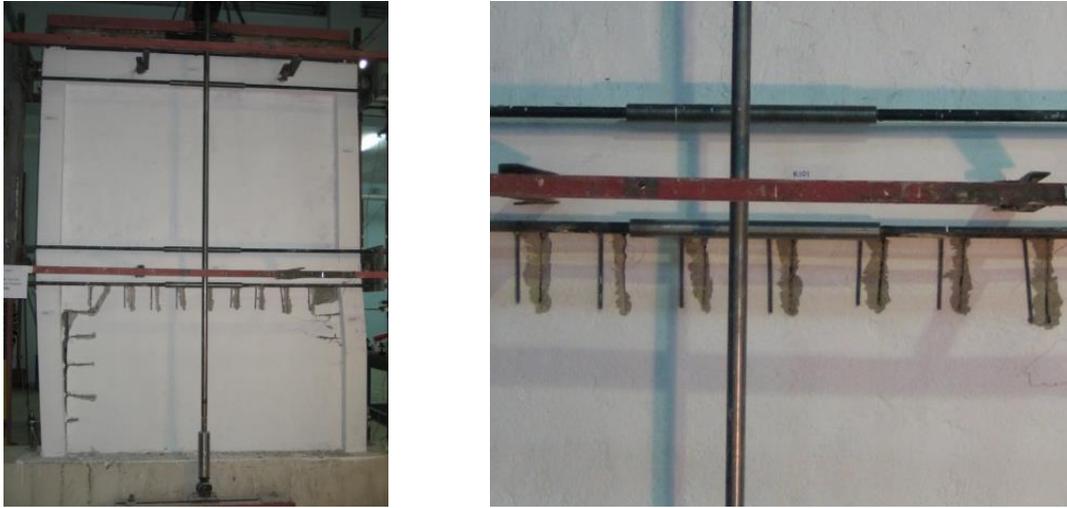
Fig. 9 Failure mode of specimen SP1 (Korkmaz *et al.* 2010)

During testing, specimen SPS1 was showed higher initial stiffness than the RFB1 and RISPS2. Also total lateral load carrying capacity of the SPS1 was increased as compared to SPS1 and RISPS2. Several flexural cracks were observed on the beams and columns. But below the first storey beam, premature and sudden failure of the wall-plaster-dowel interface was observed. The plaster cover over the dowels disintegrated and no more shear transfer between beam and the wall become possible. This failure mode was very sudden and in brittle nature. The full capacity of the mesh-plaster-wall composite couldn't used due to this premature failure. After the failure, the specimen showed similar load-displacement characteristics with the RFB2 specimen. This failure was attributed to inadequate plaster thickness and at the end of the test, it is decided to increase the thickness of the plaster. The failure mode of the specimen at the end of the test is given in Fig. 9. This specimen lost 55% of its lateral load carrying capacity immediately after failure of the dowel anchorage with the mesh plaster composite.

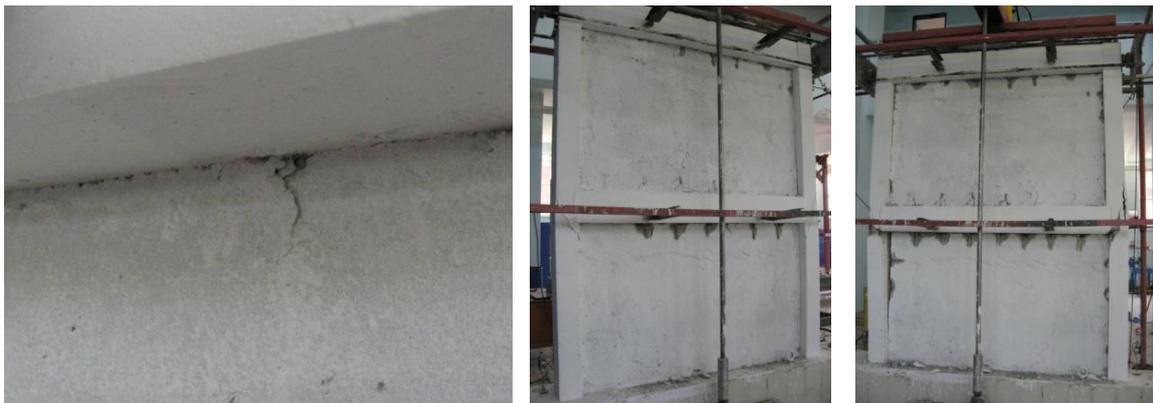
Fig. 10 Failure mode of the specimen SP2

the infill observed on the dowels. A similar but more slow type of failure was observed like SPS1. As the applied cycles and displacements increased, disintegration between dowels and plaster become serious. This disintegration dropped the lateral load capacity of the frame. The initial cracks and final failure mode of the specimen is given in Fig. 10.

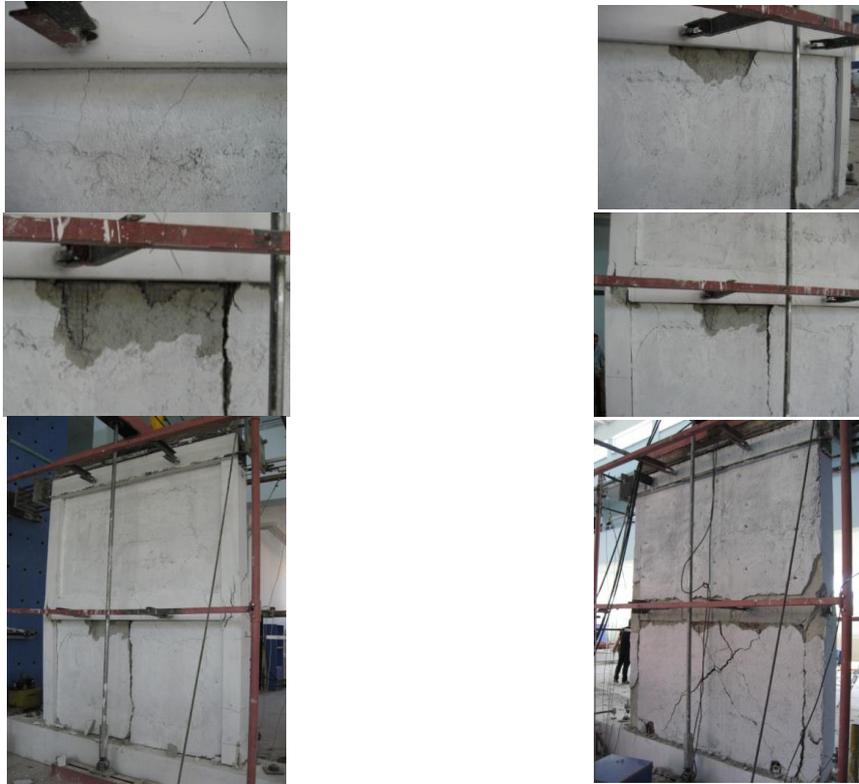
Fig. 11 Failure mode of the specimen SP3

Flexural cracks initiated and concentrated at column lap splice regions. During the testing, again several cracks were observed on the dowel points but no shear failure was occurred. Instead, the splice of the mesh reinforcement line on the middle was torn. The success of proposed strengthening method mainly depended on the connection provided between the frame and the infill.

failure progressed more slowly than the failure observed in specimens SPS1 and SP2. The test photos of the SP3 are given in Fig. 11.

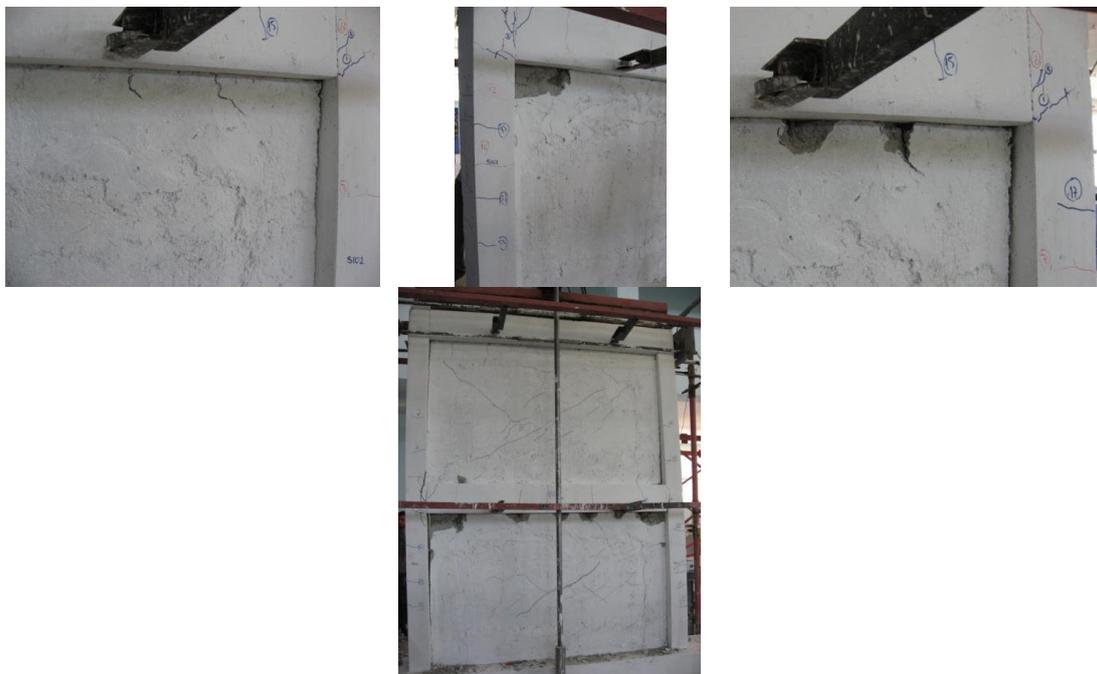
Fig. 12 Failure mode of the specimen SP4

Combined type of failure mode in SP4 was observed. Bond deterioration between dowels and the plaster was initiated but not progressed further. Corner crushing of the wall panels were observed especially on the bottom panel. Inclined shear cracks were initiated and they were spreaded over the walls. Ultimate load capacity of the SP4 was noticeably higher than the other specimens. The cracks over the plastered mesh panels showed a load distribution or load sharing between the wall and frame system. The failure mode of the specimen SP4 is given in Fig. 12.
