Structural performance of renovated masonry low bridge in Amasya, Turkey

Abstract. Masonry bridges are the vital components of transportation systems. Although these bridges were constructed centuries ago, they have served a purpose from ancient times to the present day. However, the bridges have needed local renovation and therefore have been rebuilt over different periods in many places. This study focuses on Low Bridge, which is an example of renovated masonry bridges in Turkey. It essentially assesses the structural behavior of the masonry bridge and investigates the integrity of the renovated components. For this purpose, the mechanical properties of the bridge material have been primarily evaluated with experimental tests. Then the static, modal and nonlinear time history analyses have been carried out with the use of finite element methods in order to investigate the structural behavior of the current form of the bridge.

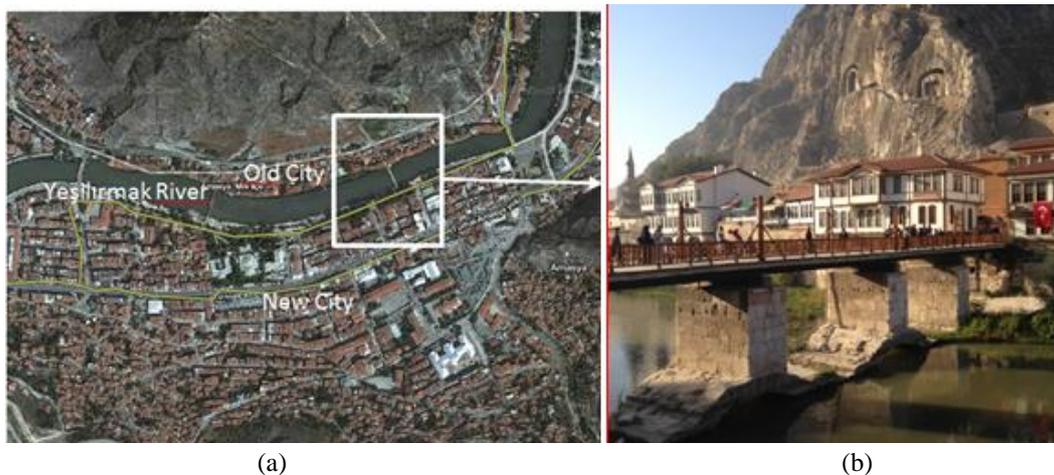
Fig. 2 Low Bridge (Adopted from Turksatmaps)

The bridge was built in 2nd century over the Yeşilırmak River, which longitudinally divides the city, and it has been linked between the old and new city (Fig. 2(a)). The bridge was originally designed as a masonry arch bridge and was constructed with hewn stones in the Roman period.

Since Yeşilirmak River has risen throughout the years, the abutments and the lower parts of the arches have remained shallow. Therefore, the bridge has been called the “Low Bridge-Alçak Köprü” because of its shape (Fig. 2(b)).

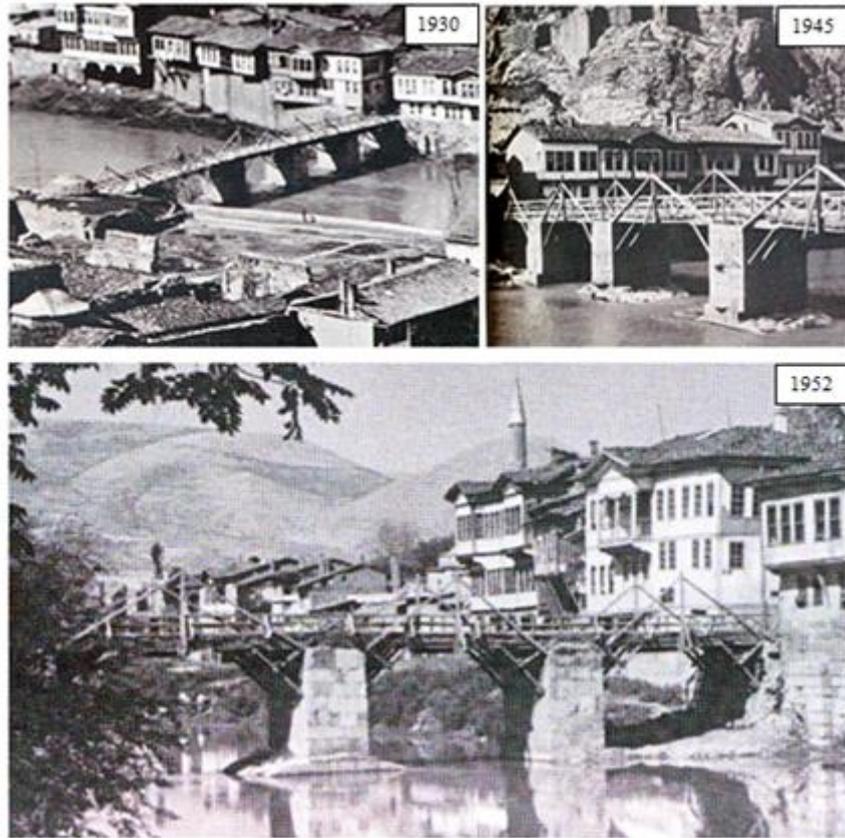
Fig. 3 The old pictures of Low Bridge (Menç 2000)

The bridge has been exposed to many destructive effects since the time when it was built. The bridge spandrels completely collapsed at an unknown date and the piers, which are also known as stone towers, were added to the highest point of the Roman arches in the Ottoman period. Subsequently, timber frames were added to the bridge piers by order of Ziya Pasha who was governor in Amasya in 1865 (Menç 2000).

The timber frames and the piers were partly destroyed again during a flood in 1881 and the bridge became unusable. According to orders of Atif Bey, who was a governor in Amasya, the stone piers were renovated and new timber frames were constructed on the piers (Menç 2000). Moreover, the bridge was moderately damaged in the 1939 Erzincan earthquake, and the bridge was renovated with minor changes. However, the timber frames were damaged due to heavy floods in the 1950s, and a reinforced concrete slab was added to the bridge instead of the timber frames (Fig. 3). Eventually, the bridge was renovated in 2009 and has reached its current form.

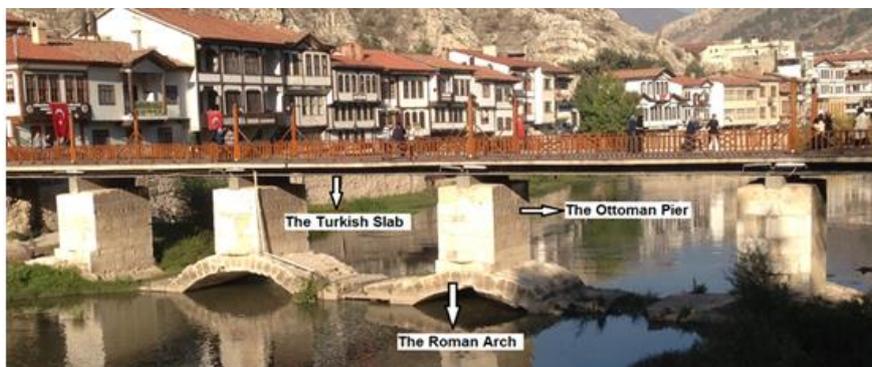
Fig. 4 Structural components of the bridge

Historical masonry bridges are very complex structures although they have very simple architectural shape. As a well-known fact, the shapes of masonry bridges are one of the important factors for their structural behavior (Cakir and Mohammadi 2013). Therefore, in the first phase of the study, a geometrical survey was conducted. According to this survey, it was discovered that the bridge consists of three major parts. The first and oldest parts are the Roman arches. The second parts are the Ottoman piers and the third parts are the Turkish slab. Therefore, the bridge has a unique architectural shape, and it reflects three different civilization effects. Fig. 4 provides a schematic detail of the components of the Low Bridge.

The bridge has four Roman arches and four piers. With respect to the curve of extrados or intrados, the arches can be classified as semicircular arches. Voussoirs were the wedge-shaped one-meter stone blocks and the intrados spans of the arches varied between 6 m and 7 m. The lower parts of the arches (from the skewback) are under water, and these points are the foundation of the bridge due to the rise of the riverbed (Fig. 5). In this bridge, having the shape of a rectangle (3.5×5 m), the Ottoman piers have dual functions (Fig. 6). One is carrying the vertical loads, such as dead load and live load, and the other is resisting the horizontal loads, such as wind loads, creep movements, and water flow effects. Because of these, the piers were designed symmetrically to

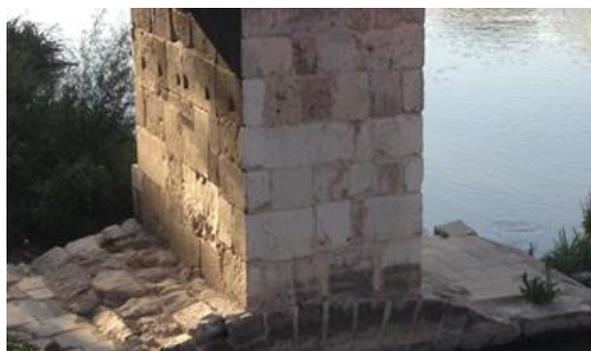
Fig. 6 Rectangular Ottoman pier

safely transmit the loads to the Roman arches and also to resist any lateral loads due to the wind or flow of the stream. The superstructure, which is the highest point of the bridge, is the Turkish slab. This deck slab, which has 0.75 m thickness, was made of reinforced concrete paving road. In addition, two timber frames were constructed to make the bridge safer for the pedestrians passing through the bridge. When all the components come together, the total bridge is almost 51 m. in length and 6 m in width. Moreover, the total height of the bridge is almost 10 m from the skewbacks to the deck slab. As of today, the bridge does not open to vehicle traffic, and the bridge is only visited as a historical heritage site (Fig. 7).

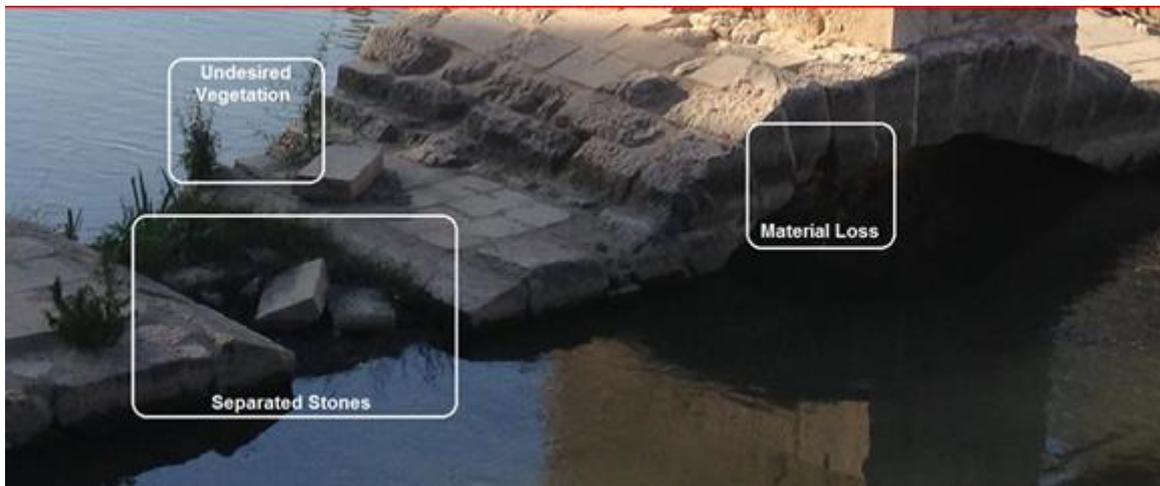
Fig. 9 The separated stones and material loss of the arches

The binding material between the masonry units has partially eroded. These abrasions may have caused the vicinity of the structural resistance to be weak. The most deteriorated parts of the bridge are the skewbacks of the arches. In some cases, abrasion and degradations are also noticed on the stone units of the masonry piers. In addition, the bridge has been subjected to several undesired materials, such as upper branches and stones, which come from floodwater (Fig. 8). Hence, the historical structure has also been locally damaged due to the heavy flood effects. The increases of river water velocity and flow rate have led to scour for the bridge, and some stones have separated from the bridge (Fig. 9). These types of damages are very dangerous because they may cause fatal and destructive crashes and fractures. In addition, they cause differential movement of the bridge components. Therefore, these damages should be seriously considered, and some precautions should be taken to avoid or to abate their effects. In addition, the deformations can be seen on the piers (Fig. 10).

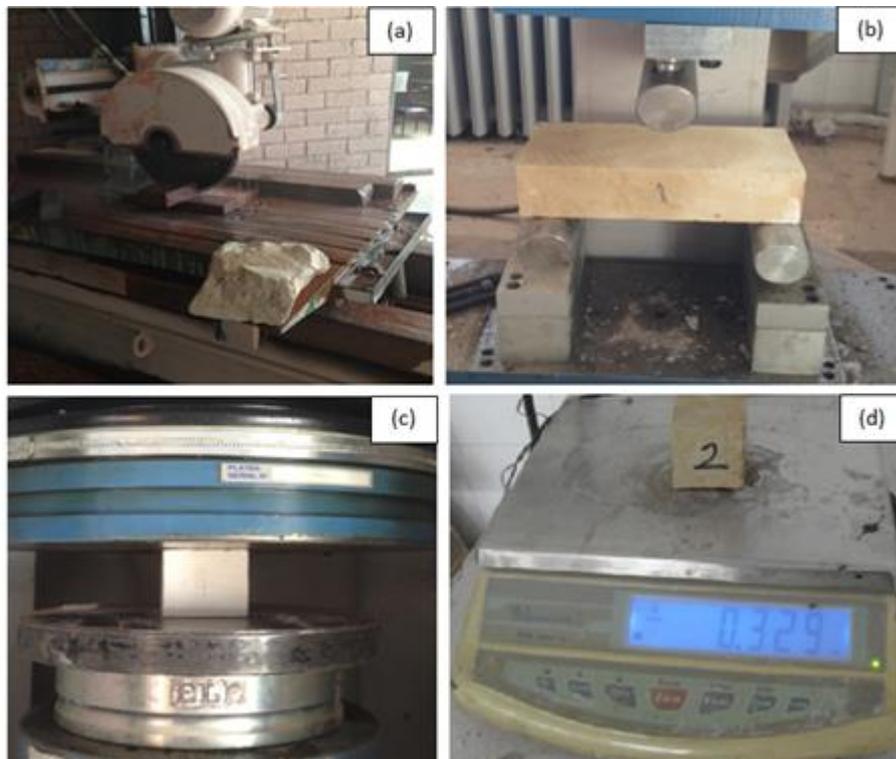
Fig. 11 (a) Preparation of the specimens, (b) Three-point bending test, (c) Compression test, (d) Density test

In this study, some laboratory tests were performed on the masonry specimens in order to determine their mechanical properties. Hence, the represented stone samples were randomly collected from around the bridge and then were prepared with the dimensions of $50 \times 50 \times 50 \text{ mm}^3$ and $50 \times 100 \times 200 \text{ mm}^3$ (Fig. 11). Experiments were conducted to obtain information on the compressive strength, tensile strength, and density. Therefore, the stones were subjected to compressive tests and three-point bending tests. The tests were conducted at the laboratories of the Department of Civil Engineering at Ataturk University, Turkey. In the experimental examination, the compressive strength of the stone samples were obtained from compression tests on five cubes following the guidelines of TS 699, Turkish Building Code (Table 1) (TS 699:2009). The bending strength of the material samples was obtained from three-point bending tests on five prisms according to TS EN 1467 and 1469, Turkish Building Codes (Table 3) (TS EN 1467:2012, TS EN 1469).

According to experimental tests of the materials, the compressive strength values of the stones changed between 40.52 MPa and 42.42 MPa. From the compression tests, the average compressive strength obtained for the stones was determined as 41.46 MPa (Table 1). The tensile strength generally varied between 2.43 MPa and 2.65 MPa and the average value for tensile strength was found to be as 2.56 MPa (Table 2). In addition, the average density of the stones was determined as 2646 kg/m³. Furthermore, the standard deviation of compressive strength was calculated as 0.846, while the standard deviation of tensile strength was calculated as 0.089. According to the Masonry Standards Joint Committee (MSJC 2005), the modulus of elasticity is determined as a function of masonry compressive strength. Therefore, in this study, Young modulus (E) for masonry units were calculated by $E=200f_d$ formula where f_d is the average compressive strength of masonry unit (TEC 2007).

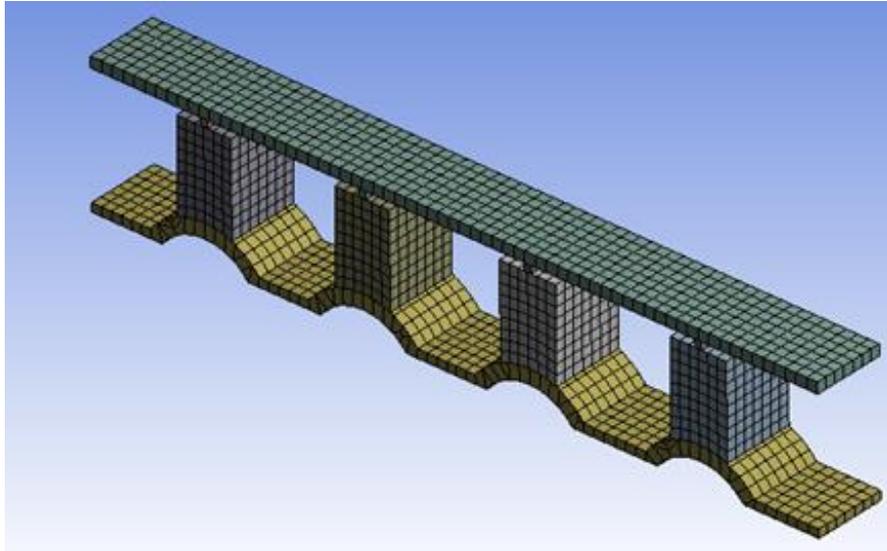
Fig. 12 Finite element model of the bridge

The finite element analysis (FEA) is one of the most useful and preferred methods in the field of engineering science. In order to analyze a structure, a numerical model is developed to represent the structure. The finite element method (FEM) is widely used in the analysis of masonry structures because of their complexity. In this study, firstly, the most suitable numerical model was prepared using FEA program, ANSYS Workbench (2012). In the modeling process, SOLID 65 elements, which has eight nodes and three degrees of freedom per node, was preferred for the description of the bridge. The three-dimensional model was discretized with 16629 nodes and 2646 solid elements (Fig. 12). The static and dynamic analyses were performed on the numerical model. The obtained analyses results were too complicated to present each node or element and, therefore, contour pictures, bars, and scale tables were used to present the results of the analyses. Moreover, it has been considered fixed boundary conditions in the foundation sections and

sidewalls. In this study, the non-linear analysis has been performed based on the Drucker-Prager failure criterion (Drucker and Prager 1952), and the material properties to be used for the analysis are presented in Table 3.

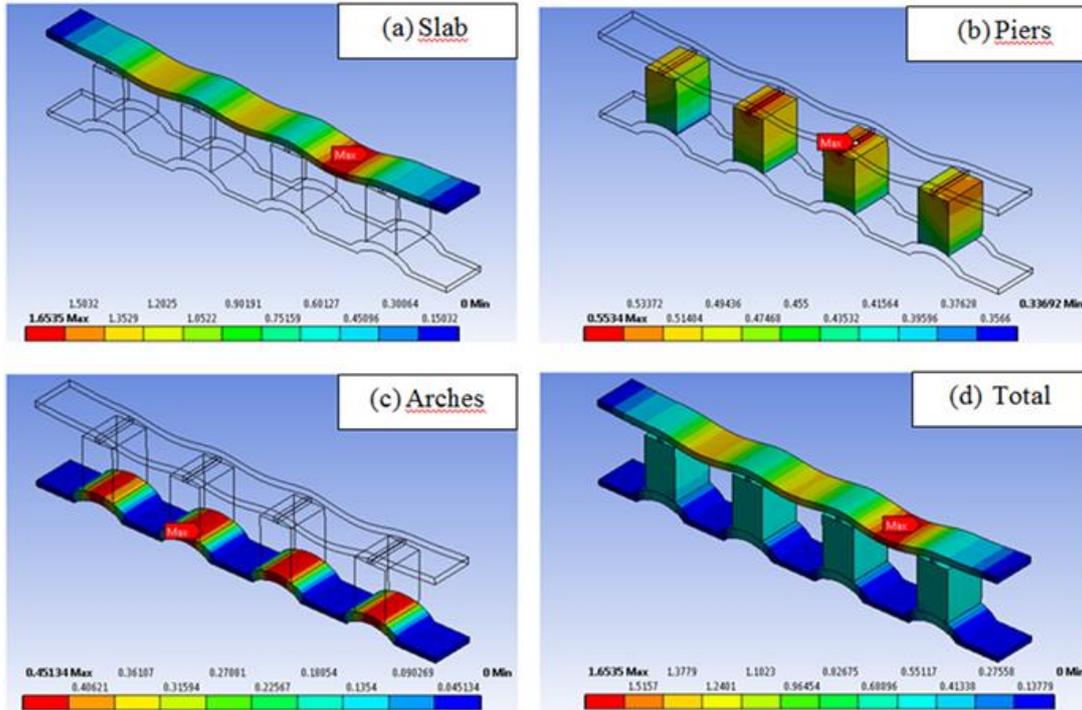
Fig. 13 Deformation of (a) Slab, (b) Piers, (c) Arches, (d) Total (mm)

The aim is to determine the non-linear static behavior of the bridge in this section of the study. Therefore, Low Bridge has been primarily performed by its self-weight in the non-linear static analysis. Fig. 13 provides schematic contours about the displacement of the components of the masonry bridge. When the components were individually investigated, the maximum displacement was observed in the vertical direction and on the top point of the slab reaching a value of 1.65 mm (Fig. 13(d)).

In this section, the results of the analyses are discussed and compared with the previous studies. When the static analysis results are examined, the maximum displacements are observed in the maximum span of the bridge. In terms of maximum tensile stresses, the stresses are outstandingly changed in the corner points of the arches and the piers. The modal analyses show that the first mode shape of the bridge has translation in *Y* direction, the second and fourth mode shapes have almost sinusoidal shape of the slab section of the bridge while the third mode are under the effect of torsion. The findings that are obtained from the static and modal analyses are similar to Boothby *et al.* (2005), Pela *et al.* (2009), Fragonara *et al.* (2011).

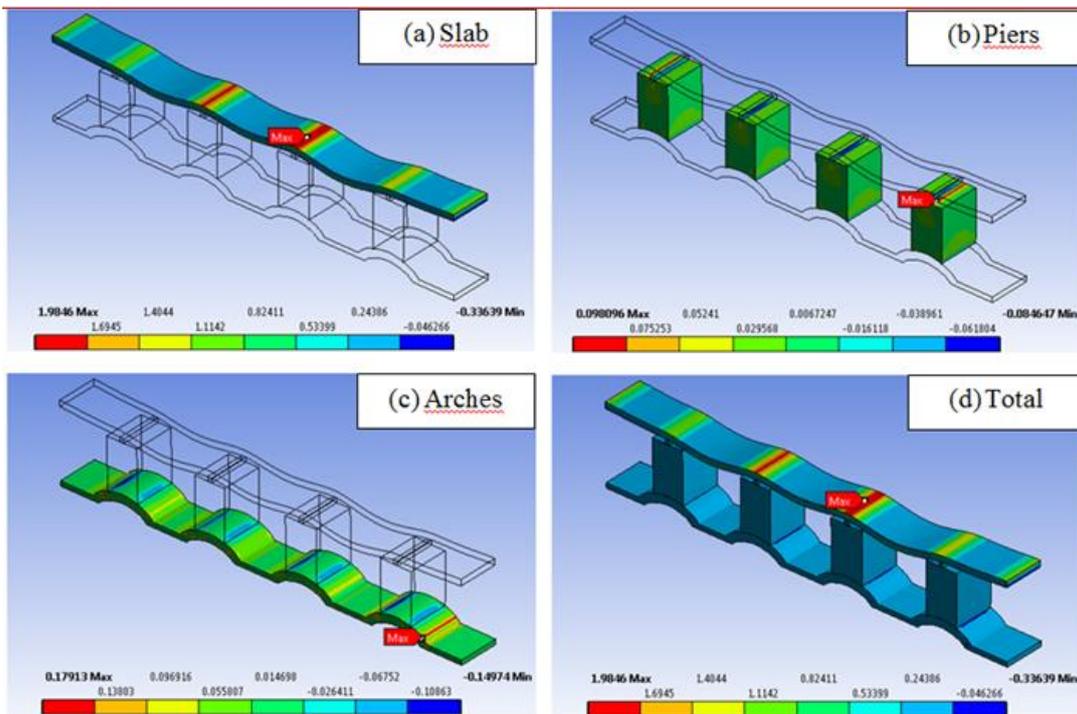
Fig. 14 1st Principal Stress of (a) Slab, (b) Piers, (c) Arches, (d) Total (MPa)

The investigation of the principal stresses observed in the structural stability system of the bridge showed that 1st principal stresses occurred in the bearing section, and the maximum values were achieved between the superstructure and the bearing parts, and tension stress was determined as 1.98 MPa (Fig. 14). The 3rd principal stresses occurred at the location between the superstructure and pier. The maximum compression strength in this section is found as 1.99 MPa (Fig. 15).

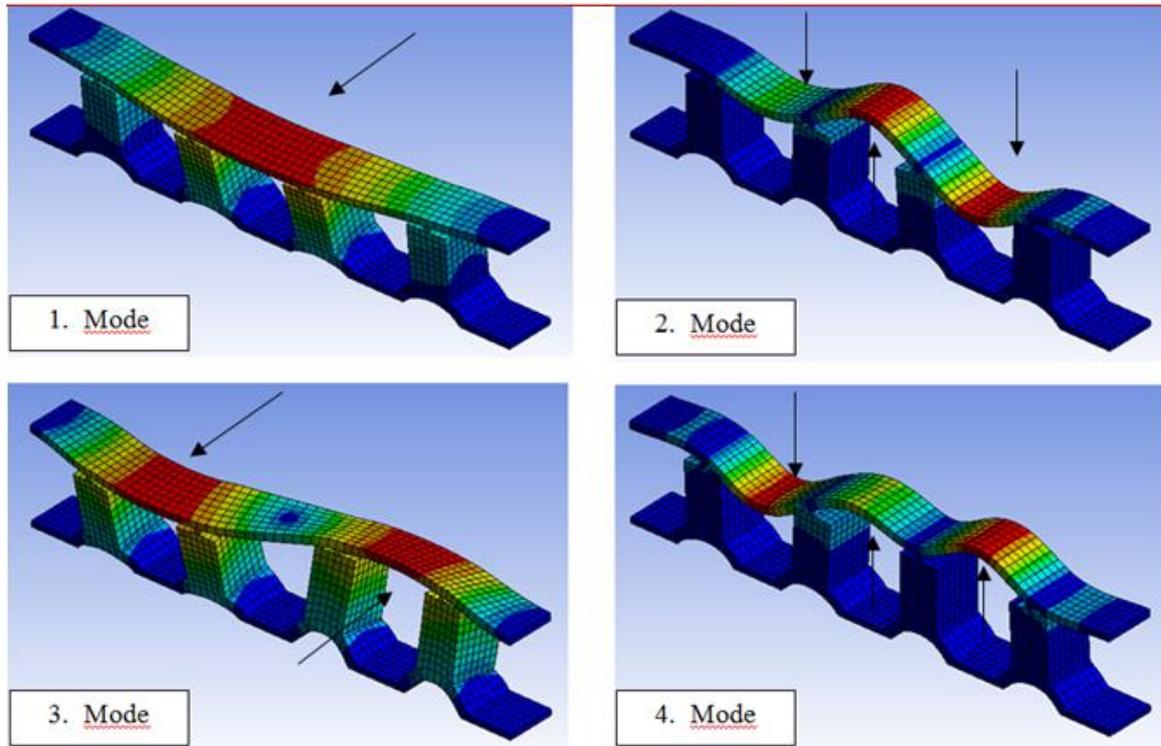
Fig. 16 The mode shapes of the first four modes

Modal analysis of vibration is simply used to determine mode shapes and characterizing resonant frequencies (Celep and Kumbasar 2011). Modal analysis changes from a multiple degree of freedom problem to a vibration problem. In the dynamic analysis of Low Bridge, mode shapes and mode vibration periods were primarily determined and the first four mode frequencies, periods, and mass participation ratios were summarized in Table 4. Furthermore, the first four mode shapes were shown in Fig. 16.

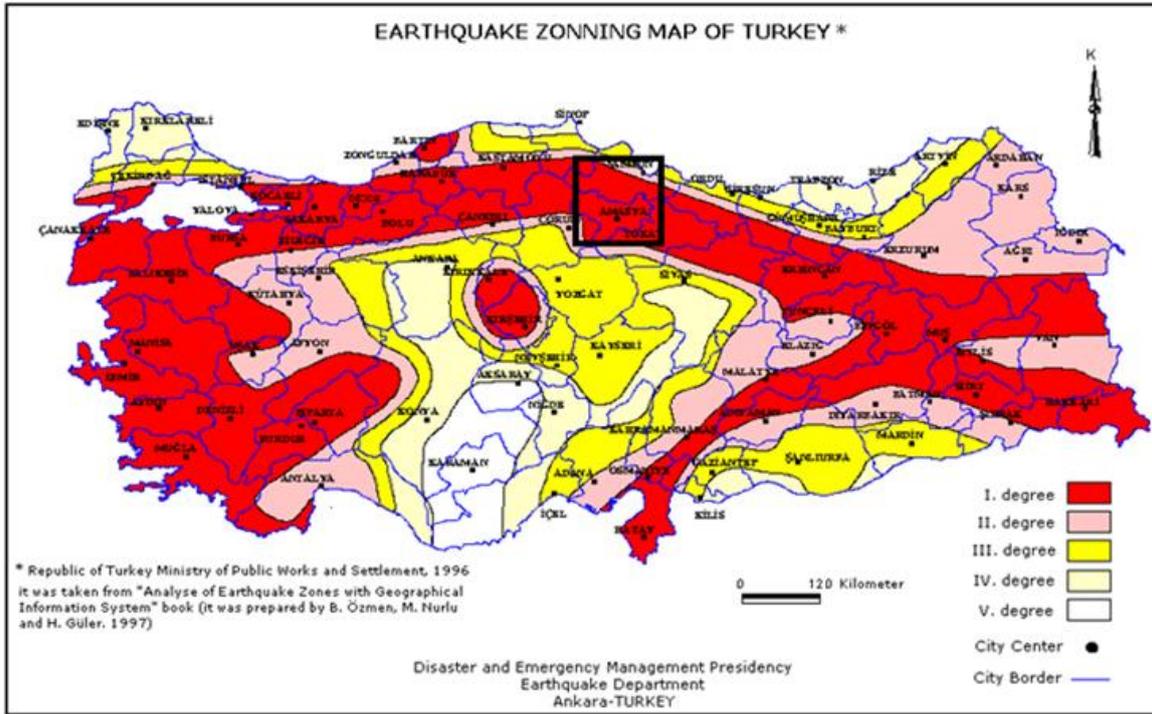
Fig. 17 Earthquake map of turkey (AFAD 2013)

Low Bridge was built in active earthquake prone zone. Seismic load is a function of the mass of the structure and the intensity of the ground acceleration. In regions subjected to earthquake motion, the behavior of the structure is very important for engineers. Historical structures are at risk when encountering seismic events, and these structures are usually deficient in resisting seismic loads. Amasya and its surrounding cities are in areas prone to seismic activities. The Amasya city center is a first-degree earthquake prone zone, which is expected to have acceleration values between 0.4 g (Fig. 17). Therefore, many destructive earthquakes have taken place in this area in the past. Seismic records show that the most powerful events occurred on March 13, 1992 in Erzincan. Erzincan is located at a seismic prone zone near Amasya. When the Erzincan earthquake occurred, it not only affected Erzincan but also other neighboring cities. The earthquake had an estimated magnitude of 6.8 on the surface wave magnitude scale and resulted in 497 deaths, 2000 injuries, 4157 severely damaged buildings in addition to the 5453 moderately damaged and 7867 slightly damaged buildings (NEMC 2012). The acceleration records of Erzincan earthquake at centre station were considered and the input ground motion was applied only in the horizontal direction (East and West) in Fig. 18.

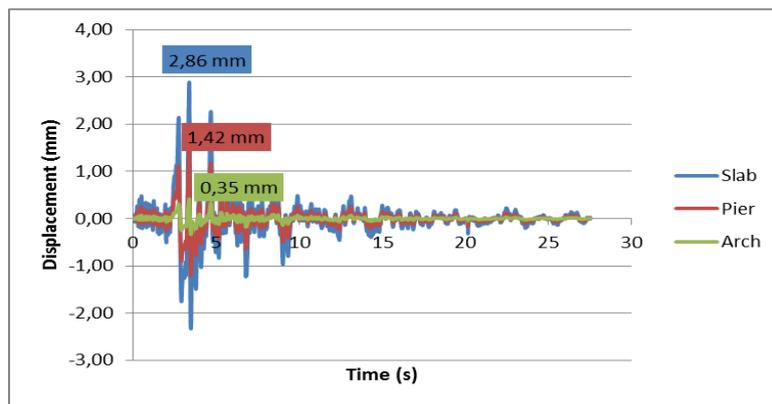
Fig. 19 Lateral displacement of the bridge components

Fig. 19 shows the lateral displacement time history at different level of the bridge. When the figure examined, it shows that the maximum displacements reached a value of 2.86 mm over the superstructure. The lateral displacements reached values of 1.42 mm and 0.35 mm in second pier and second arch, respectively.

Where h_i , R are the height of the structure, and the behavior factor related to the ductility of structure, respectively. For Low Bridge $h_i=15$ m, $R=2$ and the corresponding maximum allowable top displacement is 0.15 m. The study indicated that the displacements obtained from static and dynamic analyses are found to be lower than the values obtained from the above formula. Therefore, it can be concluded that the displacements are in the allowable limits.

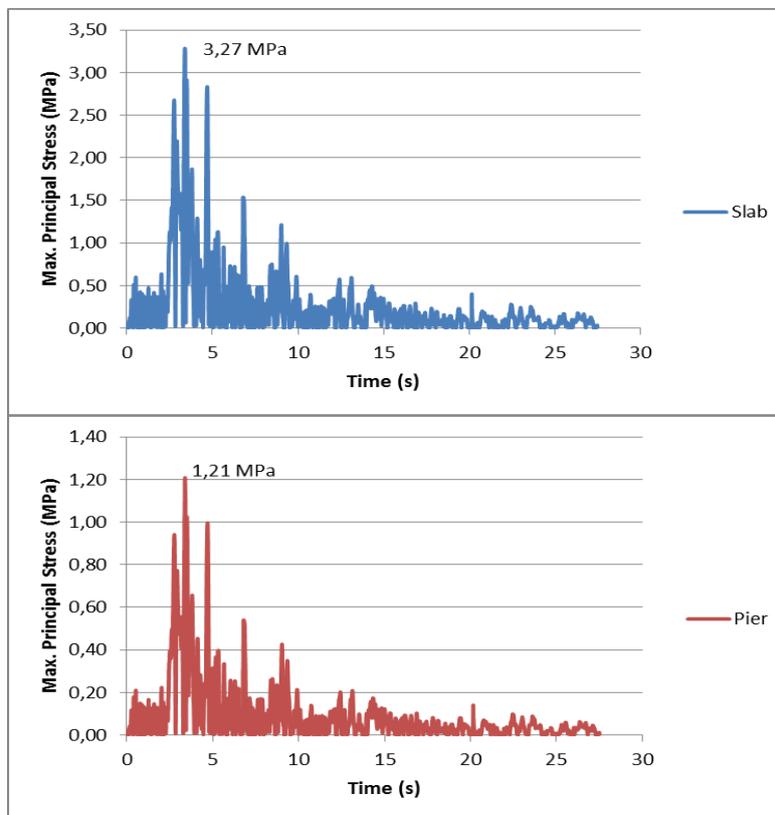
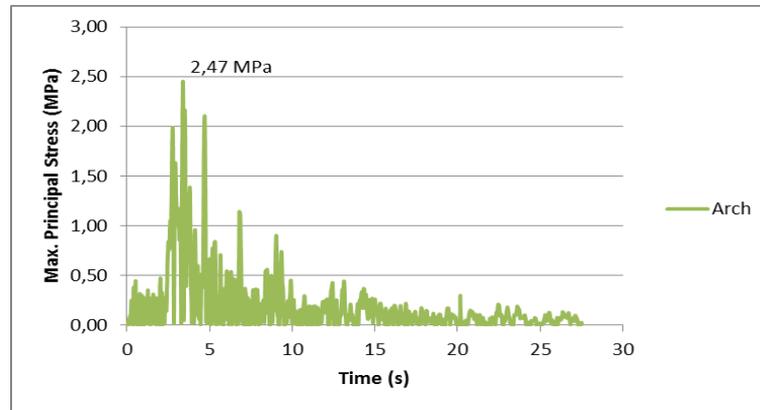
Fig. 20 Maximum principal stress in the bridge components (MPa)

The critical stresses derived through this method were intensified in the supports of the main arch that carries the piers. In particular, tension stresses were encountered in the supports of main

arch system and in the bottom sections of the main bearing elements. Furthermore, the examination of the principal stresses reflects that 1st principal stresses were encountered as tension stresses in the superstructure of the bridge and in the support point, which is between the slab and the piers parts. The maximum of those values were found to be as 3.27 MPa, 1.21 MPa and 2.47 MPa in the slab, pier and arch, respectively (Fig. 20).

The dynamic analysis results indicated that the maximum compressive and tensile stresses occurred at the base of the arches and on top the superstructure, respectively. When the maximum

tensile stress contour is examined, the stresses are outstandingly changed in piers and in top parts and springer points of the arches. As compared with the experimental tensile stress values for the stones, the tensile stress values in the piers and arches, which were constructed with the stone, is comparably low. Furthermore, the findings of the analyses show that the maximum lateral displacements occurred in the slab and upper parts of the bridge. The maximum displacements were calculated as 2.86 mm. Previous research in the literature (Dogangun *et al.* 2008, Cakir and Uysal 2014, Seker *et al.* 2014, Cakir *et al.* 2014) has suggested to use the following equation for maximum relative displacement requirement of masonry structures. Therefore, this study also considers this equation for the comparison of displacement values.

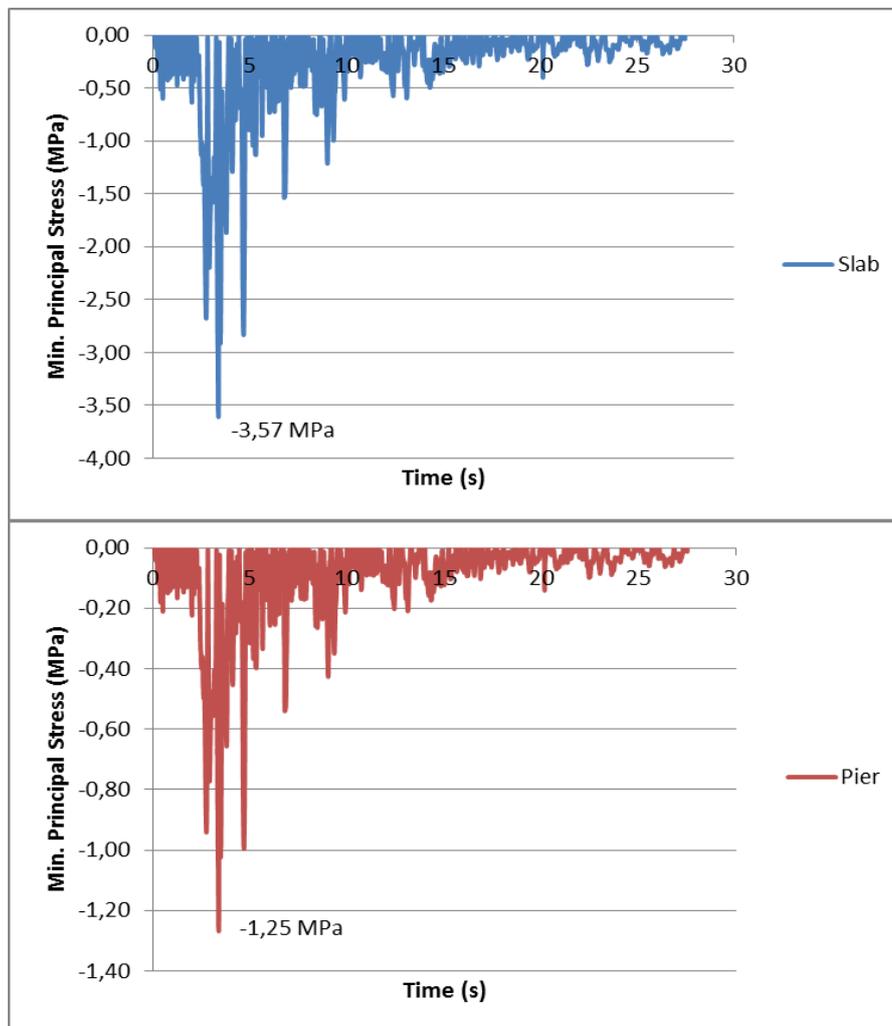
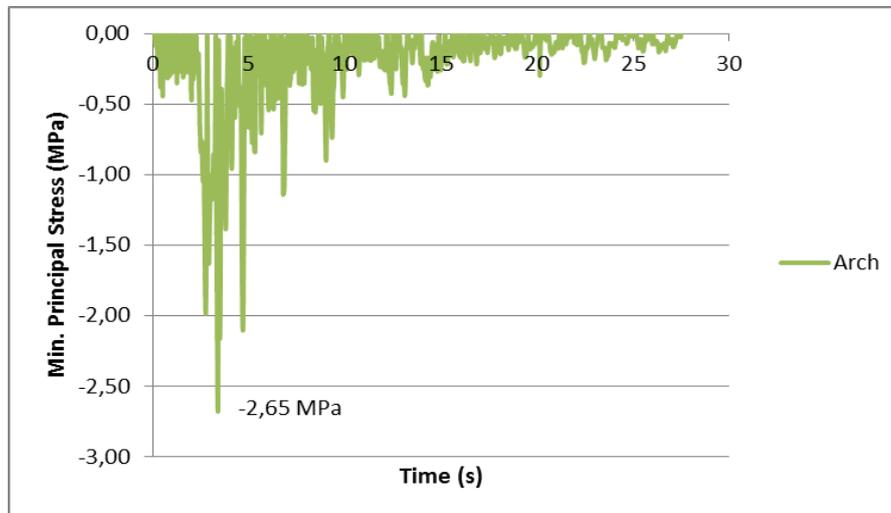
Fig. 21 Minimum principal stresses in the bridge components (MPa)

3rd principal stresses occurred as compression stresses and were intensified in the lower and support sections of the main arches. In particular, the stresses intensified the skewback points of the arches and the transient zone between the arches and the piers. When the bridge components examined, in the slab section, the maximum compression stress was found as 3.57 MPa; in the pier section, it was found as 1.25 MPa; in the arch section, it was found as 2.65 MPa (Fig. 21).
