Cyclic shear test on a dowel beam-to-column connection of precast buildings

Gennaro Magliulo^{*1}, Marianna Ercolino^{1a}, Maddalena Cimmino^{1b},
Vittorio Capozzi^{2c} and Gaetano Manfredi^{1d}

¹*Department of Structures for Engineering and Architecture, University of Naples Federico II,
Via Claudio 21, 80125 Naples, Italy*

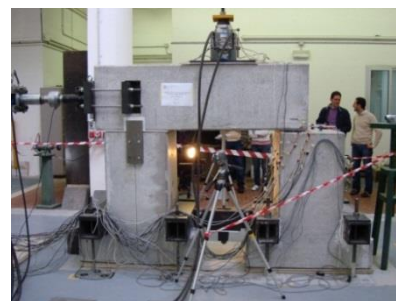
Fig. 2 Experimental setup of the cyclic shear test on a beam-to-column dowel connection

In this paper the cyclic shear test on a connection between an external column and a beam is described. The test specimen (Fig. 2) consists of two vertical concrete columns (600 mm×600 mm) with a height of 1.0 m and a horizontal concrete beam (600 mm×600 mm) with a length of 2.10 m. The tested beam-to-column dowel connection is provided on one side of the specimen, i.e., the left side in Fig. 2(a). Since the unconnected column (i.e., the right column in Fig. 2(a)) only gives the support to the beam, two teflon sheets are placed between the right column and the beam in order to avoid undesired frictional resistances. The setup is fixed by means of steel profiles that connect the base of the two columns to the floor (Figs. 3(a)-(b)).

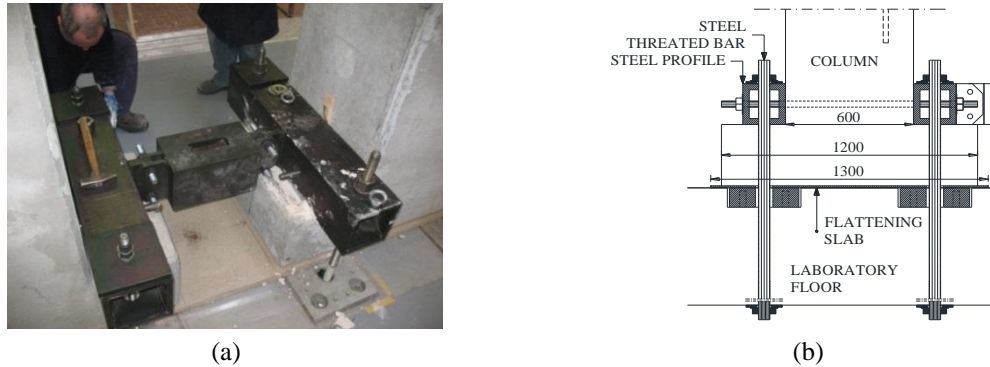
Fig. 3 Connection of the column base with the laboratory floor

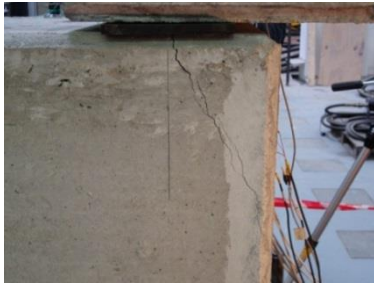
Fig. 12 First crack in the column lateral cover (West side)

The first crack appears on the column lateral surface, at the dowels depth, and it develops towards the column frontal surface (Fig. 12 and Fig. 13). The same damage pattern is observed on the two sides of the column. The crack opening is confirmed by the records of the strain gauges on the column surface (Fig. 14): at time $t=801$ sec, the strain gauge on the column lateral cover (6 in Fig. 10(a)) reaches, in the load direction, the strain (ε_{ct}) corresponding to the maximum concrete tensile strength (blue curve in Fig. 14). The failure mode and the time are also confirmed by the records of the strain gauges (parallel to the load) on the steel stirrups in the column (Fig. 15): the steel strain of the second stirrup (green curve in Fig. 15) reaches the yielding value ($\varepsilon_{y, \text{reinf}}$) few seconds before the first crack occurrence; after the crack propagates the recording strain gauge (no. 23) is damaged. The steel strain of the third stirrup from the top (no. 33, blue curve in Fig. 15) also reaches the yielding value and it shows a stirrup deformation of 0,425%; it does not get damaged,

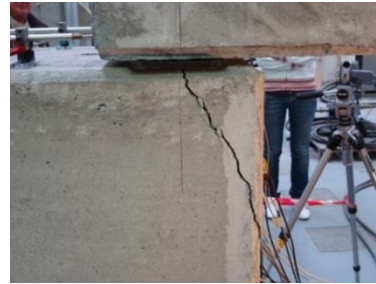
Fig. 13 Splitting of the column lateral cover (West side)

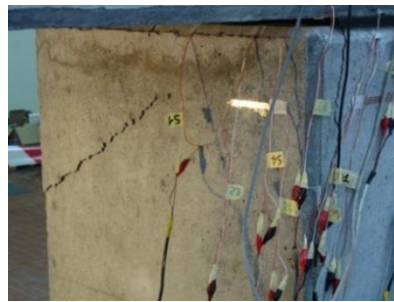
Fig. 16 Crack opening in the column frontal cover

At larger values of horizontal displacement, the lateral crack width increases and two other inclined cracks form at the column frontal surface (Fig. 16). An inclined crack also appears on the beam frontal surface (Fig. 17), with an increasing width up to the end of the experiment (Fig. 18). Also other cracks open in the column: they are parallel to the first crack and provide the expulsion of other concrete portions from the column (Figs. 19(a)-(b)). The test continues up to the complete concrete expulsion is evidenced (Fig. 20).

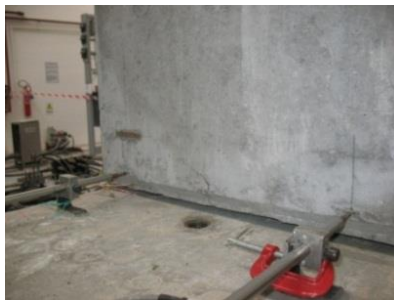
Fig. 17 Crack opening in the beam frontal cover

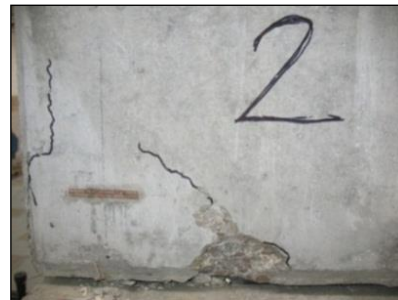
Fig. 18 Crack in the beam at the end of the test

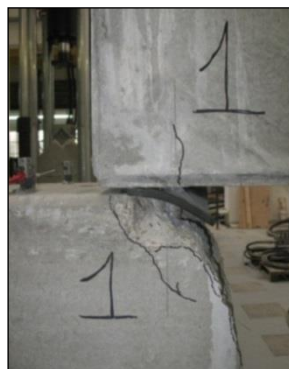
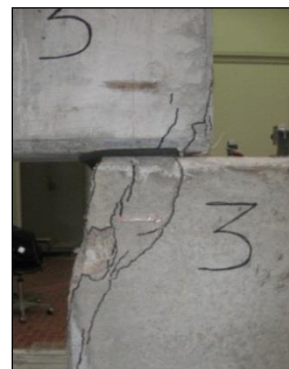
Fig. 1 Final damage state of the specimen at the end of the cyclic test

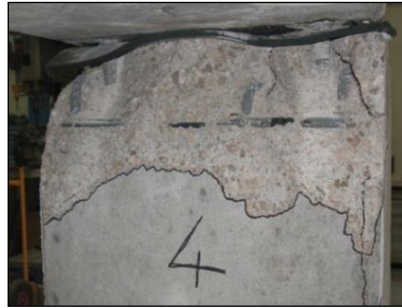
Fig. 20 Splitting of the cover at the end of the test

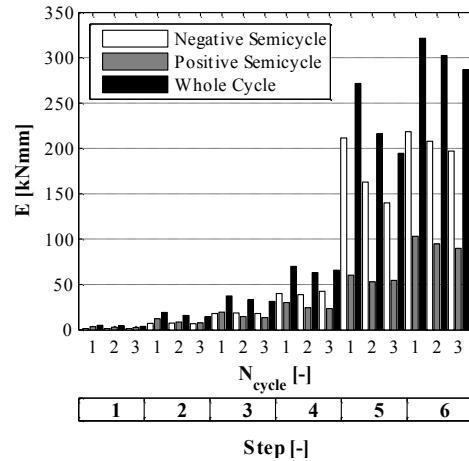
Fig. 23 Dissipated energy evaluation during the cyclic test, for the positive and negative semi-cycles and for the complete cycles, up to 6th step

Fig. 23 shows the dissipated energy during the cyclic test, evaluated as the area under the force-displacement curve. For each cycle of each step, gray bars represent the dissipated energy during the compressive loading phase (positive semi-cycle); white bars represent the dissipated energy during the tensile loading phase (negative semi-cycle). Black bars represent the dissipated energy of a complete cycle. The positive dissipated energy is quite similar to the negative one up to the third step, confirmed by the initial symmetric response of the connection, shown in Fig. 22. On the contrary, after the fourth step the negative dissipated energy is always much greater than the positive one, since the degrading behavior of the connection in the cover direction leads to higher

relative displacements in the connection at the same imposed absolute displacement with respect to the core direction. Dissipated energy of a whole cycle at each step is always greater for the first cycle due to strength reduction which occurs in each successive cycle within the same step. The low dissipated energy demonstrates the negligible influence of this kind of connection on the overall structure dissipative properties.

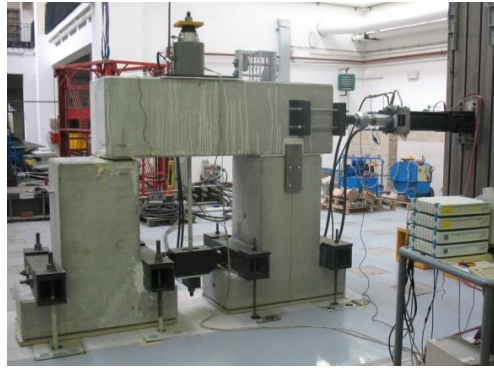
Fig. 24 Experimental setup of the monotonic shear test on a beam-to-column dowel connection

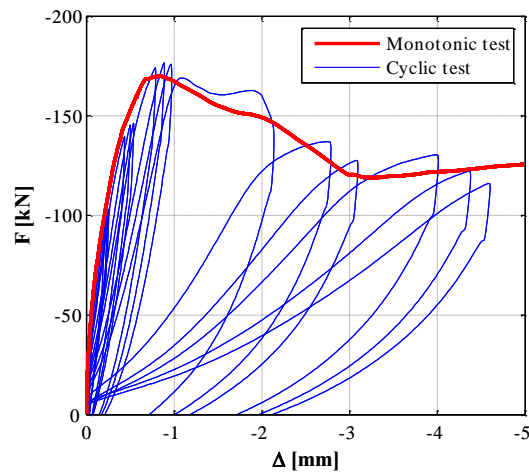
Fig. 25 Comparison between force-displacement curves: monotonic test (red line) vs cyclic test (blue line)

The results of this test are reported in Fig. 25 (red curve) in terms of actuator horizontal force and beam-to-column relative displacement. The monotonic curve, reported up to the cyclic test collapse displacement, shows a high strength degradation after the peak strength, similarly to the negative part of the cyclic curve. Moreover, the experimental evidence shows a crack at the lateral cover in the column (Fig. 26), whose appearance corresponds to the maximum value of the horizontal force of the envelope curve.

Fig. 25 shows that also the degrading branches after the failure mechanism of the cyclic and monotonic curves are very similar, even though, at this stage, the formation in the cover of the first crack and the following tensile concrete damage already occurred and the horizontal loads should be borne by the steel dowels and by the surrounding compressed concrete. This can be justified demonstrating that up to the assumed ultimate displacement value (~5 mm, which corresponds to the dash dot line in Fig. 28 for the monotonic test and in Fig. 27 for the cyclic test), the dowels are still in the elastic field of behavior and, then, their cyclic behavior does not show larger degradation with respect to the monotonic one. Indeed, during the cyclic test, the records of the strain gauge placed on the column dowel (blue curve in Fig. 27) show that the yielding steel strain

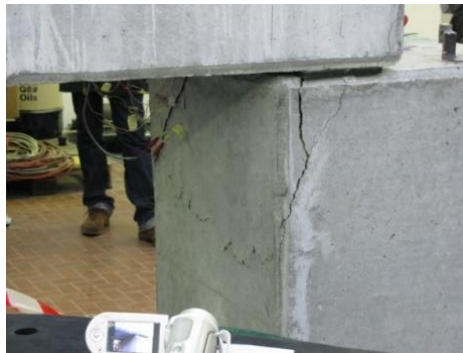
Fig. 26 Final step of the monotonic test: splitting of the concrete

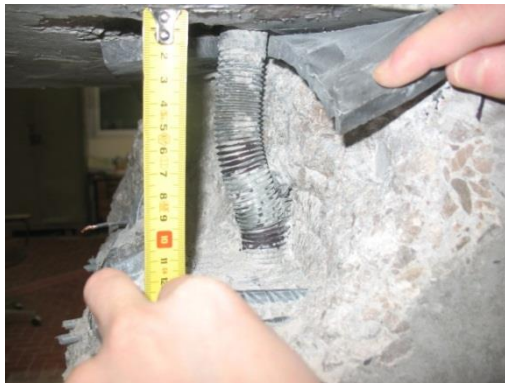
Fig. 29 Detection of the plastic hinge in one of the two steel dowels in the column at the end of cyclic test

(black curve in Fig. 27) is overpassed at a time equal to 2579s, corresponding to the 9th cycle at a displacement (Fig. 8) of ~ 8 mm (much larger than 5 mm). The considered strain gauge, located at 100 mm from the top column surface (D1 in Fig. 9(b)), is very close to the position of the plastic hinge, located at 80 mm from the bottom surface of the beam (Fig. 29).

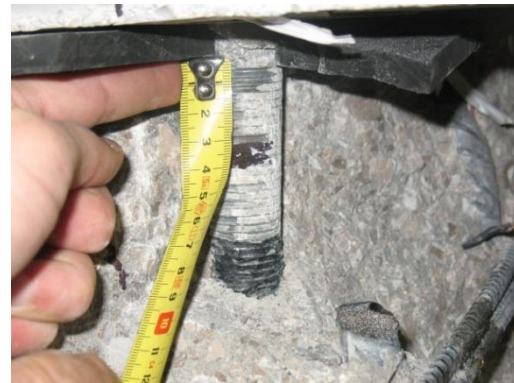
Fig. 30 Detection of the plastic hinge in one of the two steel dowels in the column at the end of monotonic test
