## Geotechnical field investigation on giresun hazelnut licenced warehouse and spot exchange

**Abstract.** This paper describes a geotechnical field investigation in Giresun hazelnut licenced warehouse and spot exchange during twelve months to determine the soil profile and static project applicability. It is also aimed to determine the superstructure loads and evaluate the relevance of foundation filling materials of the main, laboratory, package and admin buildings. The main building has  $88.50 \times 63.20$  (5593.2) m<sup>2</sup> site area. It has a big raft foundation. Eleven geotechnical reports were prepared between 2 December 2014 and 25 May 2015. Maximum settlements and safe bearing capacities were calculated to decide to be able to proceed to the next step. Also, the detail observations and evaluations were presented from October 2014 to December 2014. It has been seen that the foundation is designed as a single foundation one. But, in the light of observations, it has been evaluated that the foundation project for package building is not adequate, and after these excavations it must be revised as a raft foundation. The thickness of foundation and structural details sho

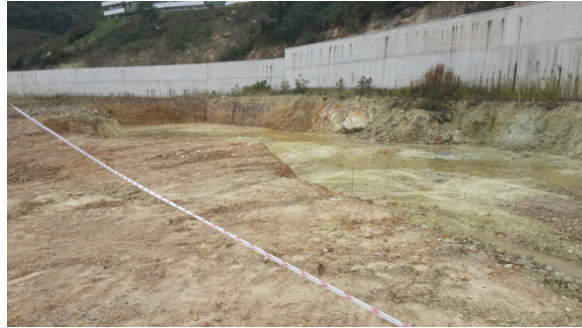
(a) Admin building

Fig. 2 Some views from the investigation in the field area on October 2014

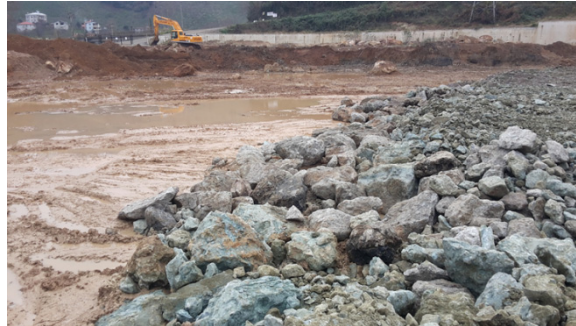
Fig. 3 Some views from the investigation at the field area on November 2014

- Admin building: The excavation is fully completed. All the filling layers are done and the plate loading tests are conducted.
- Main building: The excavation is continuing. But, the soft soil is determined at the some edge part of the main building. This region is located on the interface/border of the with package building. So, the next investigation is planned with all commissioned persons after 1-2 m excavation on this area (soft soil).
- Laboratory building: The excavation is continuing
- Package building: During the excavation, soft soil is determined. After the initial observational investigation in the field studying area, it is thought that the soft soil is located nearly about 5 m. So, the next investigation is planned with all commissioned persons after 2-3 m excavation on this area (soft soil).

Some views from the investigation on the field area are given in Fig. 3.

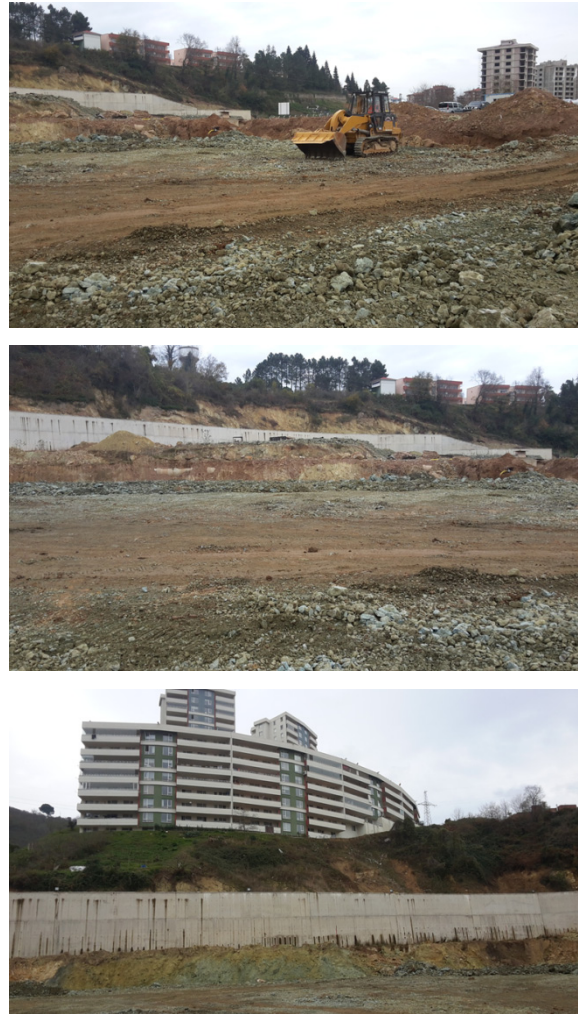
It is observed from the investigation that the excavation is fully completed on laboratory building. The first filling layer between 0-50 cm is done at some places and plate loading tests are conducted. In the superstructure loads and filling materials of foundation technical report were prepared on 3 December 2014, it is stated that *“The plate loading tests should be conducted once on each 500 m<sup>2</sup> for the silo and 3 tests for the admin building. Also, these tests should be done once on each 1000 m<sup>2</sup> for the rest.”* It is seen that the values of safe bearing capacities are suitable to proceed to the next steps. But, the number of the conducted plate loading tests are not adequate compared with the technical report.

Some views from the investigation on field area (laboratory building) are given in Fig. 4. According to the plate loading tests results, the observation report was prepared on 13 January 2015 to determine the safe bearing capacity of foundation in the first filling layer and evaluate the ability of proceeding to the next step. Also, the report was prepared again for each filling layer (laboratory building, 50-100 cm, 100-130 cm and 130-150 cm) on 13 January 2015.

Fig. 4 Some views from the investigation in the field area for the laboratory building in December 2014

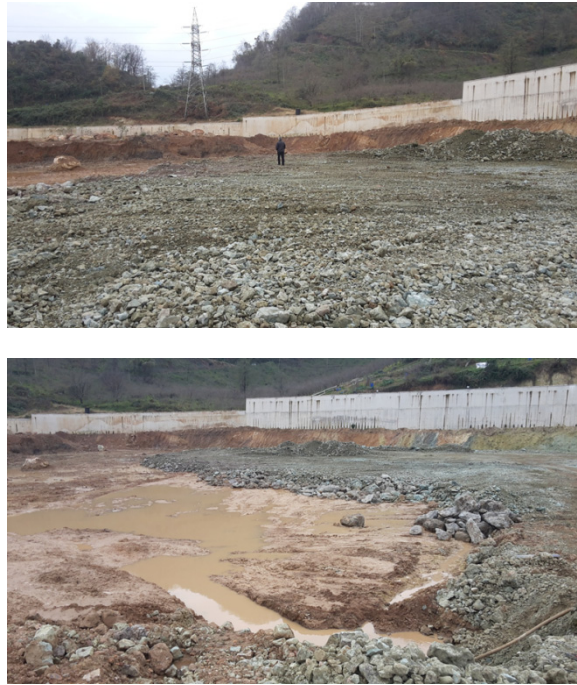
Fig. 5 Some views from the first filling layer between 0-50 cm in the main building

It is observed from the investigation that the excavation is continuing in the main building. The first filling layer between 0-50 cm is done in some places and plate loading tests are conducted (Fig. 5). In the superstructure loads and filling materials of foundation technical report, prepared on 3 December 2014, it is stated that *“The plate loading tests should be conducted once on each 500 m<sup>2</sup> for the silo and 3 tests for the admin building. Also, these tests should be done once on each 1000 m<sup>2</sup> for the rest.”* It is seen that the values of safe bearing capacities are suitable to proceed to the next steps. But, the number of the conducted plate loading tests are not adequate compared with the technical report.

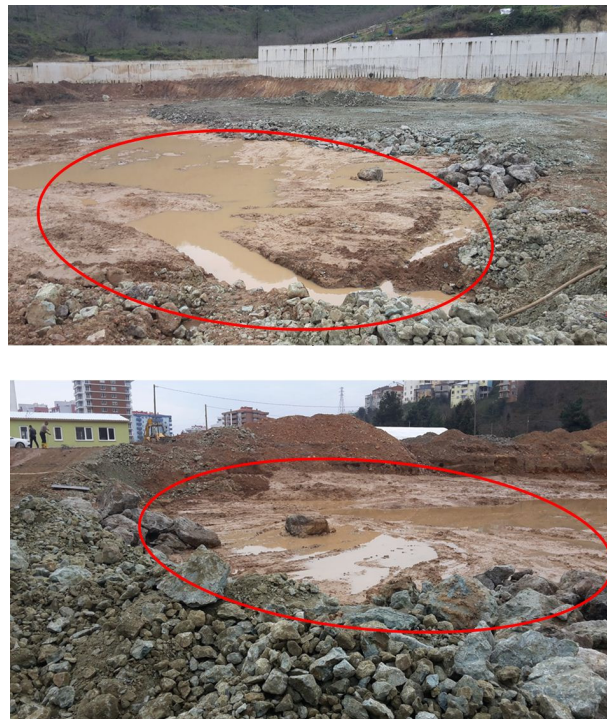
Fig. 6 Some views from the soft soil regions (front end) of the main buildings

It is observed from the investigation that some places (front end) of the main buildings have a soft soil (Fig. 6). The detail investigations are carried out with all commissioned persons and it is suggested to ensure the 50 cm support layer under 1.50 m filling layers by using of well-graded rock fill material (with a variable size distribution with a maximum rock size of 50 cm) is suggested to ensure the 50 cm support layer under 1.50 m filling layers. Before the application, the drainage system around the excavation should be done to protect the foundation soil.

- It is observed from the investigation that some places (front end) of the main buildings have a soft soil. Using the well-graded rock filling material (with a variable size distribution with a maximum rock size of 50 cm) is suggested to ensure the 50 cm support layer under 1.50 m filling layers.

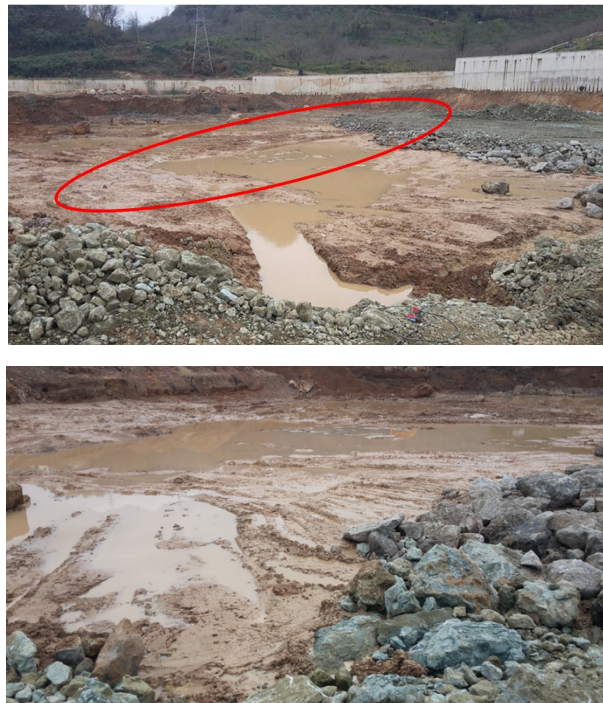
At the end of the observations, soft soil is determined at the some edge part of the main building. This region is located on the border with the package building (Fig. 7). The detail investigations are carried out with all the commissioned persons and 2.0-2.5 m excavation (this value is determined in field, observationally and can change during operation) is suggested to obtain for the sufficient foundation soil. In this region, the using of the well-graded rock fill material (with a variable size distribution with a maximum rock size of 50 cm) is suggested to ensure the 2.0-2.5 m support layer under the 1.50 m filling layers. Before the application, the drainage system around the excavation should be done to protect the foundation soil.

Fig. 7 Some views from the soft soil at the some edge part of the main building which is located on the border with the package building

- At the end of the observations, soft soil is determined at the some edge part of the main building. This region is located on the border of the package building. The 2.0-2.5 m excavation (this value is determined in field, observationally and can change during operation) is suggested to obtain the sufficient foundation soil. In this region, the using of well-graded rock filling material (with a variable size distribution with a maximum rock size of 50 cm) is suggested to ensure the 2.0-2.5 m support layer under 1.50 m filling layers.

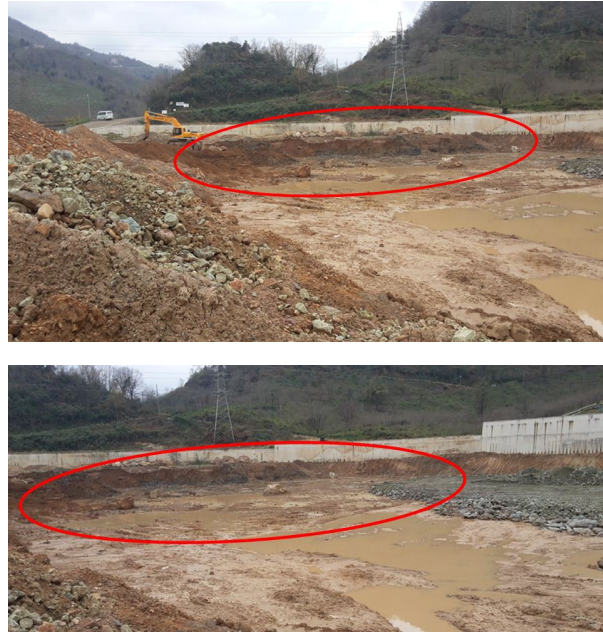
At the end of the investigation, it is seen that the package building region has a soft soil (Fig. 8). The sinking is observed during excavation by dipper dredger in the studying area (the package building). The detail investigations are carried out with all commissioned persons and 2.0-2.5 m excavation (same to soft soil of main building remarked at previous pages) is suggested to obtain

Fig. 8 Some views from the soft soil at package building

more sufficient foundation soil. Also, filling of the well-graded rock fill material is suggested under this 2.0-2.5 m excavation (nearly 3.0-4.0 m) to interlock the movements. In this application, it is aimed to ensure the sufficient support layers under 1.50 m filling layers. Before the

foundation project for the package building is not adequate after these excavations and it must be revised as a raft foundation. The thickness of the foundation and structural details (reinforced details, concrete details etc...) should be defined/drawn after analyzing the details by using a special software. Also, construction joint should be designed between different buildings interfaces such as the package, main and laboratory buildings to avoid damages and cracks in different settlements. The views of the package buildings (soft soil) are shown in Fig. 8. In these figures, the soft soil regions can be easily seen.
