Numerical study on the optimal position of a pile for stabilization purpose of a slope

Abstract. The paper describes the influence of pile reinforcement on the stability of the slope behaviour, and the exploitation of the results of in situ measurements will be conducted. In the second part, a 2D numerical modelling will be conducted by using the finite element code PLAXIS2D; in order to validate the proposed modelling approach by comparing the numerical results with the measurements results carried out on the slides studied; to study the effect of positioning of piles as a function of the shear parameters of the supported soil on the behaviour of the soil. For various shear strength of the soil a row of pile position is found, at which the piles offer the maximum contribution to slope stability. The position of piles is found to influence the safety factor in granular soil whereas it shows a slight influence on the safety factor in coherent soil. The results also indicate that the ideal position for such stabilizing piles is in the middle height of the slope. Comparison of results of present study with literature from publication: indicated that to reach the maximum stability of

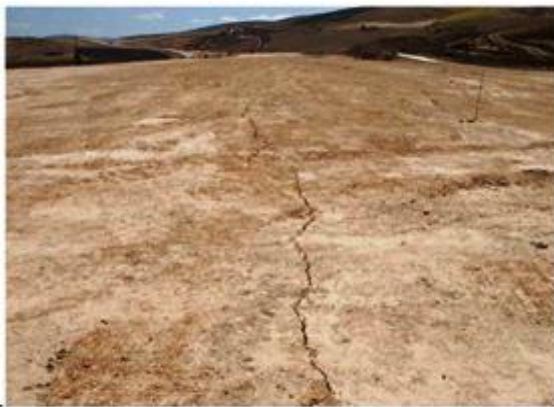
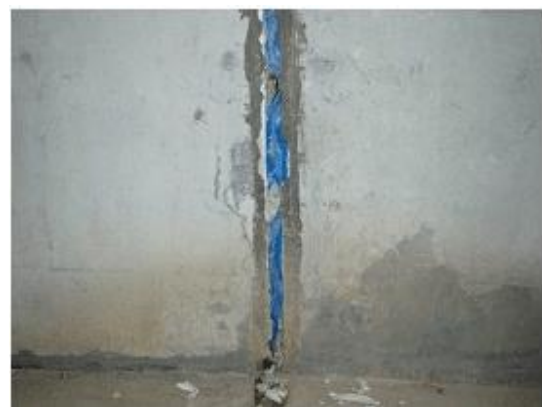
Fig. 2 Crack on the of the bank and expansion joint of OH05

expansion joint of the hydraulic structure (culvert type) (Fig. 2(b)) located at PK 211+035 is discovered. The expansion joint was below the central reserve, so it was able to start measuring the opening width of the cracks. On June 24, cracks were discovered on the body of the hydraulic structure and on the surface of the upper face of the embankment. These last cracks appeared to extend from the embankment exit (west side) to the embankment inlet (east side). The sliding line passes in the oblique direction of the road. Consequently, and based on these results, inclinometers and piezometers were installed at the entrance and exit of the road and it was started to follow with these devices.

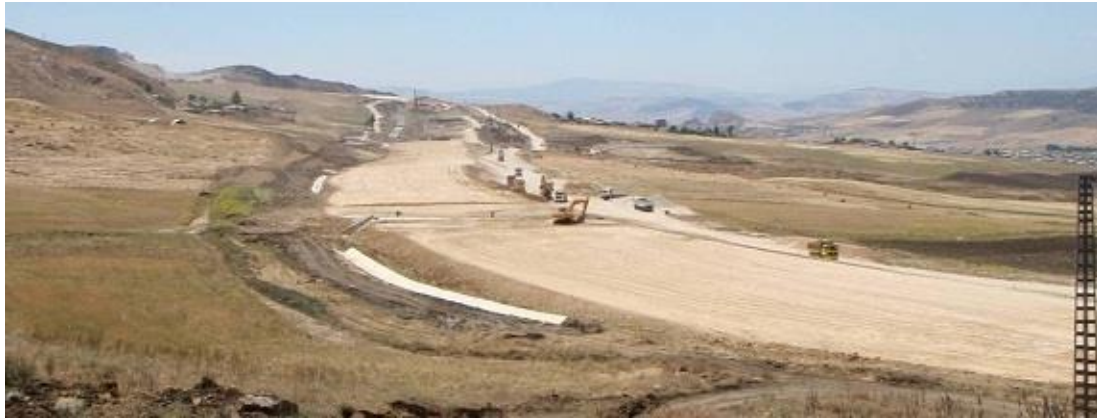
Fig. 3 The section in question

The water table is relatively high according to the preliminary investigation. Also there is movement of water down the steepest slope (Fig. 3).

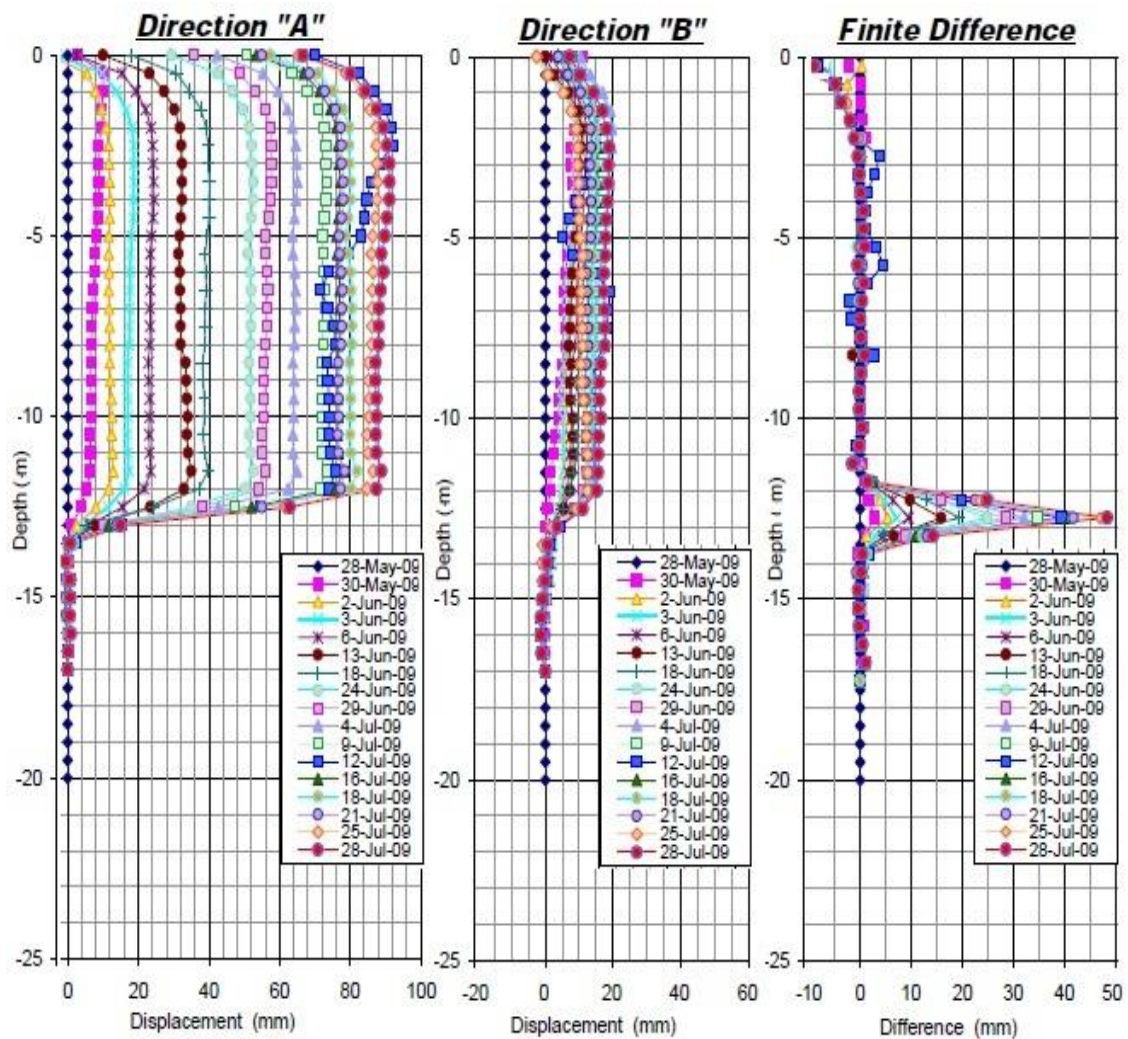
Fig. 6 Results of the measures corresponding to the Inclinometer (S4-210+480-IC02)

According to the periodic control of the inclinometer during two month (May 28 to July 28th), we have noticed that the landslide was stabilized in July 28th with a displacement. up to 89,9 mm and depth equal to 13.5 m below ground surface as shown in Fig. 6.

It should be it highlighted that the results of the inclinometer surveys, that correspond to S4-210+480-IC02 compared with the numerical results, have been obtained by the PLAXIS finite element code. The horizontal displacements according to the depth of these inclinometers are given in Fig. 6.

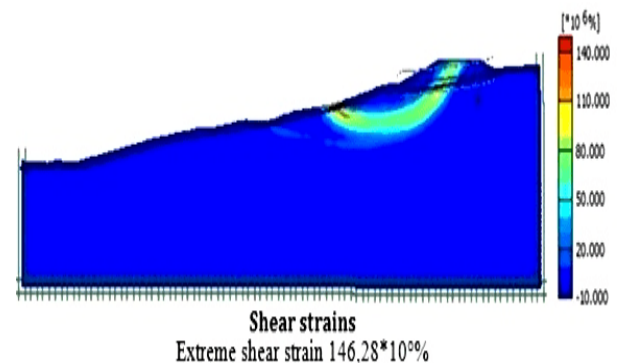
Fig. 9 Rupture surface (Shear stresses; phase ph/c reduction)

Fig. 9 shows the failure surface and the principal shear stresses in the phase ϕ/c reduction calculated by finite elements code PLAXIS 2D.

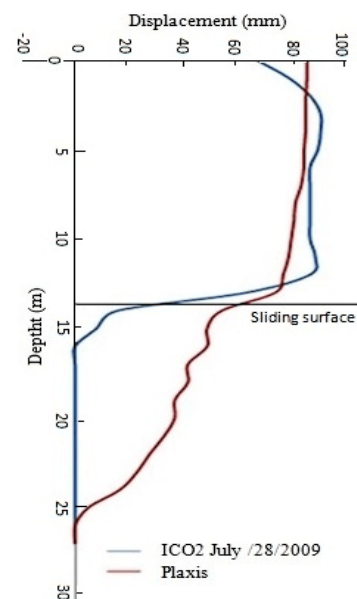
Fig. 10 Horizontal displacements (before the reinforcement)

For the purpose that the model be more reasonable and closer to reality, the horizontal displacements obtained by numerical modelling 2D are compared with experimentally results obtained by the inclinometer measurements S4 210+480-IC02 (Fig. 10).

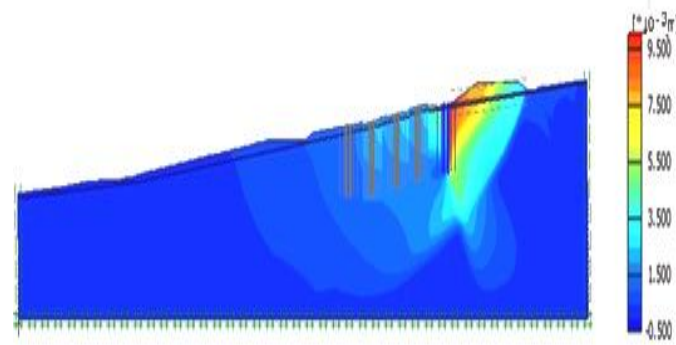
Fig. 11 Horizontal displacements with pile (9.55 mm) ($c=1$ kPa, $\phi = 8^\circ$: position $L_x/L \approx 0.25$)

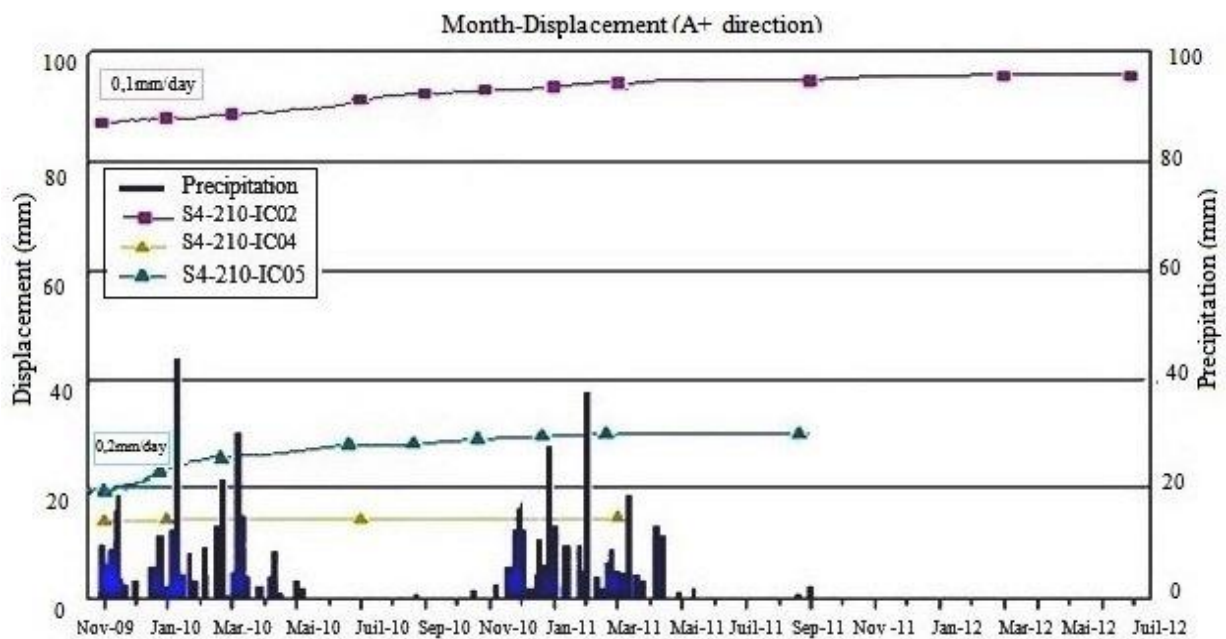
Fig. 12 Clinometridal measures of displacements

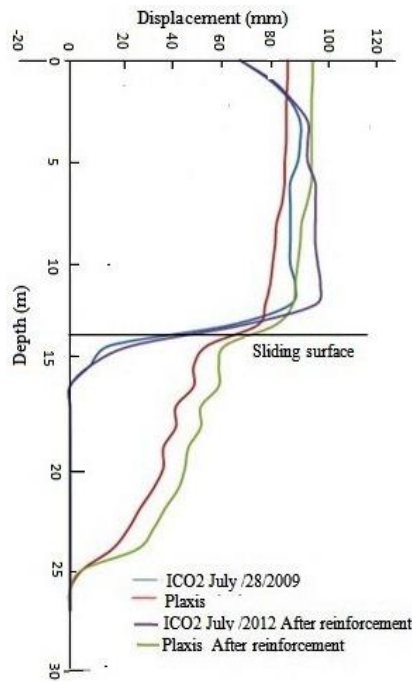
Fig. 13 Horizontal displacements(before and after reinforcement)

The figure above (Fig. 13) presents the comparison between numerical analysis (Plaxis) and the measurements

of the inclinometer S4-246-INC02, according to the direction A, before and after reinforcement of the sliding; we notice that there is a concordance between them.

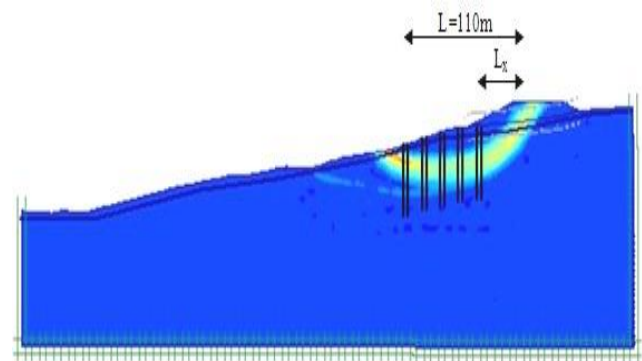
Fig. 14 Phase ph/c reduction (piles position)

Fig. 14 shows piles position (L_x/L) in the slope where L is slope length.

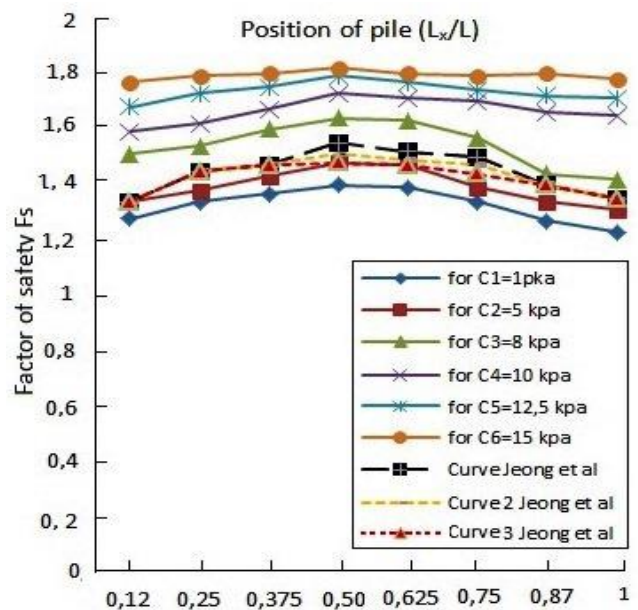
Fig. 15 Effect of pile position on factor of safety

Fig. 15 the safety factor values are given according to the (L_x/L) ratio. Results are in good agreement with that obtained by Jeong *et al.* (2003). To achieve the stability of slope, the pile must installed at the range ($L_x/L = 0.37$ to 0.62) compared with Jeong *et al.* (2003) (0.50 to 0.70).

From the figure, the values of factor of safety are higher

when the pile are located at the top of the slope than the values of the factor of safety when the pile are located at the slope toe and at the middle. By increasing the ratio (L_x/L), better amelioration in the stability of the slope is achieved. The best location of pile is when (L_x/L) is equal to 0.5 so the factor of safety reaches its maximum value (Abdelaziz *et al.* 2017, Wei *et al.* 2009).

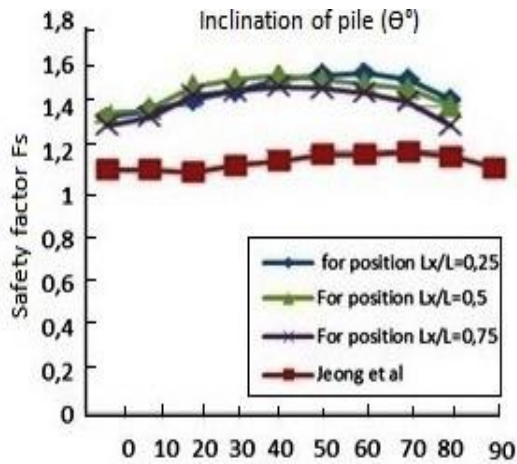
Fig. 17 Effect of pile position on factor of safety

Fig. 17 shows that the factor of safety increases with increasing of the inclination up to angle 60° because pile is

located at ($L_x/L = 0.25$ or $L_x/L = 0.5$). Then, the factor of safety decrease with increasing of the inclination over angle 50° because pile is located at ($L_x/L = 0.75$).

It can be deduced that the factor of safety increases with increasing of the inclination up to angle 70° however, it decreased gradually after that angle (Jeong *et al.* 2003).

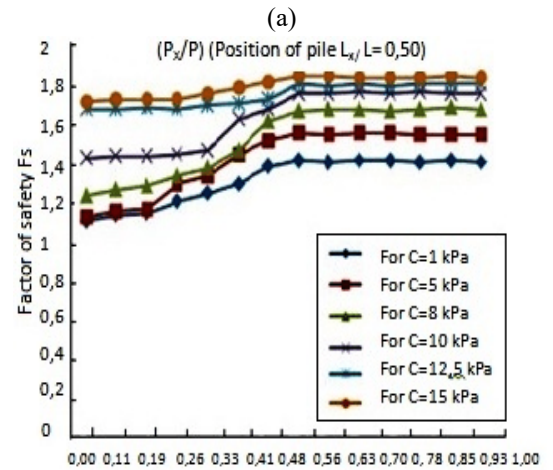
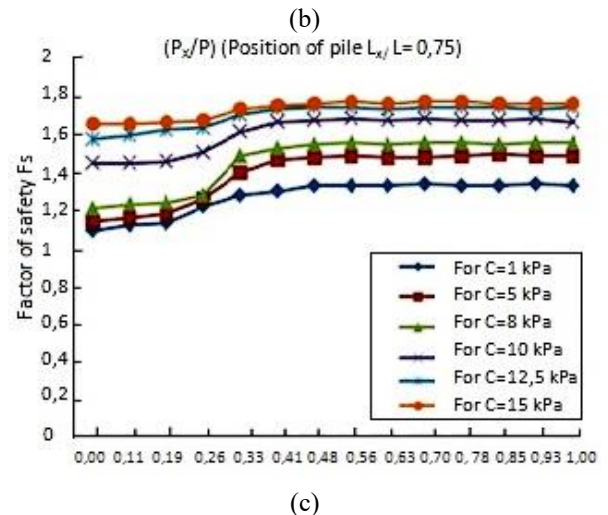
Fig. 19 Effect of pile length on factor of safety

Fig. 19(a): The factor of safety increases with increasing (p_x/p) ratio up to ($p_x/p=0.38$) because pile is located at ($L_x/L = 0.25$), because weak soils cohesion (cohesion less than 10 kN / m²). Also, the factor of safety increases with increasing (p_x/p) ratio up to ($p_x/p=0.50$) because pile is located at ($L_x/L=0.50$) as shown in Fig. 19(b).

On the other hand, the factor of safety increases with increasing (p_x/p) ratio up to ($p_x/p=0.32$) because pile is located at ($L_x/L=0.75$). However, after that ($p_x/p=0.32$) the factor of safety remained constant as the pile length ratio increases Fig. 19(c).

Pile is located at ($L_x/L = 0.5$), the factor of safety reaches the max value ($F_s = 1.39$) where it is equal to $F_s \approx 1.28$ in pile which is located at ($L_x/L = 0.25-75$) for weak soils cohesion.

Pile is located at ($L_x/L = 0.25-0.5$), the factor of safety reaches the max value compared to the pile which is located at ($L_x/L = 75$) for cohesive Soil.

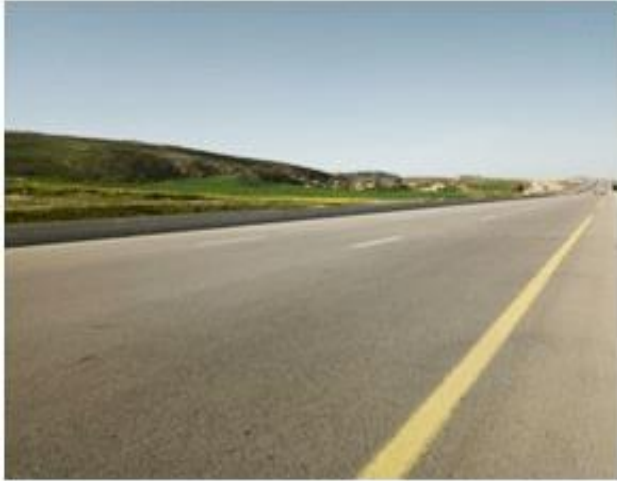
Fig. 20 The study section after the opening of the highway

- The existing slope reinforced with pile whose length is equal to 27 m ($p_x/p = 0.50$) and pile position $L_x/L \approx 0.45$ ($L_x/L = 0.37 \sim 0.62$), where the Section (PK 210+480 to PK210+800) was supported with piling wall positioned on the upper part and the middle of the slope, no cracks are detected even the highway has been put into service (Fig. 20).
