Linear regression analysis for factors influencing displacement of high-filled embankment slopes

Keywords: Liujiawan; sheet-pile wall; high-filled embankment slope; linear regression analysis

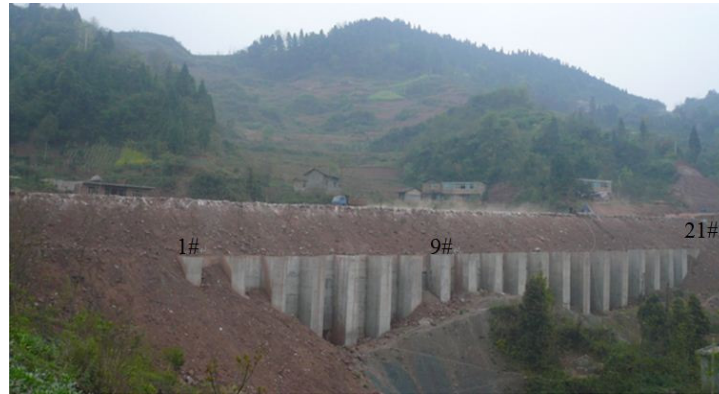
Fig. 1 The full picture after the engineering completion

Liujiawan, located in a low mountain erosion landform, is a natural slope with an average incline of 16 degrees as shown in Fig. 1. There exist two gullies which are intersected at a high-angle with the highway.

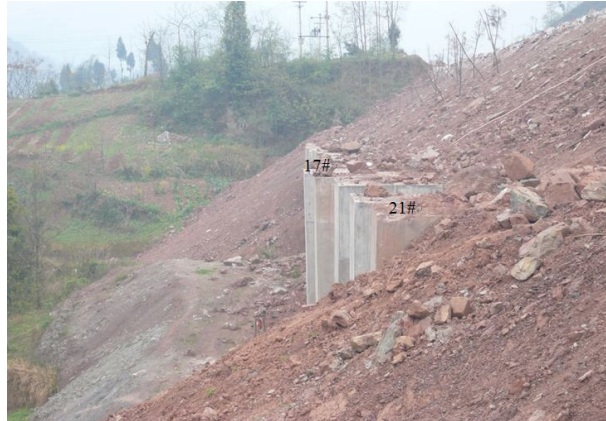
Fig. 5 The picture after anti-slide pile deformation

In early 2009, a slightly bulging deformation was found at retaining plates on the left of the embankment, therefore a deformation monitoring in the field had been carried out on the anti-slide piles since March 1st, 2009. Measured data are acquired twice in March, 5th, 2009 and April 6th, 2009. The data shows that, the horizontal displacement on the top of 6#~13# and 21# anti-slide piles were slight, while the displacements on other anti-slide piles were obvious as shown in Table 1. Especially, the accumulated horizontal displacement on 17# anti-slide pile reached 94 cm as shown in Fig. 5. All anti-slide piles deformed mainly perpendicular to the trend of highway without obvious bending deformation or dumping. It explains that the bottom of piles was not fixed successfully.

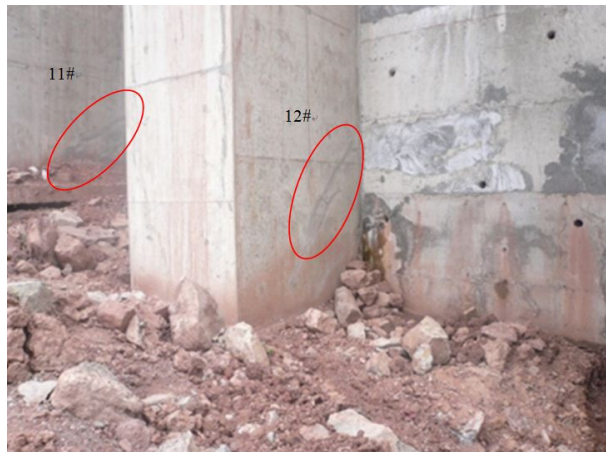
Beside the displacements, there are some cracks occurred in retaining plates between piles. Several cracks appeared on one side of No. 11 and both sides of No. 12 pile, the included angles of cracks with horizontal plate were about 45 degrees as shown in Figs. 6 and 7. In addition, there was seepage phenomenon after the rain on the retaining plate where exists the crack. These cracks indicate that shear stresses at the bottom of anti-slide pile cantilever segment are large, which lead to destruct the integrity of retaining wall, fortunately it does not go so far as to impact use normally. These anti-slide piles cracked have characteristics of a large active earth pressure, a short cantilever and a little horizontal displacement. It proves that these anti-slide piles at the bottom have the built-in effect so that the crack formed on the large active earth pressure.

Fig. 6 Crack on the lower right side of No. 11 and No. 12 pile

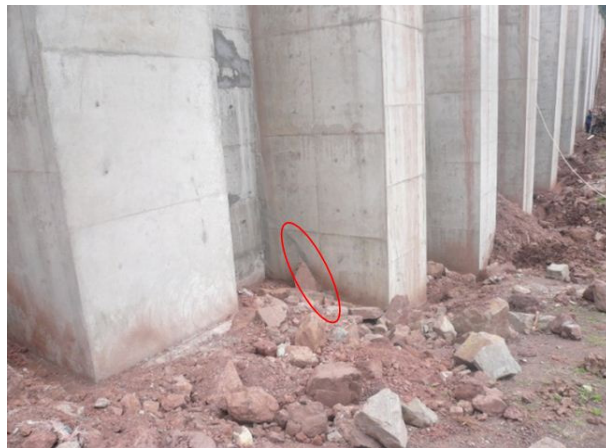
Fig. 7 Crack on the lower left side of No. 12 pile

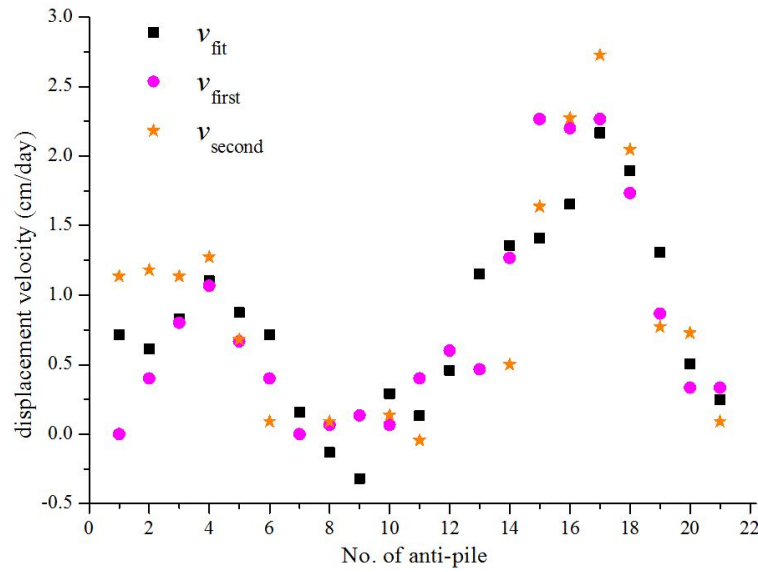
Fig. 9 Displacement velocities comparison between fit and test

In regression, the R^2 coefficient of determination is a statistical measure of how well the regression line approximates the real data points. Here R^2 equals to 0.901, it verifies multiple linear regression method is feasible. Fig. 9 also shows the comparison of fit velocities with the first and second stage velocities.
