Residual static strength of cracked concrete-filled circular steel tubular (CFCST) T-joint

M.J. Cui and Y.B. Shao *

*School of Civil Engineering, Yantai University,
Qingquan Road 32#, Laishan District, Yantai, Shandong Province, PR China, 264005*

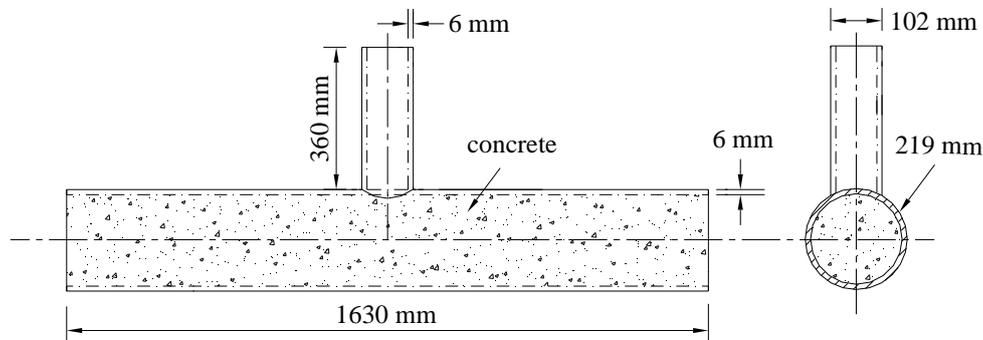
Fig. 1 Dimensions of CFCST T-joint specimen

The experimental tests are carried out on three CFCST T-joints, two of which are used to fabricate crack by fatigue test and the remaining one specimen is used for comparison. The joint parameters are demonstrated in Table 1. Fig. 1 illustrates the configuration of all the specimens.

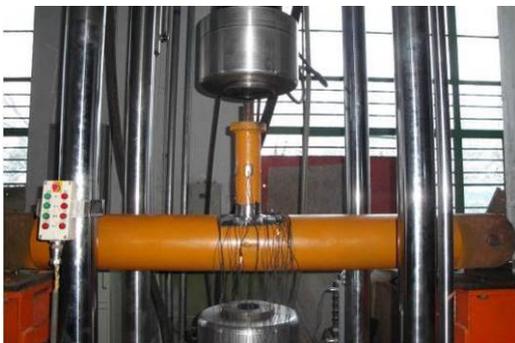
Fig. 2 View of test rig for CFCST T-joint specimen

SDS500 electro-hydraulic servo static/dynamic universal testing machine is used to perform fatigue and static tests, and it is shown in Fig. 2. During the experimental test, the boundary conditions of all the specimens are simulated as a hinge, which is gained by using steel pin to connect the ends of chord and the supports (as shown in Fig. 2). The actuator of the test rig can provide cyclic or axial tensile loadings to the specimens. The actuator can generate axial load with a magnitude of ± 500 kN or axial displacement with a magnitude of ± 75 mm. The displacement at brace end and the applied axial load to the specimens can be collected by data acquisition system automatically in the experimental process.

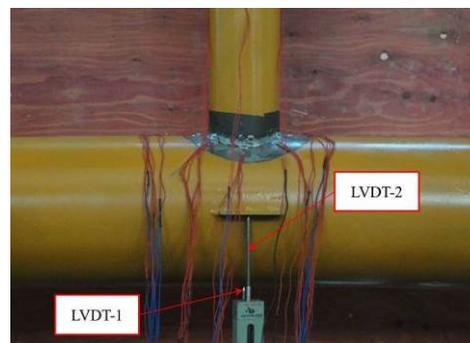
Fig. 3 Placement of LVDTs

To obtain the deformation data of the specimens accurately, two LVDTs are used to monitor the displacement of all the specimens, one of which is located at the bottom of chord, and another one is placed at the location of the neutral plane of the chord. Such placement can be found in Fig. 3. The stroke length of the transducers is 100 mm, which is large enough for measuring the displacement in the experimental test because the stiffness of the CFCST joints is remarkably large compared with the tubular joints with hollow section, which ensures that the displacement or the deformation of the CFCST joints is relatively small.

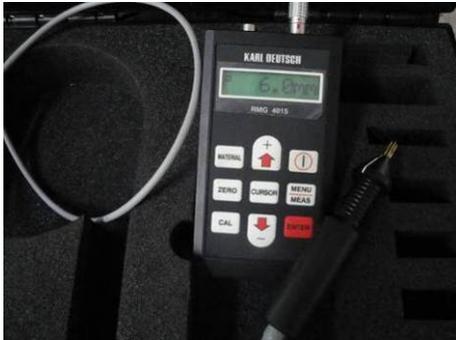
Fig. 4 RMG4015 crack depth detector

The RMG4015 detector, as shown in Fig. 4, is used to monitor the crack depth under different applied loadings. The range of the measurement is 0~99.9 mm with a precision of 0.1 mm, which is suitable for the common cracked specimens. However, the distance of the crack-depth probe is 2.5 mm, meaning that when the crack mouth opening displacement is larger than 2.5 mm, the crack depth cannot be captured.

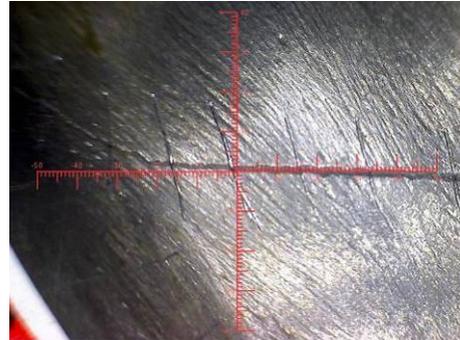
Fig. 5 Measuring interface of the digital camera

The dimensions of the crack mouth opening displacement (CMOD) are measured by using USB microscope camera which can provide high quality images to be convenient for gaining the data of CMOD. Two different magnifications can be taken to adapt to long or adjustable working distance and the precision of the instrument is 0.1 mm. The measuring interface of the camera is presented in Fig. 5.

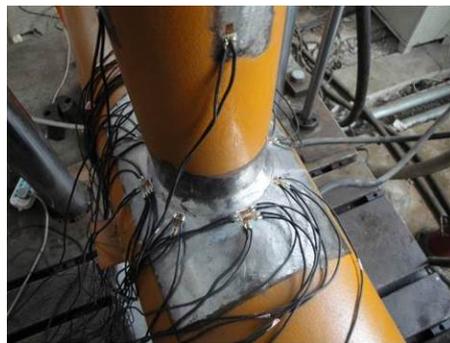
Fig. 6 Placement of strain gauges

acquisition system is used to collect the data of the strain gauges. The strain gauges are placed along the brace/chord intersection at 45° intervals as shown in Fig. 6. At each spot, two strain gauges perpendicular to the weld toe are arranged in a so-called linear extrapolation region specified in CIDECT (2000). The strains perpendicular to the weld toe (ϵ_{\perp}) can be calculated by linearly extrapolating the above two measured strain values directly. At crown and at saddle positions, two strain gauges parallel to the weld toe are also placed to measure the strains in this direction (ϵ_{\parallel}). Similarly, the strains parallel to the weld toe can also be obtained from linear extrapolation method. The stress concentration factor (SCF) at each measuring point perpendicular to the weld toe is calculated from the following equation

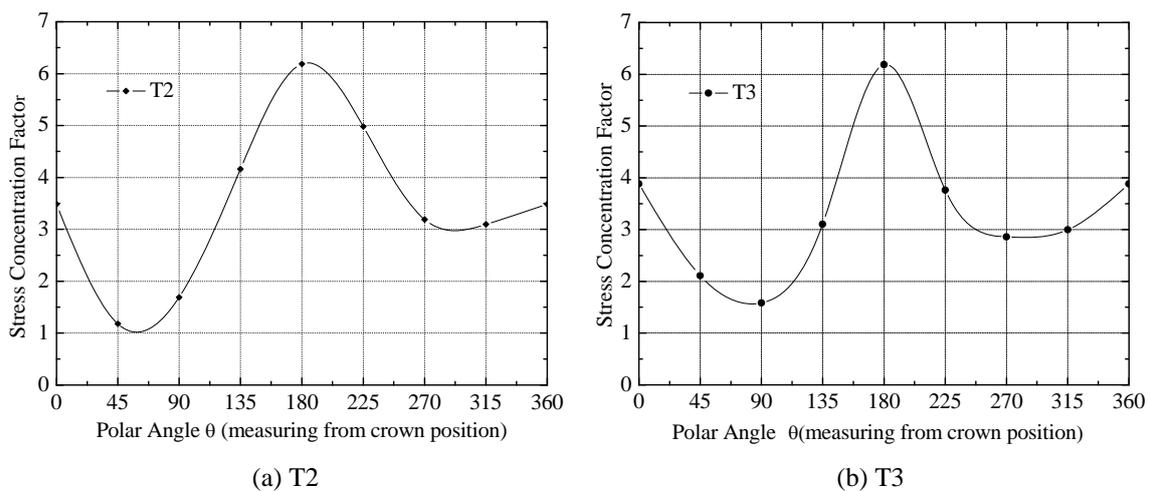
Fig. 7 SCF distribution along weld toe in the specimens

Before carrying out fatigue test, the distribution of hot spot stress along the weld toe of the specimens used for fatigue test (T2 and T3) should be determined to obtain the position of the maximum SCF, which is used to estimate the possible location of fatigue surface crack. The SCF test is conducted under the axial loading applied at the brace end with loading intervals of 12 kN in the range from 0 kN to 60 kN. Additionally, to ensure the accuracy of the calculated SCF value, the values of all the strain gauges under every axial loading are measured for three times, which are collected by the DH-3816 strain acquisition system. The average strain of the three measuring values is used for calculating the SCF from Eq. (1) in Section 3.2. Fig. 7 illustrates the SCF distribution along the weld toe, and it can be clearly found that the maximum value of SCF is located at the crown position, which indicates that the crack will initiate at this location under cyclic loadings. The peak SCF values of the two specimens are quite close since they have identical geometry and are made of same steel and concrete materials. The SCF distribution along the weld toe is not completely symmetrical, and it may be caused by initial imperfection of the specimens or different weld sizes along the intersection.

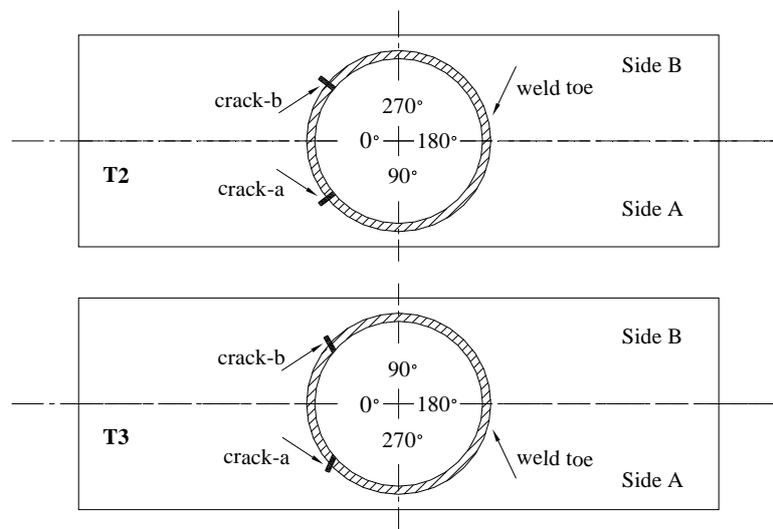
Fig. 8 Position of crack for CFCST T-joints

Specimen	Cracked position (polar angle θ)	Description (crack depth)
T2	About 30° and 330°	Side A 3.9 mm / Side B 6.6 mm
T3	About 45° and 315°	Side A 12.4 mm / Side B 11.2 mm

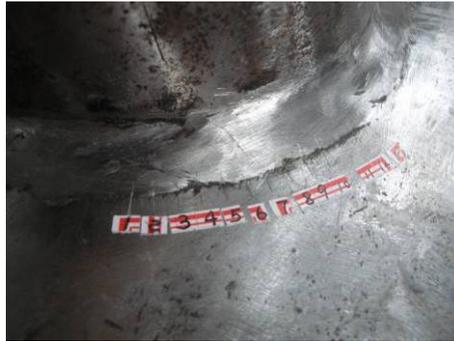
Fig. 9 Measuring points of cracked specimens

depth of cracks will be less than 14.0 mm for specimen T2, and 12.4 mm for specimen T3, theoretically. After completing the experimental test, the crack surface is not perpendicular to the chord wall from observation, indicating that the depth of the cracks can be a little larger than an estimated thickness based on the sum of the weld toe thickness and the chord wall thickness.

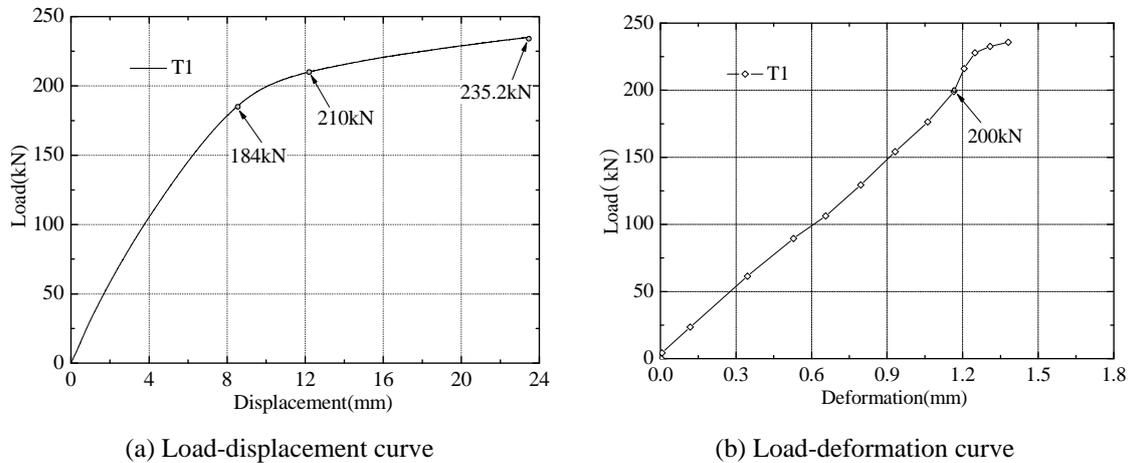
Fig. 10 Experimental curves for T1

The load-displacement and the load-deformation curves for specimen T1 are plotted in Fig. 10. The displacement in Fig. 10(a) refers to the displacement at brace end, and the deformation in Fig. 10(b) refers to the difference of the two displacements measured from the LVDTs. As can be seen from the experimental curves, the load of the specimen before reaching yield strength is fully proportional to the displacement, which represents the characteristics of the linear elastic stage. However, the stiffness of the specimen begins to decrease after the load exceeds 184 kN, and the rate of the displacement increases rapidly relative to a small increase in load. The stiffness remains stable when the load exceeds 210 kN. Therefore, it can be regarded as plastic stage of the specimen. According to the definition on the load carrying capacity of CFCST joints, the static strength of the uncracked specimen T1 is considered to be 235.2 kN. For the load-deformation curve, the stiffness in the initial elastic stage implies that the steel and the concrete can work together effectively. When the load is about 200 kN, a small jump occurs in the load-deformation curve. This phenomenon may be caused by the separation of the concrete and the steel tube at the intersection region due to the plasticity accumulation. Afterwards, relatively large deformation occurs mainly on the steel tube under continuous loading. It is noted that the entire deformation of the specimen is 1.38 mm, and such smaller value of deformation verifies the fact that the filled concrete can enhance the stiffness of the joint with hollow section.

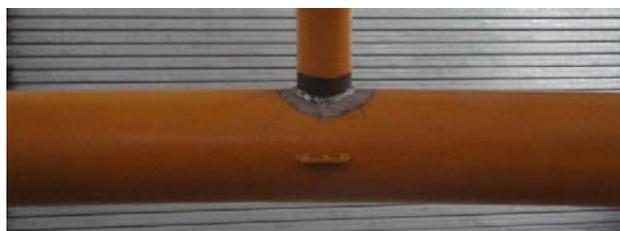
Fig. 11 Failure mode for specimen T1

The failure mode of specimen T1 is observed directly from the experimental test as shown in Fig. 11. There is no obvious deformation in the region around the intersection, indicating that only relatively small separation between the concrete and the steel tube occurs. No large separation can ensure good cooperation between the two materials and this is advantageous for improving the stiffness. Even at failure state, there is no crack observed along the weld toe in the experimental

test. However, the chord has a clear flexural deformation after the test, and such deformation cannot restore after unloading. This means large plastic deformation occurs in this specimen during the test. Hence, yielding of the chord under flexure rather than local buckling becomes the dominant failure mode of the uncracked CFCST T-joint.

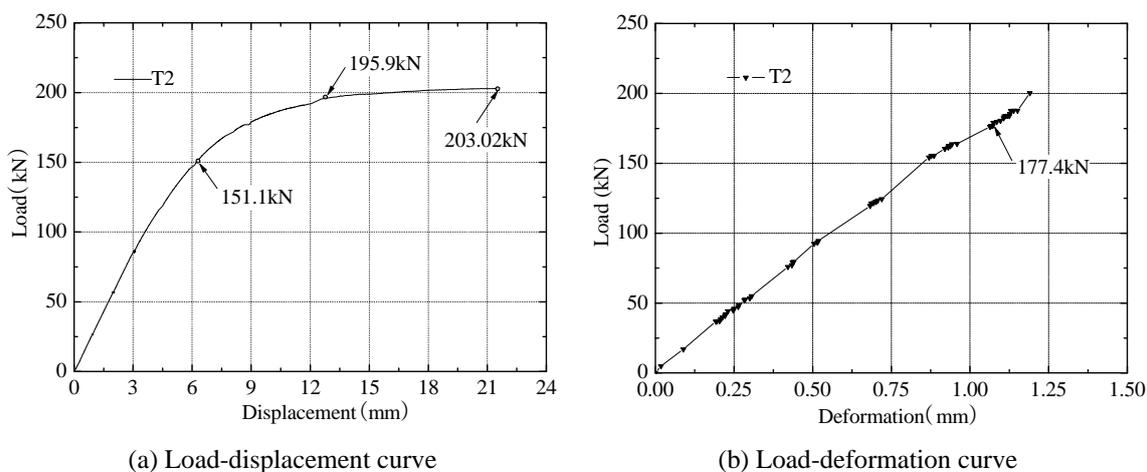
Fig. 12 Experimental curves for T2

Fig. 12 illustrates the experimental curves of the static strength testing on the cracked specimen T2. The load is linearly related to the displacement up to a load of 151.1 kN. Subsequently, the slope of the load-displacement curve is changed, and in this stage the stiffness of the specimen begins to decrease. The stiffness of the specimen is significantly small after the load reaches a magnitude of 195.9 kN. Such change may be caused by the plastic deformation formed in crack tips during the process of crack propagation. Additionally, it may be due to the crushing of the in-filled concrete around the brace/chord intersection region under the relative large applied loadings. For the load-deformation curve, the stiffness at the initial elastic stage is fully linear. In this stage the crack located at the weld does not propagate rapidly so that the stiffness of the specimen is not deteriorated severely. When the load is up to 177.4 kN, there is a drop in stiffness. The main reason is that the crack has already propagated to a large extent. Meanwhile, a separation occurs between the concrete and the steel tube at the region around the brace/chord intersection.

The global deformation of the cracked specimen T2 at final stage is 1.19 mm. According to the definition on the load carrying capacity of CFCST T-joints, the static strength of T2 is determined to be 203.02 kN.

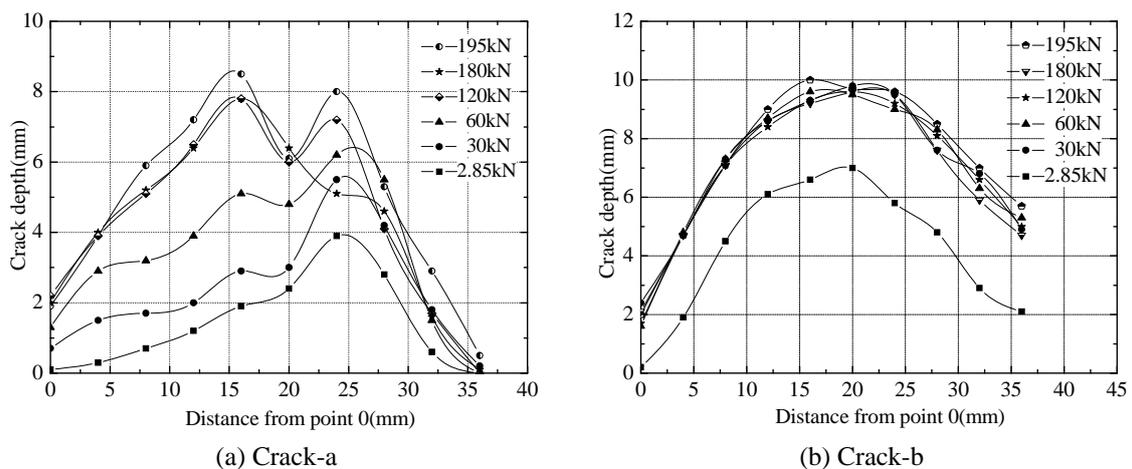
Fig. 13 Crack depth at various loads for T2 (*Note: The point 0 of the curve is the initiation point of crack-a or crack-b)

Fig. 13 shows the development of the crack depth at various loadings. As the crack occurs almost symmetrically about the crown, one of which, located at a position with a polar angle of 30°, is defined as crack-a, and the other one is denoted as crack-b. From Fig. 13, the depth of crack-a increases with the increasing of the applied axial loading until the load is up to 120 kN. As the crack depth of this specimen is relative small, the fatigue crack can propagate gradually under increasing loadings. However, there is a small increase in crack depth after the applied axial loading exceeds 120 kN. At this loading point, the crack depth in Fig. 13(a) is already larger than 6mm, which value is same to the chord thickness. Since the crack depth has not a clear increase after the load exceeds 120 kN, the crack at this time should penetrate the tube wall, and thus the crack depth cannot increase any more. For crack-b, however, there is a large increase in crack depth before reaching a load of 30 kN. The crack depth is rarely changed with the loading increase after the load exceeds 30 kN, especially for the crack depths at the measuring points within the distance of 20 mm from crack initiation (point 0). Clearly, the crack depth shown in Fig. 13(b) is bigger than 9 mm at some measuring points, and such depth also exceeds the chord thickness. The crack depth does not increase any more at some measuring points because the crack at these points may also penetrate the tube thickness.

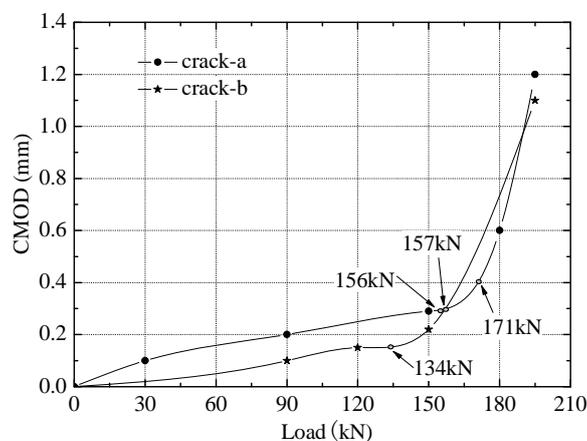
Fig. 14 Crack opening displacement at various loads for T2

Fig. 14 depicts the crack mouth opening displacement (CMOD) for specimen T2. CMOD is remarkably small when the applied load is lower, and it increases gradually with the increasing of the axial loading in initial stage. However, CMOD begins to grow rapidly after the load exceeds a magnitude of 156 kN and 134 kN, particularly 171 kN and 157 kN, for crack-a and crack-b respectively. Such increase of CMOD can be due to the fact that the crack becomes blunt. A blunted crack means large amount of plastic deformation forms around the crack tips. It is also noted that there is no drop of load in CMOD curve, meaning that plastic damage but not brittle fracture occurs.

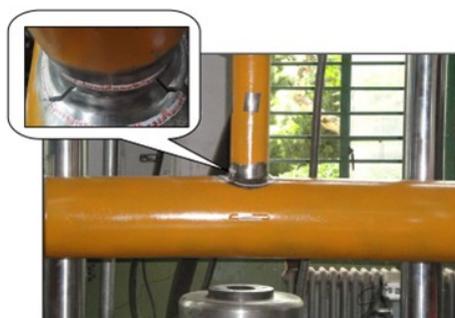
Fig. 15 Failure mode for T2

From experimental test, the failure mode of specimen T2 is shown in Fig. 15. Small deformation

around the brace/chord intersection can be found directly through observation, which is coincident with the measured deformation value. The much smaller deformation at the intersection represents that the radial stiffness of the chord is improved due to the filled concrete since a large ovalisation of the chord is the dominant deformation for a tubular joint with hollow section. The fatigue crack is located at the weld, and then propagates towards the wall of the chord. Subsequently, the depth and the opening displacement of the crack mouth extend gradually until the joint fails. For the region around the brace/chord intersection, small deformation occurs caused by cracking. Comparatively, the chord has a clear flexural deformation after the test. As such flexural deformation cannot restore after test, plastic failure of the chord under bending becomes a dominant mode for the specimen. Moreover, obvious plastic deformation can be observed at the two ends of the crack because the CMOD at the crack tips cannot recover to its original value after loading is removed. All the plastic deformations of the specimen T2 ensure the cracked joint has a good ductility before fracture.

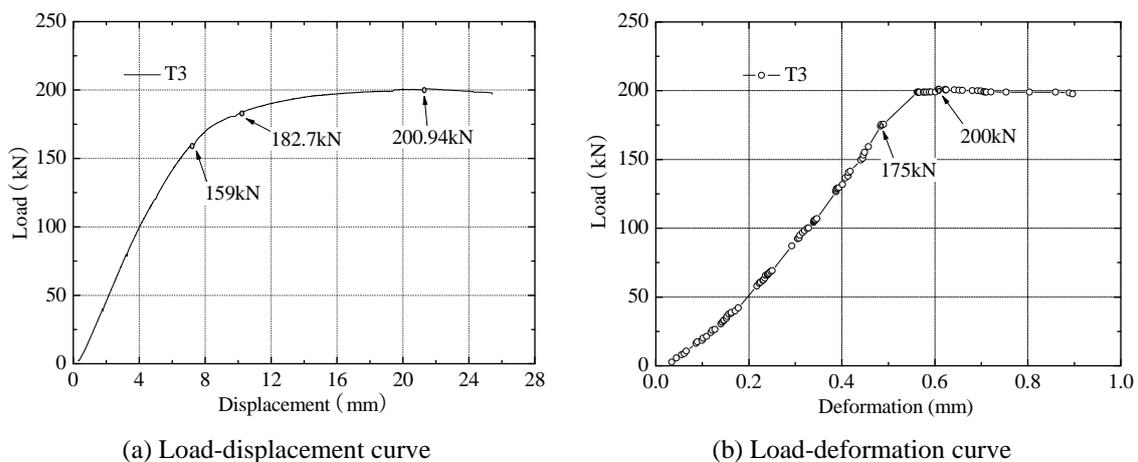
Fig. 16 Experimental curves for specimen T3

After carrying out the static test on specimen T3, the load-displacement curve and the load-deformation curve are obtained completely, and they are plotted in Fig. 16. The results show

that the stiffness of the specimen is not changed before the value of a load attains to 159 kN. Thereafter, the stiffness decreases gradually as the applied axial load increases. In this stage, the joint enters a yielding state. Once the value of the load exceeds 182.7 kN, the stiffness of the joint is rarely varied any more. After reaching the maximum load with a magnitude of 200.94 kN, the joint is unable to carry loading any more. Hence, the residual static strength of specimen T3 is defined as 200.94 kN.

In the deformation curve, the load is linearly related to the deformation in initial stage. Such linearity indicates that the filled concrete and the steel tube can work together effectively, and no separation between the two materials. The stiffness of the joint declines after the load reaches 175 kN. Such stiffness reduction may be caused by the separation of the concrete and the steel tube at the brace/chord intersection, or may be due to the concrete crushing. In final state, the overall deformation of specimen T3 is only 0.9 mm, and such small value also proves the fact that the radial stiffness of the chord is improved greatly by filled concrete.

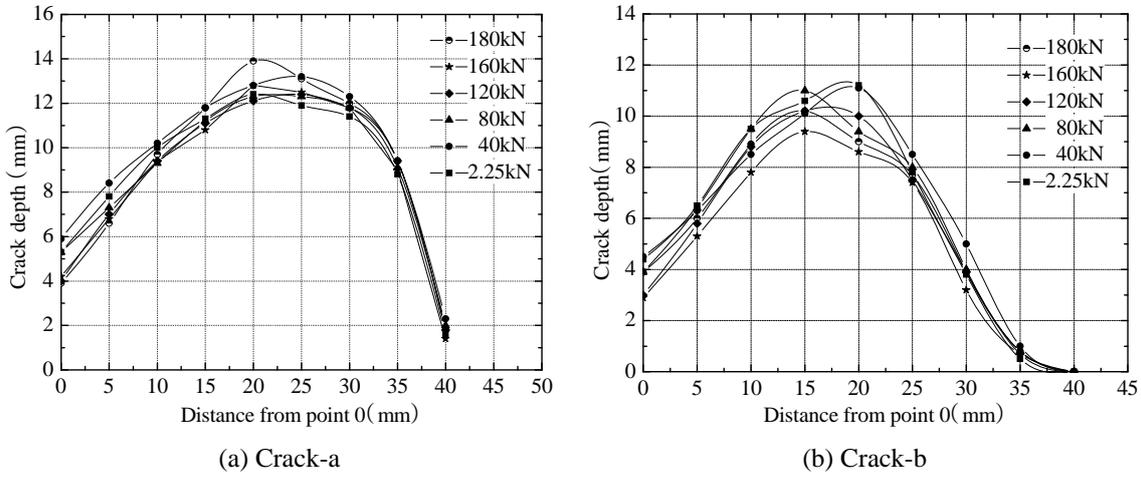
Fig. 17 Crack depth at various loads for T3 (*Note: Point 0 of the curve is the initiation point of crack-a or crack-b)

The process of crack propagation is recorded under various loadings in the experimental process. As two cracks initiate almost symmetrically about the crown position with polar angles of 45° and 315° respectively, they are also named as crack-a and crack-b respectively. Fig. 17 shows the crack depth development at various loadings. It is clearly found that the crack depth increases gradually with the load increasing, and it is mainly caused by the extension of crack towards to the wall-thickness direction of the brace. For the measuring points within a distance of 30mm from crack initiation (point 0) for crack-a, the crack depths at these points are greatly influenced by the increasing of the axial loading. For crack-b, such distance is about 25 mm. However, the crack depths of all the remaining measuring points along the crack length are scarcely affected by various loadings. Similarly, it should also be focused on the fact that the crack depths at several measuring points on the chord wall are already larger than the thickness of the chord wall. This means the crack at some positions has already penetrated the chord wall, and the crack depth cannot increase any more at these positions.

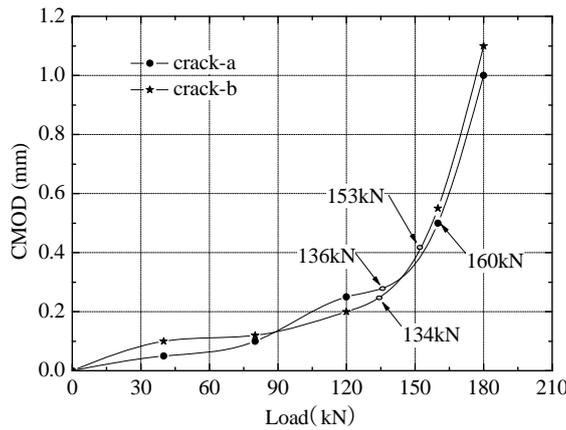
Fig. 18 Crack opening displacement at various loads for T3

Fig. 18 illustrates the crack mouth opening displacement (CMOD) for specimen T3. CMOD grows slowly as the applied load increases when the value of the load is less than 136 kN for crack-a and 134 kN for crack-b respectively. However, the CMOD increases suddenly after the

load is beyond 160 kN for crack-a and 153 kN for crack-b. This phenomenon demonstrates that a large amount of plastic deformation at the crack tips forms, and the cracks begin to be blunted. No loading drop in the curve proves that this joint fails in the form of plastic strength damage rather than sudden brittle fracture.

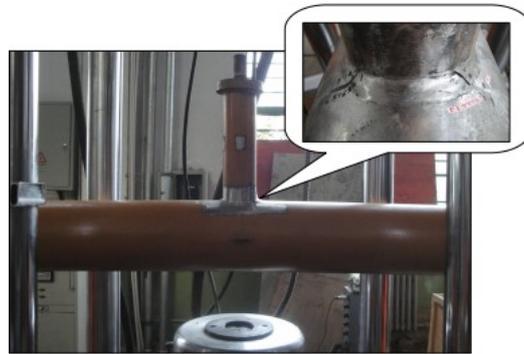
Fig. 19 Failure mode for T3

Fig. 19 depicts the failure mode of specimen T3. Similarly to the specimen T2, the overall deformation of specimen T3 is also considerably small, and only smaller local deformation can be found at the brace/chord intersection on the chord surface. For specimen T3, the crack hardly propagates in the tube wall-thickness direction because it already penetrates the tube wall at some positions.

Furthermore, plastic deformation is observed both in the chord and at the crack tips. The final failure mode is shown in Fig. 19. The chord still behaves like a flexural beam since local deformation of the chord in radial direction is much smaller compared to the global flexural

deformation of the chord. A large plastic flexural deformation still exists after the applied load is removed. Accordingly, CMOD cannot restore to its original value after unloading, which means that there is also plastic deformation at crack tips. In overall, specimen T3 has plastic strength failure rather than brittle fracture failure from experimental observation.

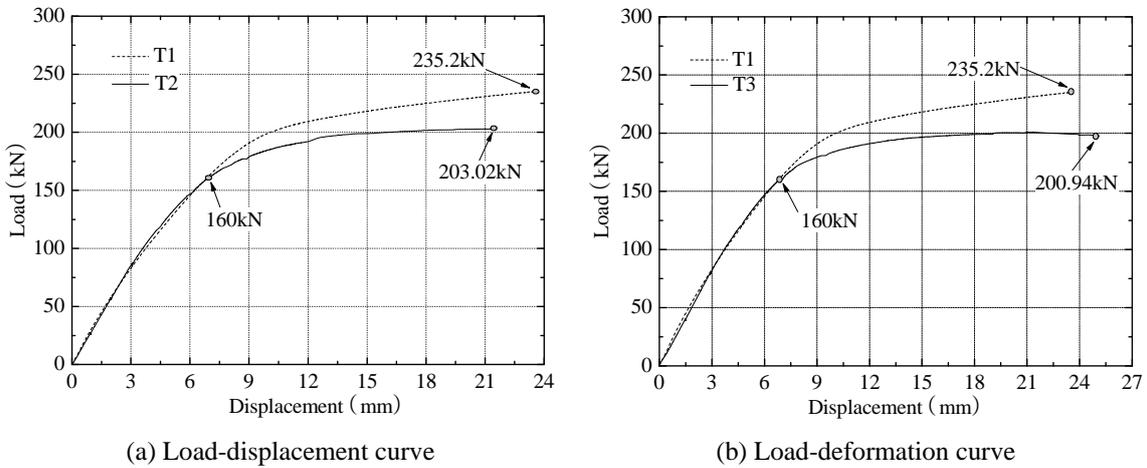
Fig. 20 Load-displacement curves

To study the effect of fatigue crack on the static strength of CFCST T-joints, the load-displacement curves of both cracked and uncracked specimens are analyzed. Fig. 20 illustrates the load-displacement curves of all specimens. It can be seen that the stiffness of the cracked specimens and the uncracked specimen agree very well in initial stage within the load of 160 kN. In this period, the stiffness of the cracked joints is not influenced by the fatigue crack greatly. However, when the axial load exceeds 160 kN, the stiffness of the cracked specimens is different from that of the uncracked specimen. The stiffness of the specimen without crack is larger than that of the specimens with crack. This difference may be possible due to large CMOD and amounts of plastic deformation at crack tips.

From the load-displacement curves, it can be clearly seen that the load carrying capacity of specimens T1 and T2 are 235.2 kN and 203.02 kN respectively. The magnitude of static strength reduction for specimen T2 is up to 13.7%. While for specimen T3, the static strength of the joint is 200.94 kN, which is reduced by 14.6% compared with that of the uncracked specimen T1. In overall, existence of fatigue does not affect the stiffness in linear and elastic stage, but it really deteriorates the static strength. It seems that the fatigue crack does not change the failure mode of CFCST joints although crack may cause steel material to become much brittle around crack front. However, this conclusion is only suitable for Q235B steel because this material has good ductility based on the Charpy test. It is still necessary to conduct further study on investigating the effect of

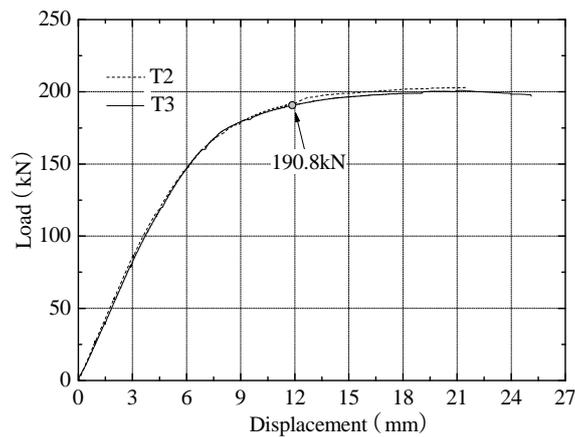
Fig. 21 Comparison of load-displacement curves for cracked specimens
