Fatigue tests of damaged tubes under flexural loading

Abstract. Despite the proliferation of the industrial application of steel tubes, the effect of collision on the surface of steel tubes subject to cyclic loading has largely remained untouched. This paper studies the fatigue behavior of steel tubes which are impacted by an external object. A dent imperfection caused by a collision was modeled and fatigue tests were conducted using a MTS machine. Fatigue life as well as the failure modes were thoroughly discussed in a way that the fatigue life of the dented tubes with similar geometrical specifications at full-scale can be generalized.

Keywords: thin tubes; fatigue life; dent and collision; failure mode

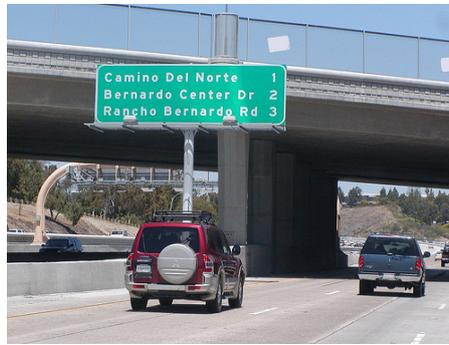
Fig. 2 Tubular members in overhead traffic signs

Steel tubes are extensively used as structural members in civil and mechanical engineering structures. Cyclic loading may expose these elements to fatigue failure in many industrial applications. On the other hand, these structures are often unprotected against external collisions during their service life. This issue motivated the authors to investigate the possible adverse effect of damage on the fatigue life of these structures under in-plane bending. Two different instances of the application of these tubular members are presented in Figs. 1 and 2 in which cyclic bending caused by wind loading can make such structures vulnerable to fatigue failure.

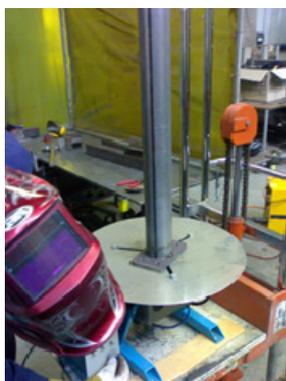
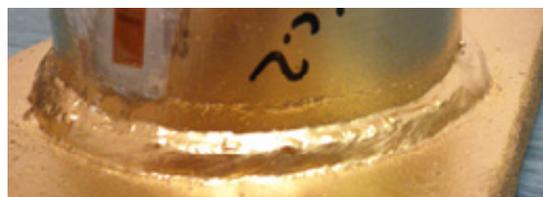
Fig. 4 (a) The rotating machine for welding; (b) a welded specimen

Specimens of initially identical geometry were made of ERW mild steel circular hollow sections with D/t ratio of 47.6 (see Table 1) which are extensively used as structural elements. Before the welding of the specimens to the end plate, one end of the tubes was machined to ensure that it was perpendicular to the plate. A rotating welding machine was employed in order to achieve a high-quality welding (Fig. 4).

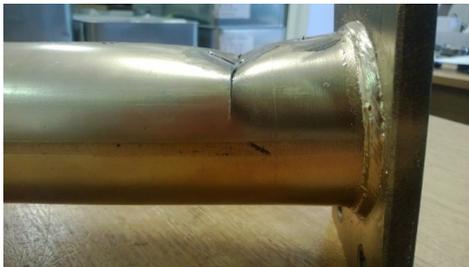
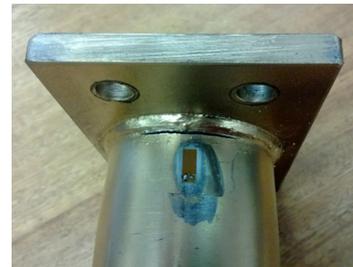
Fig. 13 (a) Fatigue crack at the edge of the dent for CLC.5; (b) tension crack at the bottom of CLC.5

called DWF. For this mode of the failure two cracks were initiated at both ends of the dented area followed by a third crack which developed at the tension side of the weld-toe (see Figs. 12 and 13). Accordingly, two areas of the specimen were affected by the fatigue crack. It is noteworthy that there was an interesting movement of the dented area under cyclic loading such that the dented area moved towards the inside of the tubes when the specimen was loaded and recovered when the loading was released. With the cyclic load frequency of 3 Hz this mode was fairly similar to the beating of a heart with a regular rhythm. Thus, the pre-failure phase of the specimens was referred to as *Heartbeat Mode* to provide an insight into the deformational mode of the dented tubes.
