Modal parametric changes in a steel bridge with retrofitting

Abstract. This paper presents the status improvement of an old damaged deck type rural road steel truss bridge through the modal parametric study after partial retrofitting. The dynamic and static tests on bridge were carried out as in damaged state and after partial retrofitting. The dynamic testing on the steel bridge was carried out using accelerometers under similar environmental conditions with same speed of the moving vehicle. The comparison of the modal parameters i.e., frequency, mode shape mode shape curvature, modal strain energy, along with the deflection parameter are studied with respect to structural analytical model parameters. The status up gradation for the upper and downstream truss obtained was different due to differential level of damage in the bridge. Also after retrofitting the structural elemental behavior obtained was not same as desired. The damage level obtained through static tests carried out using total station indicated further retrofitting requirement.

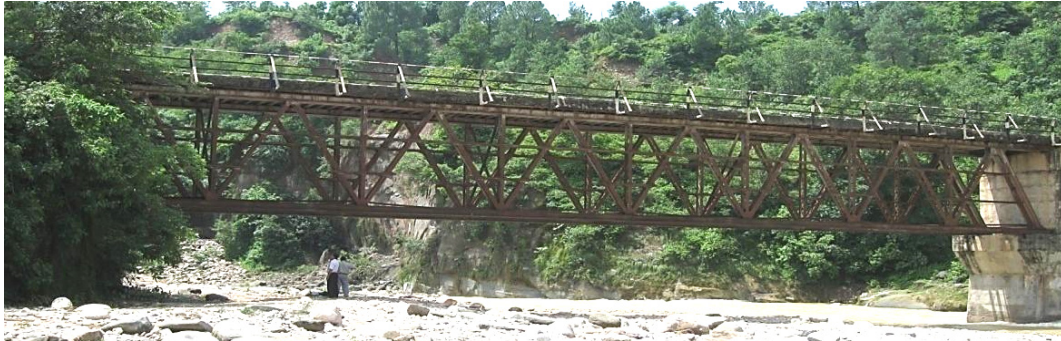
Fig. 2 Steel truss Bridge of span 47.90 m over BathuKhad

The bridge under consideration was constructed in the year around 1920, as enquired from the local people of the area (Fig. 2). The bridge was built by the British Company named as Dorman

Long & Company Limited, Middlesbrough, England on National Highway 20 on Bander Khad near the village Samloti Himachal Pradesh, India. The company had their stockyard at Karachi (now in Pakistan) and their head office was at Clive Street, Calcutta, India. The steel sections used were as per British Standard specifications of 1903. These were imported at the Karachi Stock yard and could have assembled at the site (Constructional Department 1906).

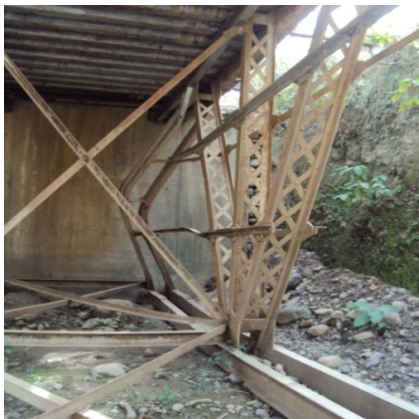
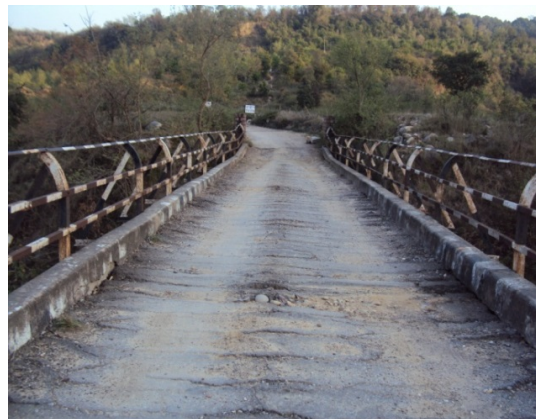
Fig. 3 Damaged bridge members and deck of steel truss bridge

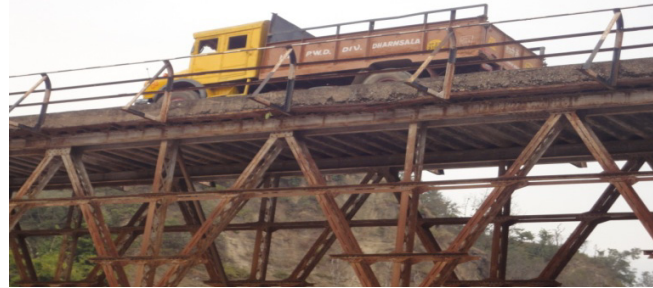
Fig. 5 Truck load of 9.56 tones at centre

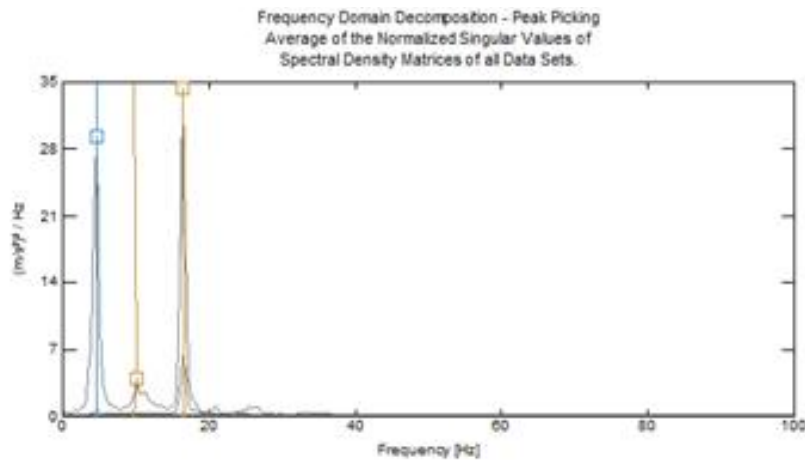
Fig. 8 Typical output from frequency domain decomposition algorithm

The modal parameters can be extracted by various methods (Doebling *et al.* 2003, Avitabile 2003). The digitized output signals generated by the data acquisition system are given as input. But, the accuracy of extraction of frequency and modal shape depends on the signal to noise ratio (Alampalli *et al.* 1997). Alongwith with various other limitations the extraction of modal parameter are also based on the availability of resources. In the present study, in order to determine the modal properties of the structure from the recorded data ARTeMIS (2004) was used. The natural frequencies of vibration and associated mode shapes were determined from measured responses using Frequency Domain Decomposition algorithm of this software (Altuni *et al.* 2010). The Frequency domain decomposition algorithm provides the normalized mode shapes for each set of the time history. Typical output of the structural frequencies obtained from the Frequency Domain Decomposition algorithm of ARTeMIS software has been shown in Fig. 8. The typical input in the ARTeMIS software is to assign nodal coordinates in the structure, member connecting the nodes, details of the files containing recorded data, which in this case is acceleration time history, direction of the installed sensor during testing which give the information to the software that whether record generated by the sensor is in phase or 180 degree out of phase with the direction of the motion of the structure and master slave node condition considered in the model. The master slave condition involves the dependency of the movement of the non-measured node on the measured nodes.

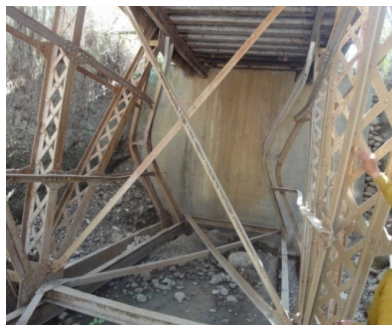
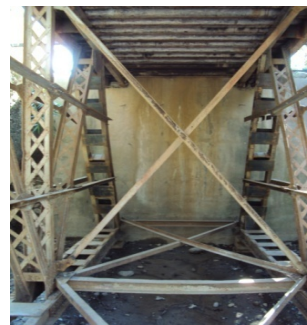
Fig. 10 End members before and after retrofitting

Although the road is a village road and traffic intensity is low and still the bridge was strengthened for Class A loading. As the end members have buckled due to overstress. Hence members were replaced with same section to strengthen the structure (Fig. 10). In order to hold the main component of the built-up section in their relative position and to equalize stress distribution (Subramanian 2008), the end members were further strengthened by stiffening with 300 mm \times 10 mm thick plate at a spacing of 30cm c/c. The horizontal stiffener of angle section 75 mm \times 75 mm \times 10 mm at a height of 1.35 m from the bottom longitudinal member has been provided as additional member.

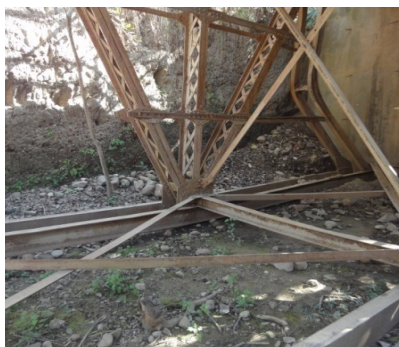
Fig. 12 Bottom members before and after retrofitting

The bottom longitudinal members were straightened and stiffened with steel plate of 300 mm \times 10 mm size as shown in Figs. 11-12. However the replacement of damaged Deck plates and retrofitting of top longitudinal member is still pending and owner agency is on the Job.

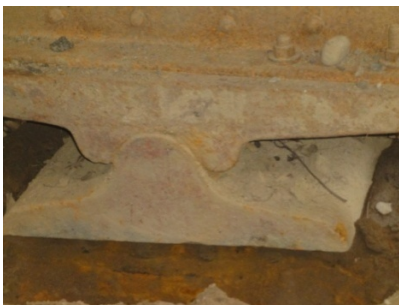
Fig. 13 Bearings before Retrofitting and after retrofitting

The roller bearing provided towards the Chughera side have become fixed as the earthsoil has been filled up in the rollers. The load was relieved from the bearings by jacking the superstructure and temporary support system was introduced. Since Rocker and rollers were in good condition hence same bearings were used after clearing the soil deposits. The rollers of bearings were reset at correct alignment. The base plate was replaced with new one. Fig. 13 shows the status of bearings before and after retrofitting. The state Public Works Department carried out the retrofitting of the bridge and the bridge was restored for traffic after partial retrofitting to avoid inconvenience to local residents.

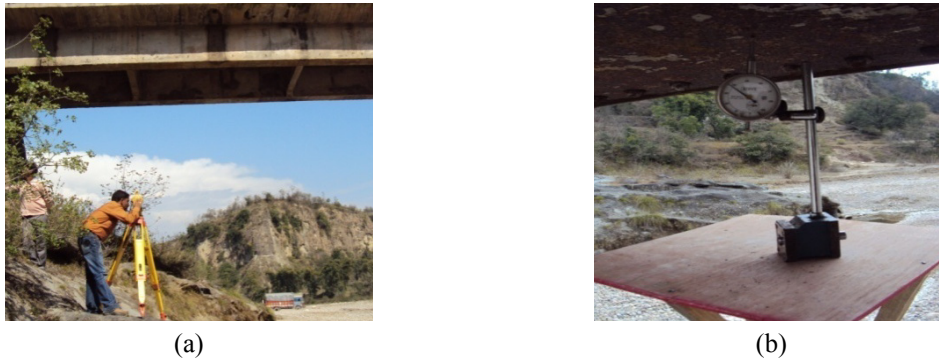
Fig. 14 Deflection measurement using: (a) Total station; (b) Dial gauge

The variation in the applied forces leads to different amplitude of displacement in the structure. In the present study displacement has been measured at different nodes by moving the truck along the span. The vertical deflections are significant and can be measured with Total station while vehicle is moving on bridge (Jauregui *et al.* 2003). The displacements were measured at different nodes on both upstream and downstream side when the truck was placed at centre of span (Figs. 14(a)-(b)).

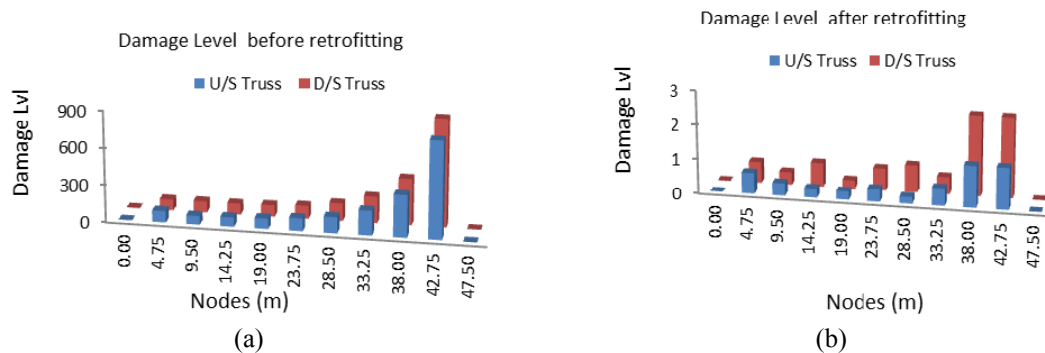
Fig. 17 (a) Damage level before retrofitting; (b) Damage Level after retrofitting

The damage level at span 38.0 m and 42.75 m was more than other nodes even after retrofitting and shows flexibility at these nodal points which is not evident from visual inspection. The damage level of downstream truss is higher than that of upstream truss both before and after retrofitting (Figs. 17(a)-(b)). However for both trusses of the bridge the damage level decreased drastically after retrofitting irrespectively of the damage level (Figs. 18(a)-(b)).

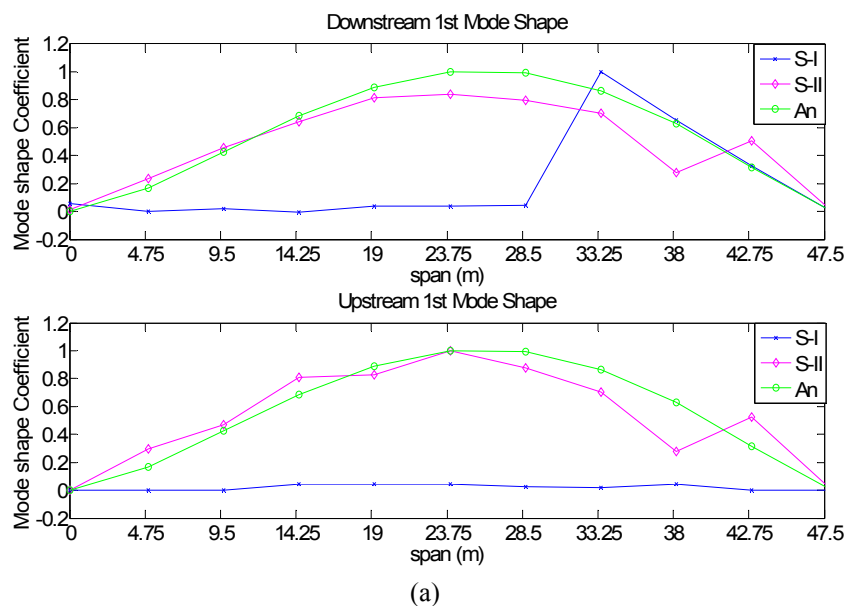
Fig. 20 (a) First; (b) Second; (c) Third Mode shape at different State and analytical Model of the bridge

- The first mode in State I of the bridge shows that the amplification in downstream truss was much more than upstream truss. There is a sharp kink in the mode shape of State I at nodes span 33.25 m due to settlement at 42.75 m. The amplification in the upstream truss and supports to 28.5 m in downstream truss was not observed since nodes at 32.5 m, 38 m and 42.75 m of downstream truss were observed to be highly flexible (Fig. 20(a)).
- Undesired 2nd mode shapes have been obtained for state I due to buckling of vertical member and bending of horizontal members of the bridge (Fig. 20(b)).
- In state II the first mode shapes are in line with the analytical mode shape except at 38 m and 42.75 m span of downstream and upstream truss (Fig. 20(a)).
- The 2nd mode shape of state II showed unexpected behavior at joints 14.25 m and 38 m in upstream truss.

- In 3rd mode shape similar trend has been observed and shows improvement in the bridge at different stages of retrofitting (Fig. 20(c)).

All the mode shapes of state II show a general improvement in the bridge after retrofitting. The difference in the behavior of upstream and downstream truss after retrofitting has reduced considerably.

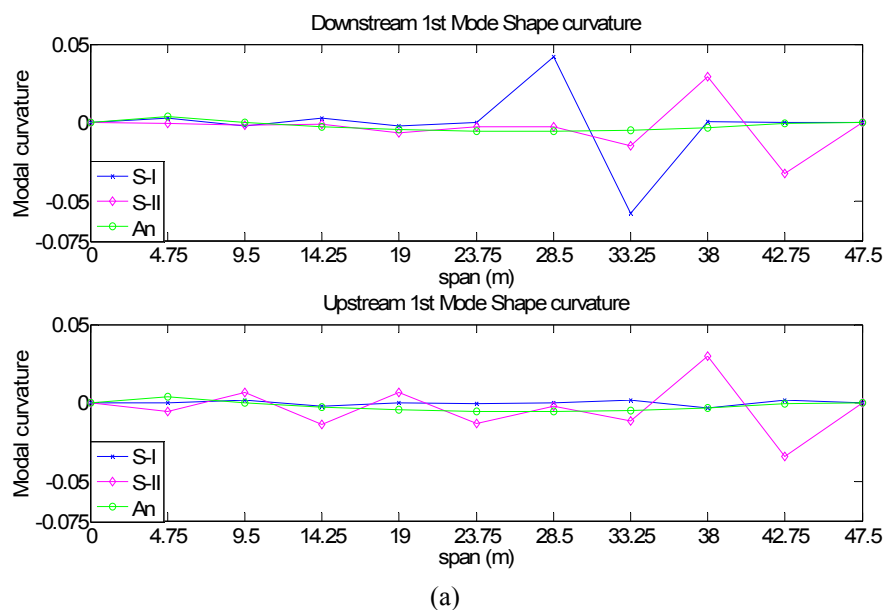
Fig. 21 Mode shape curvature for (a) 1st; (b) 2nd; (c) 3rd modes for different states of bridge

The mode shape although are able to reflect the flexible portion of the structure as a whole however the flexibility in the area of interest can still be amplified through modal shape curvature (Wahab *et al.* 1999) The difference in the mode shape of both downstream and upstream trusses for the different stages indicated some variation with analytical model for but did not presented the relative bending at different nodal locations of the bridge (Figs. 21(a)-(c)). The comparison of curvature variations in respect of analytical model of the bridge present uneven bending along the bridge. Although the estimation of mode shape curvature is not reliable, considering spacing and estimation error for the mode shapes. However in present case the study is oriented towards relative rather than absolute variation of the mode shape curvature. In Stage I the sharp change in the mode shape curvature in first mode between nodal point at 28 m and 38 m in downstream truss indicate higher amplification of the portion while the upstream truss does not indicate any variation in mode shape curvature indicating less damage compared to downstream truss. In 2nd and 3rd mode shape curvature the variation in mode shape curvature between points 28.5 m and 42.5 m indicates flexibility of nodal points. In stage II i.e., after retrofitting the nodal points at 33.25 m, 38 m and 42.75 m in both upstream and downstream truss shows different trend than that of the analytical results.

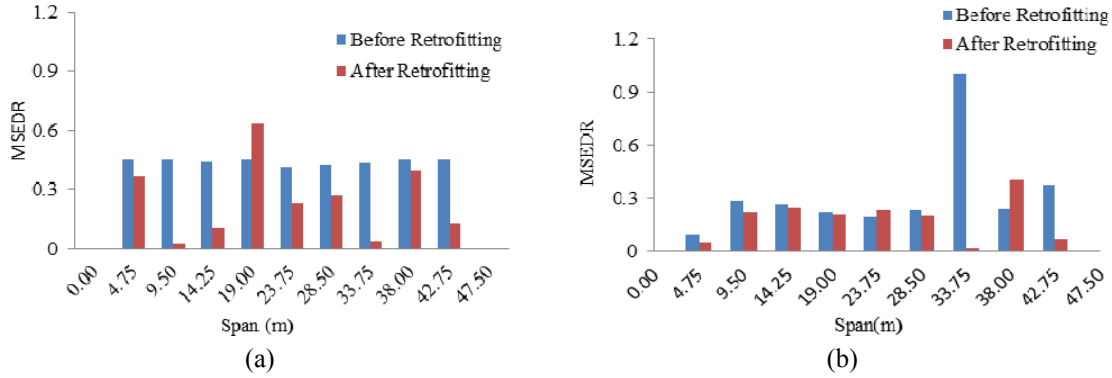
Fig. 22 (a) Downstream; (b) Upstream modal strain energy difference ratio for State I and State II

The $MSEDR$ of any damaged element is larger than any other undamaged element. Elements that are linked with the damaged have a smaller $MSEDR$ value, and, if an element is far away from the damaged element, the $MSEDR$ of this element will be much smaller. In multiple damages in the structure similar results can be obtained (Shi *et al.* 2000b). The damage localization results are shown in Figs. 22(a)-(b) with the $MSEDR$ plotted against the span. $MSEDR$ in general decreased with retrofitting due to decrease in damage level in both upstream and downstream trusses. When the bridge was retrofitted and open to traffic, flexibility at most of the nodal span in both the truss of the bridge was not observed. However, higher $MSEDR$ values were obtained at 19 m and 38 m in the downstream and upstream truss respectively.
