An innovative experimental method to upgrade performance of external weak RC joints using fused steel prop plus sheets

Keywords: RC beam-column joints; strengthening; steel prop and curb; revival sheets; cyclic loading

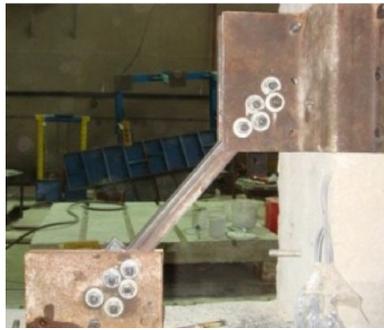
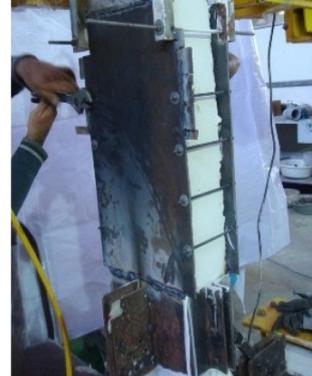
(a) The prop connection to the curb

(b) Installation of revival sheets

Fig. 5 Views of bolted steel prop and revival sheets

In Fig. 5, the actual condition of steel prop connection to the steel curbs and installation of sheets are showed.

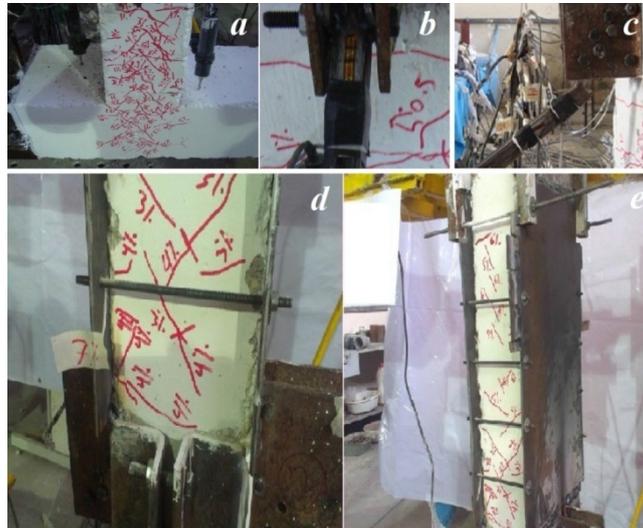
Fig. 11 Levels of the loading in the specimen SRCC-2

5.0%	Flexural cracks were propagated and more opened at top of the beams curb especially. Shear crack (with angle 45°) were extended in the beam, after the curb.	Shear cracks were generated and opened down of the curb and the panel zone. Severe damage was not observed at the beam to column joint, yet. (Fig. 11(a)) Large plastic strains were observed in the flange of the prop at its joint with the curb of the beam. (Fig. 11(b))

General observations results for the specimens SRCC-1 and SRCC-2, in some drifts are presented in Table 3. Figs. 10(a)-(d) show some levels of the loading in the specimen SRCC-1. Figs. 11(a)-(e) show some levels of the loading in the specimen SRCC-2 also.

In the specimen SRCC-1 concrete damage occurred at top edge of the beams curb, but in the specimen SRCC-2 were not seen any severe damage even after rupturing of the prop. But in the specimen SRCC-2 lots of shear cracks with short length and width were seen in the panel zone and down of the beams curb which the joint would able to be rehabilitated and be reused. In the specimen SRCC-2 the prop collected most of failures at itself. In the other word, the prop absorbed the energy of the cyclic loading and prepared enough time and opportunity for the joint to stay non-damaged. According to this observations (Table 3) in the specimen SRCC-2, the prop acts as a fuse and the most of failures concentrates at the prop.
