Structural behaviors of notched steel beams strengthened using CFRP strips

Omid Yousefi, Kambiz Narmashiri* and Mohammad Reza Ghaemdoost

Department of Civil Engineering, Zahedan Branch, Islamic Azad University, Zahedan, Iran

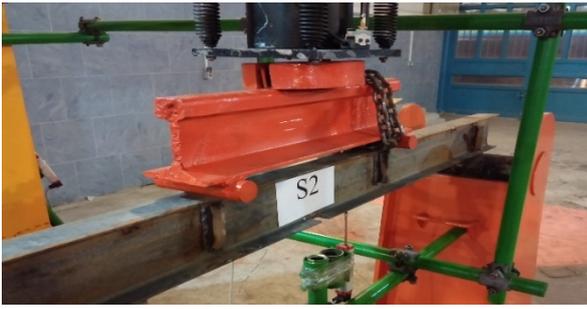
Fig. 3 Experimental test setup

Fig. 3 shows the test setup of the specimens. In order to measure vertical deflection, Linear Variable Deformation Transducers (LVDTs) were employed in the blow bottom beams flanges. The load was applied through using a hydraulic jack that includes a load cell of 450 kN capacity. The load was transferred from the jack to the main specimen by loading beam. Two symmetrical point loads were applied in order to transfer the load's pressure to the main specimen and reactions were carried by two roller

Total of five beams were examined experimentally including one non-strengthened and non-deficient beam (S1), two non-strengthened notched beams with one and two-side damages of S3, S2 respectively, beam S4 is two-side notched beam which is retrofitted using CFRP for up and bottom tensile beam flange, and beam S5 enjoys one-side damage strengthened by CFRP trips at web (damaged flange side), and up and bottom of flange as well. The experimental setup was designed based on the four-point bending test.

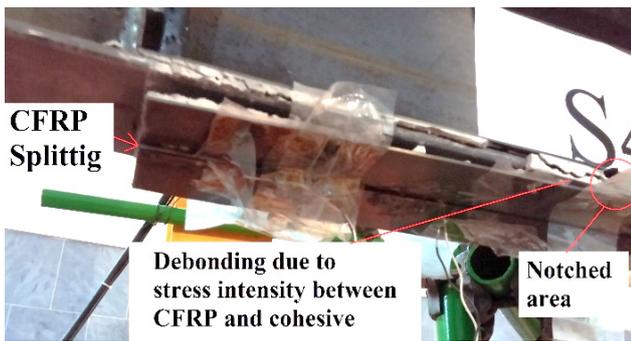
Fig. 6 CFRP splitting occurred for case S4

Fig. 7 Strain intensity (shear stress) on adhesive

intensity after yielding which caused below point load debonding. Also, shear stresses as a result of large lateral deformation caused CFRP splitting failure along strip initiated below the point loads and developed to whole length of CFRP strip as shown in Figs. 6 and 7.
