Experimental and numerical study about seismic retrofitting of corrosion-damaged reinforced concrete columns of bridge using combination of FRP wrapping and steel profiles

Hassan Afshin^{*}, Mohammad R. Nouri Shirazi^a and Karim Abedi^b

Department of Civil Engineering, Sahand University of Technology, Tabriz, Iran

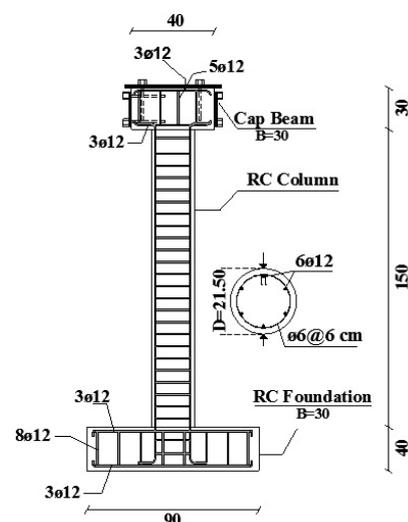
Fig. 1 Geometric schematic of test specimen; (units in cm, B = width of the footing and the cap beam)

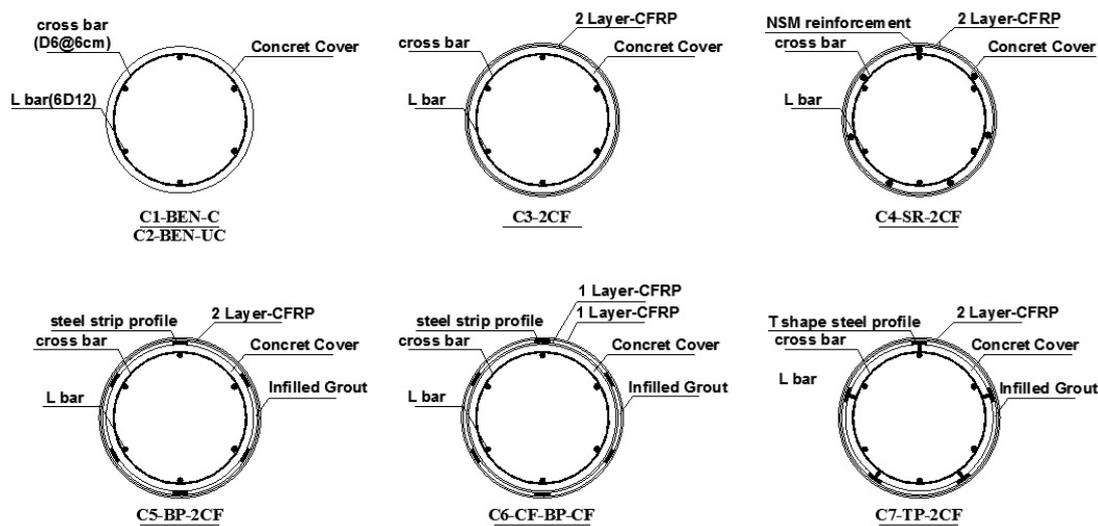
Fig. 2 Cross-sectional plan of the RC columns with their retrofitting plans

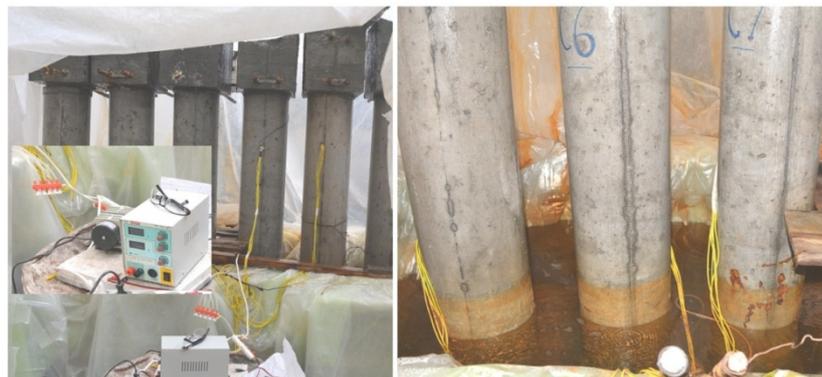
Fig. 3 A perspective of accelerated corrosion setup

a simple accelerated corrosion setup has been provided in the laboratory. It is worth noting that the specimens were not retrofitted, and vibrated along the concreting process. The mechanical effects produced around the steel rebars and the cover layer of concrete, including the depletion of steel surface and the accumulation of its rust, are among the conditions difficult to simulate with the electrochemical method. One of the main concerns for better performance of corrosion setup is to provide enough oxygen to the

corrosion cell to produce iron rust, which creates a network of fine cracks on the surface of the RC columns, the same phenomenon that has been observed in nature (Tastani and Pantazopoulou 2004). As shown in Fig. 3, all of the RC column specimens except C2-BEN-UC are placed inside the water tank containing 3% natural salt (Aquino and Hawkins 2007). The presence of oxygen is necessary for the continuation of the corrosion process and includes iron decomposition into ferrous and ferric oxides.

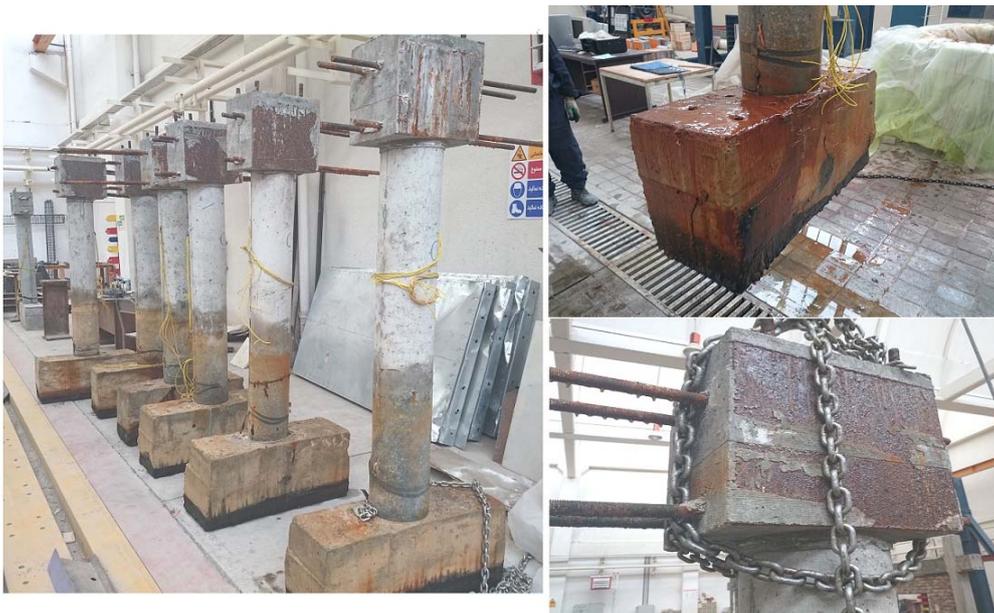
Fig. 4 The condition of damages in columns components after corrosion process

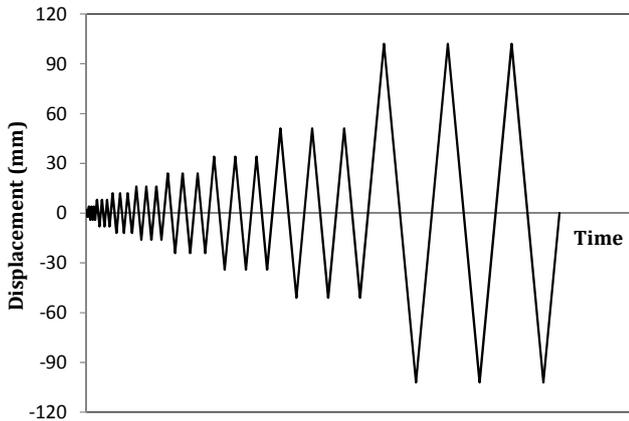
Fig. 7 Typical reverse displacement history adopted for the test

Lateral loading of the test specimens was carried out in a quasi-static manner. The horizontal loads are applied to the columns using a hydraulic jack system controlled by a computer using a shift control method based on an incremental lateral displacement pattern according to Fig. 7. In each amount of displacement, three repetitive cycles consisting of positive and negative displacements have been applied to the columns. The cyclic lateral displacements were applied in the form of the relative displacement ratio (drift ratio) of the column, which is calculated according to the following equation

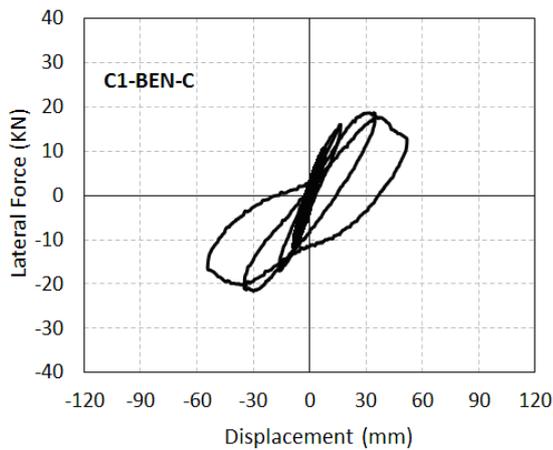
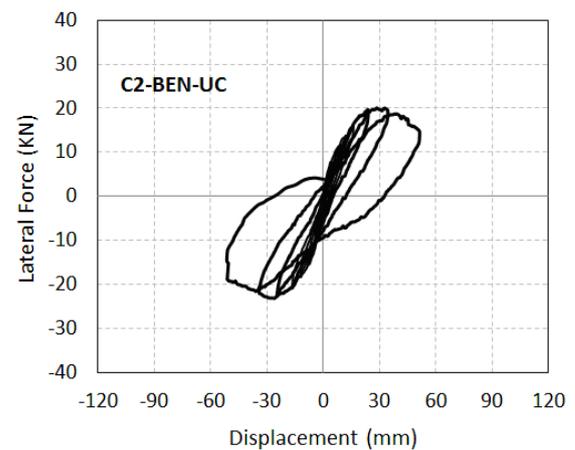
(a) Hysteresis curves of specimen C1-BEN-C

(b) Hysteresis curves of specimen C2-BEN-UC

Fig. 8 Lateral force–displacement responses of specimens

BEN1 and BEN2 were tested without any retrofit design, to compare their behaviors with those of the other retrofitted specimens. As illustrated in Figs. 8(a)-(b), the peak shear strength of specimens BEN1 and BEN2 were 18.56 KN and 19.61 KN, respectively, which indicate reduction in strength (about 6%) in the corrosion-damaged specimen. The responses of two specimens were similar in overall; the unsteady hysteresis curves, along with the smaller area observed for damaged columns due to corrosion along the unloading direction. As shown in Fig. 9(a), several small horizontal flexural cracks were observed in the specimen BEN1 before the yield load, however, major horizontal bending cracks have been observed at a distance of approximately 100 mm from each other during subsequent cycles at the bottom of the column. From the fourth cycle, the cracks were propagated down the column and led to the initiation of the process of spalling of the concrete cover near the column-footing interface. In the final cycles of loading, corrosion damage resulted in the spalling of the concrete cover and a decrease in the bond between the concrete cover and the concrete core. The final condition of specimen BEN2 is shown in Fig. 9(b). It is evident that only the bending cracks were formed along the column height, however, the width and number of cracks increased during

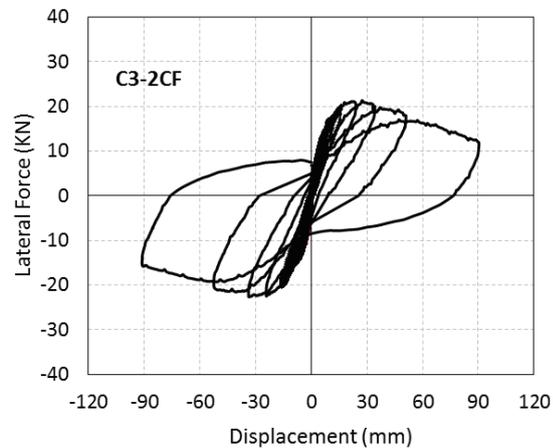
(c) Hysteresis curves of specimen C3-2CF

the final cycles. The lateral displacement-lateral force response for specimen C3-2CF is shown in Fig. 8(c). The peak shear strength and corresponding lateral displacement were 21.01 kN and 26.87 mm, respectively; however, the peak lateral strength was increased after the retrofitting process. The specimen is characterized by a well-defined yield and stable hysteresis curves on both directions of loading; however, degradation of strength began after the sixth cycle of loading and continued until the end cycles. An increase in the rate of circumferential strain is a sign of the volumetric expansion of the concrete caused by progressive damage accumulation. The expansion was due to the high longitudinal compressive stresses for the compression side.

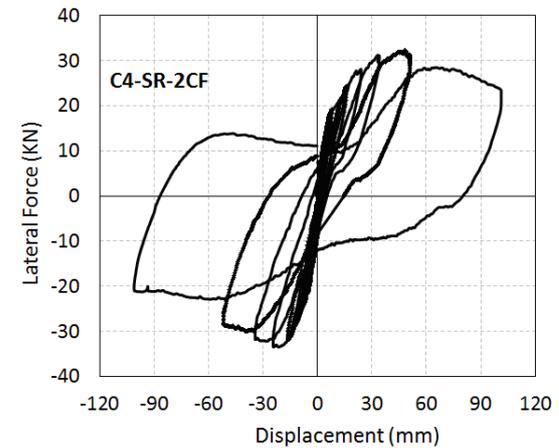
(d) Hysteresis curves of specimen C4-SR-2CF

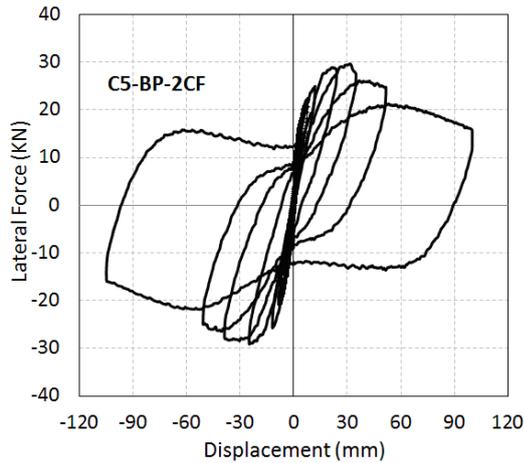
(e) Hysteresis curves of specimen C5-BP-2CF

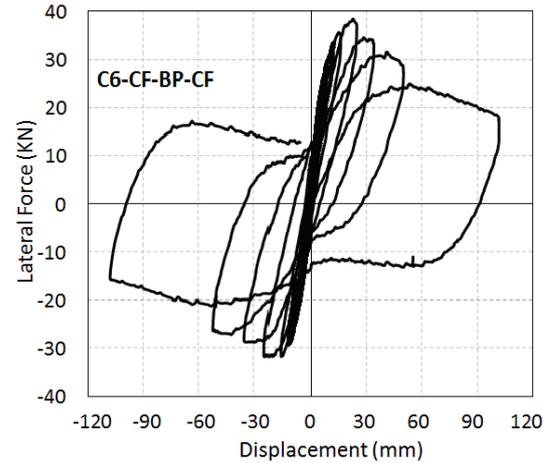
(f) Hysteresis curves of specimen C6-CF-BP-CF

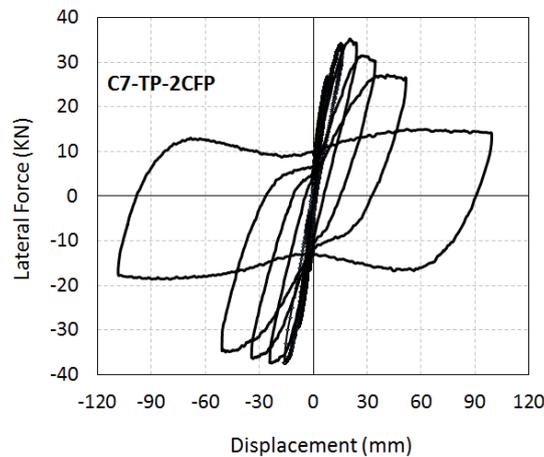
(g) Hysteresis curves of specimen C7-TP-2CF

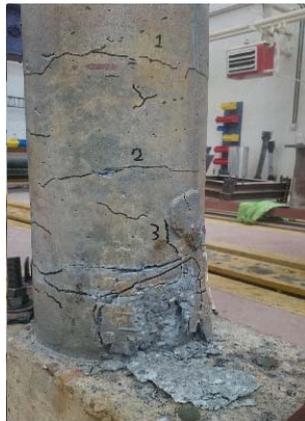
(a) Specimen BEN1 at failure

Fig. 9 Views of columns failure

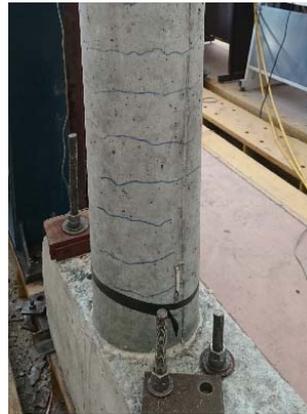
(b) Specimen BEN2 at failure

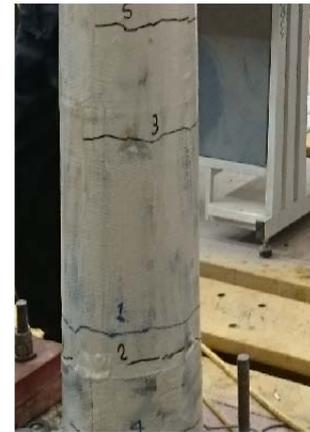
(c) Specimen C3-2CF at failure

However, for the tension side, the circumferential strains have been increased due to the concrete splitting and the mechanical locking of rebar lugs with surrounding concrete (Aquino and Hawkins 2007). As shown in Fig. 9(c), the specimen C3-2CF has suffered several horizontal flexural cracks. In the fourth cycle of loading, failure of the column initiated with the appearance of horizontal bending cracks in the area near the base of the column. The cracks propagated along the column height by increasing the lateral displacement, but the form of the cracks has not changed due to the presence of the CFRP sheets. Near the column-footing interface, the CFRP sheets were ruptured during the ninth cycle which is an indication of a significant reduction in the flexural strength of the column.

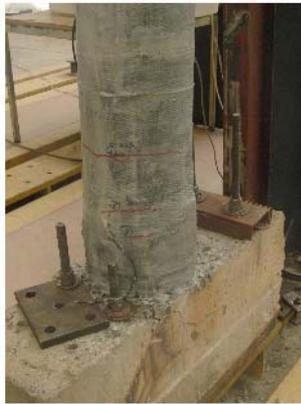
(d) Specimen C4-SR-2CF at failure

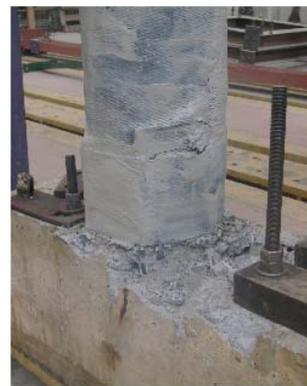
(e) Specimen C5-BP-2CF at failure

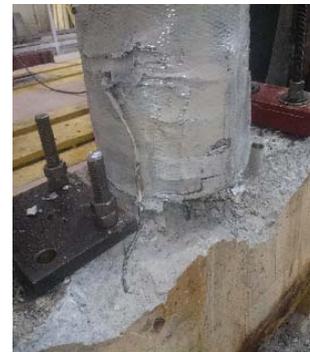
(f) Specimen C6-CF-BP-CF at failure

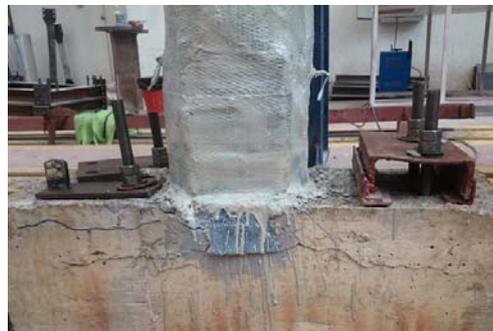
(g) Specimen C7-TP-2CF at failure

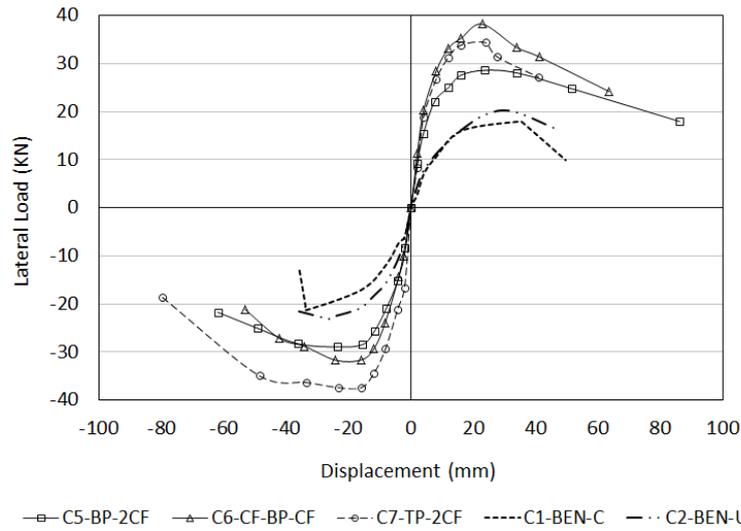
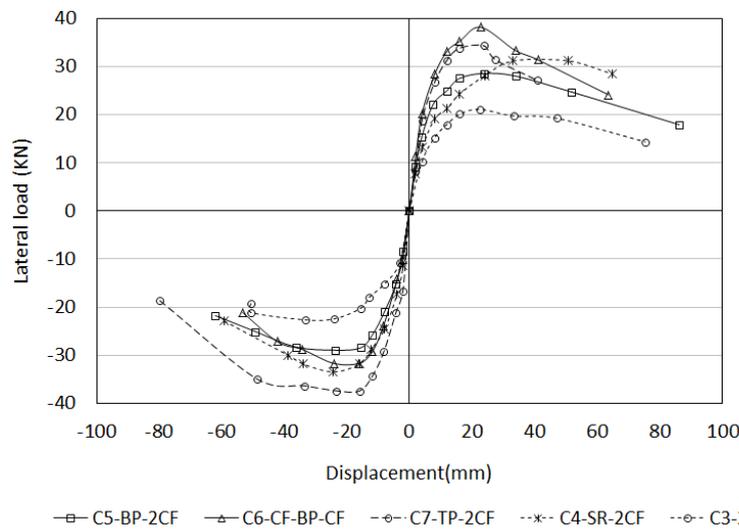
(a) Benchmark specimens in comparison to retrofitted specimens with proposed techniques

(b) Custom retrofitted specimens in comparison to retrofitted specimens with proposed techniques

Fig. 10 Lateral load–lateral displacement envelopes for all specimens

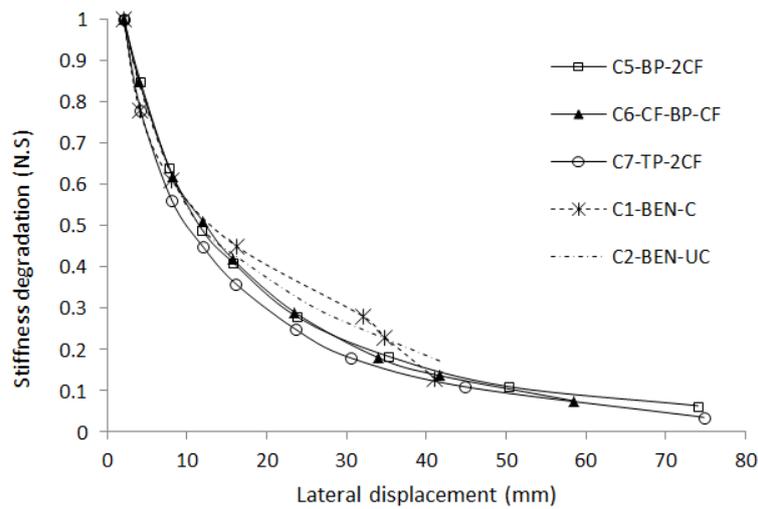
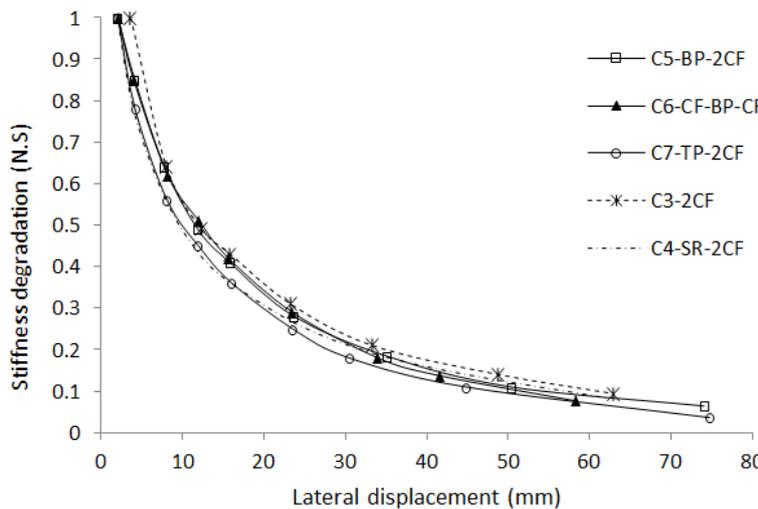
(a) Benchmark specimens in comparison to retrofitted specimens with proposed techniques

(b) Custom retrofitted specimens in comparison to retrofitted specimens with proposed techniques

Fig. 11 Stiffness degradation curves

stiffness in each cycle is normalized to the obtained stiffness for the first cycle. The graph of the normalized stiffness (N.S) in terms of lateral displacement has been shown in Figs. 11(a)-(b). The overall behaviors of retrofitted specimens were the same; however, the specimen C5-BP-2CF had less stiffness degradation than the specimens C6-CF-BP-CF and C7-TP-2CF in the last cycles of loading. Considering normalized stiffness parameter, the specimen C1-BEN-C had less degradation than the specimen C2-BEN-UC, however, an intensive degradation has occurred in the last cycle.

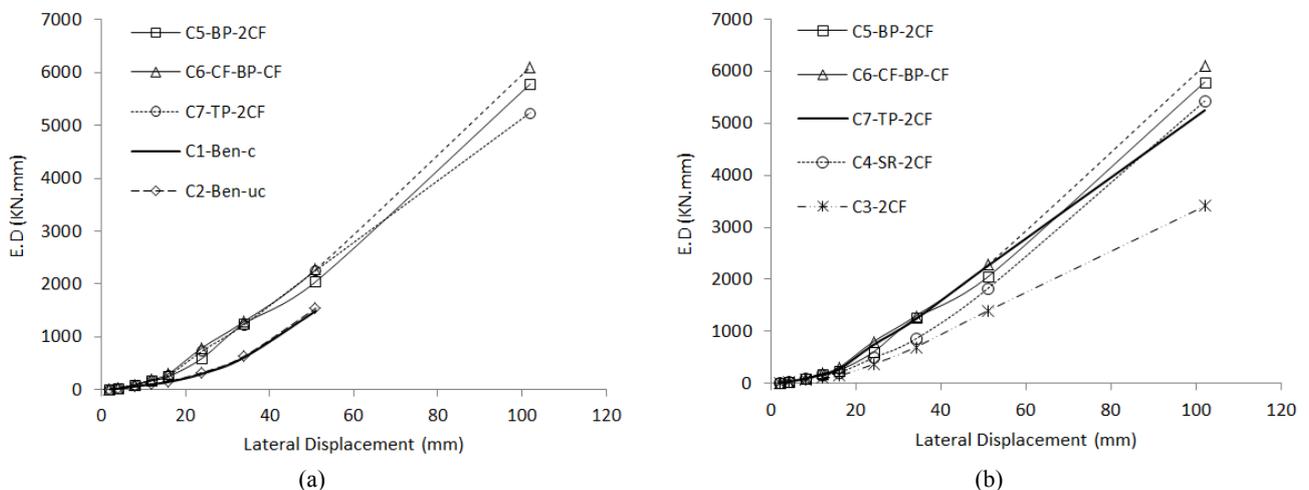
Fig. 12 Energy dissipation per lateral displacement curve

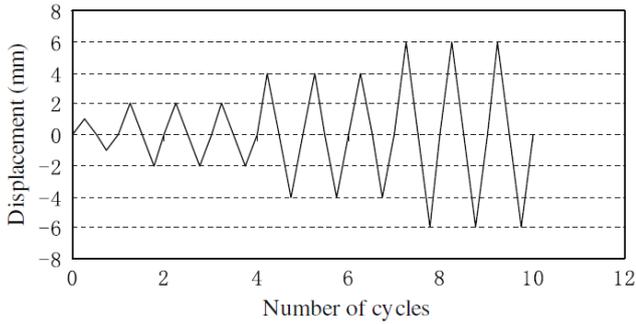
Fig. 13 Lateral displacement history (Li *et al.* 2009)

one-way hydraulic jacks and has been measured by two load cells attached to a hydraulic jack. Three full cycles were applied at each displacement using a triangular waveform, as shown in Fig. 13 (Li *et al.* 2009). Fig. 14 shows the numerical and experimental lateral force-lateral displacement responses of the test specimen C5-BP-2CF. The maximum lateral load and corresponding displacement as well as the degradation of shear strength and the enclosed area of curves of FE model are relatively close to those of the experimental specimen; moreover there is a reasonable match. In any case, the initial stiffness obtained in the FE analysis is slightly different from the value obtained in the experimental study.

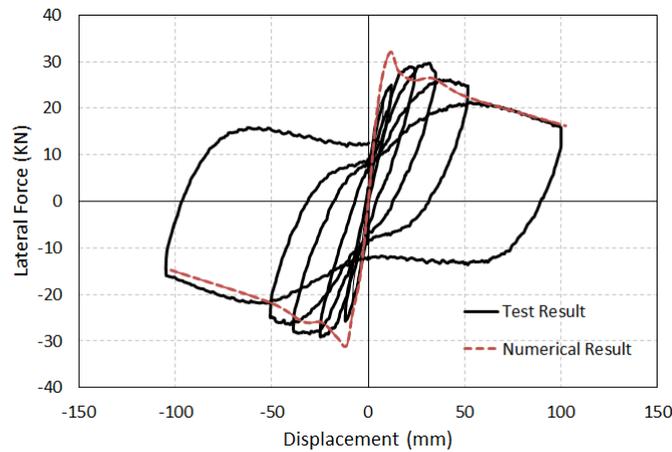
Fig. 14 Lateral force- lateral displacement curves of the specimen C5-BP-2CF; test vs. numerical result

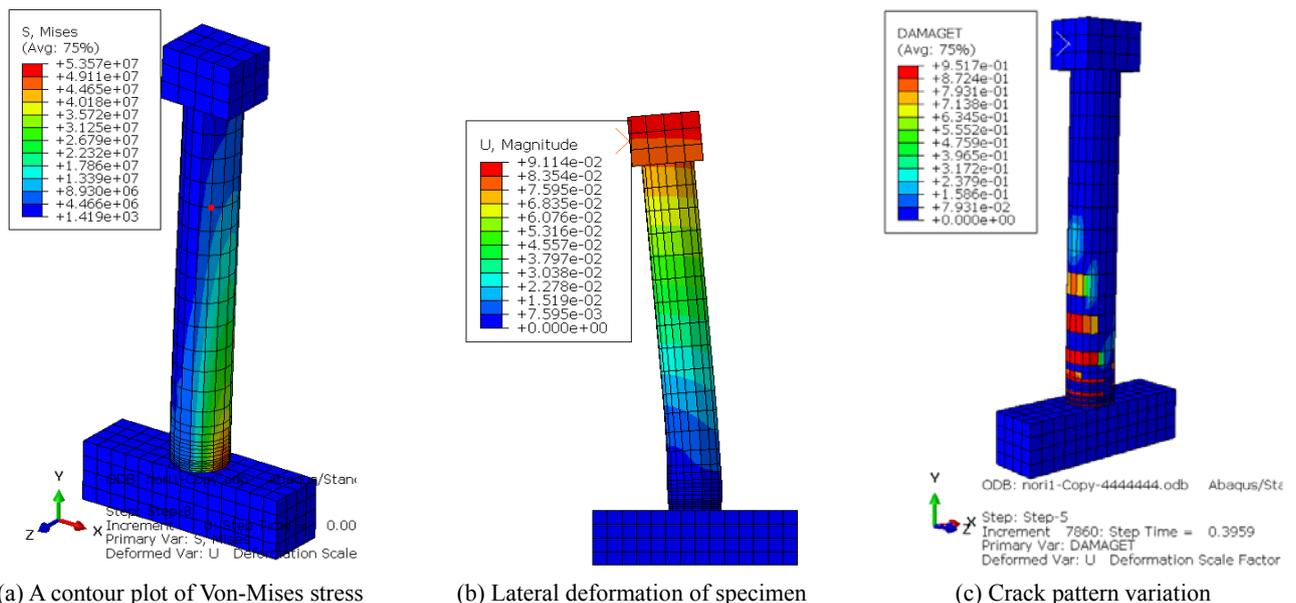
Fig. 15 Graphical plots derived from column numerical analysis

of the column, the number and size of these cracks are increased and distributed to the upper zones. A plot of Von-Mises stress distribution in the concrete, lateral deformation of the column and crack pattern variation in the steel jacket and FRP sheet are shown in Fig. 15 for the specimen C5-BP-2CF.

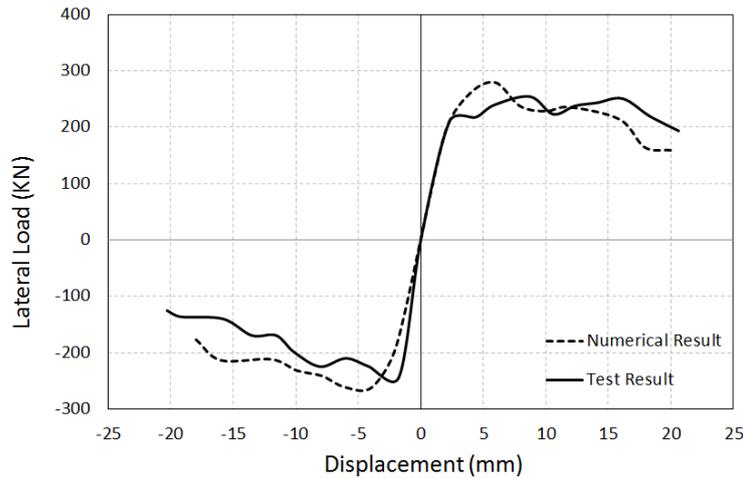
Fig. 16 Lateral force- lateral displacement curves of the specimen B121; test vs. numerical result

Fig. 16 shows the numerical and experimental lateral force-lateral displacement responses of the test specimen B121. As illustrated in this figure, the maximum lateral load, the corresponding displacement, and the degradation of lateral force have good agreement with the experimental results. The enclosed area of curves (as an energy dissipation measure) and plastic stiffness of FE curves have a little difference with those of the experimental specimen. Graphical plots of Von-Mises stress, lateral deformation of column and stress variation in the steel jacket and FRP sheet of the specimen B121 are shown in Fig. 17. Therefore, it has been found that the finite element modeling is reliable enough to be used for a parametric study about the effects of some important parameters on the behavior of retrofitted RC columns with proposed retrofitting techniques.

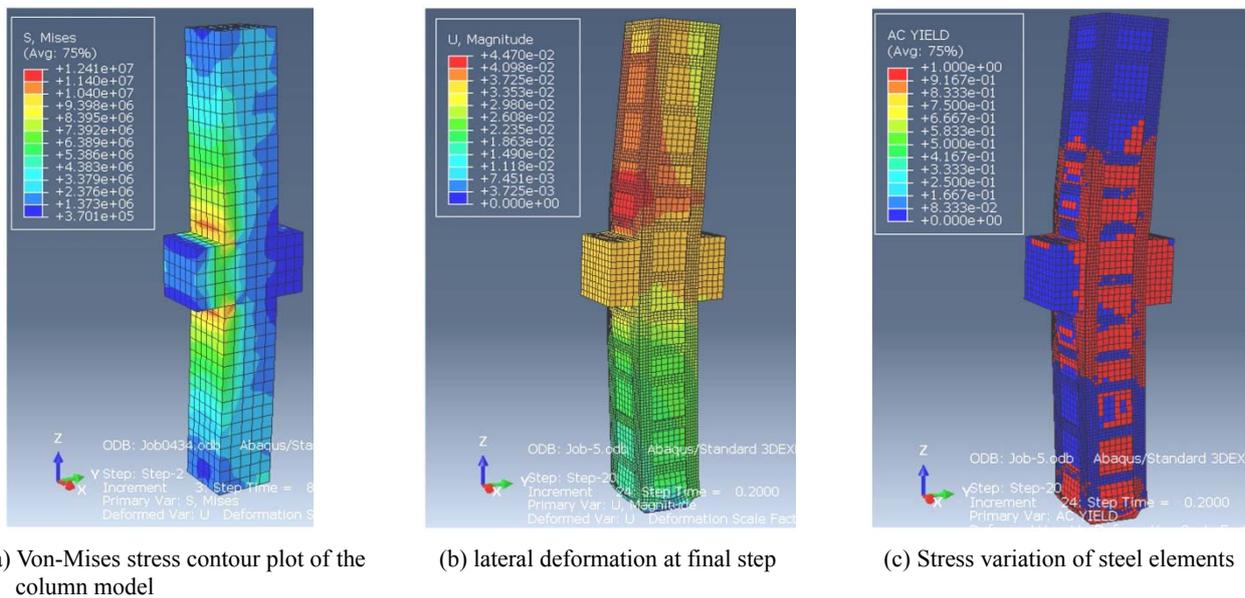
Fig. 17 Graphical plots derived from numerical analysis of test specimen B121

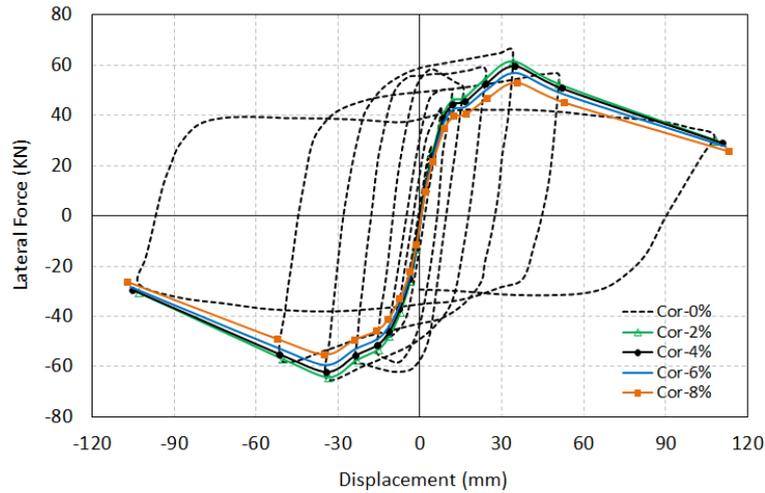
Fig. 18 The lateral load-lateral displacement curves of the models with different rates of steel rebar corrosion

effect on the structural behavior of the retrofitted RC columns. Four rates of corrosion, 2%, 4%, 6% and 8% have been considered. Fig. 18 illustrates the lateral load-lateral displacement curves of the models with different rates of steel rebar corrosion. When the rate of corrosion is low, the overall behavior will be similar. As shown in Table 12, higher corrosion level results in less lateral capacity in corroded RC column model. As the corrosion rate of the rebars increases, the cross-sectional area of the rebars will be decrease, which causes the reduction of yield strength of the column rebars. The result of these changes is the buckling of the longitudinal rebars that are subjected to the compressive stress, causing the less lateral load carrying capacity of the column. For instance, the maximum lateral loads are 61.60 kN and 53.40 kN and the ductility factors are 5.97 and 6.27, under the rates of corrosion 2% and 8%, respectively, showing more ductile behavior under a higher rate of rebar corrosion. As illustrated in Fig. 19, the maximum Von-Mises stress is appeared in the lower part of

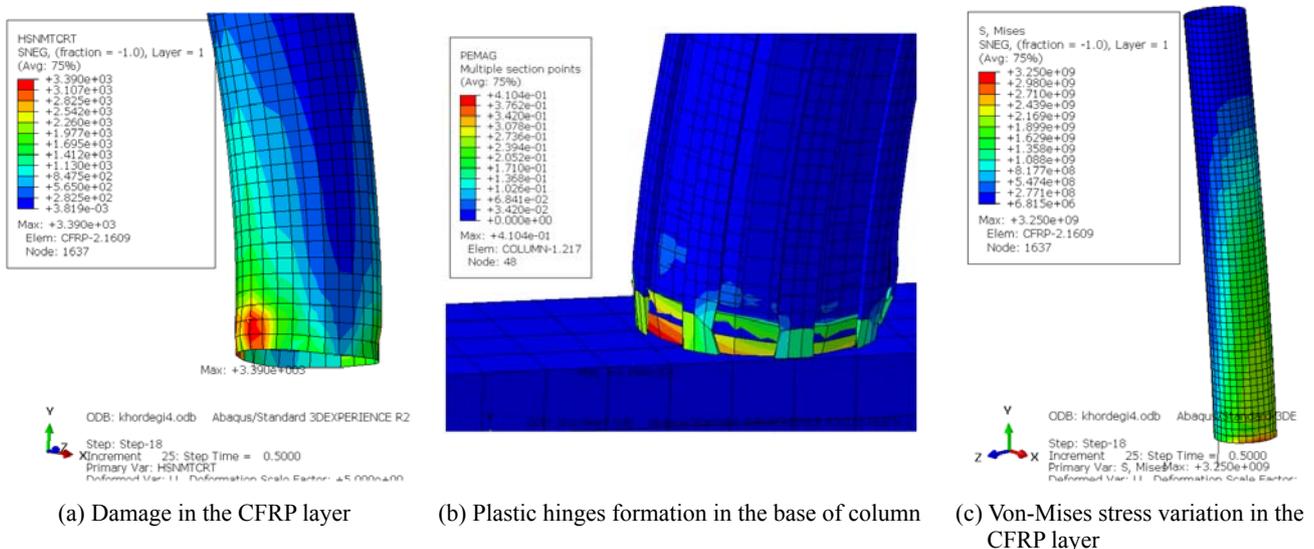
Fig. 19 Graphical plots at the end step of FE analyses

the column (corrosion rate is 8%). However, the plastic hinge formation has initiated at the lowest part and propagated towards the upper part of the model. Prior to the crushing of the column concrete cover, yielding of tensile steel rebars has been initiated. Therefore, the column has experienced a flexural-shear failure. At the seventh cycle, considerable flexural cracks were appeared on the surface of the CFRP sheet in both directions around the plastic hinge region and propagated until the failure of column.

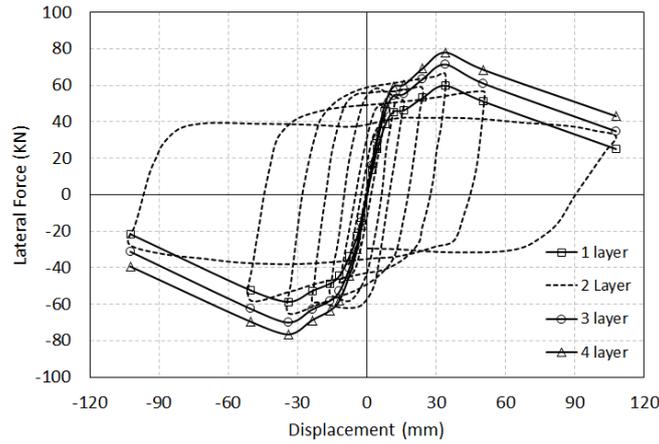
Fig. 20 Effect of number of the CFRP layers on the lateral load–displacement curves

The thickness of the CFRP sheets has a significant effect on the structural behavior of the retrofitted columns. The effect of thickness can also appear in the form of the number of CFRP layers. In this study, the number of applied layers was one, two, three and four. In Fig. 20, the lateral force-lateral displacement response curves are shown, considering the effect of the number of CFRP layers. The retrofitted model with one layers of CFRP sheet shows a more unstable hysteresis response, which is due to the lower amount of the confinement pressure on the concrete core. Therefore, a decrease is observable in the amount of lateral strength and ductility. As the number of CFRP layers increases, the confinement level in the plastic hinge region will improve, resulting in better performance under reversed cyclic displacement. As a result, the formation of internal cracks is delayed between the corrosion-damaged column and the steel jacket and the bond resistance will improve. The energy dissipation in each cycle per related displacement for each model is shown in Fig. 21. It is noteworthy

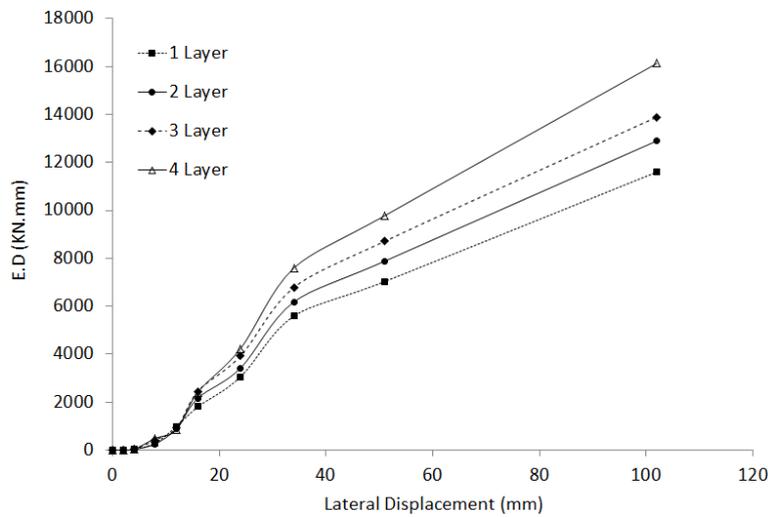
Fig. 21 Effect of number of CFRP layers on the energy dissipation of column models

that the energy dissipation of the RC column model increases by increasing the layers of CFRP. As a comparison, the amount of this parameter is 5598.5 KN.mm

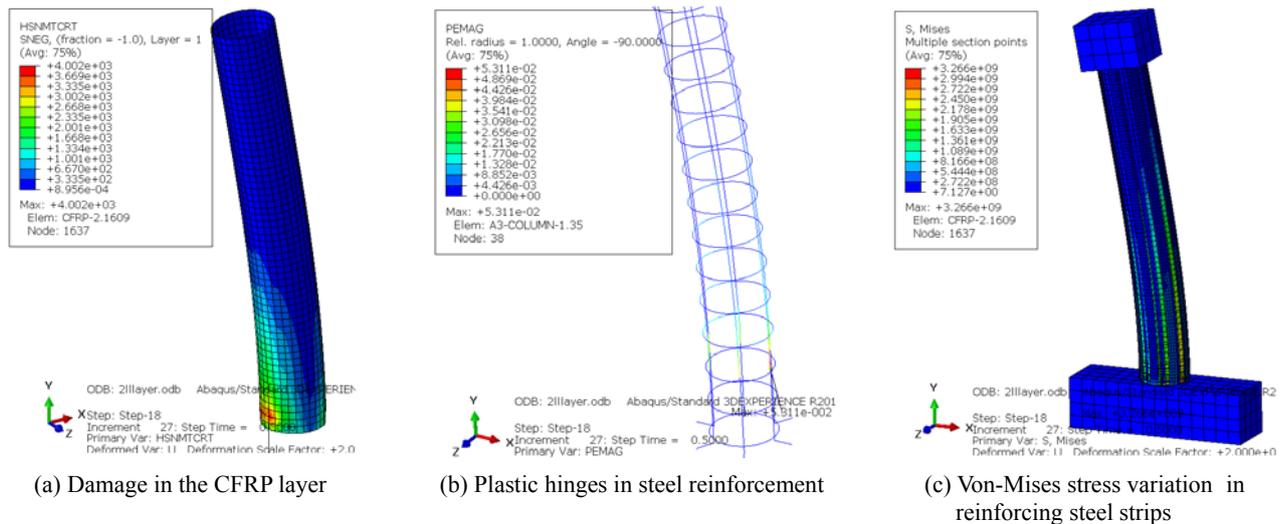
Fig. 22 Graphical plots at the end step of FE analyses

an indication of yielding of reinforcing rebars, causing the flexural-shear failure of the column (having two layers of CFRP).
