## Effect of fatigue crack propagation on natural frequencies of system in AISI 4140 Steel

**Abstract.** In this study, we investigated the effect of fatigue crack propagation of the beams which have a vital importance in engineering applications, on the natural frequency of the system. Beams which have a wide range of applications, are used as fundamental structural elements in engineering structures. Therefore, early detection of any damages in these structures is of vital importance for the prevention of possible destructive damages. One of the widely used methods of early detection of damages is the vibration analysis of the structure. Hence, it is of vital importance to detect and monitor any changes in the natural frequencies of the structure. From this standpoint, in this study we experimentally investigated the effect of fatigue crack propagation on beams produced from 4140 steel, of the natural frequency of the beam. A crack was opened on the 8×16×500 mm beam using a 3 mm long and 0.25 mm wide wire erosion. The beam, then, underwent 3 point bending tests at 10 Hz with a dynamic fatigue device and its natural frequencies were measured in scheduled intervals and any changes

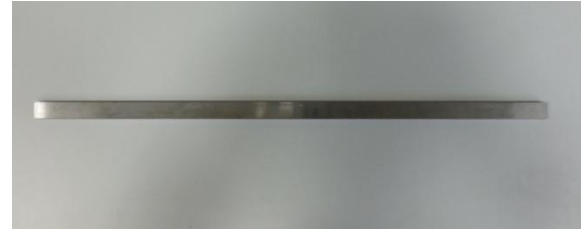
Fig. 1  $8 \times 16 \times 500$  mm beam produced from 4140 steel

The beam was subjected to tension test to identify the mechanical characteristics of its material. The yield tension of the material was determined as  $(\sigma_{yield})$  670 MPa after the tension test. The commercial 4140 steel usually has a circular cross section. Therefore we acquired a 20 mm diameter and 500 mm long cylindrical material and machined it on a milling table into a beam. We determined the width (B) and height (W) values of the beam according to the ASTM E-399 standard. The size of the machined beam is  $8 \times 16 \times 500$  mm samples machined into beams on milling table are shown in Fig. 1.

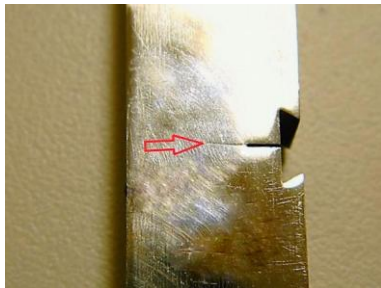
Fig. 5 Fatigue crack propagation

After the set number of cycles, the required data was obtained by measuring the amount of crack propagation and the natural frequency of the beam. The fatigue crack propagation on the beam is shown in Fig. 5. Moreover, throughout the experiment, the number of load cycles applied to the beam and the values of the crack size seen on the extensometer were recorded. The fatigue crack propagation was measured by the extensometer as seen from the Fig. 3 during the experiment. Pakdil *et al.* (2011) and Koçak *et al.* (2002) used an extensometer to measure fatigue crack length. When the following similar studies were examined, it was seen that extensometer was found to be sufficient for the crack length measurement.

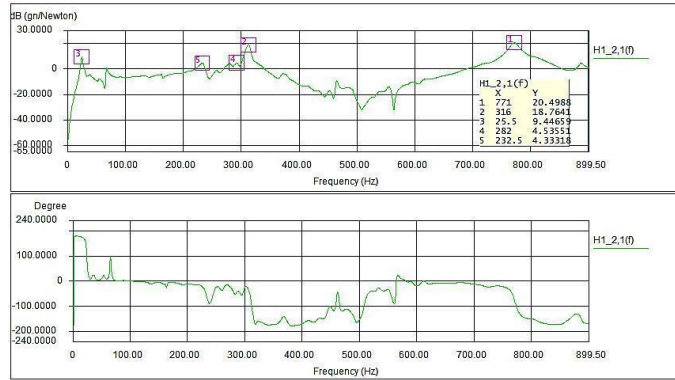
Fig. 7 The natural frequencies of beam without the fatigue test

The natural frequencies as a result of the cycles specified in Table 3 for beam no 2 were measured. The natural frequency values of beam no 2 without the fatigue test are shown in Fig. 7.

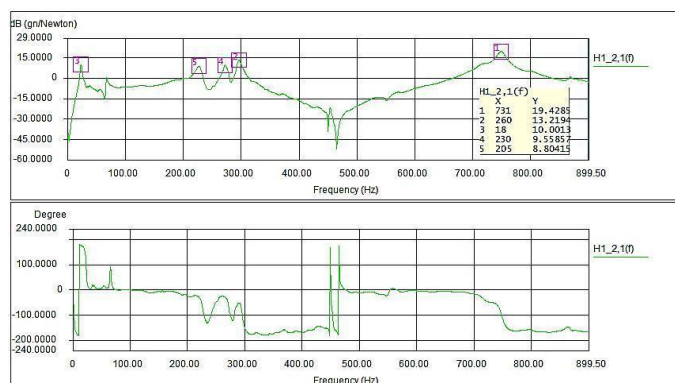
Fig. 10 The natural frequencies of beam after 168000 fatigue cycles

2<sup>nd</sup> beam's natural frequency values obtained after 15000 fatigue cycles are shown in Fig. 8, 120000 fatigues cycles in Fig. 9, and 168000 fatigue cycles in Fig. 10.

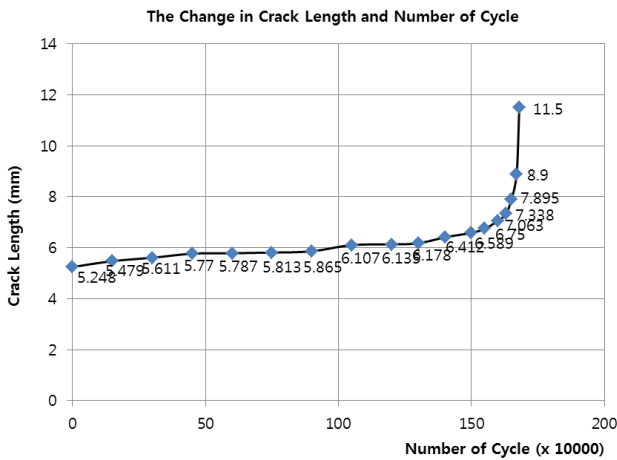
Fig. 11 The change in crack length and fatigue cycle

The change in crack length per fatigue cycle is shown in Fig. 11.

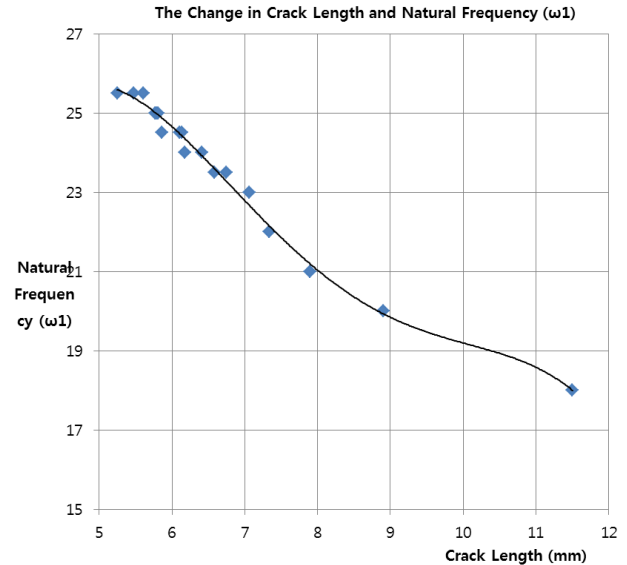
Fig. 12 The change in crack length and system's 1<sup>st</sup> natural frequency ( $\omega_1$ )

The changes in the system's 1<sup>st</sup>, 2<sup>nd</sup> and 3<sup>rd</sup> natural frequencies by crack length are shown in Figs. 12, 13 and 14.

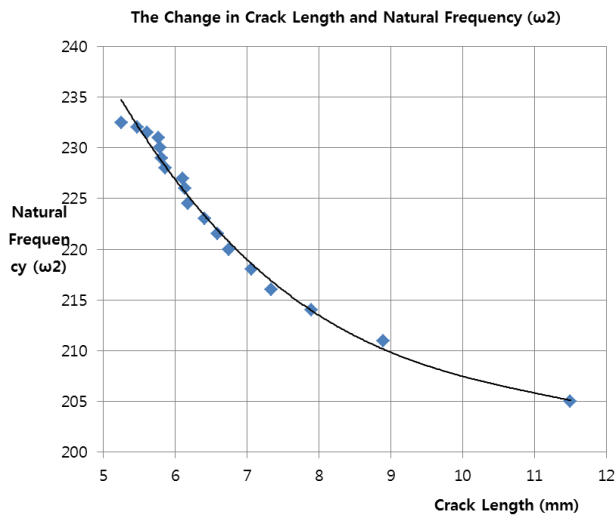
Fig. 13 The change in crack length and system's 2<sup>nd</sup> natural frequency ( $\omega_2$ )

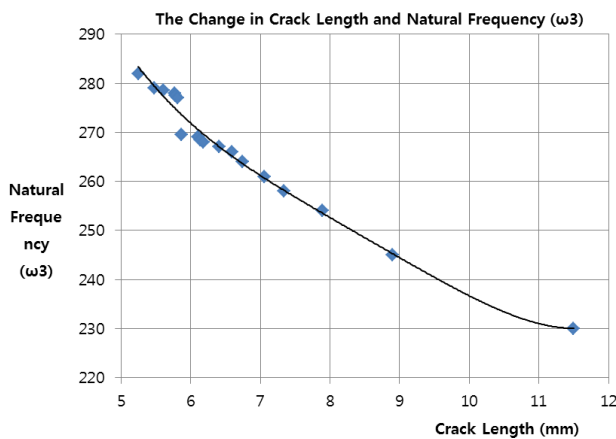
Fig. 14 The change in crack length and system's 3<sup>rd</sup> natural frequency ( $\omega_3$ )
