## Experimental studies on the behaviour of headed shear studs for composite beams in fire

**Keywords:** composite beam; headed shear stud; push-out test; transverse deck; fire

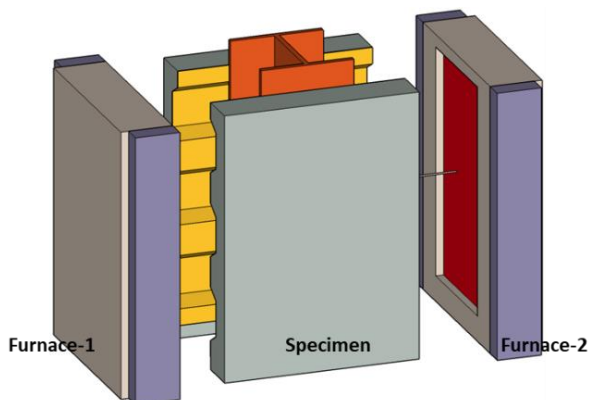
Fig. 1 Assembly drawing of the high-temperature test set-up

A customised electric furnace was designed according to the configuration of the push-out test specimen. It can replicate the ISO 834 standard fire by applying heat from both sides of the specimen, as depicted in Fig. 1. Two heating panels were attached to the specimen, and the top and bottom sides were insulated to prevent heat loss during the heating process.

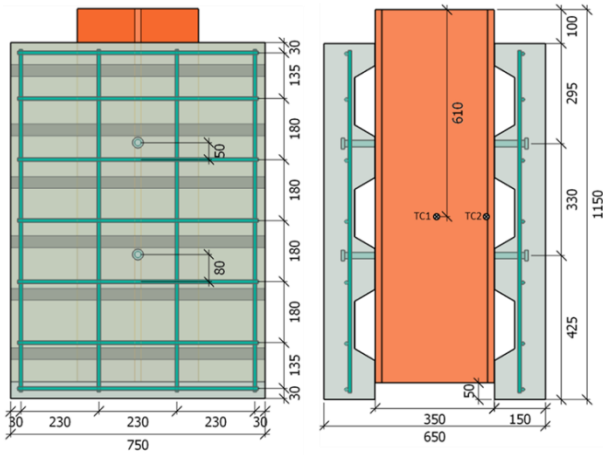
Fig. 2 Dimensions and thermocouple (TC) locations of the push-out test specimen

The Multideck 60-V2 was used for the trapezoidal deck, which has a height of 61 mm and an average breadth of 155 mm. A 19-mm diameter headed shear stud with a height of 100 mm was welded through the 1.2-mm deck to a steel flange using an automatic welding gun at a favourable side; the distance from the mid-height of the deck in the loading direction to the centre of the shear stud was 117.5 mm. In addition, the shear stud was welded directly to the steel flange when utilising the 0.9-mm deck, which formed a 34-mm diameter hole at the stud location. A 1100-mm long Universal Beam (UB) with dimensions 350 × 350 and a unit weight of 156 kg/m was used as the steel section. A 10-mm diameter ribbed bar was placed on the deck shoulder for reinforcement. The size of the concrete slab was 750 mm × 1050 mm with a depth of 150 mm. The specific dimensions of the specimen are provided in Fig. 2. A solid slab specimen was also designed to compare the stud behaviour under elevated temperatures; the same steel and concrete sections were used, and the only difference was the absence of the steel sheeting. Table 1 presents the specification of the twelve specimens.

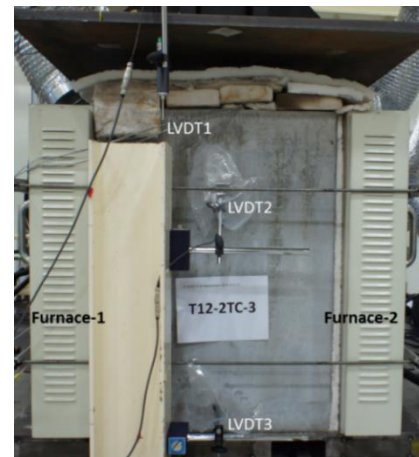
Fig. 3 Furnace and LVDT setup for the high-temperature experiment

An applied load, relative slip and temperatures were measured during the push-out tests. A square plate swivel jig was placed between the steel beam and actuator which has the maximum capacity of 2500 kN. Three linear variable differential transformers (LVDT) were installed to measure the vertical and lateral displacement at each slab as shown in Fig. 3. A relative slip between the loading plate and concrete slab was obtained using LVDT 1 and LVDT 2.

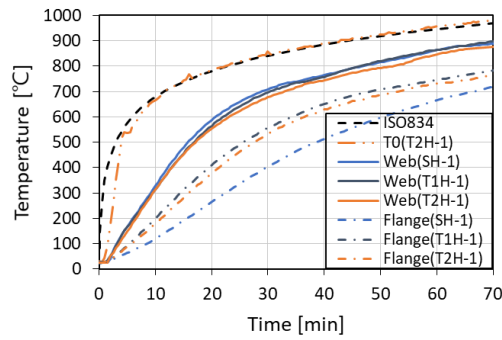
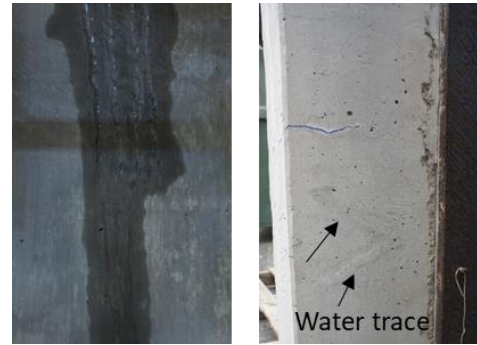
(a) Temperature distributions

(b) Concrete slab during and after the heating process

Fig. 4 Thermal response of the specimens

The measured temperature data for different slab types were presented in Fig. 4(a). The web temperature shows a similar value throughout all types of specimens, while the flange temperature of the transverse deck specimen gives a higher value than the solid slab specimen. This temperature difference was caused by the additional area exposed to hot gas in the transverse deck as well as thermal conduction between the flange and concrete slab in the solid slab specimen. Zhao and Kruppa (1996) also found the temperature difference according to the slab types in composite beam experiments. The upper flange temperature of the rib deck specimen was higher than the solid slab specimen, while a similar temperature was observed at the web and bottom flange. It can be anticipated that the shear stud in the transverse deck slab is more vulnerable to fire than in the solid slab because the higher temperature of the stud root area was observed under the identical fire exposed condition.

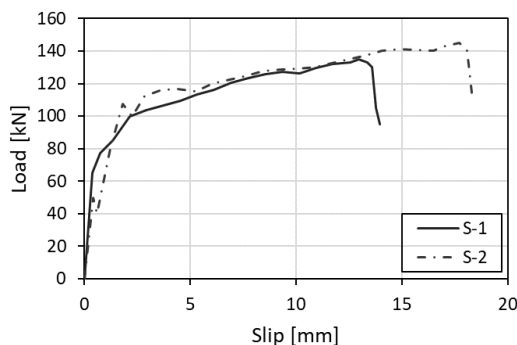
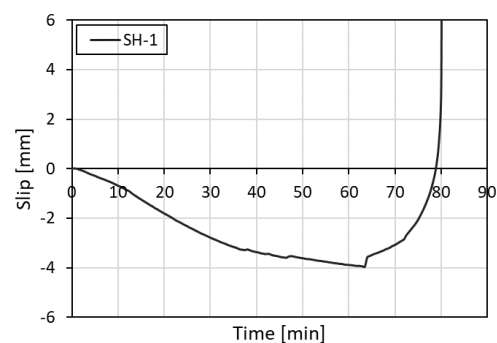
(a) Load-slip relationship at room temperature

(b) Time-slip relationship at high temperature

Fig. 5 Structural response of the solid slab specimens

The load-slip relationship at ULS and slip-time curve at FLS are plotted in Figs. 5-7 according to the specimen type. When the shear stud was embedded in a solid slab, the shear resistance consistently increased until the maximum load was reached in the ambient condition. Beyond the maximum resistance, the applied load decreased stepwise with a loud noise due to the stud tearing in the specimen. A different characteristic slip was observed depending on the fracture of each stud of four studs installed in a specimen. A constant load of 40.5 kN with the ISO 834 standard fire condition was applied to evaluate the shear resistance in a fire. The bottom of the shear stud was sheared after 80 minutes of the heating process. A negative slip was found at the beginning of the experiment owing to the thermal expansion of the steel and concrete sections, which indicates the thermal expansion force is higher than the applied load.

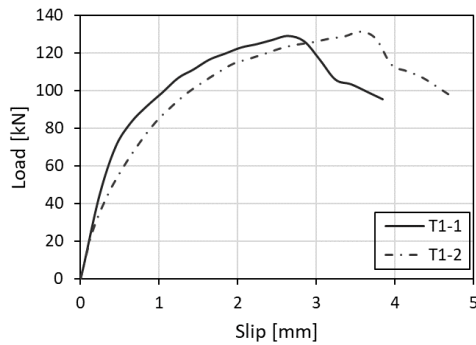
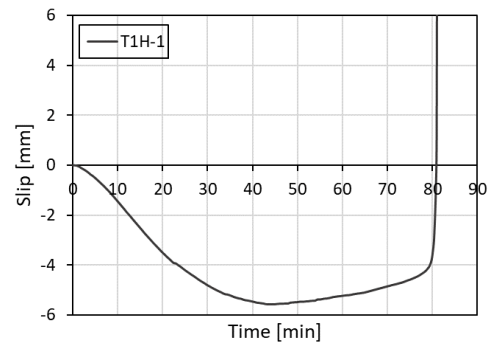
(a) Load-slip relationship at room temperature

(b) Time-slip relationship at high temperature

Fig. 6 Structural response of the transverse deck specimens with through-deck welding

Two specimens were used to investigate the shear connection capacity in the 1.2 mm transverse deck slab at ULS, which gives an average resistance of 129 kN. Although the slip at the peak load was different, both experiments showed an analogous shear resistance as depicted in Fig. 6(a). This slip difference came from the heterogeneous property of concrete because the same failure mode of the concrete pull-out was found at both push-out tests. When 20.3 kN was applied continuously during the entire heating process, the stud shearing occurred

at the interlayer between the top flange and bottom of the stud weld collar after 81 minutes of heating. A negative slip was also observed during the heating process. It consistently increased for 40 minutes, and gradually decreased from 40 to 80 minutes of the heating process by virtue of thermal degradation of the shear connection, as plotted in Fig. 6(b). The slip value rapidly changes from the negative to positive direction at 81 minutes accompanied by the stud shearing failure.

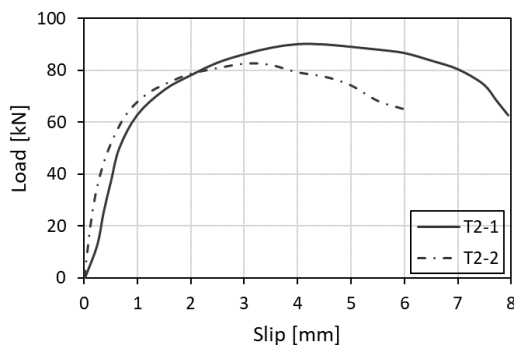
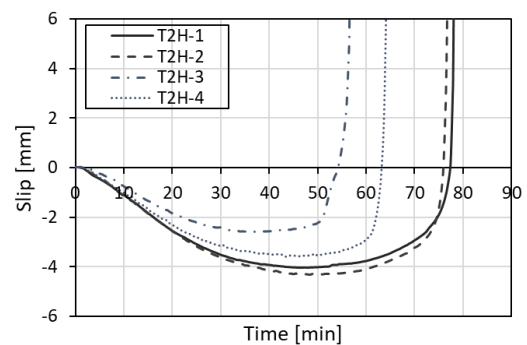
(a) Load-slip relationship at room temperature

(b) Time-slip relationship at high temperature

Fig. 7 Structural response of the transverse deck specimens with through-hole welding

When the shear stud was directly welded on the steel flange incorporating the 0.9-mm transverse deck with a 34-mm diameter hole, the average resistance of 86.5 kN was observed at ULS. The shear resistance reduces by 33% in comparison to the 1.2-mm deck specimen due to the deck thickness, stud welding method and concrete strength. In high-temperature experiments, the longer fire resistance time and higher negative slip were observed in the smaller initial load model, as shown in Fig. 7(b). The stud root area was sheared 77 minutes into the heating process when the initial loading of 30.4 kN was induced (T2H-3, T2H-4); both experiments show a comparable slip-time behaviour. Approximately 8 min of deviation was observed in the 45.6 kN models (T2H-1, T2H-2) because of the concrete crushing around the shear stud.

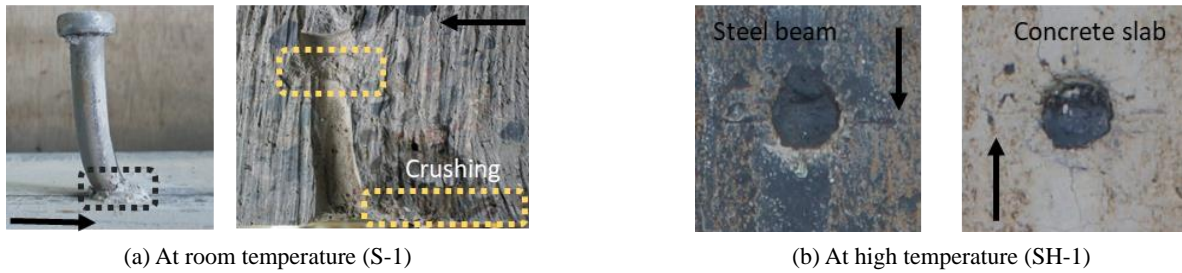
Fig. 8 Failure mode of the solid slab specimens

specimens under ambient and fire conditions with a different shearing location. The shearing occurred right above the weld collar, and the surrounding concrete was crushed in the loading direction at ULS. The overly bent stud shank is depicted in Fig. 8(a). In the high-temperature experiment, the boundary between the flange and the bottom of the weld collar was sheared off, as shown in Fig. 8(b). Higher thermal degradation of the flange shifted the shearing location down by virtue of the temperature gradient in composite beams.

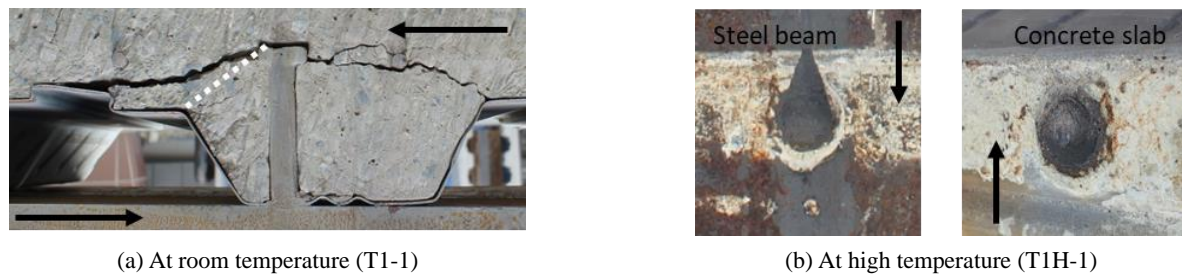
Fig. 9 Failure mode of the trapezoidal deck specimens with through-deck welding

Different failure modes were observed according to the temperature in the transverse deck specimens. The concrete pull-out failure was found at ULS, whereas the stud

shearing occurred at FLS. Considering heat paths and thermal conductivity of steel and concrete materials, the stud root area exhibits a higher temperature compared to the surrounding concrete. This higher thermal degradation of the steel material is the cause of the failure mode change. Concrete cracking around the shear stud was observed at ULS when examining the sliced specimen as provided in Fig. 9(a). This indicates that the shear resistance is determined not by the ultimate stud strength but by the concrete cracking caused by the rotation of the concrete rib. The crack started from the deck stiffener and extended to the deck shoulder through the stud head, which means the deck stiffener can be an influencing factor in determining the shear resistance in modern trapezoidal deck constructions. It makes the concrete cracking surface larger than a deck that does not have the stiffener. The deck stiffener and deck shoulder were deformed in the downward direction because of the concrete failure surface and moment at the stud root. A small amount of concrete crushing was found near the stud root in the loading direction. At high temperatures, the shearing occurred at the bottom of the weld collar in the upper-level stud and the steel flange was peeled off in the lower level stud (Fig. 9(b)) which withstands a higher load than another stud. The failure mechanism of the stud shearing was the same as the solid slab specimen.

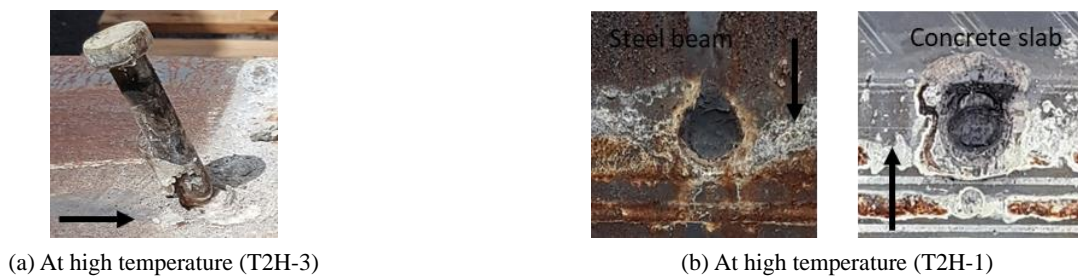
Fig. 10 Failure mode of the trapezoidal deck specimens with through-hole welding

When the shear stud was directly welded to the steel flange via a deck hole, concrete crushing and cracking were the causes of the failure at room temperature. The failure mode also changes to the stud shearing as temperature rises. When 55% of the shear resistance at ULS was induced, the stud shearing and concrete crushing were observed simultaneously. As shown in Fig. 10(a), half of the stud shank was sheared because the stud shearing was accompanied with concrete crushing; the other three shear studs in the same specimen were completely detached. When a smaller load was applied, all the shear studs in the specimen were sheared off as depicted in Fig. 10(b), which is the same failure mechanism as the other types of specimens. Therefore, it can be concluded that the primary cause of the failure at high temperatures is the thermal degradation of the steel materials (stud and flange), regardless of the slab type.

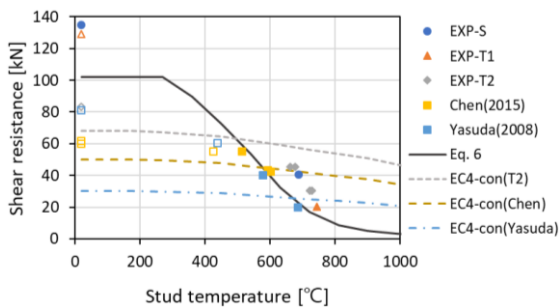
Fig. 12 Design considerations of shear resistance at FLS

The number of studs in a rib is a prominent influencing parameter in determining the shear resistance in a transverse deck slab at ULS, which has been argued regarding the relationship between the strength reduction ratio and the number of embedded studs. However, it also complies with the prediction of Eq. (6) when the stud shearing failure occurs. It can be deduced that the more a shear stud is embedded in a rib, the stronger the resistance of the shear connection at high temperatures.
