# Experimental and numerical studies on the behaviour of corroded cold-formed steel columns

**Abstract.** Experimental investigation and finite element analysis of corroded cold-formed steel (CFS) columns are presented. 11 tensile coupon specimens and 6 stub columns of corroded CFS that had a channel section of C160x60x20 were subjected to monotonic tensile tests and axial compression tests, respectively. The degradation laws of the mechanical properties of the tensile coupon specimens and stub columns were analysed. An appropriate finite element model for the corroded CFS columns was proposed and the influence of local corrosion on the stability performance of the columns was studied by finite element analysis. Finally, the axial capacity of the experimental results was compared with the predictions obtained from the existing design specifications. The results indicated that with an increasing average thickness loss ratio, the ultimate strength, elastic modulus and yield strength decreased for the tensile coupon specimens. Local buckling deformation was not noticeable until the load reached about 90% of the ultimate load for the non-corroded columns, while local buckling deformat

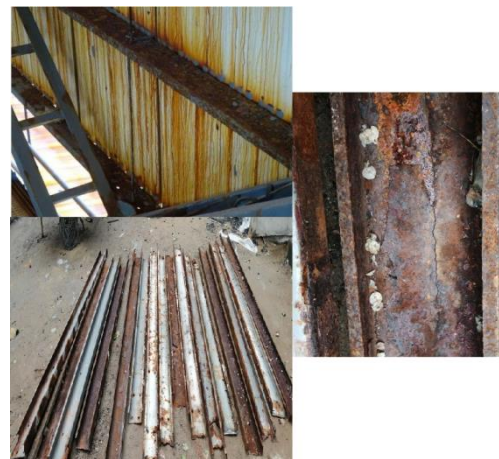
Fig. 1 Experimental materials

All specimens, including tensile coupon specimens and stub columns, came from CFS channel sections of C160x60x20 that had been in service for 4 years in an electrolysis factory (shown in Fig. 1). It can be seen from Fig. 1 that the CFS had been seriously corroded, although they had not been used for a long period of time. The CFS (low-alloy steel (Q345)) was made by using a press brake machine on galvanized steel sheets with a nominal plate thickness of 2.5 mm.

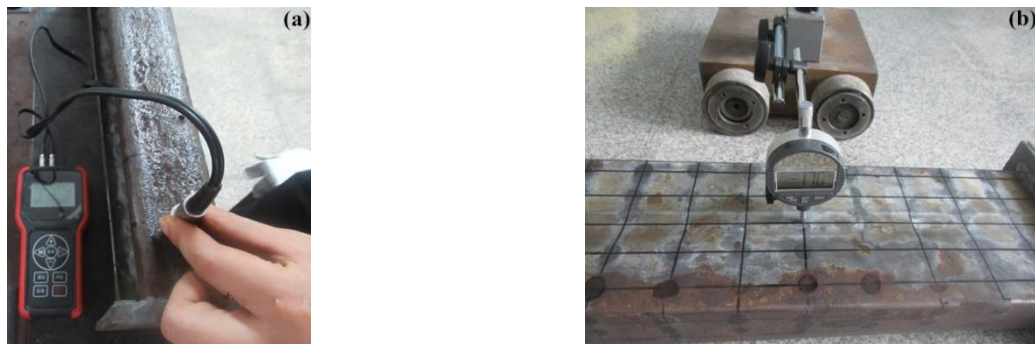
Fig. 5 Thickness (a) and geometric imperfections (b) measuring equipment

Initial geometric imperfection is a very important factor for the stability behaviour of light gauge CFS. The local and distortional initial geometric imperfections of all the stub columns were measured by using a dial indicator (shown in Fig. 5(b)). The initial geometric imperfections were

measured every 50 mm along the column lengths and 9 points were recorded in each geometric imperfection. The initial geometric imperfections along the column lengths are presented in Fig. 7.  $\Delta_w$  and  $\Delta_f$  are the local geometric imperfection measurement positions on the web and flanges, respectively and  $\Delta_d$  is the distortional geometric imperfection. Negative values represent concave imperfection, while positive values represent convex imperfections. As shown in Fig. 7, the initial geometric imperfections along column length have no obvious regularity, and the maximum local and distortional initial geometric imperfections were 1.48 and 2.14, respectively. This shows that the initial geometric imperfections of the columns in practical engineering were quite large. The maximum initial geometric imperfections are given in Table

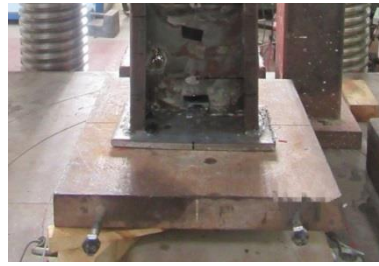
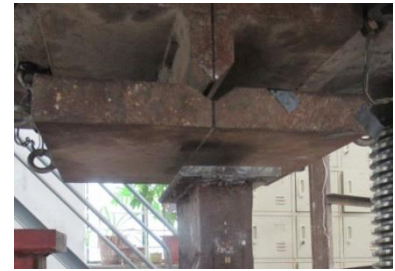
Fig. 9 Experimental set-up

An axial compression test of the stub columns was conducted using a 5000 kN capacity electro-hydraulic servo pressure testing machine (YAW-5000), as shown in Fig. 9. The top knife edge and bottom knife edge were employed to maintain the pinned-end supports, as shown in Figs. 9(b) and 9(c). After the centroid axes of the stub columns were aligned with that of the knife edge, a pre-compression load was applied. The axial compression test was carried out in displacement control at a rate of 0.05 mm/min. The test was stopped when the load drops to 75% of the ultimate load,
