Investigation of shear transfer mechanisms in repaired damaged concrete columns strengthened with RC jackets

Achillopoulou D.V.^{*} and Karabinis A.I.^a

*Reinforced Concrete Laboratory, Civil Engineering Department, Polytechnic School,
Democritus University of Thrace, Vas. Sofias 12, 67100, Xanthi, Greece*

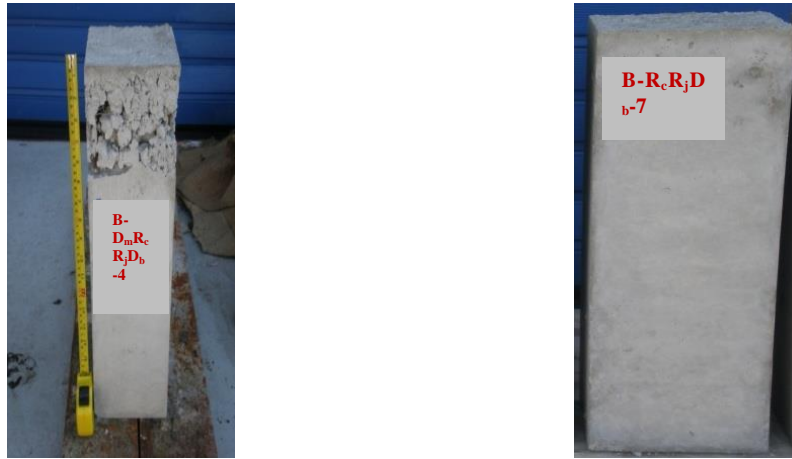
(a) Specimen with construction (initial) damages (b) Specimen without damages (B-R_cR_jD_b-7)

Fig. 3 View of specimens

The size of aggregate in combination with poor consolidation of concrete led to initial construction damages in nine columns (Fig. 3(a), Fig. 4). Those damages are usually observed in columns of old type buildings. Twelve columns were subjected to axial compression in order to create damages due to overloading (pre- loading). The pre-loading (of cores) axial load was applied monotonically (Specimens: B-R_cR_jD_b-6, B-R_cR_jD_b-7) or repeatedly (Specimens: B-D_mR_cR_j-3, B-D_mR_cR_jD_b-4, B-D_mR_cR_jD_b-5, A-D_mR_cR_jD_b-2). The monotonic loading ended after the maximum load was reached, while the repeating pre-loading continued to a decreasing branch (Fig. 5).

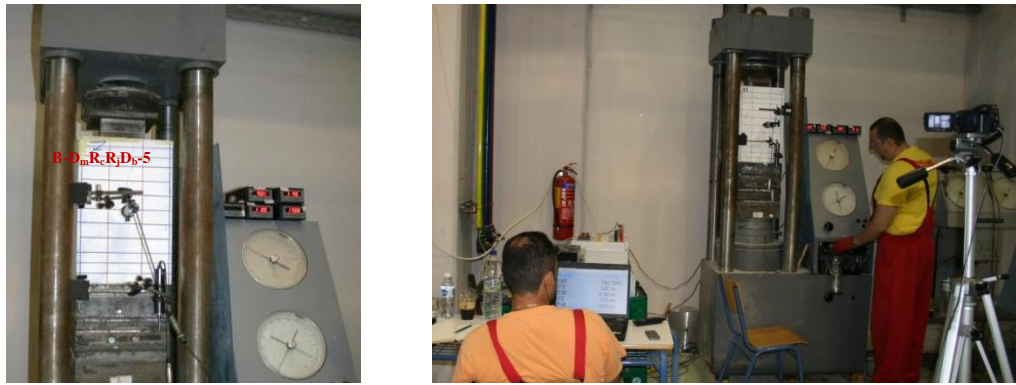
Fig. 6 Experimental setup

concrete. Nine columns were subjected to initial loading (pre-loading), two of them without construction damages. Specimens B-R_cR_jD_b-6 and B-R_cR_jD_b-7 were subjected to axial loading monotonically to maximum axial strain ($\epsilon_{pr-lmax}=6\%$) before jacketing (Fig. 5(a)), while specimens B-D_mR_cR_j-3, B-D_mR_cR_jD_b-4, B-D_mR_cR_jD_b-5 and A-D_mR_cR_jD_b-2 were subjected to pre-loading repeatedly at maximum axial strain $\epsilon_{pr-l}=10\%$ that corresponds to the 85% of the maximum load (cycles of 0.5% axial strain) (Fig. 4(b)). The axial loading is applied in a compression machine with a capacity of maximum load 3000 KN (Fig. (6)). The deformations of the column come out from the measurement of the relative displacements between the two loading platens with the use of Displacement Transducers (DT). The specimen details are included in Table 2.

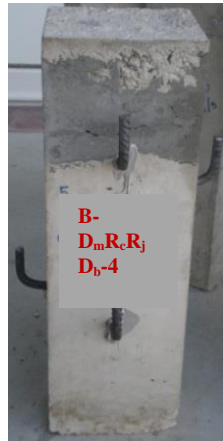
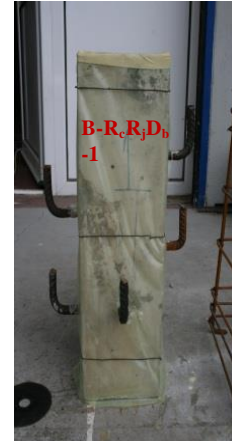
(a) Specimen (core) with dowels (B-D_mR_cR_jD_b-4)

(b) Specimen coated with synthetic polymer sheet (B-R_cR_jD_b-2)

Fig. 7 Preparation of specimens before jacketing

In ten columns 6 dowels of 10 mm diameter were placed (Fig. 7(a)) with injected cementitious grout of very small particle size and thixotropic consistency (steady expansion grout), (Sika

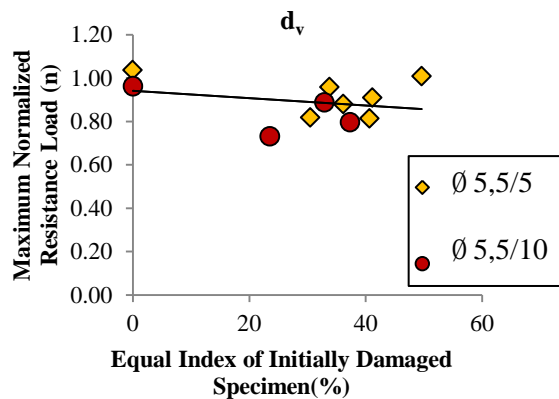
Fig. 12 Maximum normalized resistance load versus section damage index ($n-d_s$) after repair

Fig. 13 Maximum normalized resistance load versus height damage index ($n-d_h$) after repair

Fig. 14 Maximum normalized resistance load versus damage index ($n-d_v$) after repair

Figs. 12, 13 and 14 show the maximum normalized axial load of core versus the percentage of the damage of the section d_s , the percentage of the damage of the height d_h and the equal damage d_v respectively. The maximum load is normalized to the total section ($A_c=150 \times 150 \text{ mm}$) and to the nominal concrete strength of the core f_c according to equation (Eq. (13.d))

Section damage index (d_s) and height damage index (d_h) show dispersion and testify the need of the combination of the two indices to the d_v index in order to predict the resistance load accurately, which is also confirmed from Fig. 14. The correlation though, is quite satisfactory.

Also, Fig. 14 shows that the repaired cores present lower resistance load than the ones without damages which mean that the damage was not fully repaired. Also, minor damages are not necessarily effectively repaired.

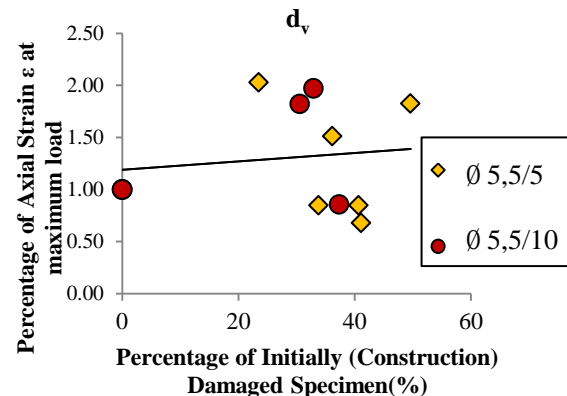
Fig. 15 Percentage of axial strain at maximum load versus section damage index ($\epsilon-d_s$) after repair

Fig. 16 Percentage of axial strain at maximum load versus height damage index ($\epsilon-d_h$) after repair

Fig. 17 Percentage of axial strain at maximum load versus damage index ($\epsilon-d_v$) after repair

Figs. 15, 16 and 17 show high dispersion between damage index d_v , d_s , d_h and the percentage of axial strain at maximum load ϵ (percentage to the ones without damages) is not sufficient. Moreover, Fig. 18, shows the total absorbed energy of cores versus the damage index d_v and

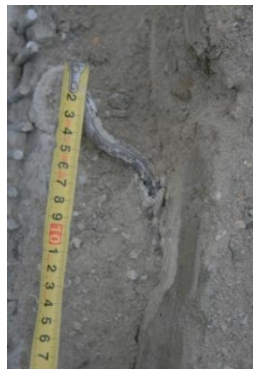
Fig. 22 Cut of jacketed specimen A-D_mR_cR_jD_b-1 after loading- dowel deformation

Fig. 22 shows a cut of the specimen A-D_mR_cR_jD_b-1 after loading and in Fig. 23 is shown the failure of the stirrups at the end of loading.

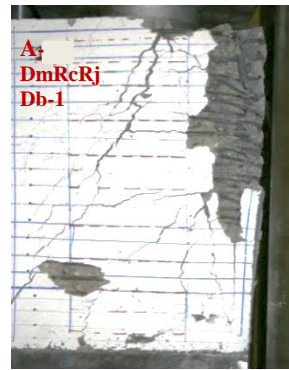
Fig. 23 Jacketed specimen A-D_mR_cR_jD_b-1 after failure of stirrups

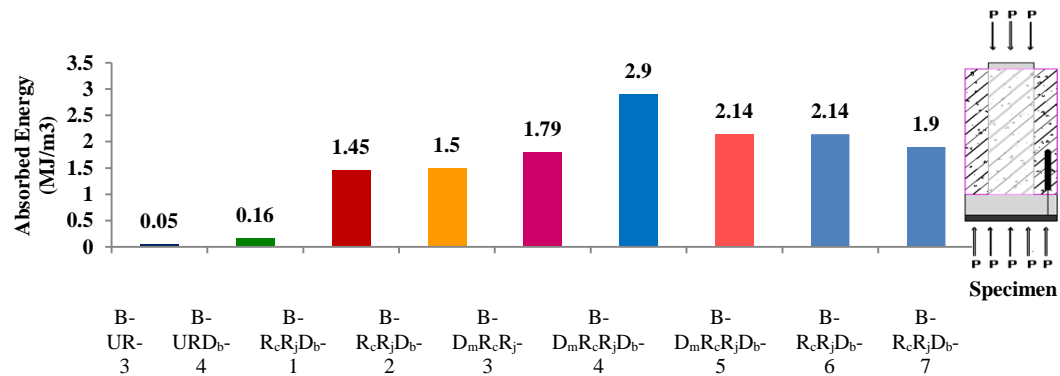
Fig. 29 Absorbed energy up to failure for load pattern B

All above are also confirmed by the energy absorbed diagram (Fig. 29). The repair of the damaged columns was effective since there is no difference at the total absorbed energy comparing with an undamaged element (B-DmRcRjDb-5, B-RcRjDb-6). The activation of confinement is also obvious specimen with the high percentage of stirrups absorbed the most energy (B-DmRcRjDb-4: $\omega_{wj}=1.86$). Finally, again, the energy of the dowel action or cohesion alone or even in combination (B-UR-3, B-URDb-4, B-RcRjDb-1, B-RcRjDb-2,) range in lower values.
