Experimental study on cyclic behavior of reinforced concrete parallel redundancy walls

Yiqiu Lu^a and Liang Huang^{*}

Department of Civil Engineering, Hunan University, Changsha, 410082, China

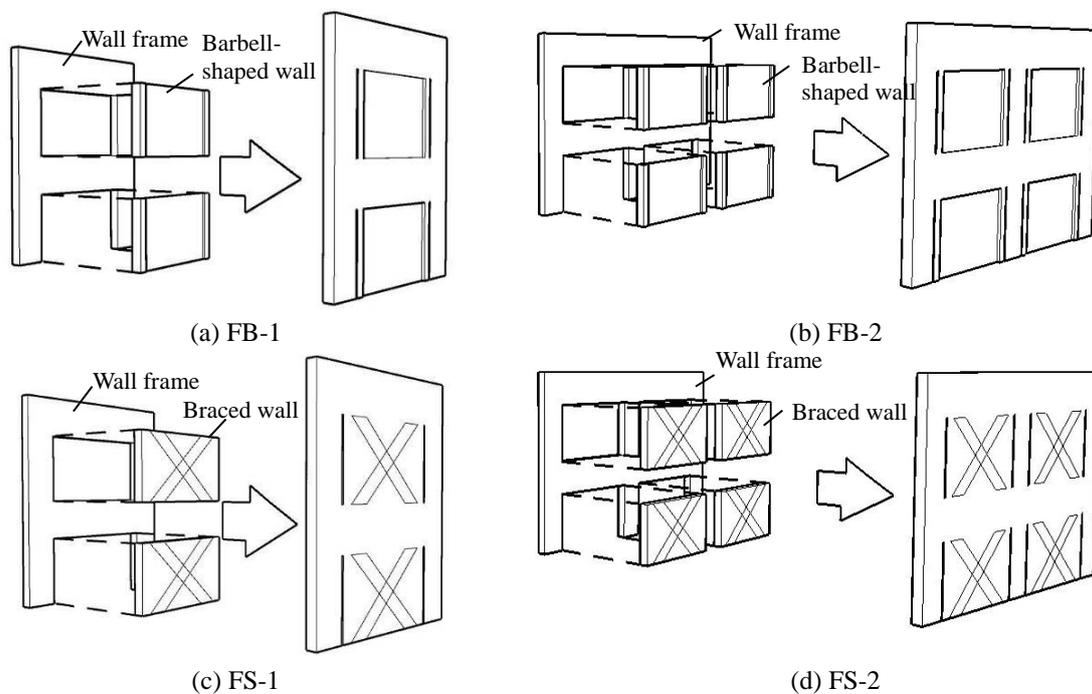
Fig. 2 Parallel redundancy walls

Four parallel redundancy specimen walls were designed. All of the four walls had two parts nested to each other. Part I is a wall frame and part II is a RC wall embedded in the wall frame (Fig. 2). The specimens were 1/2-scale two stories and were divided into two categories (Fig. 2).

For FB-1 and FB-2, the embedded walls were designed to yield and fail first and for FS-1 and FS-2, the wall frame was designed to fail first. Therefore, for FB-1 and FB-2, the section of the embedded walls were weakened to be barbell-shaped, so the barbell-shaped walls were expected to yield and fail first. Because of the good excellent energy dissipation capacity of the barbell-shaped walls, the barbell-shaped walls would dissipate a considerable part of earthquake energy and the wall frame was expected to be capable of resisting additional loads after earthquakes. Contrarily, for FS-1 and FS-2, the embed walls were strengthened by concealed bracings so that the wall frame was expected to dissipate energy and fail first. There was a gap of 10 mm between the wall frame and the embedded walls. Specimens FB-1 and FS-1 were one-bay structures with aspect

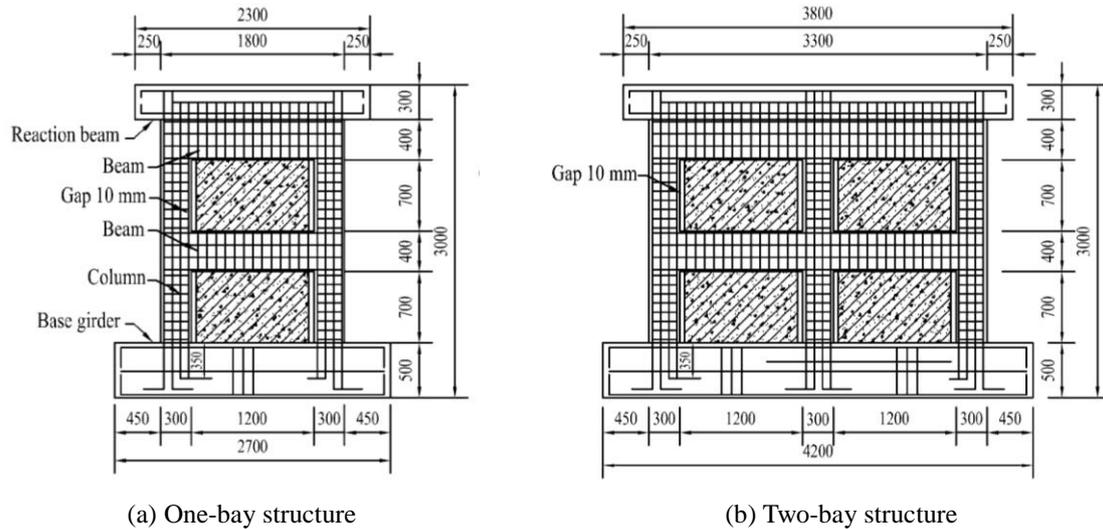
Fig. 3 Geometry of specimens (all dimensions in mm)

ratio 1.3, whereas specimens FB-2 and FS-2 were two-bay structures with aspect ratio 0.71. The overall dimensions of the specimens are shown in Fig. 3. The longitudinal and transverse reinforcement of the beams and columns were all the same in wall frame the four specimens.

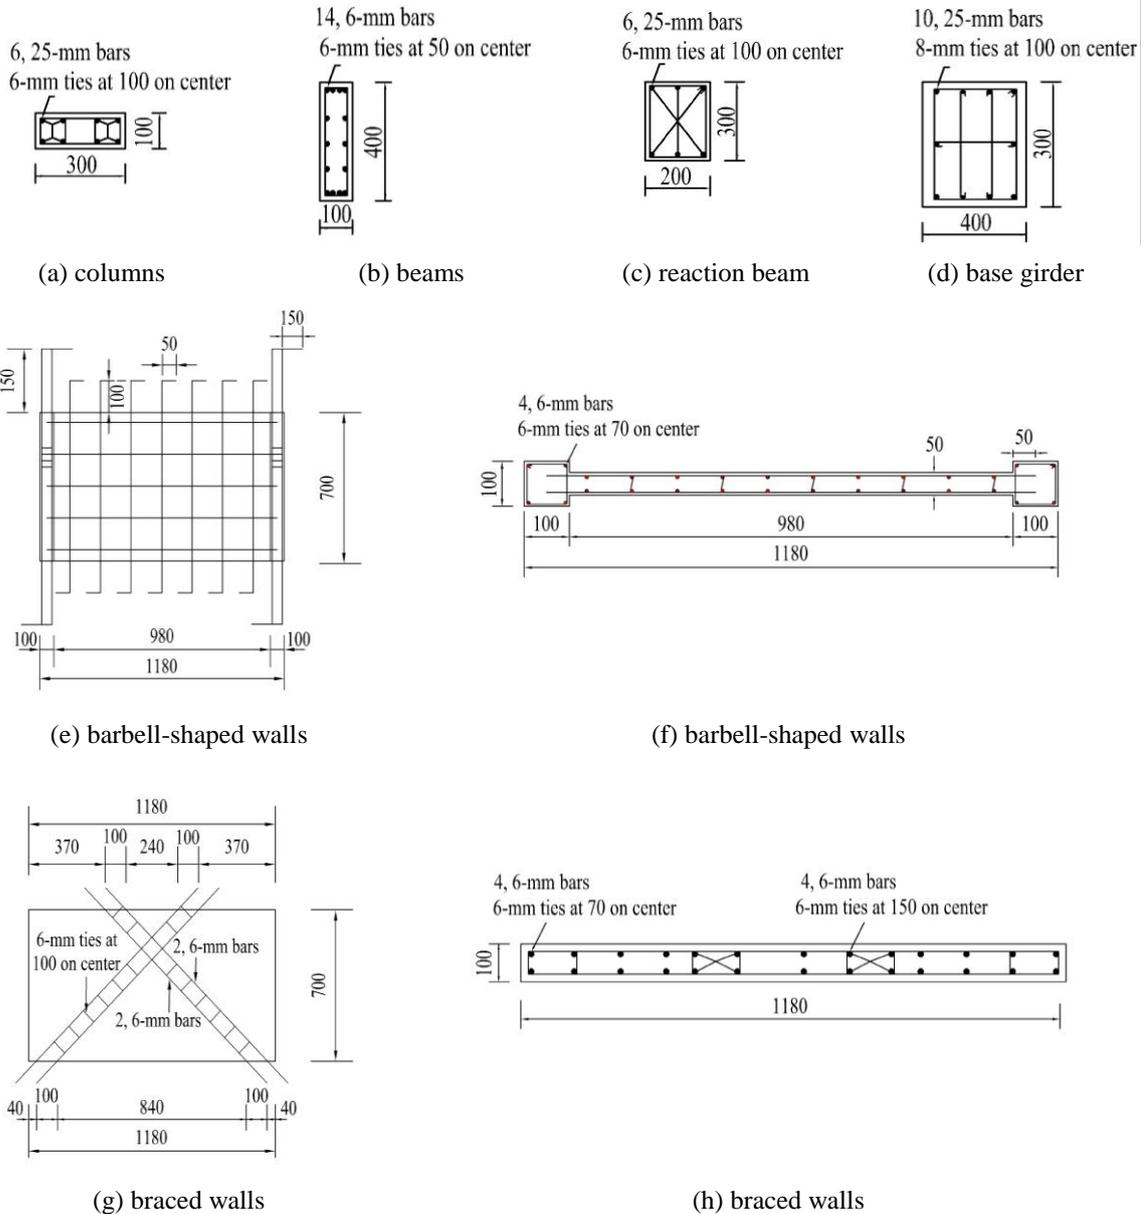
Fig. 4 Specimen details: cross sections and reinforcement (all dimensions in mm)

Vertical reinforcement was anchored in a 500 mm thick base girder fixed by concrete blocks in both sides. A reaction beam with a width and depth of 200 and 300 mm, respectively, was cast on the top of the wall panel, and a hydraulic actuator was attached to the specimen at the mid-depth of the top beam. Crossed-inclined bars were provided at the connection of the wall frame and the base girder to prevent sliding failure. The material properties of the reinforcement and concrete are summarized in Table 1. Steel reinforcement was detailed in accordance with the current practice in China (GB 50010-2010 and GB5001-2010). The design details of the specimens are shown in Fig. 4. The construction processes are as follows: 1) assemble bar cage for foundation block, including longitudinal reinforcement originating in the foundation; 2) cast concrete for foundation; 3) assemble reinforcement for wall (frame and embedded wall) and top beam; 4) cast wall concrete.

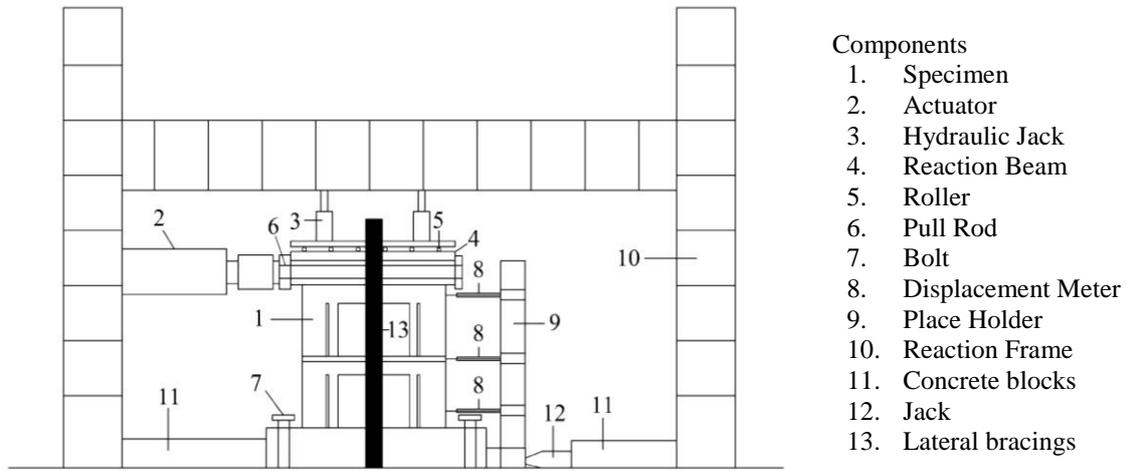
Fig. 5 Test setup

horizontal force of 1500 kN, with a maximum horizontal displacement of 200 mm, and a vertical force of 600 kN applied by means of a hydraulic jack. The reaction beam and base girder were also designed to simulate the boundary conditions of a shear wall panel in a generic building under seismic effects. To simulate the bracing effects provided by the floors, bracings were applied at the middle beam to prevent out-of-plane movements. Jacks that provided vertical force were placed on the top beam to simulate gravity loading.

- Components
1. Specimen
 2. Actuator
 3. Hydraulic Jack
 4. Reaction Beam
 5. Roller
 6. Pull Rod
 7. Bolt
 8. Displacement Meter
 9. Place Holder
 10. Reaction Frame
 11. Concrete blocks
 12. Jack
 13. Lateral bracings

The test setup is shown in Fig. 5. The testing equipment is capable of applying a maximum

Instrumentation was selected to monitor applied loads, deformations, and strains in the reinforcing steel bars. Displacement meters were placed along the height of the specimens to monitor the lateral displacement, as shown in Fig. 5. One was installed at the top of the specimen to monitor top displacement. The second one was installed at a distance of 200 mm from the wall base to measure the sliding of the base. A third one was installed at the middle of the wall to measure the middle displacement.

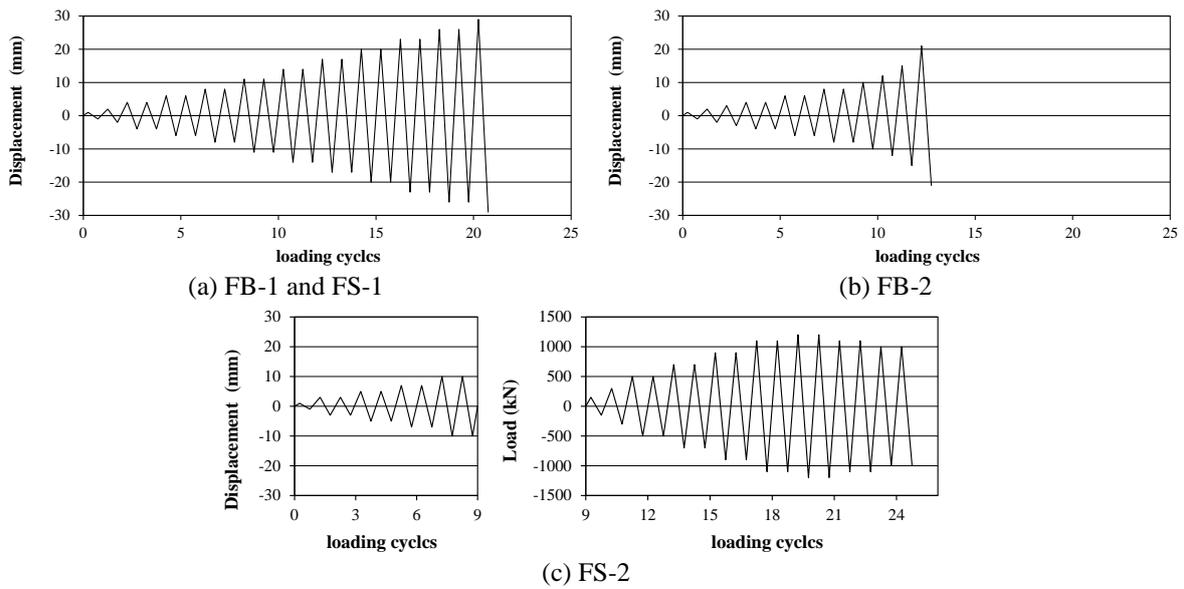
Fig. 6 Loading history for the experimental program

Cyclic displacements were applied according to the loading history, which began with very small values and gradually increased until the failure of the specimen. Each specimen load cycle consisted of a half cycle in the positive direction and a half cycle in the negative direction. The displacement increment adopted in the loading history was divided into three categories. An increment of 1 mm was adopted to push the specimens to the cracking load in both directions; an increment of 2 mm was used during subsequent cycles to push the specimens to the yield point, such that the top deflection reaches integer multiples of the yield displacement in both directions;

and after the yield point, an increment of 3 mm was adopted to continue the test until the specimen experienced a significant loss of capacity. After the cracking load, each cycle was repeated two times until the specimen was destroyed or the lateral load decreased to 80% of the ultimate load level of the specimen (Park 1989). The axial load adopted for FB-1, FS-1, FB-2, and FS-2 were 100, 100, 600, and 600 kN, respectively. The loading history of specimen FS-2, however, was different from those of the other three specimens. During the test, the bolt connecting the hydraulic servo actuator and the reaction steel frame snapped, hence the test had to be stopped. Due to the concern for the security of the personnel, the axial load was reduced from 600 to 100 kN. In the following text, FS-2' represents FS-2 with axial load of 600 kN and FS-2'' represents FS-2 with axial load of 100 kN. In addition, because there had already been plastic deformation in the wall, load control was used in further tests. Fig. 6 shows the loading history of the four specimens.

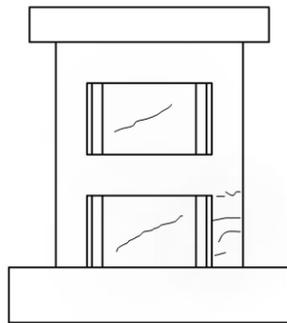
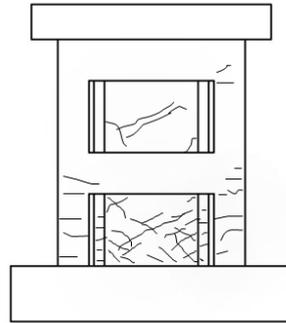
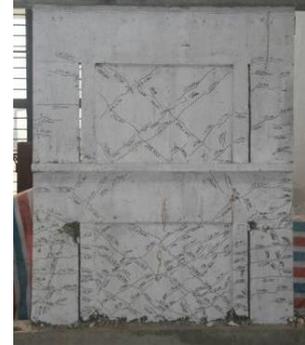
Fig. 7 Crack pattern of FB-1

(a) the stage of cracking

(b) the stage of yielding

(c) the stage of failure

Specimens FB-1 and FB-2 behaved in a similar manner in the failure process, but differences were still observed during the test. First, for FB-1, the reason for failure of the specimen was the spallation of the concrete at the bottom of the barbell-shaped walls. For FB2, the large shear crack caused the failure of the barbell-shaped walls. This led to a great drop in the horizontal load-carrying capacity of the specimen. Walls FB-1 and FB-2 were basically governed by bending failure and shear failure, respectively, because the aspect ratios of two specimens were 1.3 and 0.71. For the wall beams, more shear cracks were notably observed in FB-2. During the failure process of FB-1, the main damage focused on the concrete at the bottom of the barbell-shaped walls, hence no great damage could be found in the other locations of the wall. However, for FB-2, the wall beams could also behave as a significant role in resisting shear load because the wall beams were surrounded by the four barbell-shaped walls. Thus, there were many shear cracks observed.

The four specimens showed very good cooperative work performance during the test. The crack patterns and failure modes of the four specimens are shown in Figs. 7, 8, 9 and 10. There were some common features among these four specimens.

First, the failure of one part led to the overall damage while the other wall could still bear capacity. For walls FB-1 and FB-2, the wall frame was still in good condition after the failure of the barbell-shaped wall. When the wall failed, the bottom concrete of the barbell-shaped wall was completely damaged. However, the concrete at the bottom of the column was slightly crushed, as can be seen in Figs. 7 and 8, hence it still could bear additional loads after the failure of the barbell-shaped wall. As for walls FS-1 and FS-2, the failure of the wall frame caused the damage of the overall wall, and the braced walls could still bear capacity, as can be seen in Figs. 9 and 10. Thus, hierarchy existed in the failure process of the parallel redundancy walls. If one desires to obtain different seismic behaviors, the embedded wall can be designed to different forms. This behavior is different from that of traditional walls with no separation of primary and secondary parts.

Second, in all specimens, as Figs. 7, 8, 9 and 10 show, the side columns developed horizontal cracks, and the embedded walls and the middle columns developed diagonal shear cracks, indicating the two parts had different dissipation mechanism. Flexural behavior occurred in the side columns while shear behavior occurred in the embedded walls. Such behavior also indicated

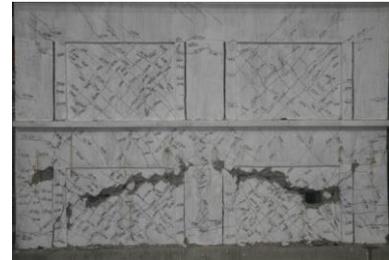
Fig. 8 Crack pattern of FB-2

(c) the stage of failure

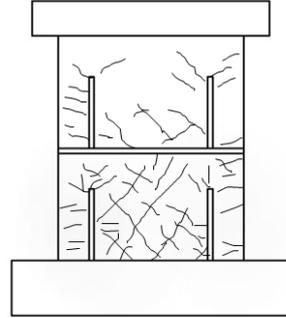
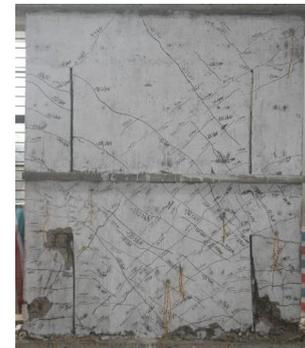
Fig. 9 Crack pattern of FS-1

(b) the stage of yielding

(c) the stage of failure

The failure of the wall frame caused the overall failure of the wall for both FS-1 and FS-2. The difference was the damage location, where it was the wall columns for FS-1 and the wall beams for FS-2. For FS-2, the greater stiffness and higher lateral capacity enabled the braced walls to provide more lateral shear capacity. Therefore, the wall beams and the braced wall collaboratively resisted shear loads. Finally, the overall wall failed by the damage of the wall beams due to its low capacity compared with the braced wall. However, for FS-1, braced walls resisted less shear loading and the bending load for wall columns was greater than the shear load for wall beams. Hence, the wall columns were damaged and the wall beams remained in good condition.

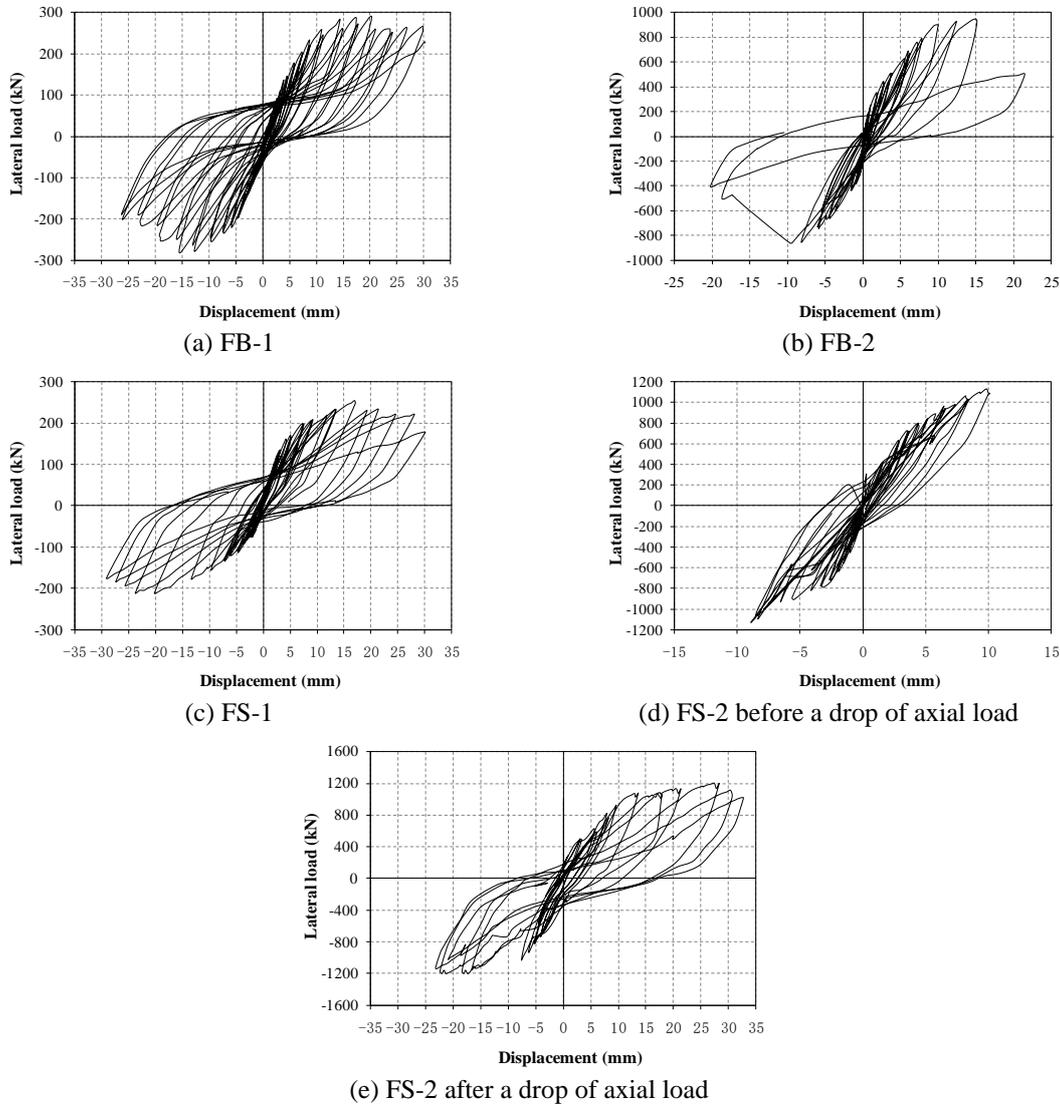
Fig. 11 Hysteresis loops of the specimens

Fig. 11 shows the hysteresis loops of the four specimens. Two hysteresis loops could be obtained for FS-2 because it was loaded twice with different axial loads. All walls experienced

stages of cracking, yielding, and failing. Before cracks appeared, the wall was basically elastic and the loading curve overlapped with the unloading curve. After that, the loops formed a spindle shape and its enclosed area was small, which indicated that little energy was dissipated at this stage. Deterioration of strength and stiffness was not very obvious. At the level of yielding, the hysteresis loops showed a much wider and thicker anti-S shape where the larger enclosed area of the loop indicated that much higher energy was dissipated compared with that of previous stages. These four specimens were shown to possess desirable seismic behavior.

The hysteresis loop of FB-2 had a relatively rapid drop of strength after reaching the maximum strength because of the small aspect ratio of 0.71. This indicated a relatively low capability of energy dissipation and ductility compared with that of FB-1. In spite of this, the wall could still

sustain cyclic load after the rapid drop of strength, and the enclosed area of the loop was still large, which indicated good ductility. The loop of FS-2 was unsymmetrical after the axial load was decreased because of the plastic deformation of the wall in the first loading. Displacements in the positive direction were greater than those in the negative direction.

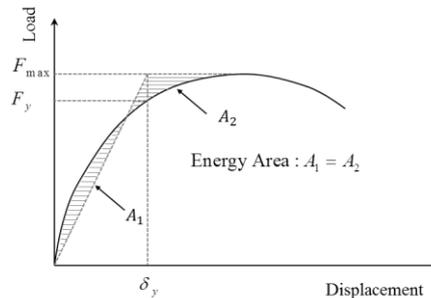
Fig. 12 Yield point determination

Measured displacement and lateral loads for the cracking, yielding, peak, ultimate points, and ductility capacity of the specimens are listed in Table 2. Yielding point was determined based on the equal energy area method, as shown in Fig. 12. Ultimate point was defined as the point on the envelope of the hysteretic curves at which the lateral load dropped to 80% of its maximum value (Park 1989). Displacement ductility was defined as the ratio of ultimate displacement to yield displacement. Load-displacement relationships of each specimen, which were obtained from the envelopes of the hysteretic curves, are shown in Fig. 13. The load-displacement curve of FS-2' and FS-2'' are both plotted.

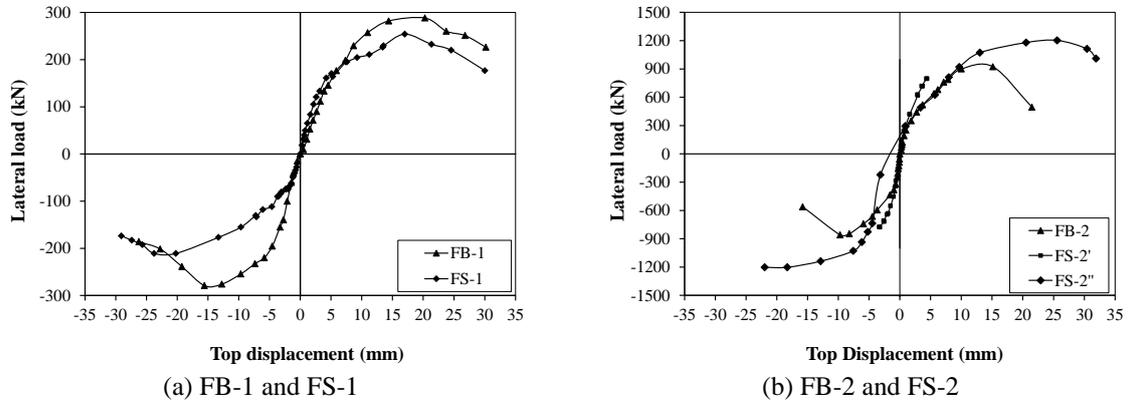
Fig. 13 Shear force-displacement envelope curves of specimens

It shows that the load-displacement envelopes for one-bay structures were more stable than two-bay structures. The bearing capacities of the two-bay structures were about three to five times as much as those of one-bay structures, which indicated that aspect ratio had a significant effect on

ductility and bearing capacity of the specimen. With the increase of aspect ratio, the bearing capacity improved as the ductility decreased. Moreover, the bearing capacity of specimen FB-1 was about 1.24 times as much as that of FS-1, whereas the bearing capacity of FS-2'' was about 1.3 times than that of FB-2. Ductility capacity of specimens FS-1 and FS-2 were basically the same as those of specimens FB-1 and FB-2, respectively. This showed that, the number of bays (one or two bay) affects the ductility capacity of the system. Also, the type of embedded wall affects the bearing capacity of the system more significantly.

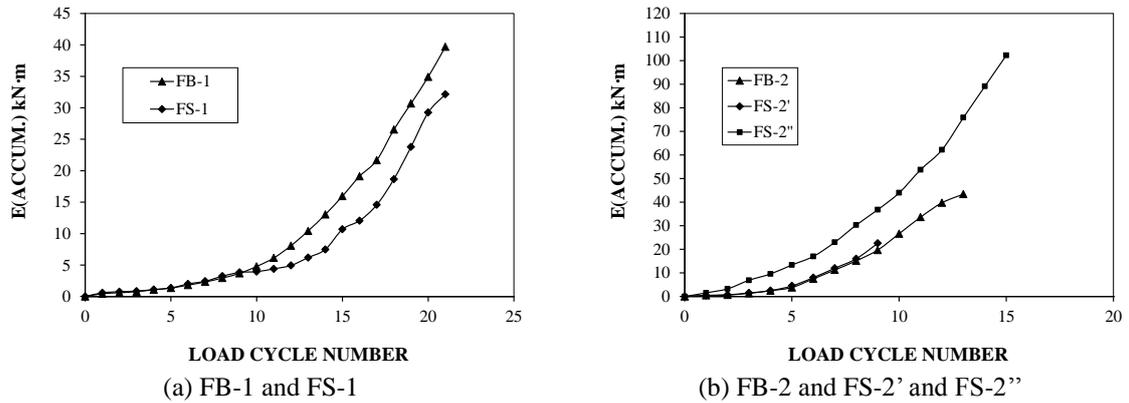
Fig. 14 Cumulative energy dissipated versus load cycle number

Of particular significance to the seismic performance of RC walls is the energy dissipation capacity. There are different ways to evaluate the energy dissipation capacity of a structure. Energy dissipation of the test specimens under cyclic load in this study was defined as the area enclosed by the load-displacement hysteresis loops. Fig. 14 plots the cumulative dissipated energy versus the load cycle number for specimens FB-1, FS-1, FB-2, FS-2' and FS-2''. Because FS-2 was

loaded twice, there are two energy dissipation curves for FS-2. In the parallel redundancy walls, two parts were nested to each other, and each part was independent and can withstand vertical and lateral loads alone. Therefore, an effective energy absorption mechanism was formed in which the weaker part would yield and fail first, thus absorbing a greater degree of the energy exerted by earthquakes. In FB-1, the barbell-shaped walls failed first, whereas in FS-1, the wall frame failed first. The dissipated cumulative energy corresponding to each load cyclic number was slightly larger in specimen FB-1 than in FS-1. This is because the barbell-shaped walls in FB-1 were more seriously damaged than the wall frame in FS-1, which dissipated more energy than FS-1. This indicates that embedded wall has a significant effect on the energy absorption mechanism of parallel redundancy walls. The energy capacity for FB-2 was quite similar with FS-2' when FS-2' had the same axial load with FB-2. This was because both of the walls were under very small displacement and the energy capacities for both walls were very low, the difference could not be seen clearly. However, when the axial load for FS-2'' was lowered down to 100 kN, the energy capacity for FS-2'' was much larger than FB-2. This indicates that axial load also has an influence on the energy dissipation capacity.

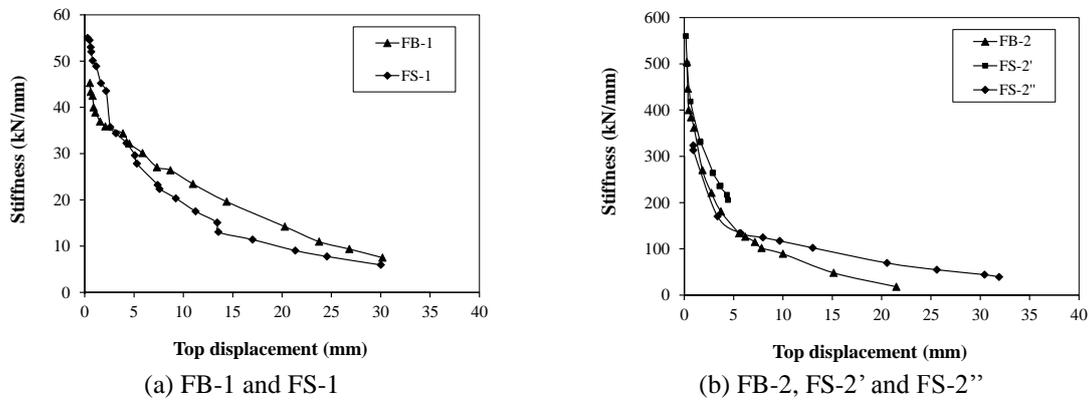
Fig. 15 Secant stiffness versus top displacement

Fig. 15 illustrates the variation of secant stiffness with top displacement of the four specimens. For reasons previously discussed, specimen FS-2 was loaded twice. The two cases of loadings of FS-2 are shown separately in Fig. 15 as FS-2' and FS-2''. For all the specimens, the stiffness gradually decreased. When the axial load ratio and aspect ratio were the same, the initial stiffness of wall frames with braced walls were larger than walls with barbelled walls. This is shown in Fig. 15, where the initial stiffness of FS-1 and FS-2' were 55 kN/mm and 560 kN/mm, which are larger than FB-1 (45 kN/mm) and FB-2 (504 kN/mm), respectively. However, FS-1 experienced greater stiffness deterioration than FB-1. This indicates that as the embedded walls get stronger, the initial stiffness becomes larger and stiffness deterioration becomes more serious. In addition, decreasing the axial load decreased the initial stiffness. This is also shown in Fig. 15. When axial load was decreased to 100 kN for FS-2, the initial stiffness was much smaller than FS-2' which held the axial load of 600 kN.
