The effect of mortar type and joint thickness on mechanical properties of conventional masonry walls

Abstract. Masonry walls are of a complex (anisotropic) structure in terms of their mechanical properties. The mechanical properties of the walls are affected by the properties of the materials used in wall construction, joint thickness and the type of masonry bond. The carried-out studies, particularly in the seismic zones, have revealed that the most of the conventional masonry walls were constructed without considering any engineering approach. Along with that, large-scale damages were detected on such structural elements after major earthquake(s), and such damages were commonly occurred at the brick-joint interfaces. The aim of this study was to investigate the effect of joint thickness and also type of mortar on the mechanical behavior of the masonry walls. For this aim, the brick masonry walls were constructed through examination of both the literature and the conventional masonry walls. In the construction process, a single-type of brick was combined with two different types of mortar: cement mortar and hydraulic lime mortar. Three different joint thicknesses were used for ea

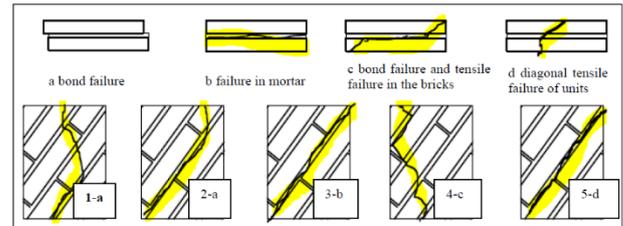
Fig. 1 Failure mechanisms for shear specimens (Van der Pluijijm 1999, Schueremans 2001)

Masonry walls usually reach failure mechanism under out-of-plane effects with shearing effects. In walls with rather large cross-sections are unlikely to exhibit damages originating from normal stresses. Masonry walls commonly bear normal stresses at a very little rate of their capacities and normal stresses in the walls do not exceed 10-15% of the existing capacity. The shearing mechanism occurs owing to the fact that the mortar fails or due to adherence loss between the masonry unit and the mortar. Different failure modes can take place depending on the magnitude and direction of the normal stresses occurring in the wall (Fig. 1). Fig. 1(a) shows a bond failure mechanism while Fig. 3(b) shows mortar failure. In addition, Fig. 4(a) shows bond failure and tensile failure and Fig. 5(a) shows diagonal tensile failure of units.

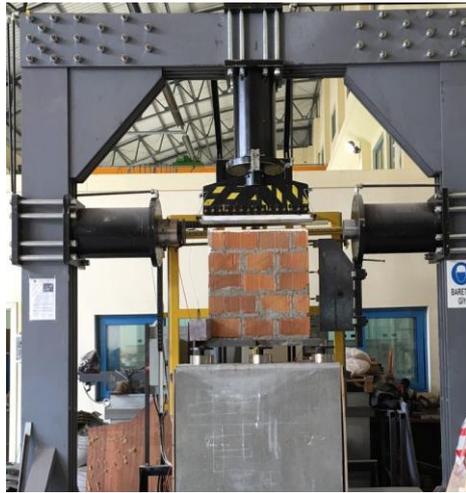
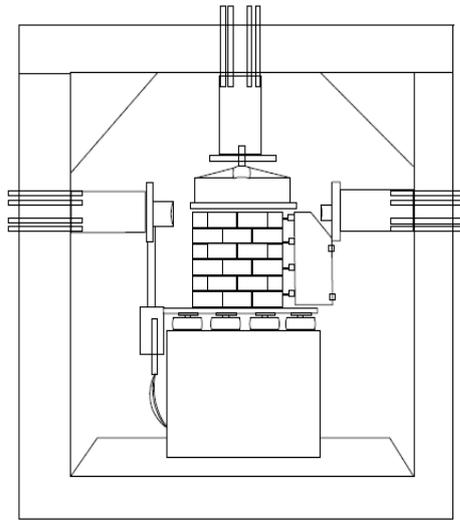
In this study, the test setup in Fig. 3 was established to determine the mechanical behaviour of the masonry walls under vertical and horizontal loading. Before the loading tests, the upper surface of the walls and also the lateral surface to which the horizontal load was applied had been capped with the gypsum mortar. The masonry walls were laid to a reinforced concrete footing with a height of 1.10 m. For the vertical loading, a hydraulic ram with a capacity of 2000 kN was used and uniform distribution of the load was provided via a steel plate placed under the cylinder rollers. In addition to this, there was another hydraulic ram with a capacity of 500 kN to provide horizontal loading. The masonry walls were subjected to a combination of vertical preloading and in-plane horizontal shear loading at 28th day after the production. In order to measure displacements occurred during the horizontal loading, the instrumentation including four LVDTs was fitted at different heights of the wall. The load measurements were taken by the load cells, and all load-displacement values were recorded simultaneously in a data acquisition system.

Fig. 3 Experimental setup

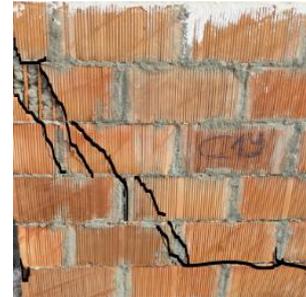
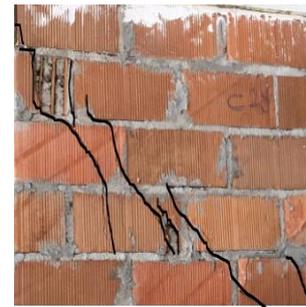
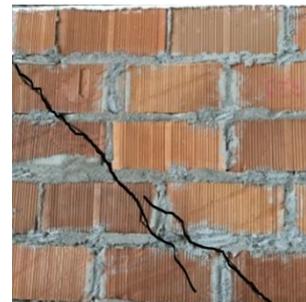
Fig. 4 Damages of the cement mortar walls

As seen in Fig. 4, a main diagonal crack was observed extending from the top row brick, to which the lateral load was applied, to the bottom row. However, several cracks formed on the walls apart from this main crack. In general manner, the damages initiated from the brick surface and proceeded through joint surfaces in the form of capillary crack. The damages that occurred in the bricks were more obvious due to the fact that the compressive strength of the

mortar was higher. It must be noted that spalling-type damages also occurred in the bricks of the C10 and C20 walls. The strength of the mortar used was nearly 31% more than that of the brick. The distinct disintegration was observed at the brick-mortar interfaces of the C10 wall and there were more obvious damages in the masonry units on this wall than on the other walls. Another noteworthy point was that the mortar and brick acted together in the wall of C30 and a main crack in the form of a significant line occurred during the loading. In the lower left zone (the lateral load side) of the walls, tensile stresses formed at the supporting zone.

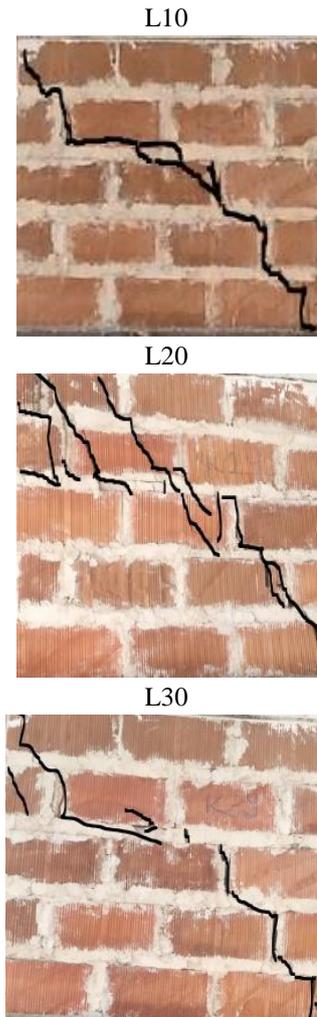
Fig. 5 Damages of the lime mortar walls

At the end of the loading, the main diagonal crack occurred on all three walls (Fig. 5). The tensile stresses formed at the bed joints, and under the vertical load, distinct segregations at the head joints were clearly observed. Since the strength of the mortar was close to the strength of brick, the brick acted in conjunction with the mortar under the loads. In general, at the left (the lateral load side) bottom bricks, the tensile damages occurred whereas the brick sections that adjacent to the head joints were also damaged.

While the damage was along a single diagonal line on the L10 wall, additional capillary damages were observed on the other two walls. The failure mechanism occur on the walls as a result of the shear forces.

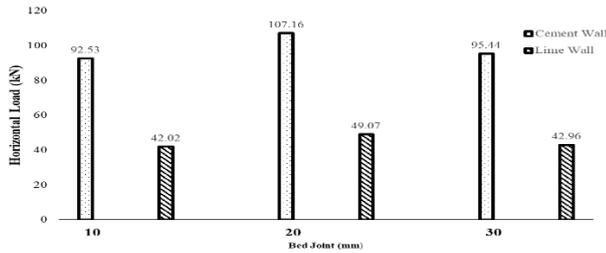
Fig. 6 Relation between the bed joint thickness and the lateral load capacity of the walls

Examination of the brick masonry walls under the in-plane loads pointed to the fact that both type of mortar and joint thickness mainly affects the lateral load capacity of the walls. According to the test results, for each joint thickness, the lateral load capacity of the cement mortar walls was approximately twice that of the lime mortar walls (Fig. 6). In term of the bed joint thicknesses, the walls with the bed joint thickness of 20 mm, whether made with cement mortar or lime mortar, were found to have higher lateral load capacity, and this was followed by the walls with the bed joint thicknesses of 30 mm (Fig. 7). The highest lateral load capacity was 107.16 kN in the C20 wall while the lowest ones were observed in the L30 and L10 walls as 42.96 and 42.02 kN, respectively.

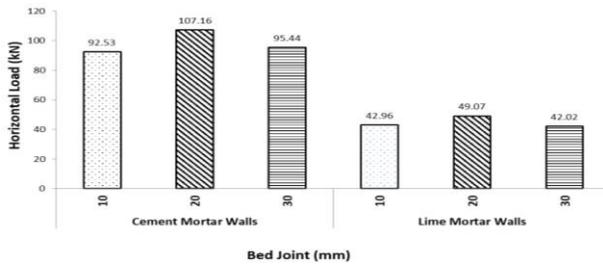
Fig. 7 Relation between the mortar type and the lateral load capacity of the walls

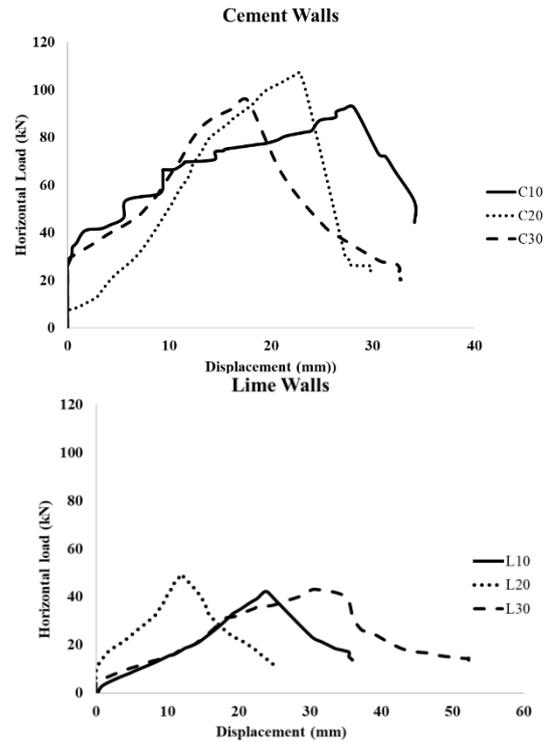
The displacements in the cement mortar walls were up to 32.67 mm whereas they were as high as 52.67 mm in the lime mortar walls. When the test results were evaluated with respect to the bed joint thickness, the lowest displacements were obtained in the 20 mm-walls. As seen in Fig. 8, the walls failed to conserve their energy when the ultimate load point was exceeded. Once C10 wall reached the ultimate load, no longer considerable displacement occurred.

Fig. 8 Load-displacement curves of the walls
