Behavior of composite box bridge girders under localized fire exposure conditions

Gang Zhang^{*1}, Venkatesh Kodur², Weifa Yao³ and Qiao Huang³

Abstract. This paper presents results from experimental and numerical studies on the response of steel-concrete composite box bridge girders under certain localized fire exposure conditions. Two composite box bridge girders, a simply supported girder and a continuous girder respectively, were tested under simultaneous loading and fire exposure. The simply supported girder was exposed to fire over 40% of its span length in the middle zone, and the two-span continuous girder was exposed to fire over 38% of its length of the first span and full length of the second span. A measurement method based on comparative rate of deflection was provided to predict the failure time in the hogging moment zone of continuous composite box bridge girders under certain localized fire exposure condition. Parameters including transverse and longitudinal stiffeners and fire scenarios were introduced to investigate fire resistance of the composite box bridge girders. Test results show that failure of the simply supported girder is governed by the deflection lim

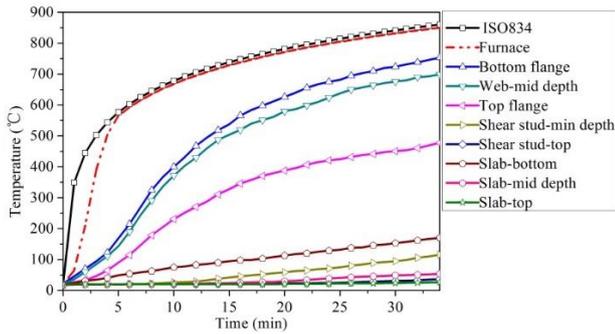
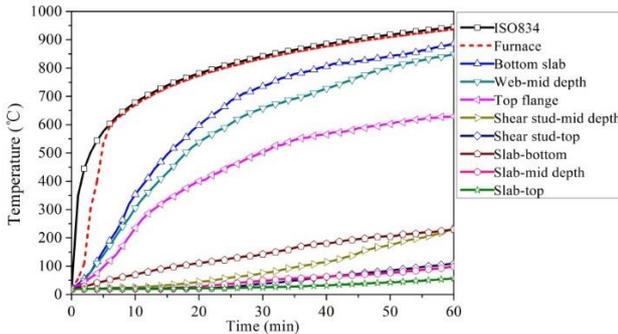
Fig. 6 Measured temperature profile in girders CG1 and CG2 as a function of fire exposure time

(a) Composite girder CG1

(b) Composite girder CG2

Girders CG1 and CG2 were exposed to ISO834 fire exposure (ISO 1999) in each test. The measured temperature-time curves at various cross-sectional locations in each girder are shown in Fig. 6. It can be seen from Fig. 6 that top flange in each box girder has much lower temperature as compared with bottom flange throughout the fire exposure duration. This is mainly attributed to the fact that the concrete slab provides insulating effect to the top flange of the steel girder and concrete due to its higher thermal capacity and lower thermal conductivity properties can absorb much of the heat from the top flange. Also, the top flange is not directly exposed to fire.

Shear studs present in the composite girder experience much lower temperatures as compared with the top flange temperature. This is due to the fact that the shear studs are embedded in concrete and concrete slab, acting as heat sink, absorbs much of the heat from studs. Temperatures in concrete slab are much lower than that in steel web, and this produces significant thermal gradients along the depth of the composite girder section. These gradients induce thermal stresses which in turn influence structural behavior of fire exposed composite girders.

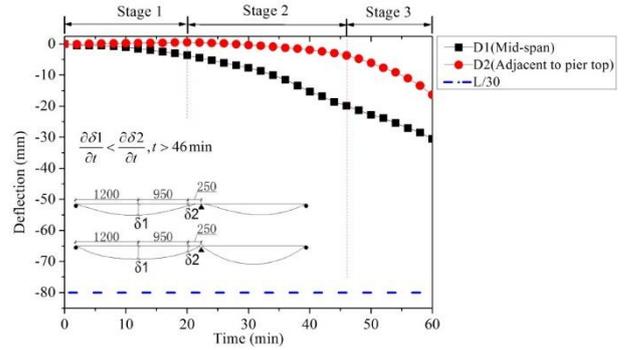
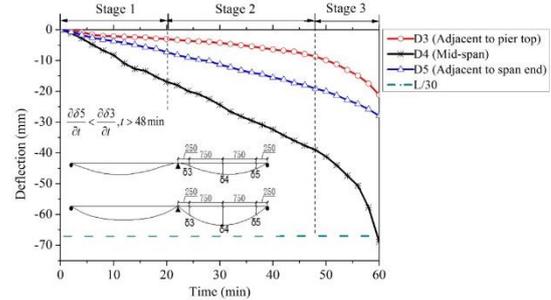
Fig. 8 Details of PC box scaled model girder

(a) span 1 in composite girder CG2

(b) span 2 in composite girder CG2

Fig. 8(a) shows the deflection progression in span 1 of composite girder CG2 plotted as a function of fire exposure time. The deflection response plotted corresponding to locations D1 and D2 on girder CG2 (shown in Fig. 3(b)) can be grouped under three stages. In the initial stage of fire exposure (up to 20 min), deflections at locations D1 and D2 increase slowly mainly caused by the thermal bowing resulting from high temperature gradient developed between the bottom flange and web and concrete slab of the girder section. At this stage, though strength and elastic modulus of steel and concrete reduce slightly, the structural stiffness of composite box girder in this span remains almost unchanged this is mainly attributed to the fact only less than 40% of the span is exposed to fire, and also location D2 is located in the hogging moment zone. In the next stage of fire exposure

(between 20 and 46 min), deflections at locations D1 and D2 increase slightly due to the considerable reduction in strength and stiffness properties of steel in fire exposure zone. In the final stage of fire exposure (after 46 min), deflection at location D2 increases with a more rapid pace than that at location D1, this is mainly contribute to the fact that the web and bottom flange adjacent to the pier top experiences significant buckling resulting from lower initial bending capacity and faster degradation of bending capacity during fire exposure. Thus, the function of the hogging moment zone fails and the two-span continuous composite box girder has transformed into two simply composite box girders.

The deflection progression at locations D3, D4 and D5 (See Fig. 3(b)) in span 2 of girder CG2 plotted as a function of fire exposure time is shown in Fig. 8(b). During the early stage of fire exposure (up to 20 min), deflections at all locations increase gradually with fire exposure time. The initial deflections are mainly caused by high temperature gradients through the girder section and the slight reduction in elastic modulus of steel resulting from the elevated temperature in the girder section. Between 20 and 48 min, the rate of deflection increases more quickly due to faster degradation of strength and stiffness in steel at high temperatures. After 48 min, generally deflection in each location increases rapidly due to the spread of plasticity and the effect of high-temperature creep. As shown in Fig. 3, locations D3 and D5 were symmetric about the center of the span, and located in the hogging moment zone and the positive moment zone respectively. The rate of rise in deflection at location D3, within the hogging moment zone, is lower than that at location D5 in the positive moment zone. However, the deflection in the hogging moment zone increases at a faster pace than that in the positive moment zone towards final failure stage. This behavior is mainly due

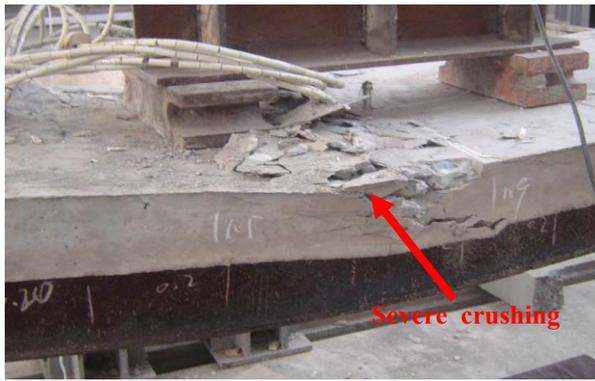
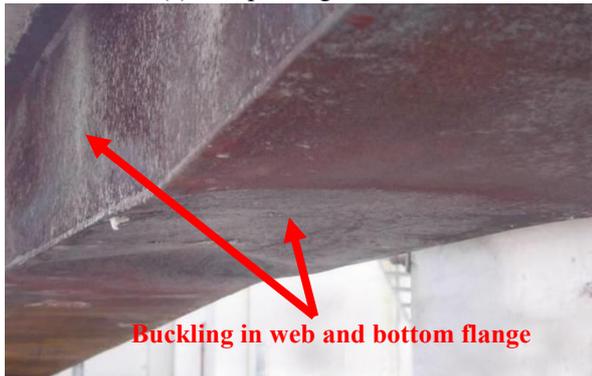
Fig. 9 Illustration of failure patterns in CG1 and CG2 after exposure to localized fire

(a) Composite girder CG1

(b) Composite girder CG2

Fig. 9(a) illustrates failure pattern and extent of deformation in the simply supported composite girder CG1. During the initial stage of fire exposure, a large amount of

water vapor from the concrete escaped with the rise in temperatures in the slab. At 33 min, this girder experienced significant degradation in flexural capacity (See Fig. 7) and thus failed, which resulted from yielding at the bottom flange and severe crushing in the concrete slab. When the tested simply girder were exposed to fire, the neutral axis of the composite box section moved upward due to degradation of steel strength of the web and bottom flange at elevated temperature. The neutral axis was located in the concrete slab at failure stage. Hence, test observations indicated no buckling in the web and bottom flange due to the fact that the web and bottom slab was located in tension region when the tested girder approaching failure at elevated temperature. The girder formed a V shape at failure stage due to large deflections, large rotations at the girder span ends and also severe crushing of concrete at the mid-span zone.

The failure pattern and extent of deflection in the composite girder CG2 after fire exposure are illustrated in Fig. 9(b). The composite girder CG2 experienced significant bending buckling in the web and bottom flange as well as severe transverse cracking in the concrete slab in the hogging moment zone. When the tested continuous girder was exposed to fire, the neutral axis of the composite box section in the hogging moment zone moved upward due to degradation of steel strength of the web and bottom flange at elevated temperature. At the failure stage the neutral axis moved into the concrete slab, and the web and bottom flange in the hogging moment zone was mainly located in longitudinal compression region, thus vulnerable to significant bending buckling in the web and bottom flange under fire conditions. The fire-damaged features in the positive moment zone of the continuous composite box girder CG2 were similar to that of the composite girder CG1.
