# Rehabilitation and strengthening of exterior RC beam-column connections using epoxy resin injection and FRP sheet wrapping: Experimental study

Comingstarful Marthong\*

Department of Civil Engineering, National Institute of Technology Meghalaya, Shillong 793003, India

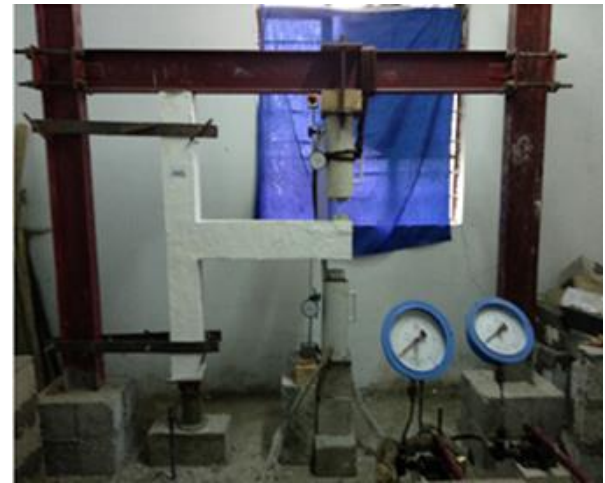
Fig. 3 Testing of beam-column connection (a) Test set-up (b) Actual testing arrangement

The setting of the test set-up and the actual testing arrangement is shown in Fig. 3. A loading frame of 500 kN capacity and hydraulic jack of 100 kN were used for applying the load to the specimens. In the test set-up, the

column was positioned vertically while the beam is placed horizontally. In order to represent the gravity load, an axial load using hydraulic jack was applied to the column. The moments were approximately zero at the mid-span of the column when subjected to lateral loading. Roller supports were provided at both ends of the column in order to simulate the actual conditions of zero moments. The reversed loading was applied manually at a distance of 100mm from the free end of the beam by mean of two hydraulic jack mounted at the top and at the bottom. The hydraulic jack of 100 kN capacity was equipped with an in-built manually operated pumping units fitted with bourdon tube type load gauge and high-pressure flexible hose pipe. Two 100 mm range dial gauges were also placed at the top and bottom face of the beam tip to measure the vertical displacement of the beam.

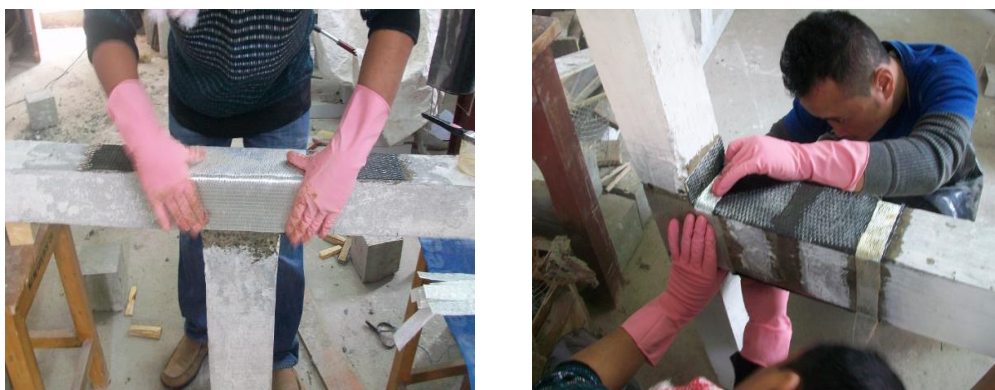
(b) Wrapping of specimens using FRP sheet

Depending on the deficiency types, another set of damaged control specimens of BWF, BWS and CWS were rehabilitated as mentioned above and then wrap using FRP sheets as per the design configuration adopted by Chowdhury *et al.* (2013) which is shown in Fig 6a. These specimens were name as BWFR<sub>e</sub>, BWSR<sub>e</sub> and CWSR<sub>e</sub> respectively. Strengthening of BWF specimens was carried out primarily to enhance the flexural capacity of the beam using CFRP. However, the increase in load carrying capacity led to the increase in shear force at any section of the beam. Thus, in order to ensure eventual flexural failure of the beam, shear enhancement of the beam was also done using GFRP. The joint was adequately strengthened with GFRP. BWS specimen eventually would fail in flexure which is the most preferred mode of failure. In order to strengthen the shear deficient the strengthening in the beam was done using GFRP as per the design configuration. A strip of one layer having width of 40 mm was wrapped around the beam with a spacing of 70 mm c/c. This strengthening scheme enhanced the shear capacity of the beam making it higher than the flexural capacity. Hence at this level the beam was expected to fail at the original flexural capacity of the control specimen, resulting a slight increment in the overall capacity. Further, flexural strengthening was also carried out to achieve an appreciable increase in capacity of the specimen. The flexural strengthening was carried with CFRP to such an extent that even after the flexural strengthening the beam fails in flexure. Thus, it was ensured that after the flexural strengthening, the flexural capacity of the beam remains less than the enhanced shear capacity. The flexural strengthening was carried out in beam by providing CFRP in a manner similar to that of BWF. For CWS the specimens under this category were strengthened similar to the earlier specimens. In order to strengthen the shear deficient control specimens, the strengthening in the column was done with GFRP. This strengthening scheme enhanced the shear capacity of the column. To maintain a similar trend to that of the other type of specimens, nominal flexural strengthening in the column was also carried out by CFRP. The joint was also adequately strengthened with one layer of GFRP. The typical strengthening process is shown in Fig. 6b.
