# Case study on seismic retrofit and cost assessment for a school building

Andrea Miano\* and Giovanni Chiumiento<sup>a</sup>

Department of Structures for Engineering and Architecture, University of Naples Federico II, Naples, Italy

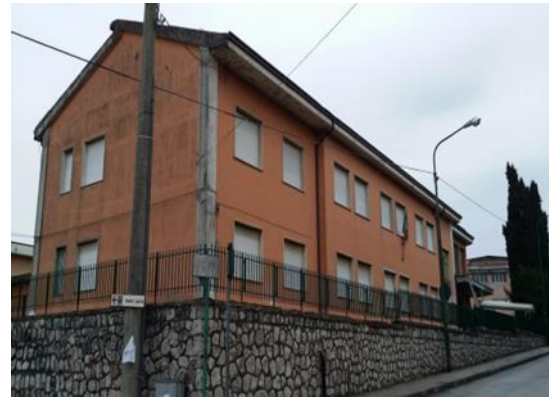
Fig. 1 Photo of the lateral view of the building

at the intrados of the roof ridge is about 2.70 m. Apart from the external emergency staircase, there is only one internal staircase. The one way slabs are made of precast reinforced concrete beams and blocks. The building turns out to be irregular, because the first two floors have an almost L-shaped plan, whereas the other two floors have an approximately rectangular plan layout. The school building area is around 980 m<sup>2</sup> at the 1<sup>st</sup> and 2<sup>nd</sup> floors, while it is around 810 m<sup>2</sup> at the 3<sup>rd</sup> and 4<sup>th</sup> floors. Figure 1 and Figure 2 show respectively a photo and a typical plan of the building.

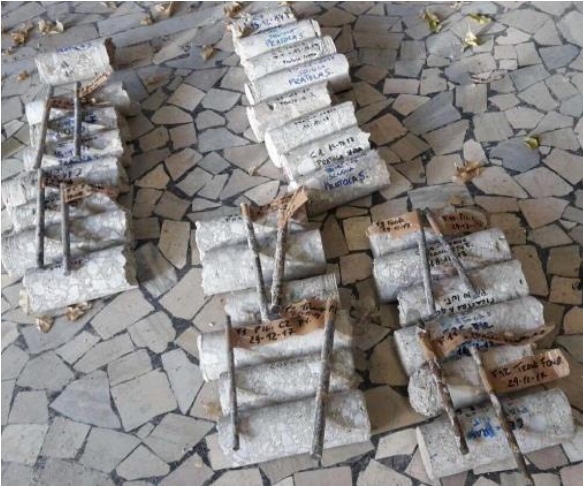
Fig. 3 Concrete cores and steel bars extracted and tested in the case study

A very important to discuss herein is that in the real applications/design projects sometimes is impossible to do the tests in each part of the building due to physical obstacles. In the case study, the tests have been done where possible. For example in the foundation floor, many members were covered by the terrain/ground and it was practically difficult and expensive to investigate them. In fact, the mechanical equipment was not able to work in these areas, due to the reduced spaces. Another important problems occur in the columns, where there has been the inability to take samples of steel bars on the upper floors. This was related to the fact that for all columns in these floors, it was found the presence of only the corner bars. This circumstance has been judged dangerous from the engineers. Then, Thus, steel pieces from the corner bars were not collected. However, the variability of the mechanical material properties in the steel can be considered inferior with respect to concrete (Verderame *et al.* 2001). Figure 3 shows the concrete cores and the steel bars extracted from structural members for the case study.

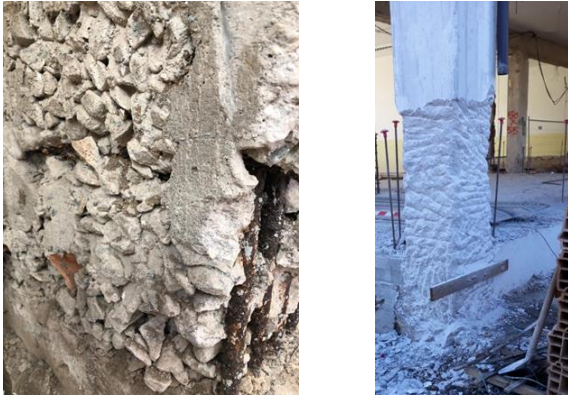
Fig. 6 a) Low quality concrete in a perimeter column; b) Total absence of stirrups in a corner column

It is to note that load tests were done on the slabs. The slabs showed a safe condition both based on strength and deformation verifications. Then, it was important to avoid too invasive modifications on the slab configuration through the retrofit strategies. Due to this reason, it has been considered not convenient to have RC jacketing of the beams. Instead, mainly the columns, but also the beams, showed evidence of structural malfunction. This was due to the poor quality of the concrete and to the absence of adequate seismic-detailing requirements, as shown in Figure 6.
