Analysis of behavior of bare and in-filled RC frames subjected to quasi static loading

Abstract. Study on the inelastic response of bare and masonry infilled Reinforced Concrete (RC) frames repaired using Carbon Fibre Reinforced Polymers (CFRP) and Glass Fiber Reinforced Polymers (GFRP) subjected to quasi-static loading is presented in the work. The hysteresis behaviour, stiffness retention, energy dissipation and damage index are the parameters employed to analyze the efficacy of FRP strengthening of bare and brick in-filled RC frames. It is observed that there is a significant improvement in load carrying capacity of brick infilled frame over bare RC frame. Also FRP strengthened brick infilled frame performs much better than FRP repaired bare frame under quasi static loading. Repair and retrofitting of brick infilled RC frame shows an improved load carrying and damage tolerance capacity than control frame.

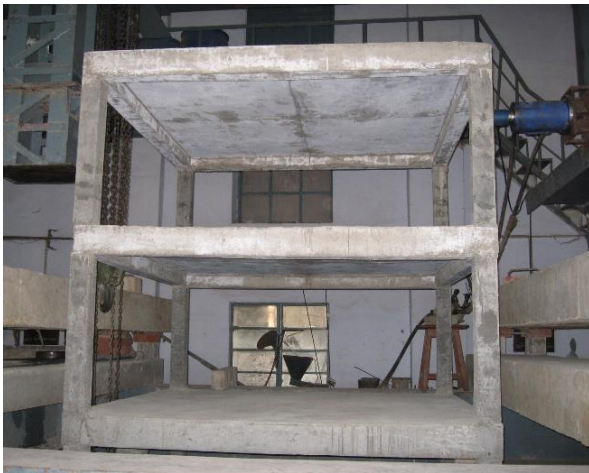
Fig. 2 Actual RC Bare Frame used in the study

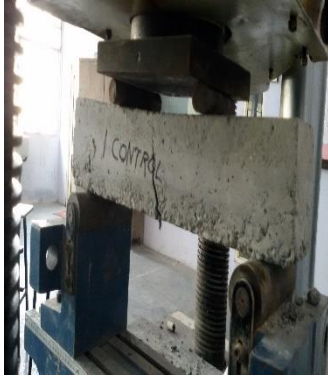
Fig. 4 Control Beam

To examine the bonding ability of epoxy in crack filling, standard prism of 100mm \times 100mm \times 500 mm length were casted and tested in two point loading (Fig. 4).

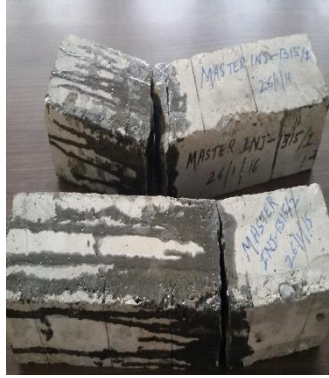
Fig. 5 Failure of Epoxy jointed Prisms

Damaged prisms were reconnected using three different types bonding agents of cement slurry, M Brace 2200I and Master Injector 1315 epoxies. Two samples of each were tested. The reconnected samples were allowed to cure for a week and again tested in two points loading till failure (Fig.5). It is also important to investigate the performance of CFRP and GFRP to loads and also the effectiveness of the different binders used for bonding FRP's to concrete. For this standard prism of 100mm \times 100mm \times 500 mm length were cast and tested. A pair of control prisms and strengthened with GFRP and CFRP in tension zone are

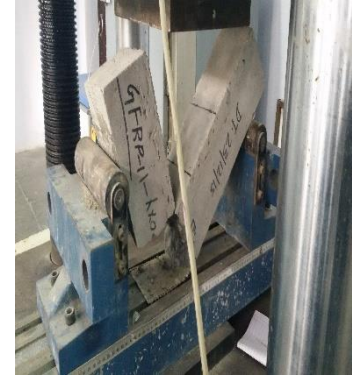
Fig. 6 FRP wrapped prisms

tested subjected to two points loading to estimate the load-deflection characteristics (Fig.6).

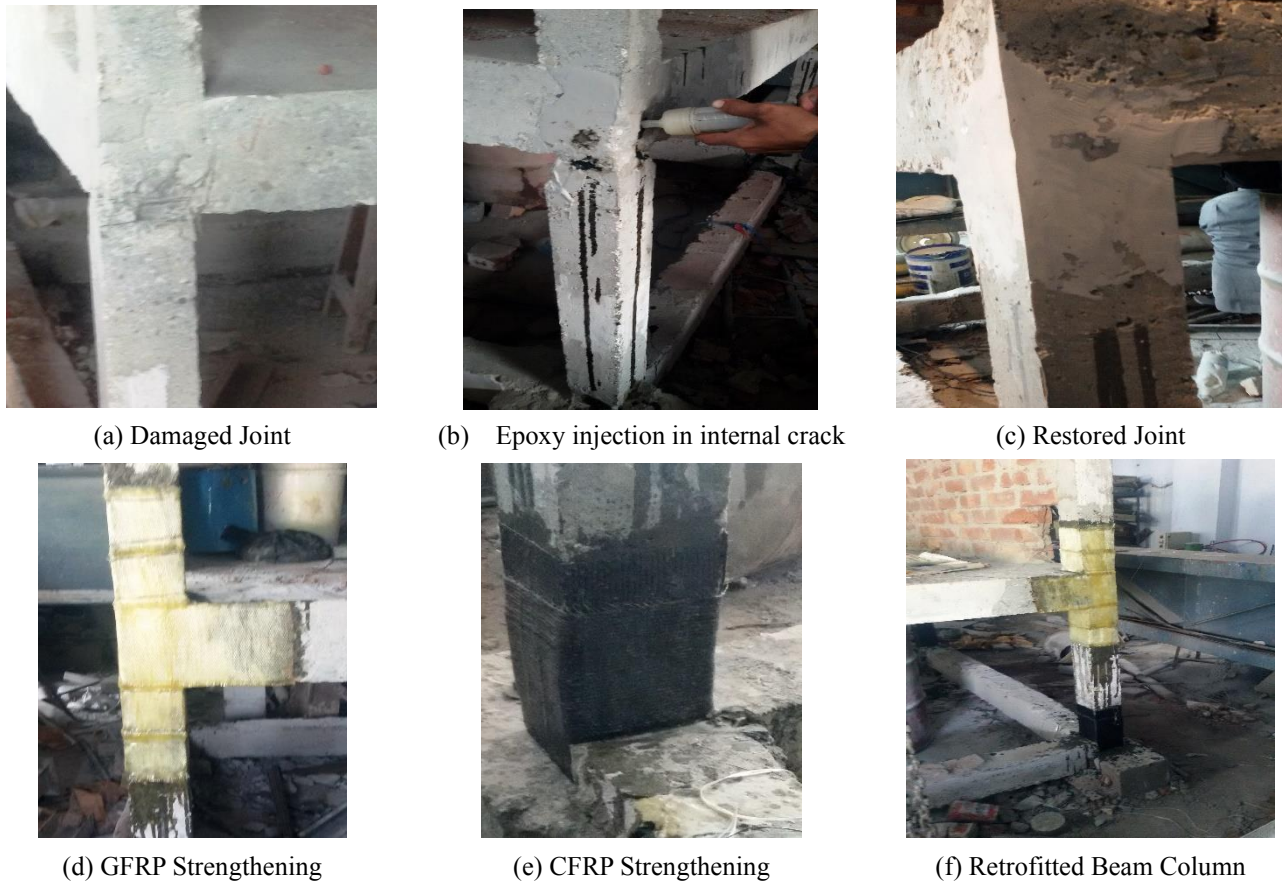
Fig. 9 Strategy for Retrofitting of Frame

Initially the bare and brick infilled RC frames were tested to failure with loading as shown in Fig. 3. The failed and the deformed frames were restored again to their initial position using a hydraulic system. Damaged concrete was removed from the joint region and the surfaces were cleaned to remove dirt (Fig. 9a). All the corners of damaged elements were beveled and rounded to a radius of 10 mm in order to avoid corner stress concentration due to sharp edges on FRP. First the surface cracks were filled with M Brace 2200I putty (Fig. 9b) and then the surface was smoothened. Master injector 1319 was used to fill the internal cracks to create bond between the cracked regions in the damaged part of the frame (Fig. 9c). Two different FRP materials of GFRP and CFRP were used with M Brace epoxy (Fig. 9d). GFRP was used in the beam-column joint of every floors (Fig.9e) and CFRP was used to strengthen the column hinges (Fig.9f). The wrapping system of FRP

sheets was followed in two steps: the first layer affixed perpendicular to the loading direction and second layer was wrapped to confine the existing layer in parallel direction. Stepwise strategy of FRP retrofitting followed for the frames is shown in Fig. 9.

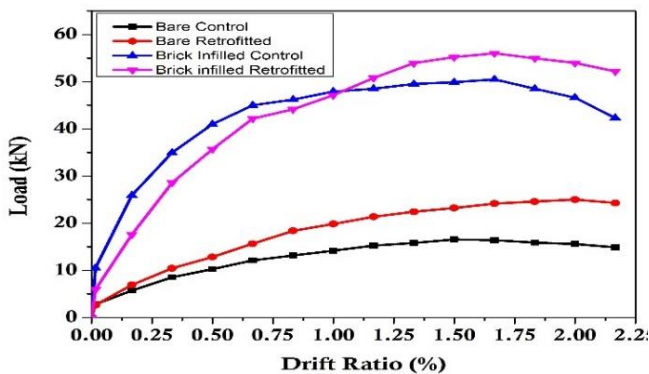
Fig. 13 Comparison of load deflection curves of Control and Repaired Bare and Brick in-filled frames

The initial part of the load-deformation curve shows linear behavior upto yield followed by non-linear behavior. In the bare frame, maximum load of 16.5 kN was attained at deflection of 45 mm in control and 24.6 kN load in

retrofitted frame was attained at deflection of 55 mm. In brick infilled frame, maximum load of 49.5 kN was attained at 45 mm deflection in control frame and in retrofitted brick infilled frame, the load attained was 56.03 kN at 50 mm deflection. It points towards the effect of FRP confinement resistance to deformation. Also the peak load values indicate significant increase in the load carrying capacity of brick-infilled frames vis-à-vis bare RC frames (200%). It is a direct indicator of the confining effect of brick infills on a RC framed structure when subjected to axial loads.

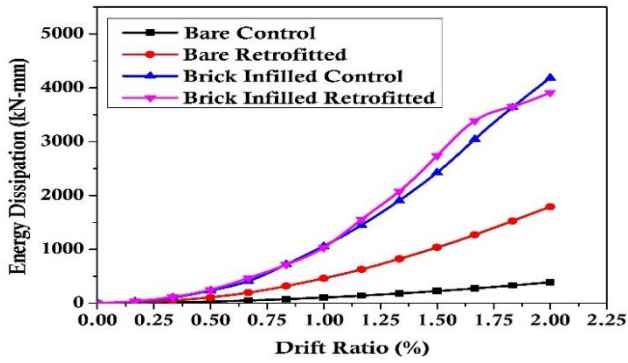
Fig. 15 Energy Dissipation V/s deflection of control and retrofitted frame

Energy dissipation is estimated by the area under the load deformation curve. Fig. 15 shows the energy dissipation curve of all the framed structures.

Energy dissipation capacity of the control bare frame is nominal in comparison to the retrofitted bare frame. The repaired frame shows enhanced energy dissipating capacity than the bare frame. The performances of control and retrofitted brick infilled frames were similar upto 50 mm deflection. As a result of severe cracking in the hinge region, the control frame failed to show better post peak load carrying capacity and a decrease in the energy dissipation capacity. On the other hand, in the retrofitted

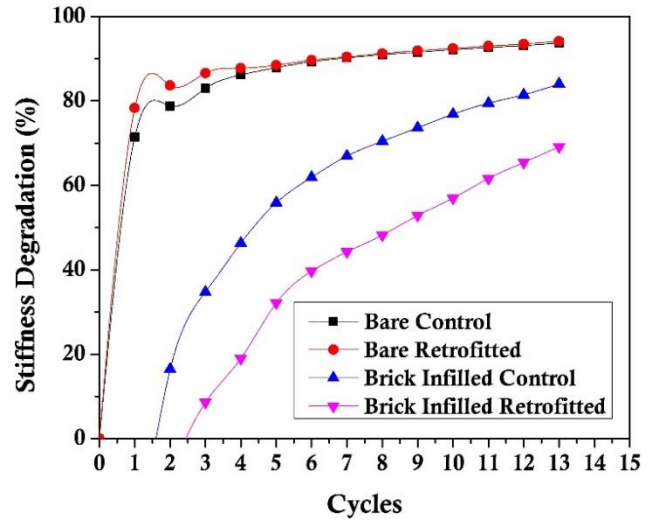
Fig. 16 Stiffness degradation of Control and Retrofitted Frames

The rate of change of stiffness degradation over the post elastic range is the measure of inelastic performance of the component. The stiffness degradation post elastic drift for each tested frame specimen is plotted in Fig. 16. Sudden or rapid degradation in stiffness shows the brittle performance while low rate of stiffness degradation shows ductile performance. It is observed that bare frames undergo maximum degradation (upto 80%) in first few cycles indicating their behavior whereas in masonry infilled frames, rate of degradation is comparatively pointing towards their ductile behavior.

Also the comparison of control and retrofitted frames shows that initially the loss of yield stiffness was high in retrofitted specimens than control frames. This is because of the employed yielded reinforcement in the RC frame. In the damaged RC frame, the surface concrete in the impaired location has been thoroughly removed and replaced with epoxy putty and the internal cracks were injected with epoxy. But the reinforcement in the hinge region was not replaced and hence all the hinge regions were critically strengthened using external FRP reinforcement. Thus, the retrofitted specimens show higher loss in initial yield stiffness than control frame. But the post elastic stiffness degradation was comparatively low in retrofitted frame as compared to control frame. It illustrates the influence of external FRP strengthening in non-linear performance.

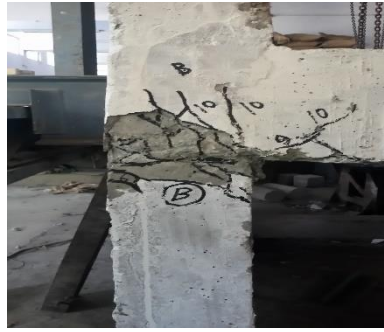
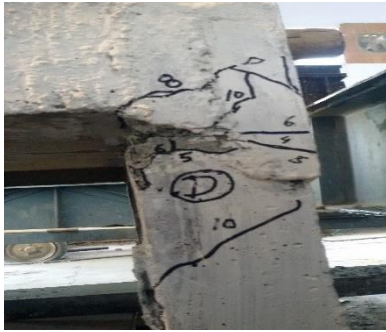
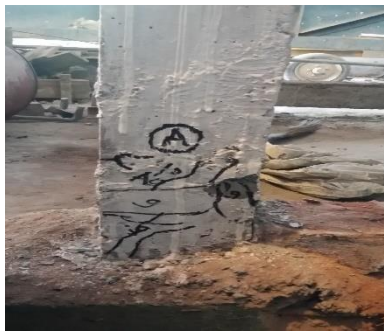
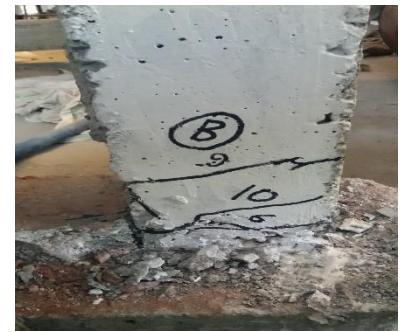
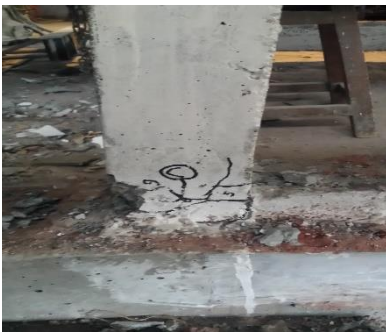
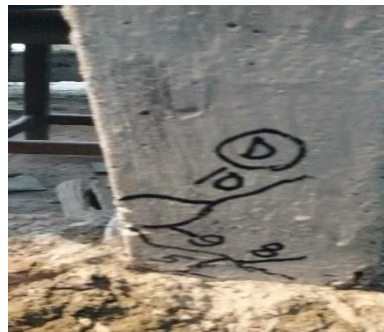
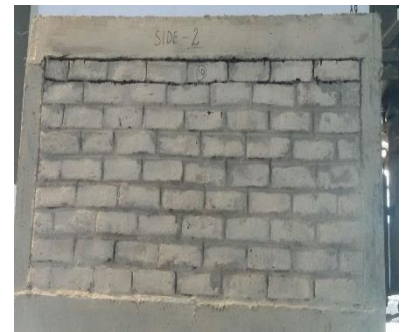
(a) Cracks in Column A

(b) Cracks in Column B

(c) Cracks in Column C

(d) Cracks in Column D

(e) Cracks in Column Hinge A

(f) Cracks in Column Hinge B

(g) Cracks in Column Hinge C

(h) Cracks in Column Hinge D

(i) Cracks in Brick Infill

Fig. 19 Damage in Column-Beam and Column-Foundation after loading in control brick infilled frame

In the brick infilled frame, the infill in the first and second storey made the ground storey soft and hence the failure intensity was high in the ground storey as depicted in Fig 18b. Predominant cracking was observed in the first floor beam-column joint region whereas the second floor and the roof depicted no evidence of cracking because of the soft storey effect. The horizontal cracking witnessed below the joint region reduced the stiffness and restricted the deformation capacity and was further followed by shear cracks in the joint region. As a result of the dense crack concrete cover, spalling occurred in the joint region. The effect of seismic detailing supports the RC frame to deform but the brittle nature of concrete exhibits concrete crushing failure at the foundation hinge region. There is no severe damage in the infill; horizontal sliding cracks were noticed in the infill at the mortar joints as shows in Fig. 19 (a-i).

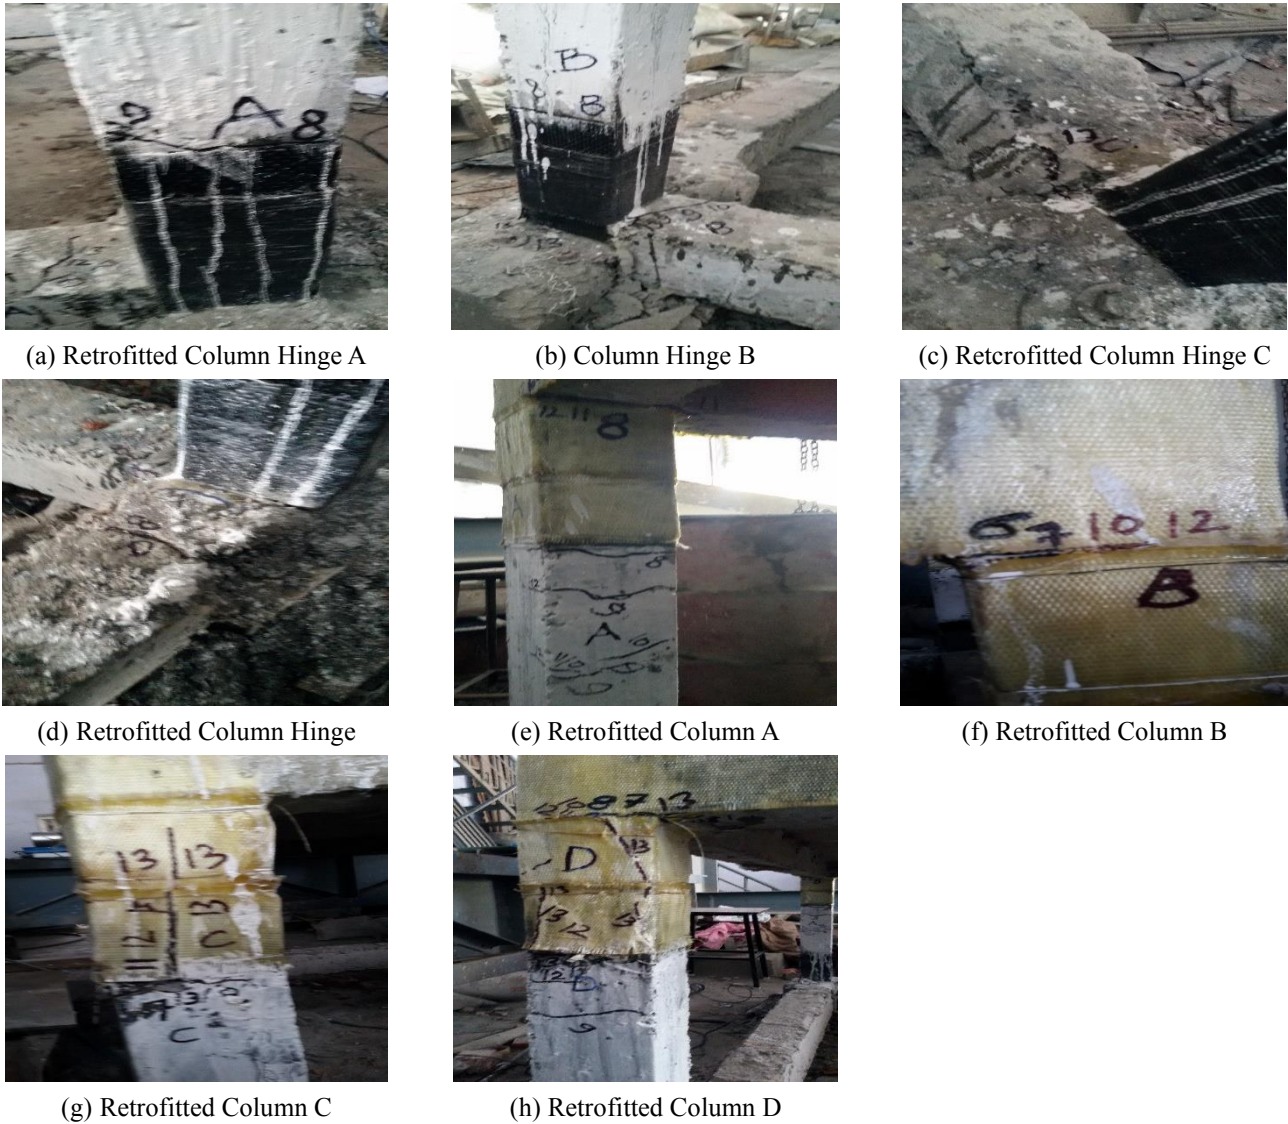
Fig. 20 Damage in Column-Beam and Column-Foundation after loading in Retrofitted Brick infilled frame

increase in unwrapping sound witnessed the failure of retrofitted frame by increasing the load. Fig. 20 (a-h) shows the cracks below and above the strengthened portion followed by FRP rupture in few locations. The primary failure is because of the horizontal crack below the FRP strengthened region. Thus the ultimate deformation of the repaired frame is identical with the control frame.

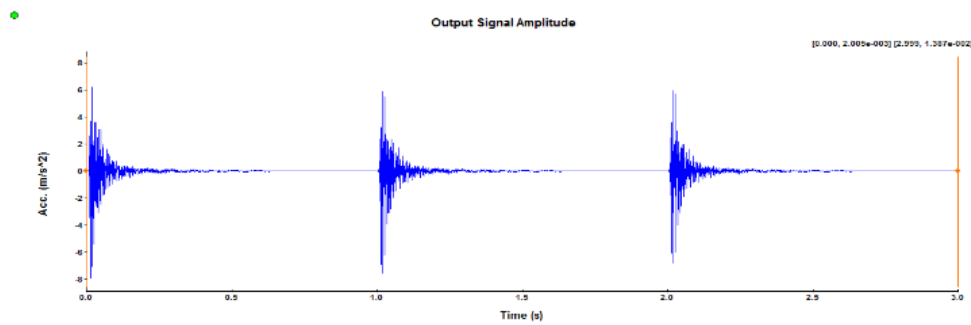
Fig. 23 Time History Plot
