## Japan's experience on long-span bridges monitoring

Yoza Fujino<sup>\*1</sup>, Dionysius M. Siringoringo<sup>1a</sup> and Masato Abe<sup>2b</sup>

**Abstract.** This paper provides an overview on development of long-span bridges monitoring in Japan, with emphasis on monitoring strategies, types of monitoring system, and effective utilization of monitoring data. Because of severe environment condition such as high seismic activity and strong wind, bridge monitoring systems in Japan historically put more emphasis on structural evaluation against extreme events. Monitoring data were used to verify design assumptions, update specifications, and facilitate the efficacy of vibration control system. These were among the first objectives of instrumentation of long-span bridges in a framework of monitoring system in Japan. Later, monitoring systems were also utilized to evaluate structural performance under various environment and loading conditions, and to detect the possible structural deterioration over the age of structures. Monitoring systems are also employed as the basis of investigation and decision making for structural repair and/or retrofit when required. More recent interest

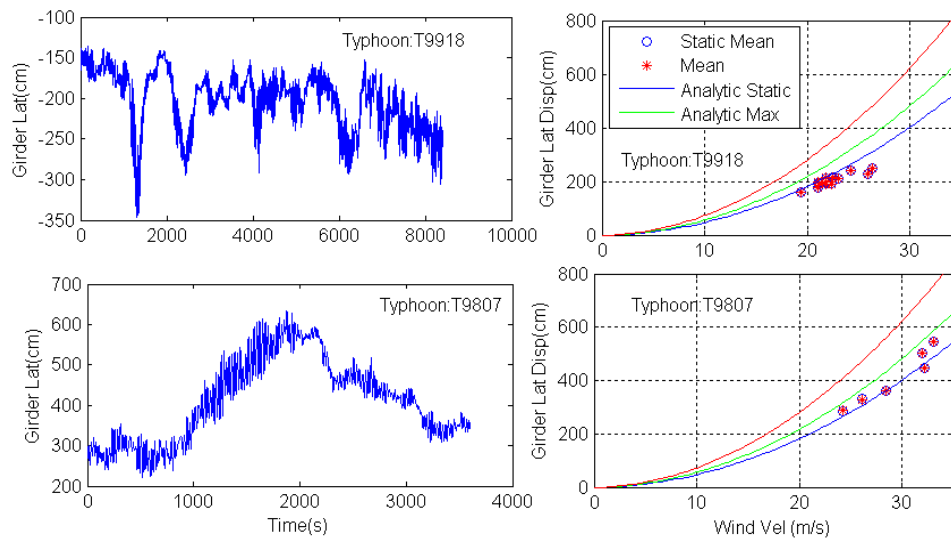
Fig. 2 Lateral displacement measured at the middle of girder of Akashi-Kaikyo Bridge during Typhoon 7 in 1998 (T9807) and Typhoon 18 in 1999 (T9918)

Two and a half year after its opening, a couple of strong typhoons have passed through the Akashi–Kaikyo Bridge. Monitoring system collected data of the bridge response as well as strong winds during the typhoons. Analysis of the full-scale data measured on the Akashi–Kaikyo Bridge during Typhoon 7 in 1998 and Typhoon 18 in 1999, respectively was conducted in the study by (Miyata *et al.* 2002). Focus of the study was on the power spectral density (PSD), spatial correlation of wind-speed fluctuation and response of the deck. The study notes that static lateral deflections of the deck in the middle of the center span are in good agreement with the analytical value when the bridge excited by winds whose directions are nearly normal to the bridge axis (Fig. 2). Meanwhile, analysis of spatial correlation shows discrepancies between the measurement and estimated exponential formula used in design.

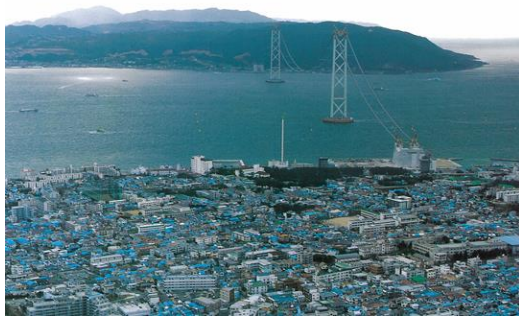
(a) Akashi-Kaikyo Bridge after 1995 Kobe Earthquake

(b) Observed movement after 1995 Kobe Earthquake by GPS and Leveling

Fig. 4 Observed movement at Akashi-Kaikyo Bridge after 1995 Kobe Earthquake

The Akashi-Kaikyo Bridge was still under construction when the 1995 Kobe earthquake occurred as shown in Fig. 4. Construction of abutments and towers had been completed, while part of superstructure was suspended by the main suspension cables. Fault movement occurred right below Akashi Kaikyo Bridge. The base movement of the abutments and pylons due to fault action are shown in Fig. 4(b) (Lin and Uda 1996). GPS monitoring was effective to identify this movement. There was no severe damage observed on the bridge but the planned center span was altered from 1990 m to 1991 m.

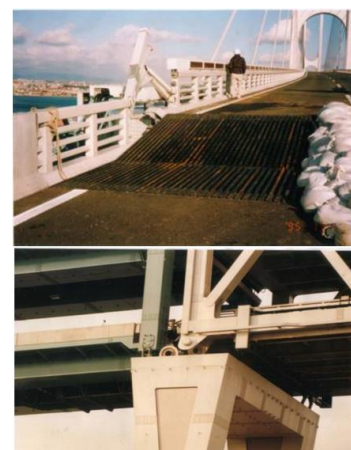
(a) Higashi Kobe Bridge Monitoring System (T: Location of sensors)

(b) Damage at end-bearing

Fig. 5 Higashi Kobe Bridge and Damage at end-bearing during 1995 Kobe Earthquake

Higashi-Kobe Bridge (Fig. 5), a cable stayed bridge with central span of 485 m opened 1994, was also located near the strong motion area of 1995 Kobe Earthquake. The bridge's bearing link systems connecting end girders and piers failed as shown in the Fig. 5(b), losing the vertical support to prevent uplift. Failure of wind shoe, whose function was to prevent transverse motion of the girder due to excessive transverse motion of the girder-end, led to the failure of the bridge's bearing link. Fortunately the bridge was supported by intermediate piers at the side spans that provided additional redundancy, so that total collapse was prevented.

The bridge was instrumented and successfully monitored during the earthquake. Girder response contains spike-like wave forms in time history that reflects the collisions of girders and damage to the bearings and the links (Ganev *et al.* 1996). From analysis of recorded seismic responses, it was concluded that pounding occurred between tower and deck, and that response of the soil-structure system strongly influenced by pore-water pressure buildup in the saturated surface soil layers. After this event, uplift prevention cables are applied to similar structural details to add redundancy in case of link failure. In addition, the structure is built on reclaimed land, and liquefaction was observed at the ground motion record. This record, with modification, is used for current design code of highway bridges for evaluation of bridges on the softest ground condition.

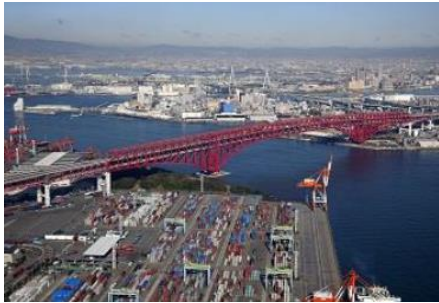
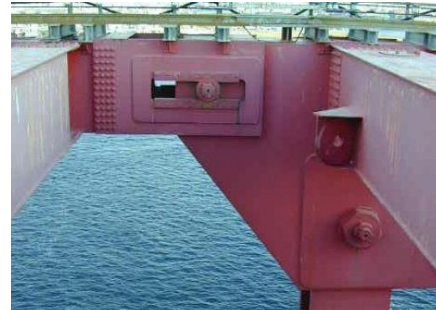
(a) Minato Cantilever Truss Bridge

(b) Movement at the pin connection

Fig. 6 Minato Cantilever Truss Bridge and movement at the pin connection

In the study by Kanaji and Suzuki (2007), similar spiking response was reported at the Minato Bridge during 2004 Kii Peninsula Earthquake (Mw 7.4). The bridge, shown in Fig. 6(a), is a cantilever truss, and connections are placed at central span to suspend the center girder as described in Fig. 6(b). In this case, the spiking behavior is considered due to motion and contact of this connection.

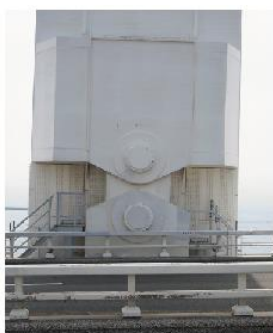
Fig. 8 Photo of LBC at tower of Yokohama-Bay Bridge and Monitoring system and observed seismic record at 2011 Tohoku Earthquake. (a) accelerations of tower at deck level during the main shock showing spike indicating impulses (b) time interval between successive lateral poundings (Siringoringo *et al.* 2013)

Yokohama-Bay Bridge responses were also recorded during the 2011 Great East-Japan Tohoku Earthquake (Siringoringo *et al.* 2013). Ground motion lasted more than 3min and the maximum girder horizontal response of 60 cm was observed. Fig. 8 shows the tower transverse acceleration, where periodic spikes resembling impulses are observed. Periodic spikes indicate occurrence of transverse pounding between tower and girder, and the spikes appear on the girder vertical accelerations as well. By observing time interval between two successive spikes, the structural mode that triggers the impulses was estimated. It was concluded that the girder first transverse mode triggered the pounding, since the average time interval between two consecutive spikes was observed to be around 3.2sec (0.31~0.32 Hz).

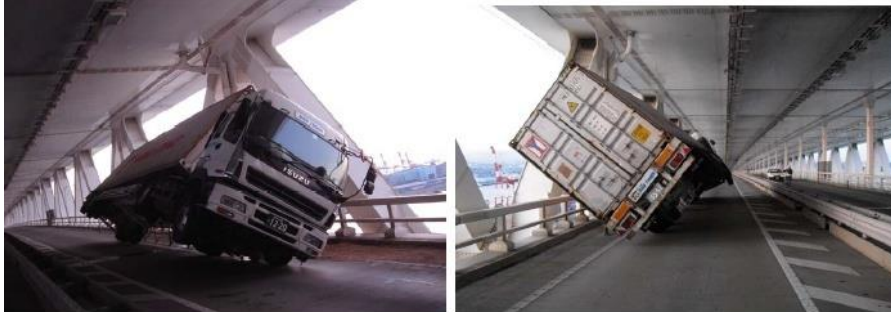
Fig. 9 Photos Rollover incident of a cargo truck on the lower deck of Yokohama-Bay Bridge during the March 11, 2011 Great East Japan Earthquake

During the 2011 Great East-Japan Tohoku Earthquake, the Yokohama Bay Bridge was closed for about 30 hours due to an overturned cargo truck accident on the lower deck as shown in Fig. 9. The girder transverse vibration caused the truck to become unbalanced and overturned. Even if no major structural damage is observed, traffic disruption due to excessive vibration could cause human loss. As wind monitoring data is used to regulate traffic at strong wind conditions, earthquake monitoring and early warning data should also be incorporated into traffic control to reduce this risk.

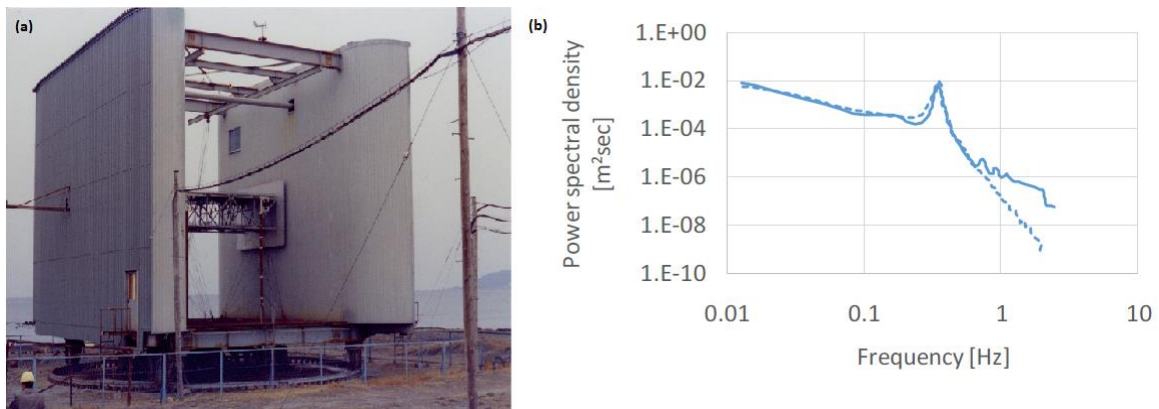
Fig. 10 (a) Large scale bridge model (courtesy of Honshu-Shikoku Bridge Authority) and (b) Comparison between in-situ model response and estimation based upon wind tunnel experiment (average wind speed 12.6 m/sec, elevation 0°). Solid line: observation; dashed line: estimation

In the beginning of development of long-span bridges in Japan, issues associated with quantification of external forces, especially wind loading was significant in design process. Limited experiences from the past and large uncertainties within design assumptions made verification in the scaled experimental testing an important design step. Fig. 10(a) shows an example of large scale one-tenth sectional bridge girder model constructed and operated from 1973 to 1975 to verify wind resistant design method for the Honshu-Shikoku Bridge Project that includes the Akashi-Kaikyo Bridge. The observed response is compared with estimation based upon wind tunnel testing as shown by Fig. 10(b) (Okauchi 1978).

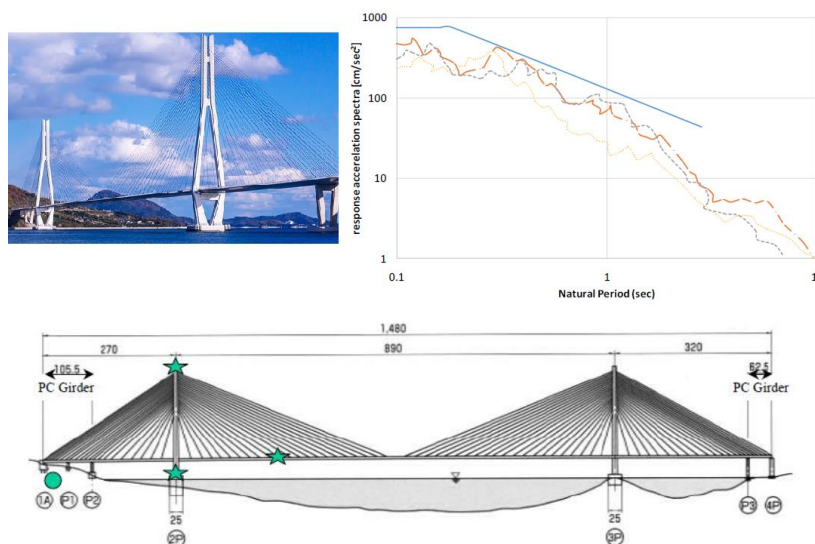
Fig. 13 Monitoring system for Tataru Bridge (●:seismometer; ★:accelerometer) and Comparison between design spectra (straight line) and observed response spectra in the 2001 Geiyo Earthquake

Observed seismic response was also used to verify seismic design. One example of such case is the Tataru Bridge (Fig. 13) the longest cable stayed bridge in Japan that was strongly excited by 2001 Geiyo Earthquake (Mw 6.7). The maximum ground acceleration at the bridge site was 144 cm/sec<sup>2</sup>. From observation of seismic response it was revealed that actual seismic load in term of response spectra calculated from recorded ground motion was below the design specification as shown in Fig. 13. Seismic behavior of the bridge was studied by simulation analysis to verify the structural model and assumptions using the observed ground motions. The simulation results were found to be in good agreement with observed responses (Kawato *et al.* 2005).

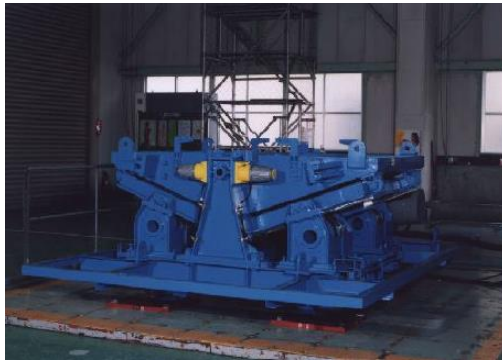
(a) Pendulum type control device

(b) Location of installation at Hakucho Bridge tower

Fig. 14 Vibration control system of Hakucho Bridge tower (Fujino *et al.* 2012)

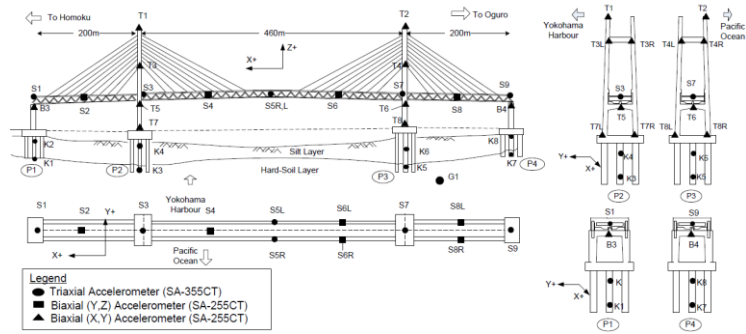
Fig. 17 Yokohama Bay Cable-Stayed Bridge sensor layout for permanent monitoring system (Siringoringo and Fujino 2008b)

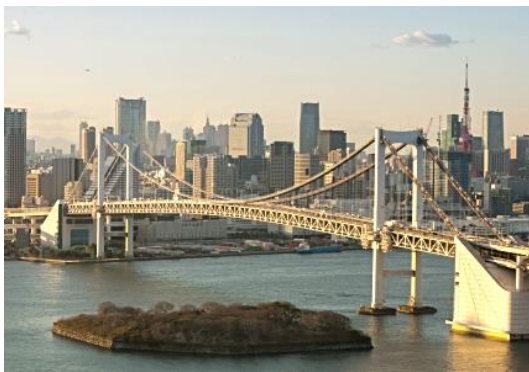
Fig. 18 Rainbow Bridge Tokyo and sensor layout for permanent monitoring system (Siringoringo and Fujino 2008b)

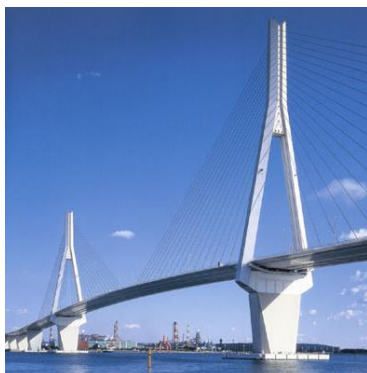
Fig. 19 Tsurumi-Tsubasa Bridge and sensor layout for permanent monitoring system (Siringoringo and Fujino 2008b)

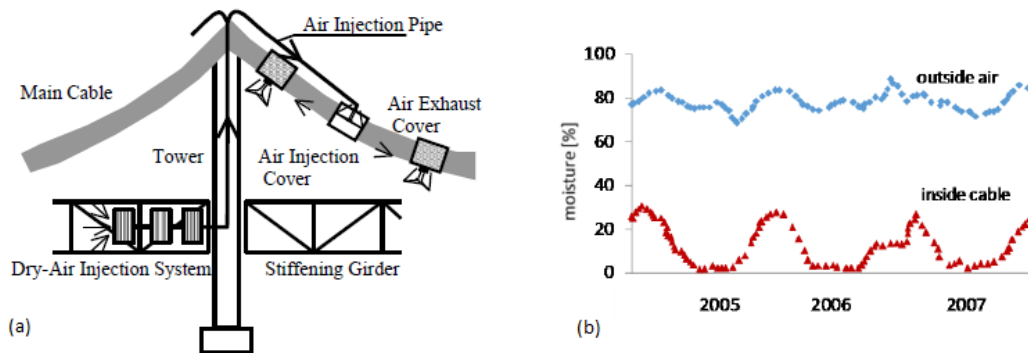
Fig. 24 (a) Dry air injection system for Akashi-Kaikyo Bridge and (b) Moisture monitoring of main cable

Also at the Akashi Kaikyo Bridge, dry-air injection system, whose conceptual drawing is given in Fig. 24(a), is introduced to protect main cables from corrosion (Kitagawa *et al.* 2001). Monitoring of moisture in the cable is required to control quality of the air. Fig. 24(b) shows comparison of moisture between outside air and inside cable, indicating advantage of the system.

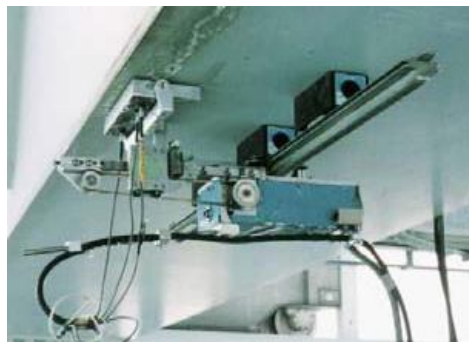
Fig. 25 Automated Ultrasonic Testing system for fatigue crack inspection on HSBE bridge girder. (Okuda *et al.* 2010)

Fatigue damage on steel members is also an important issue for long-span bridges especially the ones that carry railway. This factor was carefully examined ever since the design and fabrication stage of the bridges at the Kojima–Sakaide Route of the Honshu-Shikoku bridge link. Large number of axle loading was expected for bridges during the service life of bridges in this route since they support the railway lines. The bridges employ high-strength steel, which is sensitive to fatigue, to primary members. Honshu-Shikoku Bridge Expressway authority has developed a welding methodology as well as a welding inspection system called “AUT: Automated Ultrasonic Testing system” (Okuda *et al.* 2010). The system was effective in detecting welding defect in the factories. Several improvements on the system have been made before it was deployed on-site for inspection so that the system can be available to inspect existing welding lines (Fig. 25). Two inspections were conducted by year 2000 and there was no sign of crack progress found on the bridges. This was attributed to the fact that actual load of train is smaller than the design assumption (Okawa and Kurihara 2010).
