# Bridge health monitoring in the United States: A review

**Abstract.** The assessment of bridges' health has become a relevant component of the maintenance paradigm especially in those countries in which many structures are rated in poor condition and/or are over 50 years old. Additionally, the permanent monitoring of bridges helps engineers in validating the design prediction of bridge structural response to external loads. With more than 600,000 highway bridges, 46.4% of which rated as fair and 7.6% rated in poor condition, United States is one of those countries in which the installation of reliable bridge health monitoring systems is strategically necessary to minimize and optimize repair and rehabilitation costs and to minimize the risk of failures. In this paper, a thorough review of the scientific literature on structural health monitoring systems installed in U.S. bridges over the last 20 years is presented. This review aims to offer interested readers a holistic perspective of recent and current state-of-the-art bridge health monitoring systems and to extract a "general paradigm" that is common to many real structures. The review, conducted through a comprehensive search

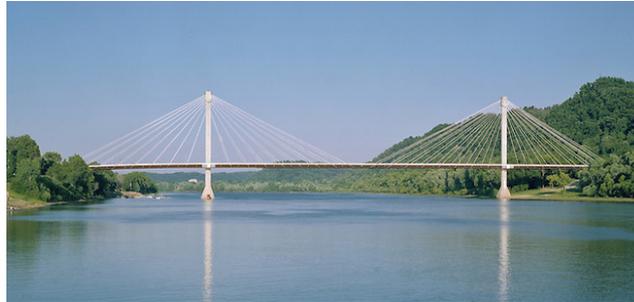
Fig. 1 The U.S. Grant Bridge. Credity <http://feinknopf.photoshelter.com/image/I0000cvarWU9ouEg>

**10.** The old **U.S. Grant Bridge** was closed in 2001 for demolishing. Its replacement (**Fig. 1**) was completed in 2006. During construction, the new bridge was instrumented with different types of sensors, whose locations were chosen using original design calculations and erection analysis (Helmicki and Hunt 2013). The following variables were monitored: weather; thermal cross-section of pylons, exterior girders, and concrete-decking sections; longitudinal and tangential stress at pylon cable anchorages; tip displacement of the outermost-decking sections in response to thermal, wind, and dead load in order to ensure proper alignment; dynamics of the stays. Helmicki and Hunt (2013) reported that most of the monitored segments exhibited a relative agreement with the design values.

Once opened to traffic, the monitoring system remained active when the Kentucky abutment and backwall began to exhibit cracking that started near the beam seat but became pervasive with increasing length and width over each subsequent inspection. This degradation was attributed to field modification to the location and installation of the steel pulldowns internal to the abutment. The rehabilitation, completed in 2009, included additional welding at the beam seat to resist further movement. A truckload test was conducted to evaluate the rehabilitation and compare with expected design values. Some of the strain gages detected a significant change in the truck response near the abutment: the post-rehabilitation influence line exhibited a more pronounced middle span response and an increased tensile bias in the Kentucky end-span, as compared to the baseline. This “new” influence line was used to re-calibrate a FEM developed previously.

Compared to baseline data, the measured results showed a decrease at the middle span and an increase at the Kentucky abutment.

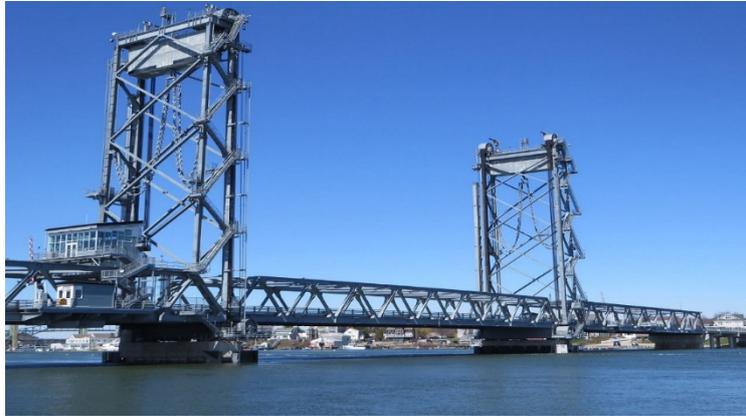
Fig. 2 The World War I Memorial Bridge. (Credit: Ken Gallager at English Wikipedia, CC BY-SA 3.0 <https://commons.wikimedia.org/w/index.php?curid=48356074>)

~~~~~  
**16.** The **World War I Memorial Bridge** (Fig. 2) is a vertical-lift bridge opened in July 2013. Shahsavari *et al.* (2019) described a SHM program that began in March 2017 to observe the: (1) dynamic performance of the horizontal span and the lift tower; (2) strain distribution through the gusset-less connection for design verification and fatigue performance assessment; (3) effects of corrosion on load-carrying capacity. Twelve accelerometers, uniaxial strain gauges, eleven strain rosettes, and tiltmeters were installed. The accelerometers monitor the vibrations along the length of the horizontal span and height of the tower. The rosettes at two gusset-less connections on the span and at the three joints on the tower determine the force path through the webs of the connections. The uniaxial gauges, mounted on a diagonal member connecting the instrumented connections on both east and west faces of the bridge, assess the symmetric behavior of the bridge. The tiltmeters monitor the tower movement due to wind, bridge lifts, and combinations of the two.

Shahsavari *et al.* (2020) presented a decision-making protocol for assessing structural behavior and capacity under various damage scenarios. A 3D FEM in SAP2000 was built and calibrated using the SHM data collected from a controlled truckload test. The model was used as a benchmark to: (1) assess the global response of the bridge as a function of damage level; (2)

The numerical accelerations were decomposed at multiple frequency resolutions using the wavelet packet transform. Shahsavari *et al.* (2020) hypothesized that the energy rate indexes of all wavelet packet components vary significantly due to an abnormal change in the global performance or in-service condition of the bridge. The 3D model was calibrated by running a controlled pseudo-static load test using a dump truck with a gross weight of 17,690 kg. With the bridge temporarily closed to traffic, data were sampled at 100 Hz. To reduce uncertainty and variability on data reading due to sensor bias (small offset in the signal average output), before performing the load test, all sensors were calibrated to ensure collecting reliable data. The pseudo-static test was designed with two stopping positions on each lane of the bridge. Several simplifications were made in the model but still the modal and static numerical predictions matched fairly well with the field observations (see Tables 1 and 2 of Shahsavari *et al.* 2020). Different damage scenarios were simulated: truck accident (A), vessel collision (B), fatigue damage (C), and loose bolts (D).

It is noted here, that Chen *et al.* (2018) measured the displacements due to the lift using video cameras located 80+ m away, to extract vibration frequencies and mode shapes of the bridge. The measured signals were compared with those from accelerometers and strain gauges installed on the bridge, and identified characteristics of the bridge were compared to a FEM.

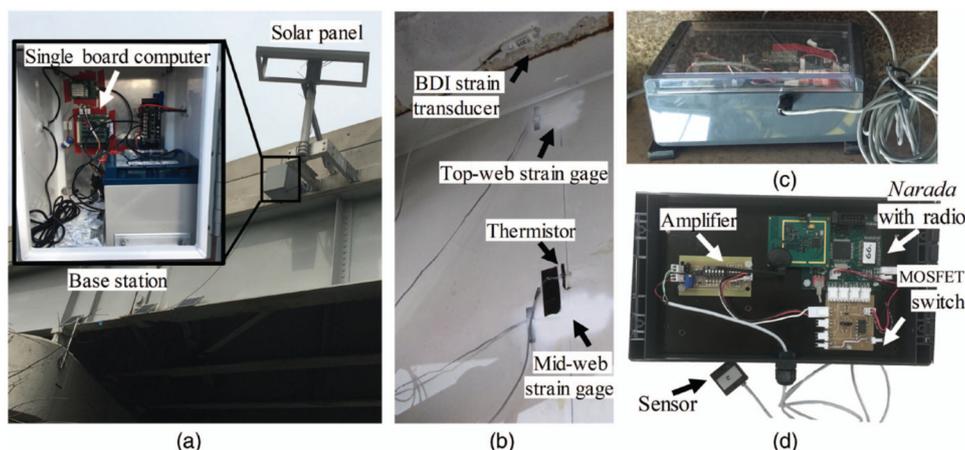
Fig. 3 Highlights of Telegraph Road Bridge instrumentation: (a) base station with solar panel used for power; (b) installation of strain sensors (BDI strain transducer on slab and metal foil gages on girders); (c) wireless sensor enclosure for strain gage data collection magnetically mounted to steel girder flange; and (d) internal components of wireless sensor node. (Figure from Hou *et al.* 2020a)

**30. The Telegraph Road Bridge** is a three-span slab-on-girder highway bridge, completed in 1973. The bridge has been repaired several times, including deck resurfacing in 2011. The original concrete deck had a nominal compressive strength of 20.7 MPa but the new overlay was specified with a 48.3 MPa compressive strength; cylinder tests during the 2011 resurfacing resulted in compressive strengths between 44.1 MPa and 51.0 MPa (Hou *et al.* 2020a, b). A dense network of strain gauges, accelerometers and thermometers was installed, and data were collected daily (Fig. 3). The network was designed to process data in the repository and to extract truck-load events using machine learning. Environmental variations were compensated using nonlinear regression (O'Connor *et al.* 2017). The system was turned on every 2 h to collect data for 1 min with strain, acceleration, and temperature sampled at 100, 200, and 1 Hz, respectively. The first modal frequency of the bridge was estimated to be around 2.5 Hz (O'Connor *et al.* 2017).

Hou *et al.* (2020b) presented the results of 3.5 years monitoring to quantify the composite action in slab-on-girder, and to observe the flexural response of the spans to vehicular loads. The study was complemented with a calibrated analytical model and a FEM both based on field measurements allowing tensile strains in the deck to be estimated under load. The composite action of the bridge was estimated at six different locations. The authors found that the developed partial composite action introduces increased tensile strain in the deck, affecting the durability of the deck itself.

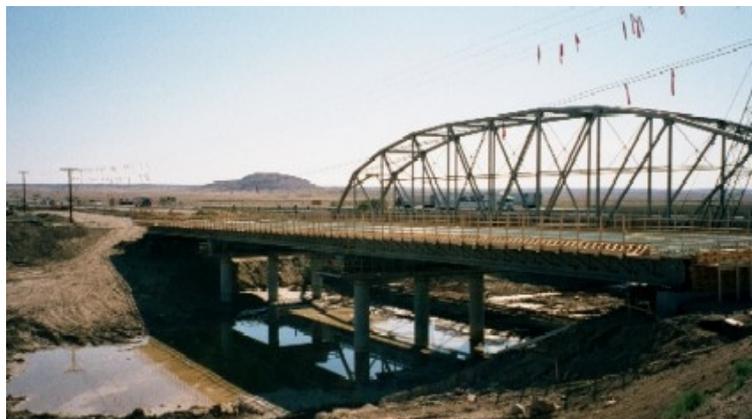
Fig. 5 Photo of the Rio Puerco Bridge. (From SMARTEC 2017b)

~~~~~  
47. The Parker through truss **Rio Puerco Bridge** (Fig. 5) consists of three spans of precast, prestressed I-beams. The bridge was instrumented in 2000 with 64 SOFO sensors to monitor prestress losses, including the early age of the girders (SMARTEC 2017b). Four girders were instrumented with 10 SOFO fiber optic sensors and 6 thermocouples each before pouring and measurements began immediately after pouring. This allowed engineers to determine prestress losses in the girders and real initial strain state of the girders. The results helped to confirm and adjust theoretical models and confirmed the good condition of the bridge after construction.

According to SMARTEC (2017b), the long-term monitoring continues to be carried out.

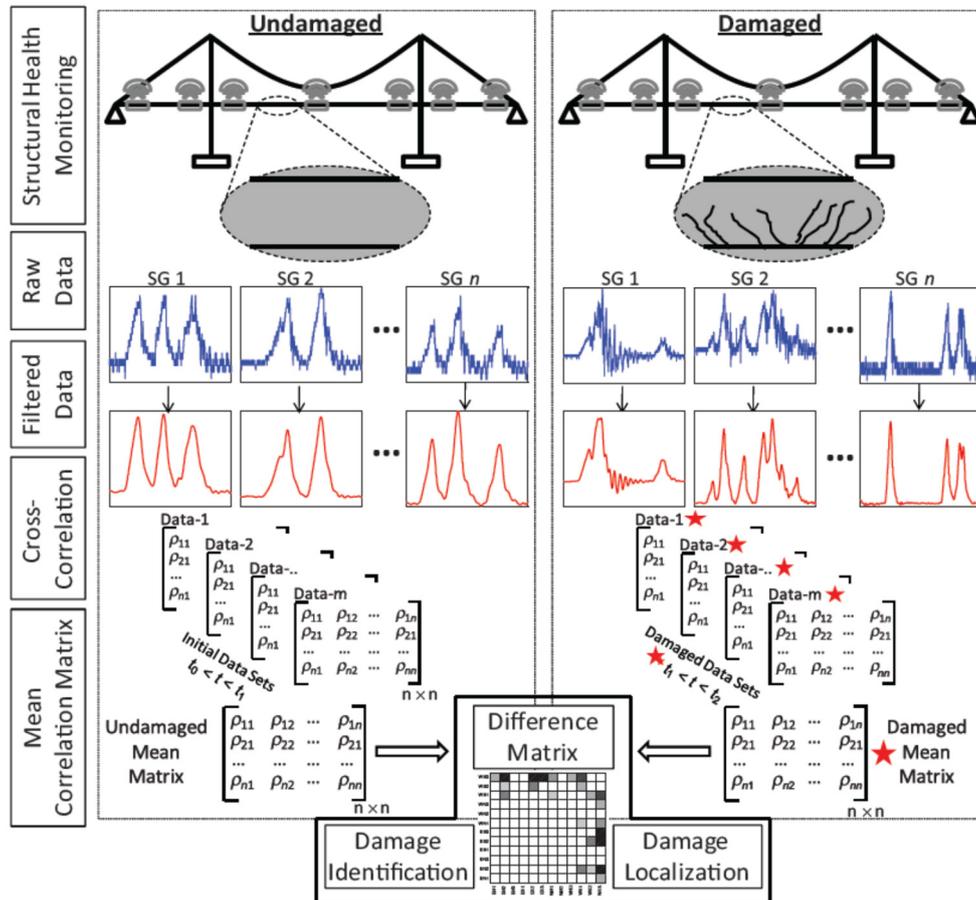
**55. The movable Sunrise Boulevard bridge** was selected to prove a correlation-based SHM methodology to detect and localize structural changes using strain data under operational loading conditions (Catbas *et al.* 2010, 2012). The method tracks the correlation coefficients between strain time histories at different locations. The analysis is framed in **Fig. 6**: strain dynamic data

Fig. 6 Overview of the data analysis method proposed by Catbas *et al.* (2012)

relative to the pristine and damaged structure are collected. The dynamic components for each channel are filtered out for the correlation analysis, and the correlation coefficient of each channel is calculated against all the channels to form the correlation matrix for each data set. The procedure is repeated to obtain the correlation matrices throughout the monitoring period and to create a population of matrices from each data set. Finally, set of matrices are averaged for both undamaged and damaged scenarios and their difference matrix is calculated (Catbas *et al.* 2012).
