## Robotized inspection and health monitoring in the Gran Sasso National Laboratory

**Abstract.** The Gran Sasso National Laboratory (LNGS) is the largest underground research center in the world devoted to neutrino and astroparticle physics. It is located in galleries below about 1400 meters of rock mass. In this environment, inspection and monitoring actions are challenging for the maintenance and the safety of the infrastructures and they require a combined use of different strategies. The paper address issues related to the structural safety of the whole environment by proposing solutions for inspection and monitoring of different areas and elements, such as the gallery vaults, the structures of the experimental prototypes, the plants and the machinery. A generic framework is discussed to evidence the features of each specific solution and the interaction between different systems. Tunnel structural healthy is the most difficult to evaluate because the vaults are coated by not removable panels which waterproof and insulate the environment. Therefore, specific solutions are proposed for the inspection and monitoring of the vaults which are visible only in the interspace realize

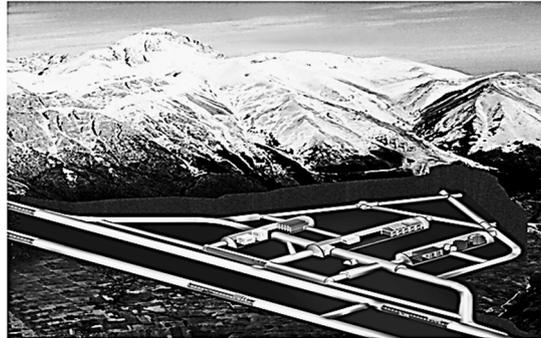
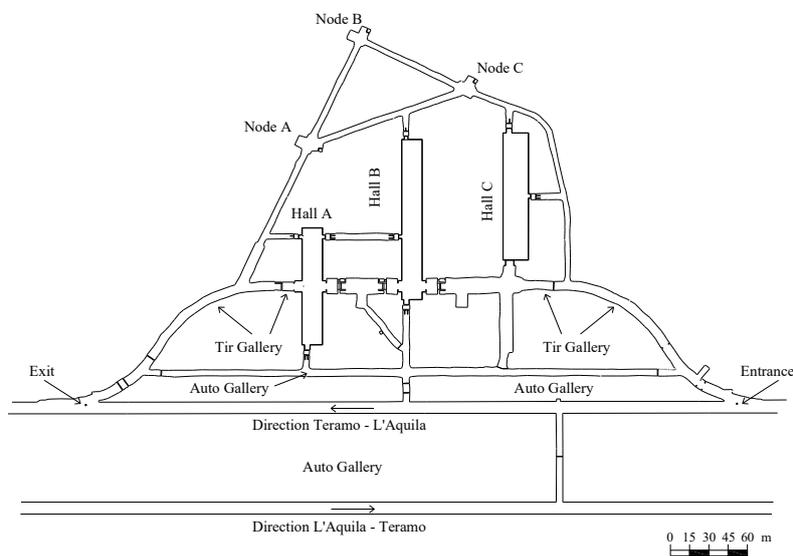
Fig. 1 Gran Sasso National Laboratory

(a) 3D view

(b) Plan with indication of the main galleries

It is possible to entry to the Halls only through the highway tunnel; just outside this highway tunnel (Assergi, Italy) there are the offices dedicated to services of management, protection, administration and also refectory, sheds for storage, conference rooms and small dorms. For the presence of all these facilities, the LNGS is undoubtedly the most ideal place to conduct this specific activity research. The structures of the underground laboratories are showed in Fig. 1. There are three large Halls (Hall A, Hall B and Hall C) and service tunnels (Tir- Gallery and Auto-Gallery), with a total area of about 18000 m<sup>2</sup>.

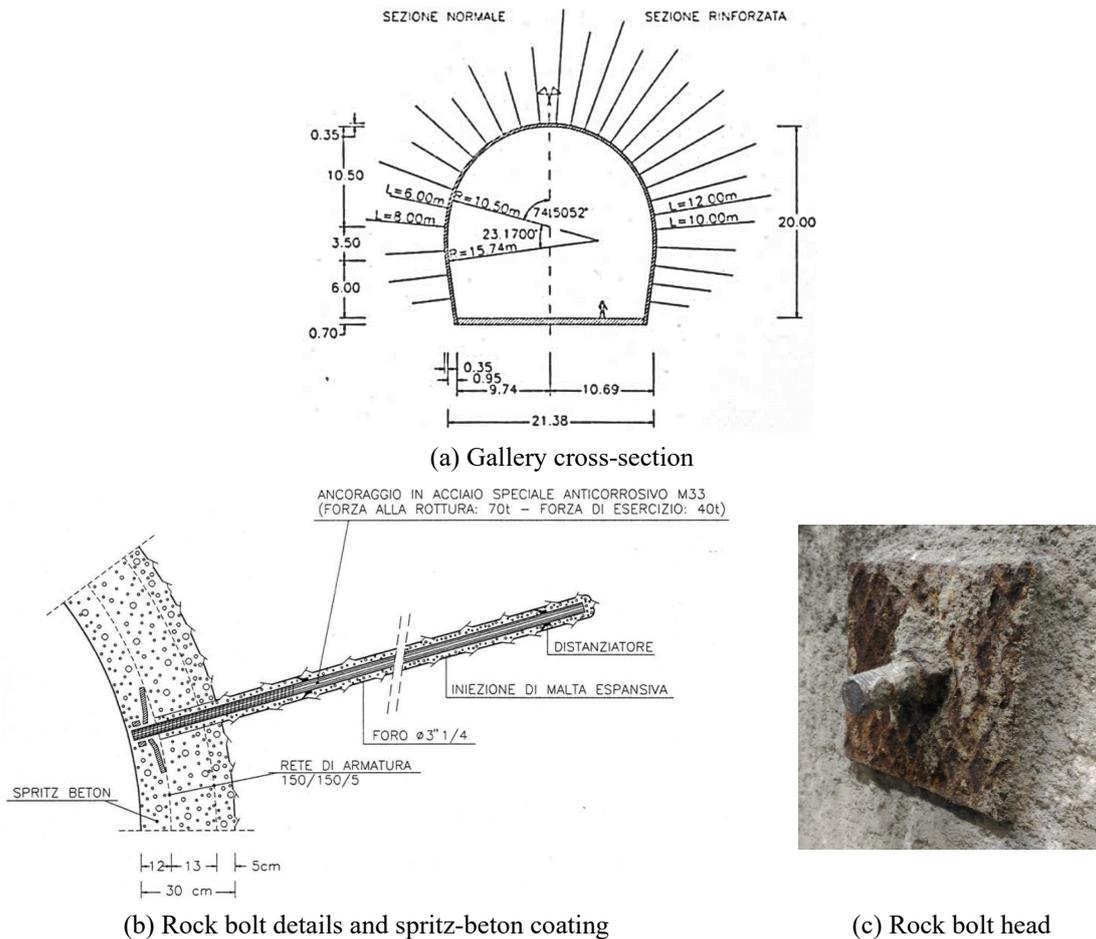
Fig. 2 Consolidation interventions in the galleries designed by Lunardi (1990) and actual condition of a rock bolt head in a picture taken in an accessible point of galleries

the rock mass, due to the excavation, would be stressed over its capacity strength. Moreover, the brittle behavior of the material required the adoption of the stabilization interventions especially to improve the overall cohesion of the rock. For these reasons, Lunardi decided to insert passive anchorages (Fig. 2) to join the discontinuity points and to increase the shear strength of the rock because of the huge coverage and the large dimension of the excavations and above all because of the fragile behavior of the limestone and its overcoming of load-bearing capacity during the excavations. The technical characteristics of the anchorage used are the following: material martensitic stain-less steel (AISI 420), diameter 30.6 mm, length from 6 to 8 m, compressive strength 100 MPa, mesh of 2 meters for side. In the areas, where the rock was more damaged, the length of anchorages is from 10 to 12 m and the mesh is denser (see Fig. 2(a)). Thanks to these consolidation interventions, the coating facilities were designed with very thin thickness (spritz beton layer 30 cm thick showed in Fig. 2(b)) and the use of the cement (source of harmful radiation for experiments) was minimized. Indeed, the rock is became self-bearing and so the crowning in reinforced concrete has no load-bearing function but it is only used to prevent water and stone falling

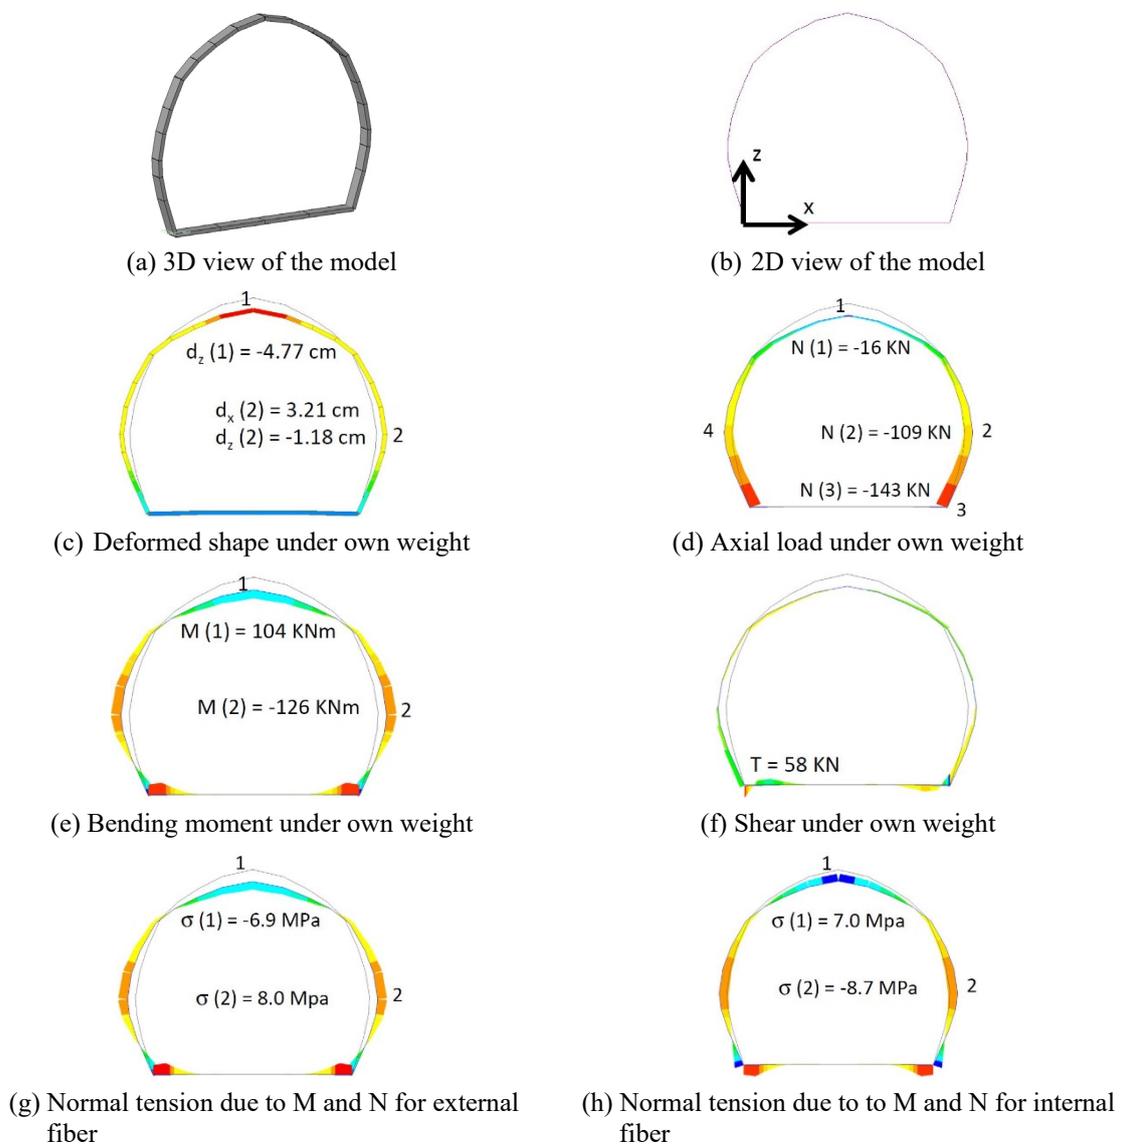
Fig. 3 Numerical modeling of the transversal cross section

and ground shaking, Hashash *et al.* (2001). A preliminary static analysis could be performed through the implementation of a one-dimensional finite element model representative of a transversal cross section of the LNGS underground tunnels. Beam elements (based on the Timoshenko theory) are used to describe the curved geometry of the vault; the section of the beam is rectangular (30 cm height and 1 m width). Moreover, it is right to underline that, in some small zones of the concrete ring, the thickness increases up to 40/50 cm. Anyway, the idealization of the structure has brought to a model with a constant thickness of 30 cm. A first simple linear one-dimensional elastic model is shown in Figs. 3(a) and (b). The bottom beam of the model is considered constrained on elastic soil and the coefficient adopted is  $10 \text{ kg/cm}^2$  (reasonable value for a rocky soil). As well explained previous, such reinforced concrete coating has no load-bearing function and so the results related to the displacements and stresses are due only to the self-weight. The contribution of the anchorages has not been modeled to simulate an unfavorable limit situation in which all the anchorages lose their functionality (e.g., fracture or loss of friction). The deformations obtained with these models can be considered as limit values which require further observations and experimental tests that aimed to evaluate the conditions of the vaults. Based on above consideration, the results reported in Figs. 3(c)-(f) are related to a load case in which only the self-weight of the elements is taken into account. The main parameters selected to implement the numerical model are reported in the below Table 1. This analysis allows to identify the critical points of the galleries that need to be inspected to assess the actual conditions of the structure (points 1, 2 and 4 in Fig. 3(d)). These locations will correspond to the positioning of the sensors in the subsequent structural monitoring system. It can be observed that the maximum displacement value ( $-4.77 \text{ cm}$  in z-direction) occurs at keystone, while a swelling of the vault ( $3.21 \text{ cm}$  in x-direction) occurs at 5 m height. It is right to observe that, under the self-weight, the horizontal distance between two points, placed at the same quote for each lateral side (points 2 and 4, see Fig. 3(d)), show a spacing. In real conditions, the swelling, even in the case of total interruption of the action of anchorages, is still reasonably constrained by the surrounding rock. The normal stress is only compression (maximum value  $143 \text{ kN}$ ). Due to bending moments at keystone, the fibers stretched are inside the vault, while at 5 m height they are out of the vault (Fig. 3(e)). Moreover, the normal tensions, due to bending moment and axial force, assume a value around 33% of the characteristic strength of the concrete.

Due to its function the main points, on which to collocate the sensors, have been individualized through the evidences of a numerical model representative of a transversal section under self-weight. After that, other loading effects to be considered could be the seismic one. However, the Gran Sasso mountain has a strong attenuation power of the seismic swarm, see De Luca *et al.* (1998). This phenomenon has been also experimentally checked during the L'Aquila 2009 Earthquake. Indeed, the processing of the measurements recorded during such earthquake by two accelerometer stations placed one inside the gallery (named GSA) and the other one external to the mountain (i.e., in free

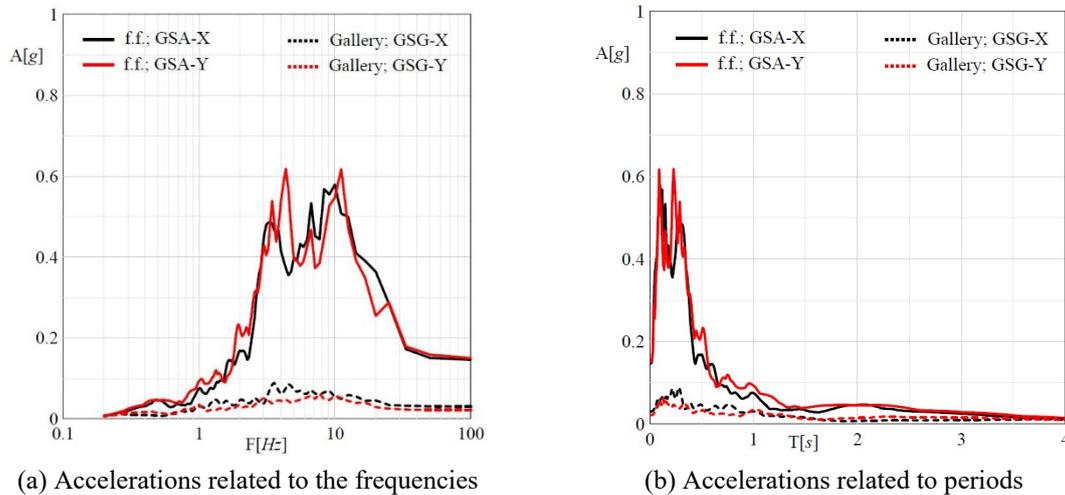
Fig. 4 Response spectra in terms of accelerations of the measurements recorded during the L'Aquila 2009 Earthquake in the stations GSA (external to the mountain) and GSG (inside the Gallery). f.f.: free field, Gallery: inside the Gallery. X and Y are both horizontal directions orthogonal to each other

field, named GSA), both on the soil, showed a strong attenuation up to a tenth as demonstrated by the spectral accelerations reported in the below Fig. 4. Therefore, the structural monitoring system has been thought, mainly, to follow the degradation of the material. Other information related to the processing of such measurements can be found in Potenza and Gattulli (2011).

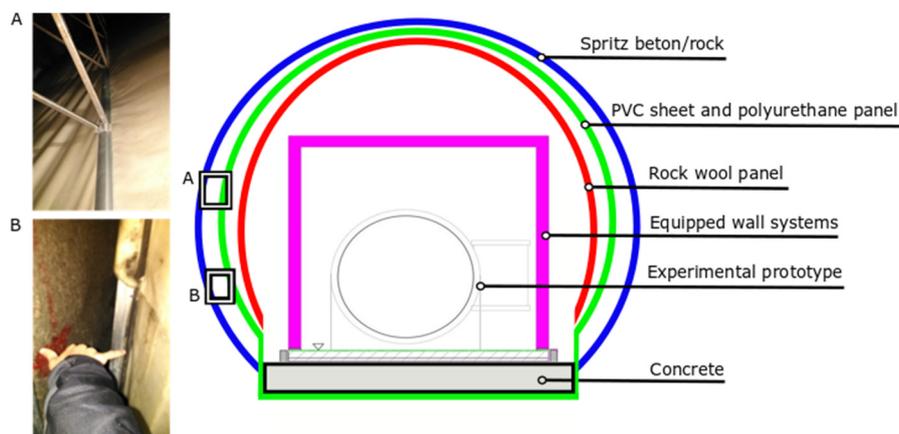
Fig. 5 Sketch of gallery cross section evidencing the interspace between spritz beton/rock layer and polyvinyl chloride (PVC) panels: detail A shows the aluminum structure, detail B the interspace length ( $\cong 20$  cm)

As shown in Fig. 5, the interspace between the spritz beton/rock layer and the coating panels is variable along the cross-section: it grows from the top to the bottom of the vault; at the base of the vault it is about 20 cm width (picture B in Fig. 5). In this restricted interspace there is also the aluminum structure that supports the coating panels (picture A in Fig. 5).

Therefore, in this case, an appropriate robotic system must be quite small and able to move itself in the delimited interspace between the panels and the spritz beton/rock surface of the gallery by avoiding the obstacles provided by the aluminum structure.

As emphasized in Section 2.2, it is needful to inspect the conditions of the keystone, where the largest displacement occurs. Moreover, in this area the fibers stretched are inside the vault, the cracks may arise from inside of the vault and they may be observed by a robot capable to move in this interspace.

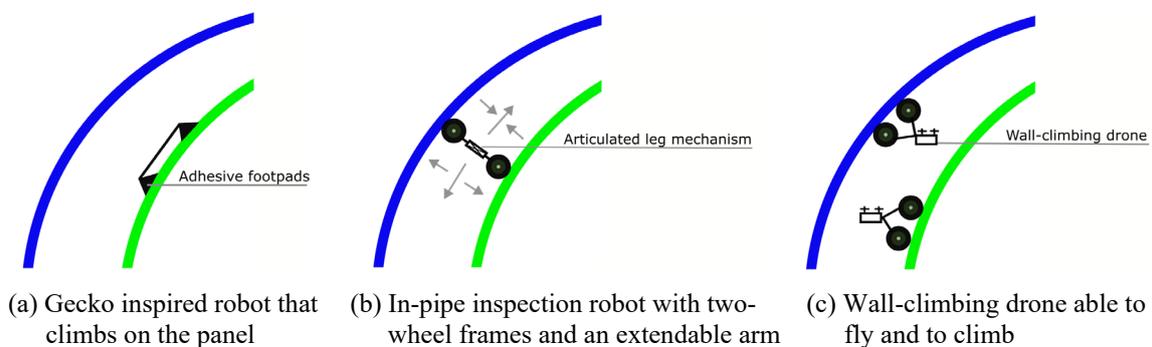
Fig. 6 Sketch of the proposed solutions for the inspection of the rock surface with robots able to move in the interspace between the spritz beton/rock (blue) and the PVC sheet/polyurethane panel (green)

These issues could be solved by adopting an in-pipe inspection robot, such as the prototype developed in Oya and Okada (2005) that is a steerable and wheel-type robot composed of two-wheel frames and an extendable arm which presses the frames against the interior wall of a pipe through a articulated leg mechanism to support the robot. Only one wheel has driven power; one-wheel frame can rotate around the axis of the arm and both of the wheel frames can twist. The ability to twist allows to turn the robot and to avoid obstacles. The height of the robot is adaptable from 140 to 210 mm. A sketch of this robot is reported in Fig. 6(b). The use of articulated/extendible legs will provide the robot to adjust itself to the curvature of the wall, not being affected by humidity or dust, and to fit to the variable interspace. The articulated legs will have wheels to roll over the surface and adjust the height to the space. Additional DoFs (Degrees of Freedom) will be used to

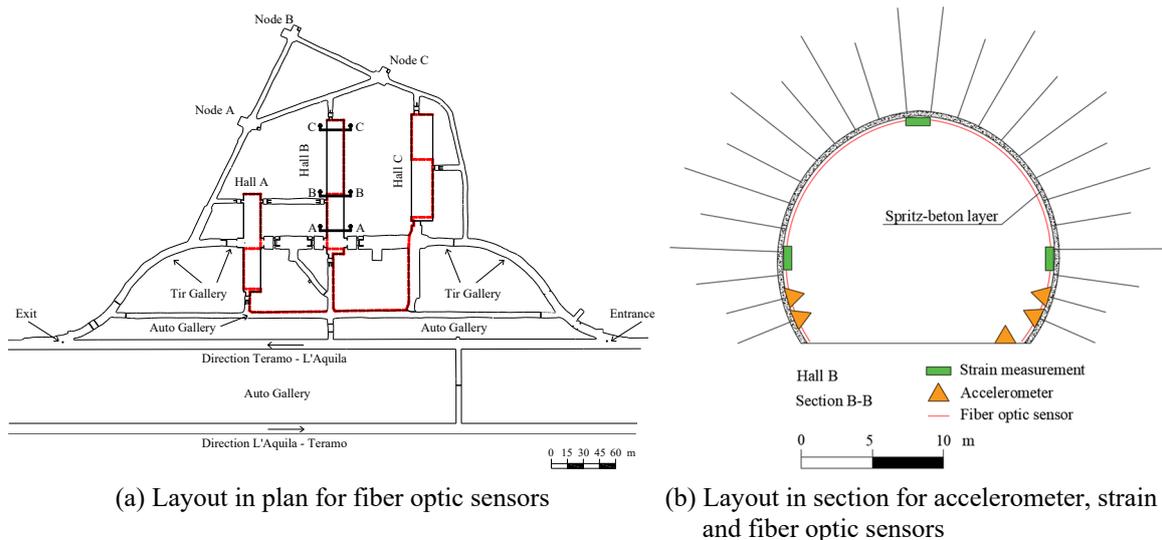
Fig. 7 General layout for a possible structural monitoring system within the LNGS Galleries composed by accelerometer, strain and fiber optic sensors

The possibility to integrate these robotic systems with some devices able to perform fiber optic installation should be assessed in order to install a monitoring system widespread in all galleries, as shown in Fig. 7(a). The installation of fiber optic sensor on tunnel surface allows to evaluate the deformations of the tunnel and to detect possible anomalous structural behaviors. In this layout have been highlighted the position of the extensometers (Fig. 7(b)) whose collocation has been determined by the evidences of the numerical model (i.e., where the stress and deformations are

largest). Moreover, some accelerometers have been introduced at the rock bolts top to measure its structural response due to both environmental noise (sometimes developed by heavy work carried out inside the galleries) or rare events like seismic waves of low intensity (Fig. 7(b)).

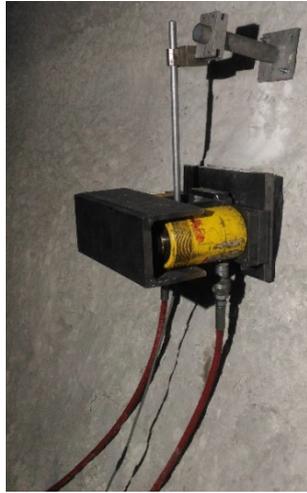
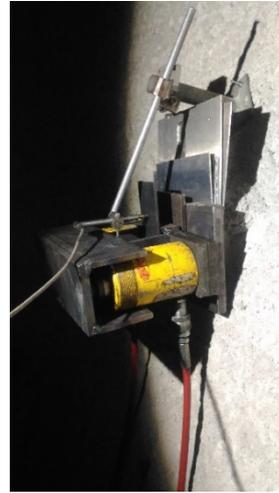
(a) Load test instrumentation, view 1

(b) Load test instrumentation, view 2

Fig. 8 Non-extraction load tests carried out on the anchorages reachable by human operators: 20-ton hydraulic jacks were connected to the head of the tie rod by means of a supplied sized metal structure to evaluate the existence of an operating load
