In situ dynamic investigation on the historic “İskenderpaşa” masonry mosque with non-destructive testing

Abstract. Turkey is a transcontinental country located partly in Asia and partly in Europe, and hosted by diverse civilizations including Hittite, Urartu, Lydia, Phrygia, Pontius, Byzantine, Seljuk’s and Ottomans. At various times, these built many historic monuments representing the most significant characteristics of their civilizations. Today, these monuments contribute enormously to the esthetic beauty of environment and important to many cities of Turkey in attracting tourism. The survival of these monuments depends on the investigation of structural behavior and implementation of needed repairing and/or strengthening applications. Hence, many countries have made deeper investigations and regulations to assess their monuments’ structural behavior. This paper presents the dynamic behavior investigation of a monumental masonry mosque, the “İskenderpaşa Mosque” in Trabzon (Turkey), by performing an experimental examination with non-destructive testing. The dynamic behavior investigation was carried out by determining the dynamic characteristic called as natural frequencies, m

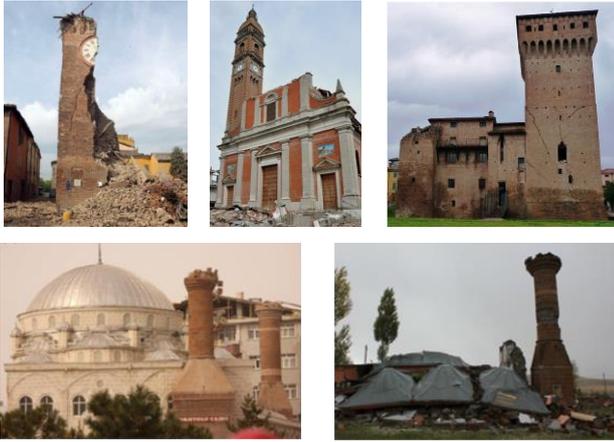
Fig. 1 Photographs of collapsed or heavily damaged historic masonry structures

Historic monuments are the most visible aspects of the civilizations. In addition to their cultural value, historic monuments contribute significantly to esthetic beauty of environment and also important to stimulate the economic activity in regions. These monuments, however, are universally threatened by many deleterious effects such as vandalism, poor maintenance, weathering, soil settlements, man-made and natural phenomena. In some cases, applications intended to preserve, clean, or restore monuments may also cause deleterious effects. These factors, in particular natural phenomena such as earthquakes, are the source of demolishing and destroying of many historic monuments. Their preservation, together with monitoring at regular intervals and structural safety assessment against earthquakes, has become a high concern due to some dramatic events, such as in Italy the sudden collapse of the Civic Tower (Macchi 1993), the abrupt collapse (6 years after the earthquake) of the Dome of the Noto Cathedral (Binda *et al.* 2003, Bartoli *et al.* 2013), Estense Fortress, Cathedral of San Paolo and Modenesi Tower in Italy (Parisi and Augenti 2013), collapse of historic slender towers during 2011 Van earthquake in

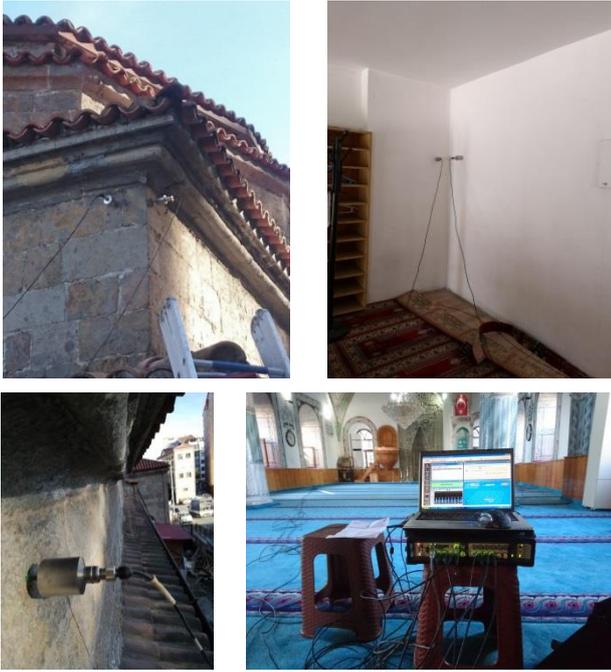
Fig. 4 The accelerometer connections and test equipment

dynamic characteristics experimentally. During the test, a B&K 3560 data acquisition system with 17 channels and B&K 8340-type uni-axial accelerometers having 10V/g sensitivity, uni-axial signal cables, PULSE and OMA software were used as the test equipment. The frequency range was selected as 0-25 Hz and nine accelerometers were located at the top of the mosque (more vibrations occur on the upper part of the structures) in transverse and longitudinal directions (Fig. 4). The accumulated data with B&K 3560 was then transferred into PULSE Labshop software (PULSE 2006) and Operational Modal Analysis software (OMA 2006) for signal processing. The modal parameters were then extracted using the EFDD and SSI methods. Some parameters considered during the measurements are below:
