Detecting and localizing anomalies on masonry towers from low-cost vibration monitoring

Paolo Borlenghi^a, Carmelo Gentile* and Antonella Saisi^b

Department of Architecture, Built environment and Construction engineering (ABC),
Politecnico di Milano, Piazza Leonardo da Vinci 32, 20133 Milan, Italy

(Received July 8, 2020, Revised November 11, 2020, Accepted November 21, 2020)

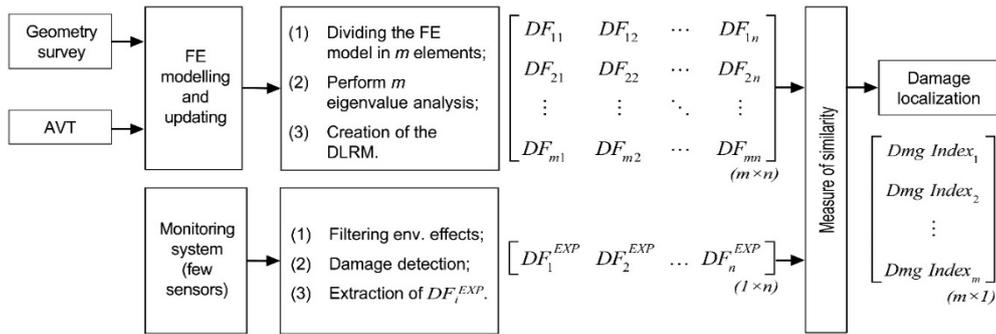
Fig. 1 Proposed damage identification scheme for masonry towers

The proposed methodology – summarized in Fig. 1 – involves the following steps: (i) preliminary analysis, including geometric survey and ambient vibration tests (AVTs); (ii) FE modeling and updating; (iii) creation of a Damage Location Reference Matrix (DLRM) from numerically simulated damage scenarios; (iv) detection of the onset of damage from dynamic monitoring; (v) localization of the anomalies through the comparison between the experimentally identified variation of natural frequencies and the DLRM matrix, containing information on the numerically simulated damage scenarios. Compared to previous studies using a sensitivity-based approach (see, e.g., Kim and Stubbs 2003, Messina *et al.* 1998), the present technique is not limited to academic examples or very simple structures, and can be applied to three-dimensional structures. Furthermore, for a single damage position, the use of a similarity measure guarantees that a correct indication of the damage location is provided with noisy data.

The DLRM approach (Fig. 1) is developed to give information on the damage location using only the observed changes in natural frequencies.

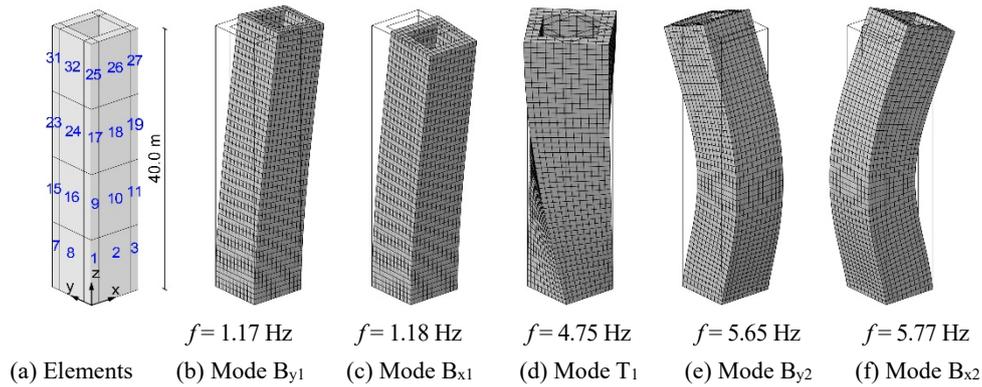
Fig. 2 Idealized tower divided into 32 elements and vibration modes used in the damage localization

To clarify the working principles of the proposed approach, the model of an idealized masonry tower is used. Fig. 2 shows the geometry adopted and the n vibration modes considered. As pointed out by different scholars (see, e.g., Cabboi *et al.* 2017, Ubertini *et al.* 2018, Standoli *et al.* 2020), five modes are often identified with Operational Modal Analysis in masonry towers: the first torsion mode (T) and four bending modes (B).

The DLRM contains the m percentage of variations of the n considered natural frequencies. The creation of the DLRM is performed as follows: (i) as shown in Fig. 2(a), the previously calibrated FE model is divided into m elements by differentiating corners and walls in plan, and floors in height; (ii) m eigenvalue analyses are performed reducing the elastic modulus of each element by a certain quantity (e.g., the 40%); (iii) the changes in the n natural frequencies are collected in an m -by- n matrix called DLRM.

It should be noticed that the number of elements m in which the tower is divided (Fig. 2(a)) is dependent on the geometry of the investigated building; on the other hand,

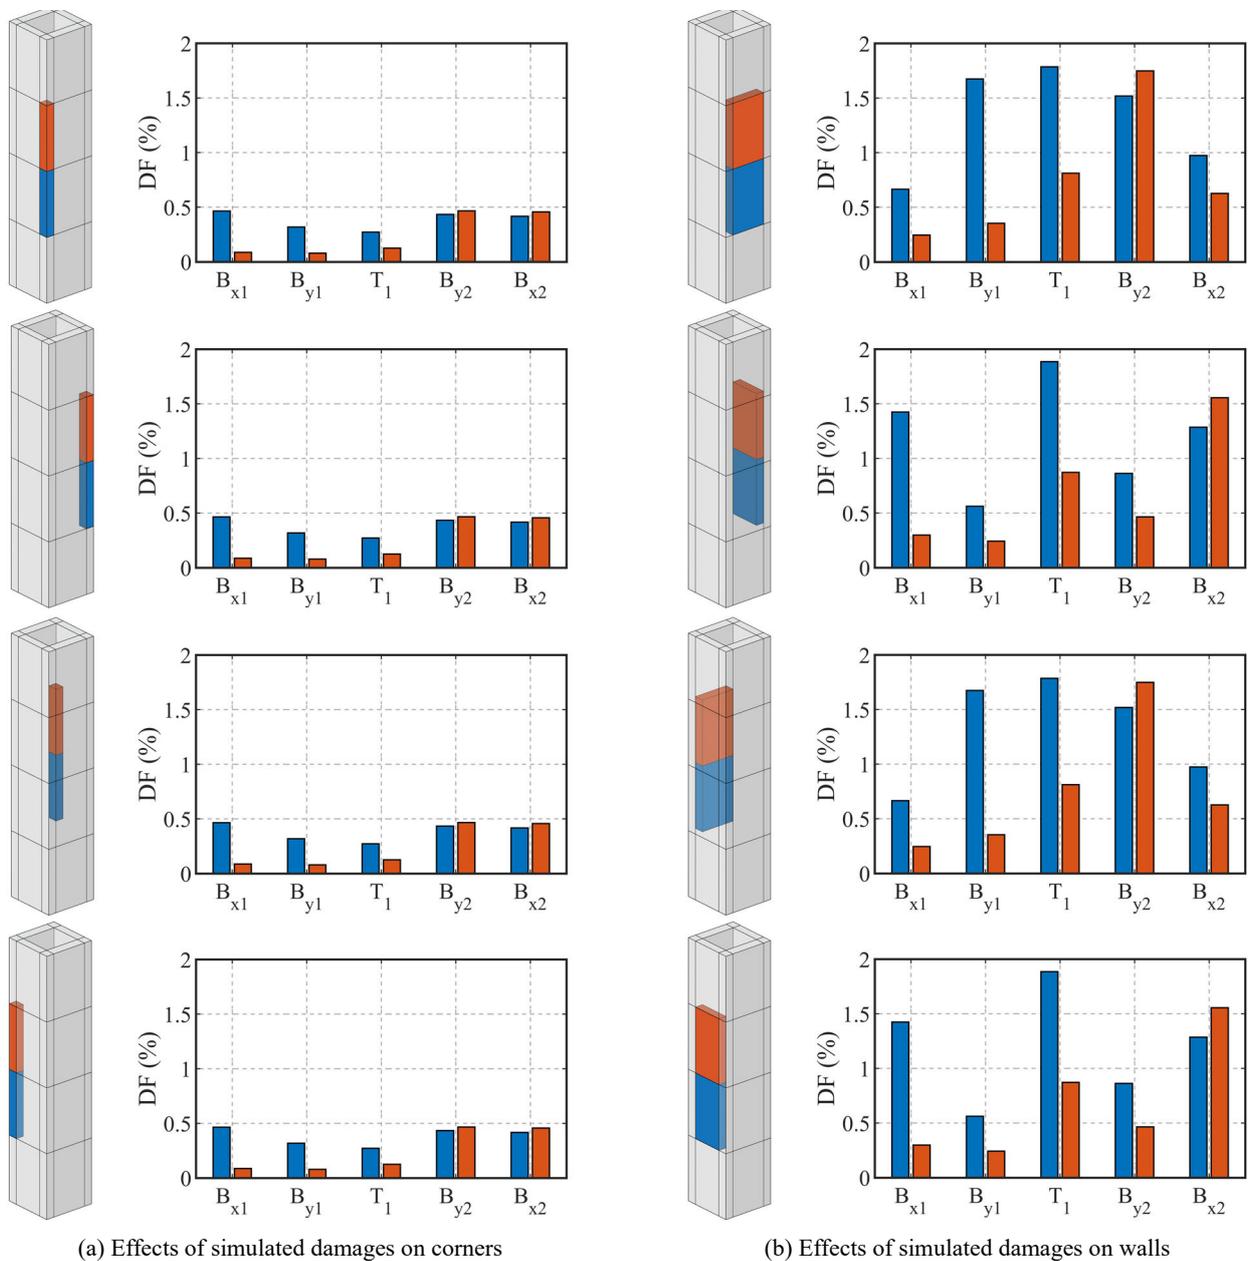
(a) Effects of simulated damages on corners (b) Effects of simulated damages on walls
 Fig. 3 Comparison between the simulated Damage Scenarios (DSs) of the first and second floor in terms of frequency discrepancy (DF, Eq. (2))

To give an example of how the location of damage affects the natural frequencies, Fig. 3 illustrates the comparison between the simulated damages of the idealized tower for the elements of two consecutive floors. The damages are obtained reducing the elastic modulus of each element by 30%.

From the analysis of this simplified application, it is possible to draw the following observations on the effectiveness of the localization procedure using the frequency variations: (i) the simulated damages belonging to different floors gives in all cases different pattern of frequency variations (Fig. 3); (ii) the simulated damages of the four corner elements belonging to the same level (bars with the same color in Figs. 3(a)-(b)) gives the same frequency variations; (iii) the simulated damages on the four wall elements belonging to the same floor (bars with the same color in Figs. 3(c)-(d)) gives the same frequency variations when aligned on the same direction.

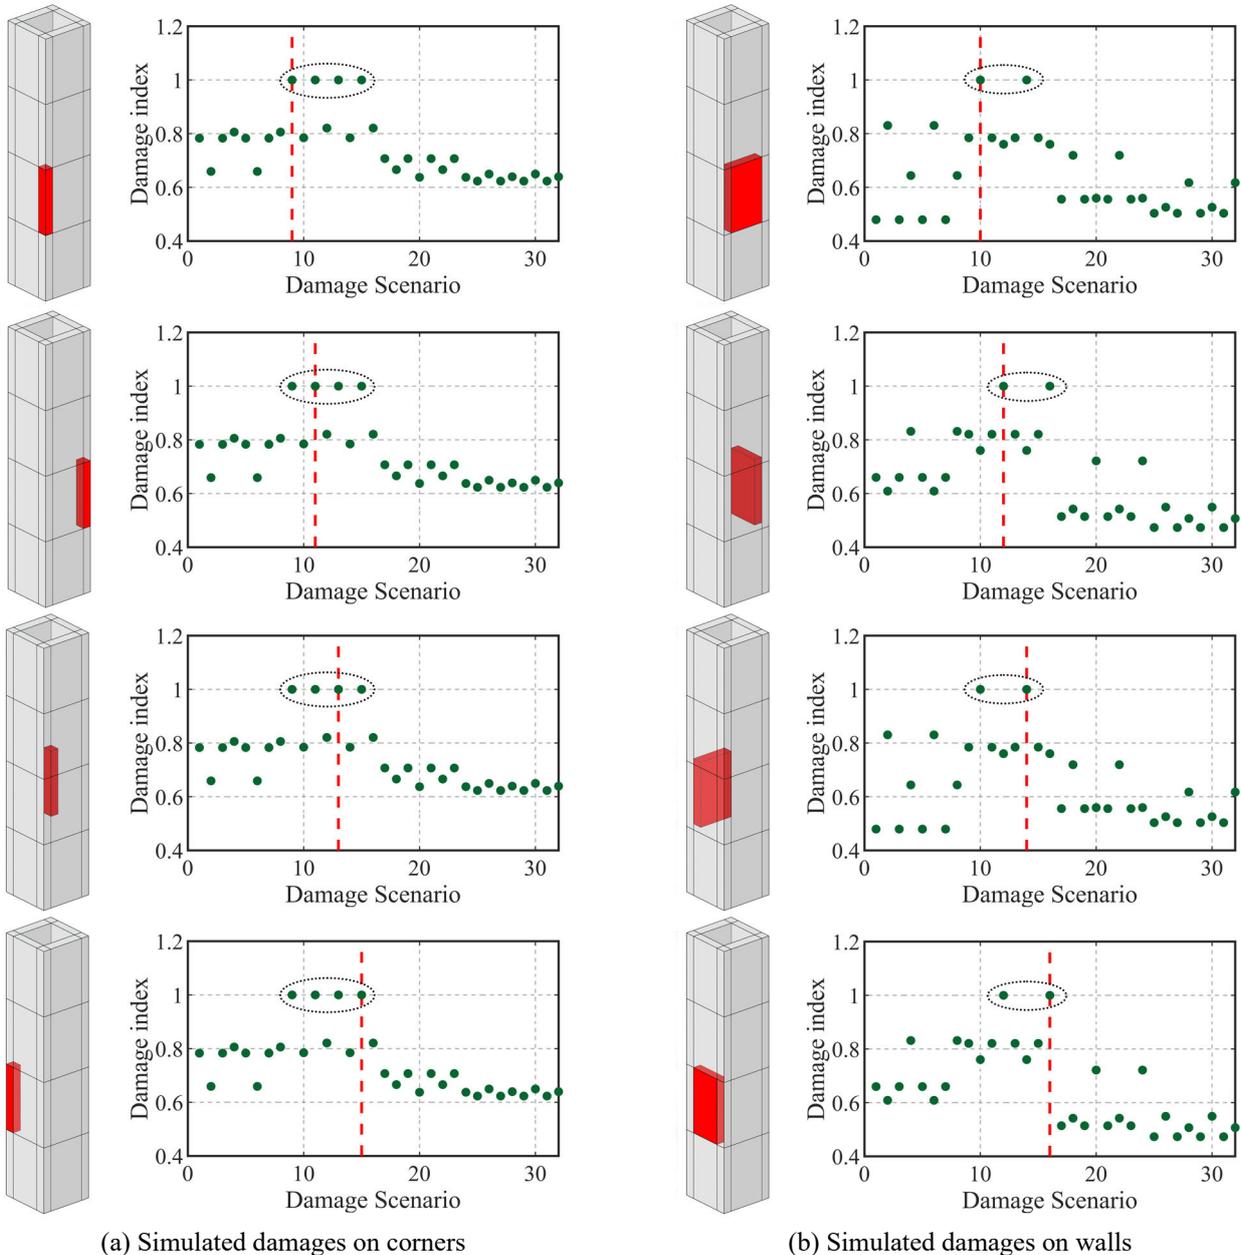
Fig. 4 Localization of 8 simulated damages obtained by decreasing the Young's modulus of first-floor walls and corners by 20% (the red dashed line represents the actual damage location)

In Fig. 4, the localization procedure is exemplified using the model of the idealized tower. Eight simulated frequency

shifts (DS_{EXP}) are computed reducing the elastic modulus of the eight elements of the first floor by the 20%. The different simulated DS_{EXP} are then compared with the j -th DS of the DLRM. The following observations can be drawn:

- as expected, it is not possible to distinguish between the DSs on corner elements belonging to the same floor;
- similarly, it is not possible to differentiate between the DSs on wall elements belonging to the same level and same direction.

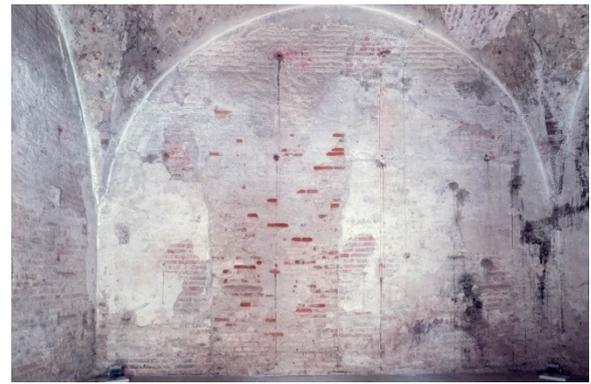
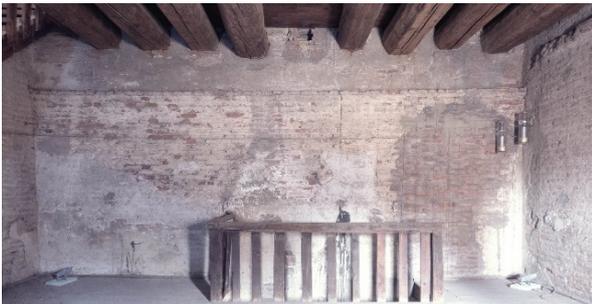
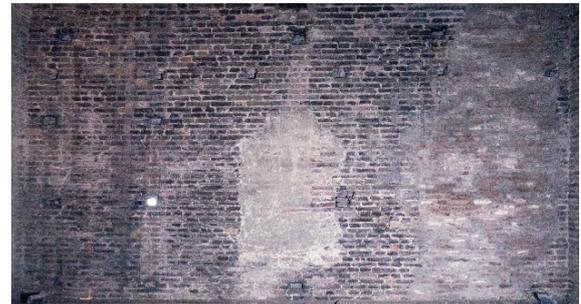
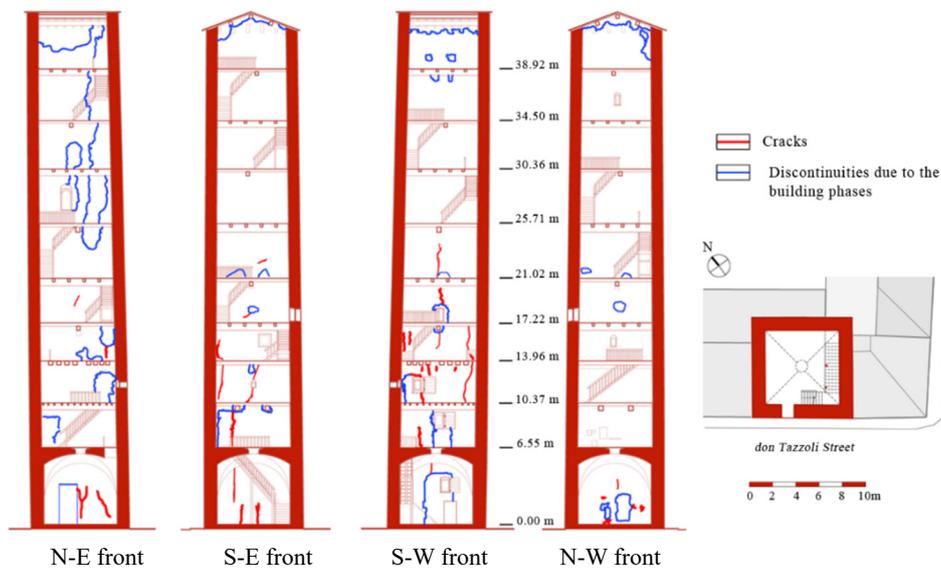
(b) Internal views on N-E front, ground floor

(c) Internal views on N-E front, second floor

(d) Internal views on N-E front, seventh floor

(e) Overall damage survey of the inner fronts

Fig. 5 The *Zuccaro* tower: external and internal views, and damage survey of the inner fronts

The *Zuccaro* tower (Fig. 5), about 43 m high, is a defensive structure built in the Middle Ages (Saisi *et al.* 2019) in the historic town of Mantua. The first record regarding its existence dates back to 1143. The few and small openings and the tower location at the limits of the city Middle Ages fortifications suggest its original defensive role. As shown in Fig. 5(a), the tower is nowadays included in a building aggregate, surrounded on three-sides by low-rise constructions.

The results of on-site inspections of the tower inner fronts are summarized in Fig. 5(e). From the stratigraphic survey, the discontinuities caused by different building phases or local masonry reconstructions are identified. Furthermore, the on-site inspections highlighted the following aspects:

- Sharp discontinuities and deep cracks were found around the corner between the S-W and S-E walls starting from the base up to 17.22 m;
- Some deep and thick cracks were identified on the cross vault at the ground level;
- The presence of large areas with fragmentary and non-homogeneous masonry was identified starting from the height of 21.0 m on the N-E front (see Fig. 5(e));
- Extended dark areas resulting from the fire of 1979 were found in the inner walls.

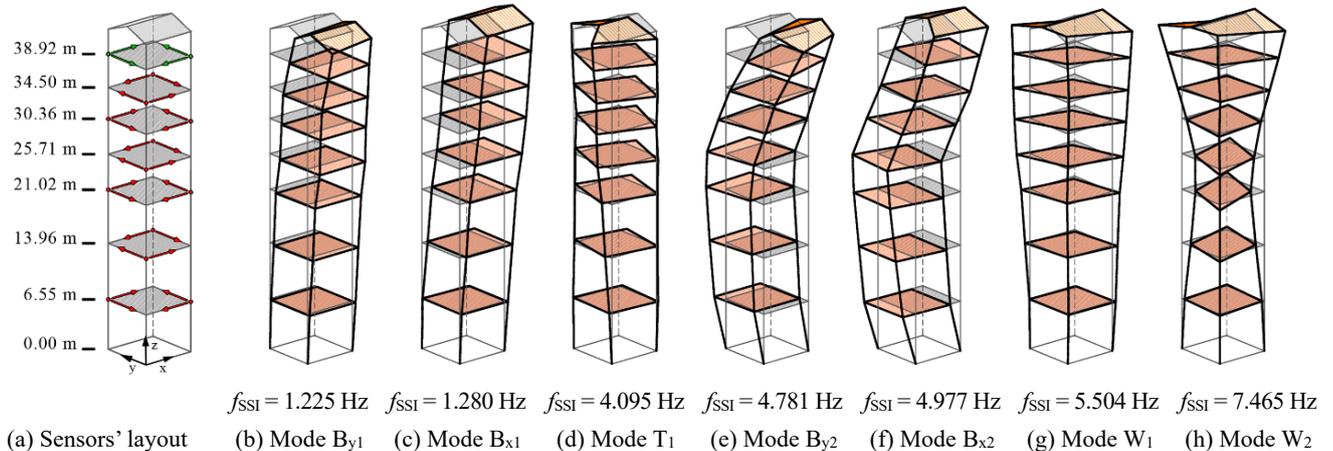
Fig. 6 Instrumented cross-sections and layout of accelerometers during the vibration test performed in December 2017, and identified vibration modes (SSI)

During the first test, 2 bi-axial seismometers (electrodynamic velocity sensors, 78 V/(m/s) sensitivity) were installed at the opposite corners of the top floor to measure the dynamic response of the structure under ambient excitation. During the second test, high-sensitivity accelerometers (sensitivity of 10 V/g; peak acceleration of ± 0.5 g) were employed to measure the response of the tower in 14 points belonging to 7 selected cross-sections (Fig. 6(a)).

Overall, seven vibration modes were identified in the frequency range of 0-9 Hz. The identified modes were classified as 4 bending modes (B), 1 torsion mode (T), and 2 modes involving a warping (W) distortion of the tower cross-sections. As shown in Fig. 6 (referring to the test performed on December 2017), the sequence of lower 5 modes (i.e., 2 couples of closely-spaced bending modes with an intermediate torsion mode, Figs. 6(b)-(f)) is very similar to what observed on similar towers (Cabboi *et al.* 2017, Ubertini *et al.* 2018, Standoli *et al.* 2020), whereas the last two modes (Figs. 6(g)-(h)) are distinctive features of the investigated structure. It is further noticed that, to the authors' knowledge, vibration modes involving warping distortion of the cross-sections have not been observed before on historic towers; in the case of *Zuccaro* tower, the warping distortion is conceivably related to the cross-section characteristics, namely the size of the structure's side and the absence of stiff floors.

It is finally observed that the results of the test performed in December 2017 (Fig. 6) were assumed as experimental reference in the calibration of the numerical model.

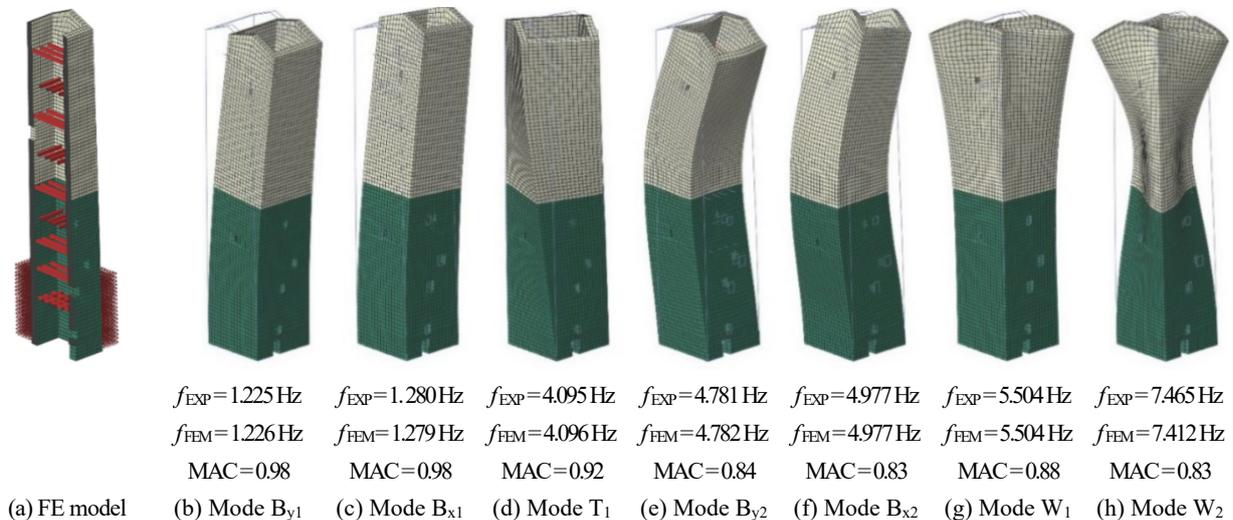
Fig. 7 FE model of the Zuccaro tower and vibration modes of the optimal (updated) model

Fig. 7 shows the mode shapes of the optimal (updated) model, corresponding to the experimental ones (Fig. 6), and the correlation with the modal parameter of the real building. It should be noticed that an excellent correlation between the numerical and experimental modal responses is obtained, resulting in a maximum frequency discrepancy of 0.71% and a minimum MAC (Allemang and Brown 1982) of 0.83. Hence, the optimal model is capable of accurately representing the observed dynamic characteristics of the building and can be considered an appropriate baseline model for long-term dynamic monitoring.

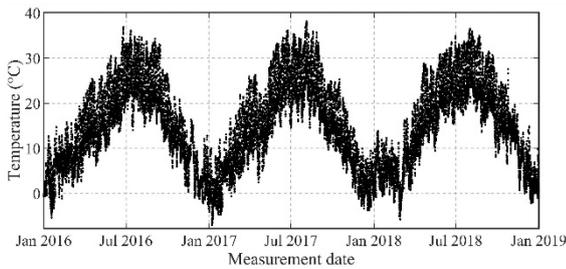
Fig. 8 Temperature data from S. Agnese weather station (from January 2016 to December 2018)

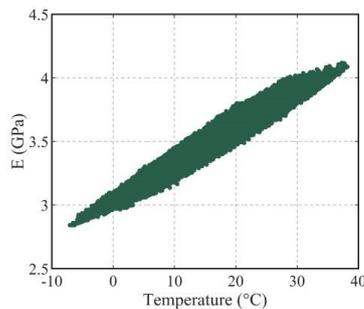
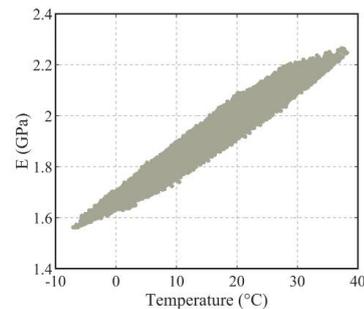
(a) E_{low} height ≤ 21.02 m

(b) E_{up} height > 21.02 m

Fig. 9 Correlation between the air temperature and the Young's modulus of lower and upper parts of the tower

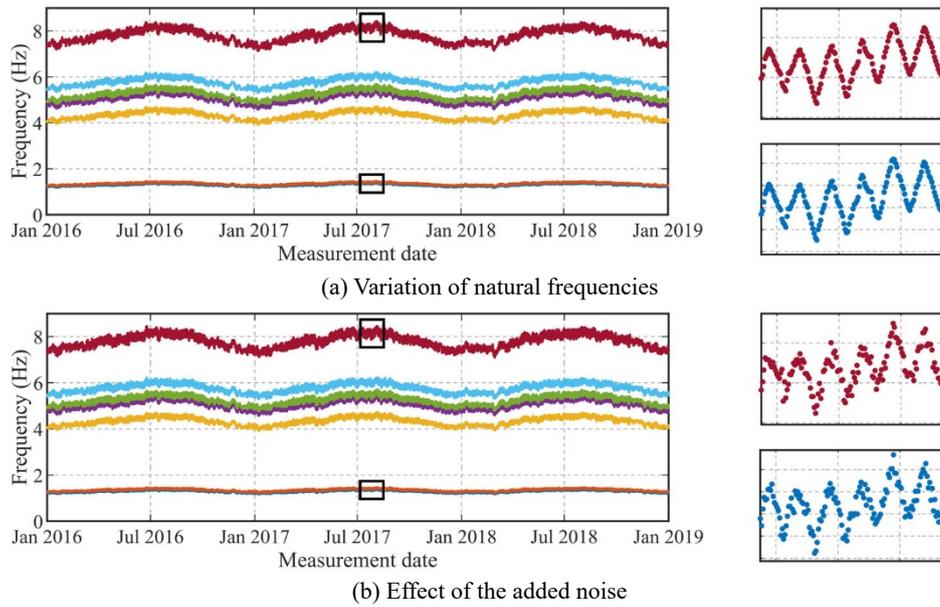
Fig. 10 Three years of pseudo-experimental data and 6-days zooms of the first (B_{y1}) and last (W₂) mode

comparison of Fig. 10(b) and Fig. 11 demonstrates the effectiveness of the adopted procedure in cleaning the data. It is worth noting that the resulting standard deviation after the filtering corresponds almost completely with the added noise (Table 4).

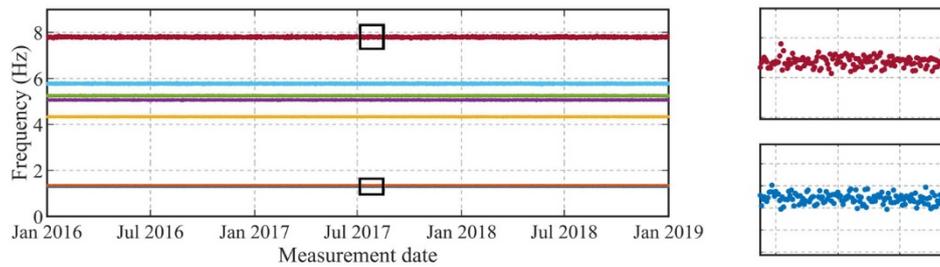
Fig. 11 Filtered data from PCA-based regression: variations over three years and 6-days zooms of the first (B_{y1}) and last (W₂) frequency

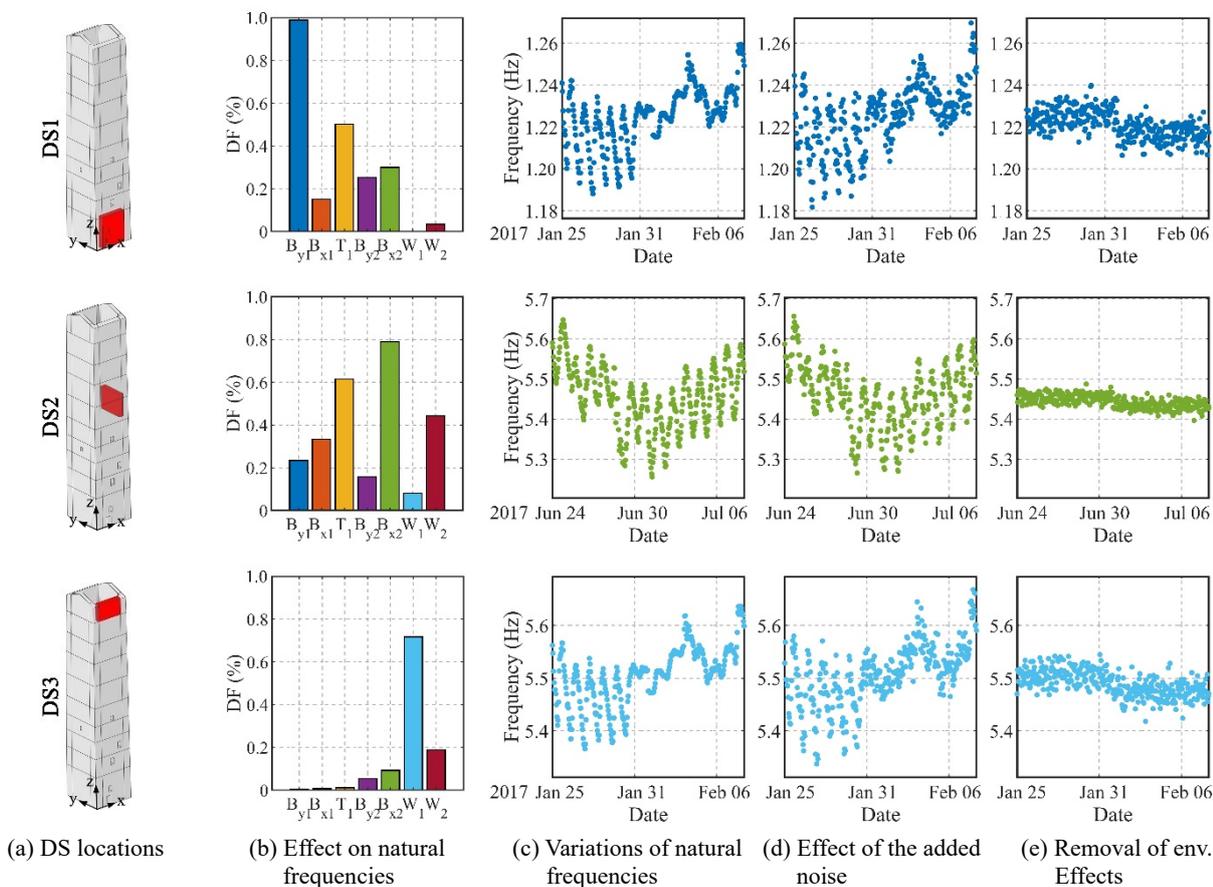
Fig. 12 Simulated damage scenarios (DSs): actual locations, percentage variation of natural frequencies and 12-days zooms of the natural frequencies most affected by damage

DS1 and DS3 were simulated during the winter season (1st of February) – when the daily frequency variations are smaller – while DS2 was simulated during the summer season (1st of July). Subsequently, the random noise was added on the generated data, hiding the sharp changes of natural frequencies in the daily variations caused by environmental effects; it is indeed impossible to recognize the frequency shifts inspecting the diagram (Fig. 12(d)).

Notably, the localization of the last DS relies on the induced frequency shift on mode W_1 (see Fig. 12(b), DS3), which is associated with distortion of the cross-section. Conversely, the other localizations rely also on bending modes (see Fig. 12(b), DS1 and DS2), which are characterized by a direction-dominated component of motion. As a consequence, when the damage affects mainly the warping modes its localization through the DLRM approach turns out to be less accurate even if the region involved is roughly identified.

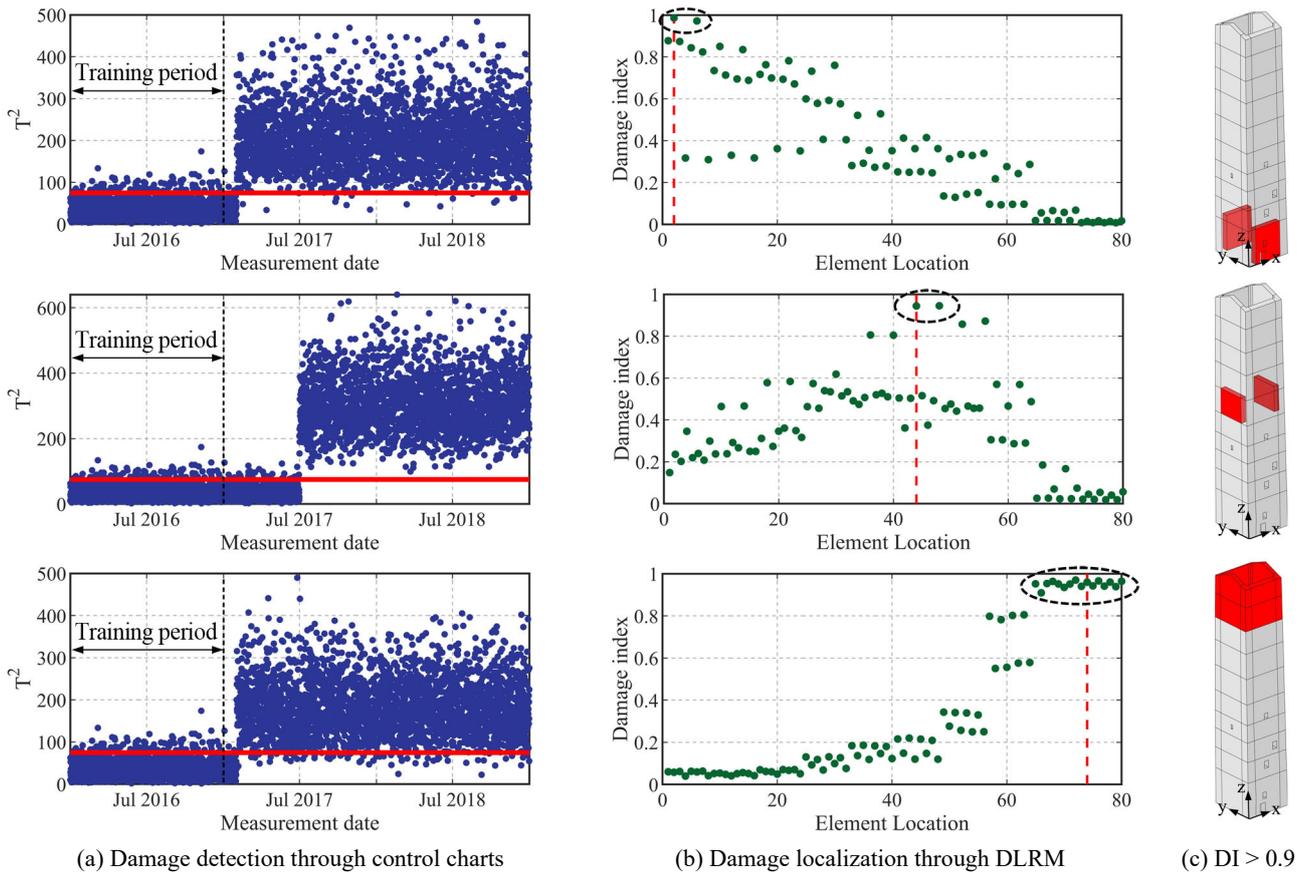
Fig. 13 Damage detection and localization for the three simulated damages

The residual errors obtained from the PCA-based regression were used to define a multivariate control chart based on the Hotelling’s T^2 -statistic. The data were divided into subgroups of 12 hours, and a process mean was defined using a period of 12 months. The structural anomalies are detected each time an observation lays outside the control limit. As shown in Fig. 13(a), the three damage scenarios are clearly detected, and more specifically:

- During the training period a limited number of observations exceed the control limit;
- At the time the damage is introduced, the control limit is suddenly exceeded by the T^2 -statistic, exhibiting a more significant dispersion.

Once the presence of a structural anomaly is detected, the localization is performed with the DLRM approach (Figs. 13(b)-(c)). The damage location matrix was created employing the previously updated numerical model. The model was divided into 80 elements – 8 elements per floor – to capture the possible effect of local damages. The Young’s modulus of each element is decreased by 50%, and the resulting frequency shifts are collected as described in Section 2. Nevertheless, due to the approximate symmetry of the structure, it is not expected to distinguish between damages occurring in parallel walls.

using Eq. (4). The results just after the damage detection from the control charts are shown in Fig. 13(b). The red dashed line represents the correct damage location, whereas the green dots are the Damage Indexes (DIs) of each element. The elements with higher DIs are more likely to be damaged. The localization is more precise for DS1 and DS2, while the algorithm is less effective for DS3. Fig. 13(c) illustrate the positions of the elements with a Damage index higher than 0.90. The inspection of Fig. 13 suggests the following comments:
