A sensor for confident identification of structural damage in reinforced concrete buildings

Abstract. A specific type of structural damage that would benefit from remote sensing is discussed and a solution is suggested.

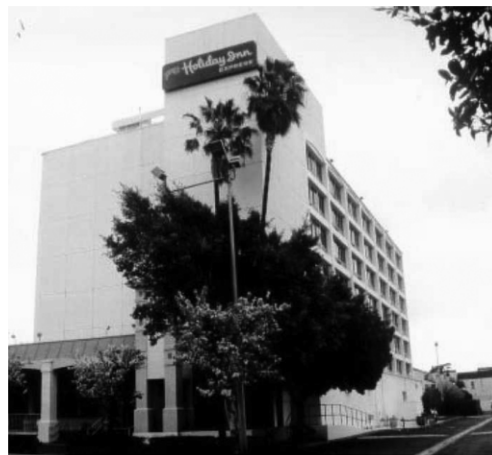
Fig. 1 Holiday inn building, Van Nuys, CA

The seven-story Holiday Inn Building (Fig. 1) was built in 1966. Figs. 2 and 3 show the plan and an elevation of the reinforced concrete structure. The reinforced concrete frames along the boundaries of the structure were built to resist the lateral forces induced by earthquakes. The footprint of the structure measured approximately 66 ft (N-S) by 150 ft (E-W). The height of the main structure was approximately 66 ft.

The building suffered light damage in the San Fernando earthquake of 1971. At that time, only three sensors had been mounted on the structure. After the 1971 event, the building was equipped with 16 accelerometers installed at locations indicated in Fig. 4(CDMG 1994), during the Northridge earthquake, the damage was serious but the structure did not collapse. The peak ground acceleration

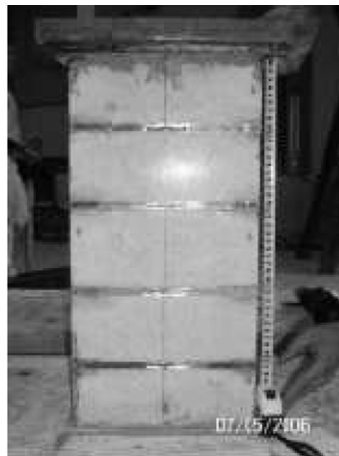
Fig. 16 Test specimen

with four sensors each: two with a 1/8-in. gage length and two with a 3/8-in. gage length. The locations of the two types of sensors used were alternated along each face.

The sensors were oriented as shown in Fig. 16 (perpendicular to the longitudinal axis of the column). This orientation enables the sensors to detect cracks forming at an angle with respect to the longitudinal axis of the column. This type of cracking has been observed repeatedly to lead to structural failures during past earthquakes.

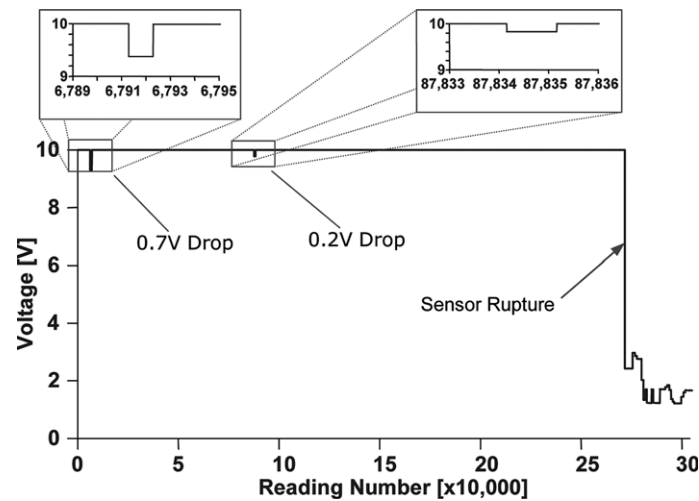
For the ADAM-6017, the control center polled the status of all eight channels of a data acquisition module (even if some of the channels were not connected to a sensor) once every second. Fig. 21 gives a representative trace of the data reports for one of the sensors connected to the ADAM-6017. Notice that there were two “blips” showing a 0.7 V and 0.2 V drops each lasting shorter than one second. The rupture of a sensor was associated with a large drop in the measured voltage as indicated in Fig. 21. Although the circuit design would have us expect zero voltage output after sensor rupture, the final voltage was not zero but fluctuated from 1 to 2 V. The large and permanent voltage

Fig. 21 Representative sample of recordings made with the ADAM-6017

drop after rupture of a sensor broke has allowed us to detect the rupture confidently.
