## Full-scale experiments of cantilever traffic signal structures

Héctor J. Cruzado<sup>\*1</sup> and Chris Letchford<sup>2</sup>

**Abstract.** Wind-induced vibrations of mast arms of cantilever traffic signal structures can lead to fatigue failure. Two such structures were instrumented each with a sonic anemometer and a camera that records the motions of the tip of the arm. It was observed throughout this experiment that large amplitude vertical vibrations of mast arms with signals with backplates occur for the most part at low wind speed ranges, between 2 to 7 m/s, and as the wind speed increases the amplitude of the vertical vibrations decreases. The results of these experiments contradict the generally accepted belief that vortex shedding does not cause significant vibrations of mast arms that could lead to fatigue failure, which have been attributed to galloping in the past. Two damping devices were tested with mixed results.

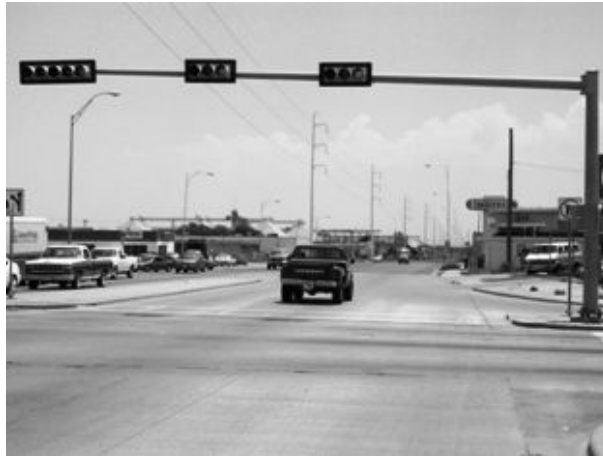
Fig. 1 Cantilever traffic signal structure with straight mast arm

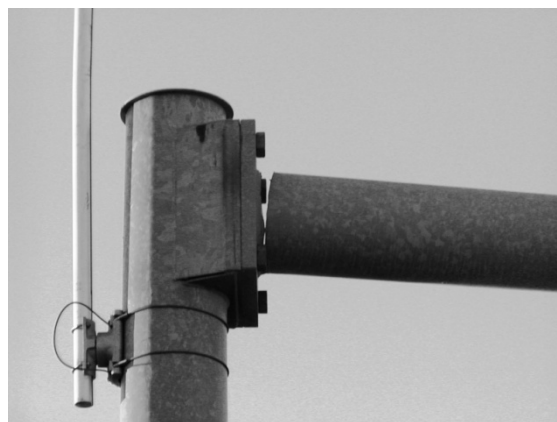
Fig. 2 Fatigue failure of mast arm in Lubbock, Texas

More importantly, vibrations of the mast can be a bigger problem because they could lead to fatigue failure. Fig. 2 shows one example of the many failures reported by state departments of transportation. The state of Missouri had over 12 traffic signal mast arms fail in a period of six years (Hartnagel and Barker 1999). Similar failures have been reported in Wyoming, California, and Texas (Chen *et al.* 2001).

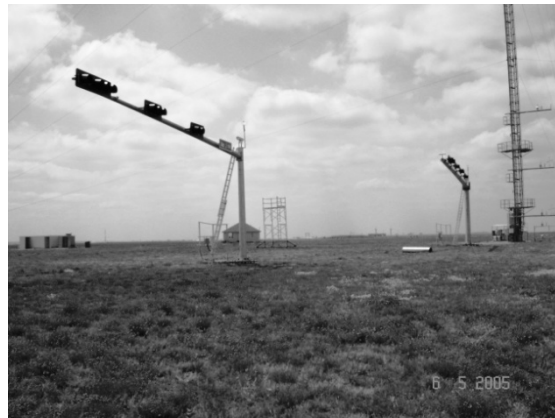
Fig. 3 The two cantilever traffic signal structures tested at Reese Technology Center

Full-scale field experiments were conducted with two out-of-service cantilever traffic signal structures installed at the Reese Technology Center facilities of the Wind Science and Engineering Research Center of Texas Tech University (see Fig. 3). Each structure is instrumented with a sonic

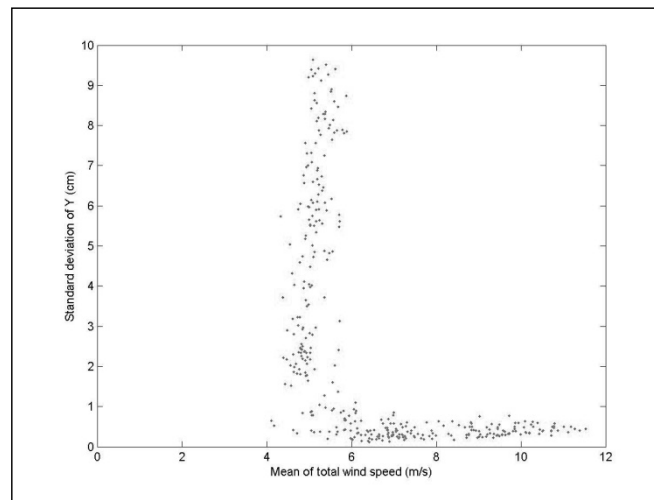
Fig. 9 Effect of total wind speed on vertical vibrations of the arm

The results indicate that there was a slight increase in horizontal vibration amplitudes over the wind speeds measured (4-12 m/s) but more significantly high-amplitude vertical vibrations were observed when the total wind speed was between 4.5 and 5.5 m/s as shown in Fig. 9. No clear relationship was observed between the horizontal and the vertical vibrations with the turbulence intensity.

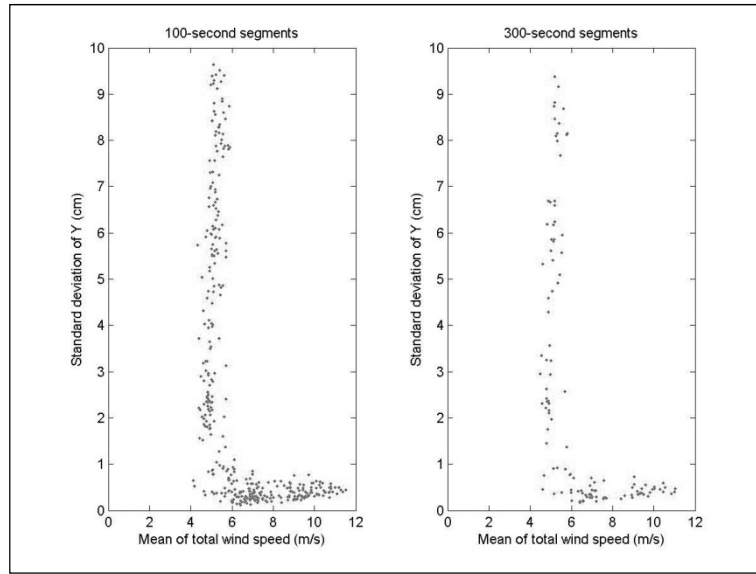
Fig. 11 Comparison of data analysis using segments of 100 and 300 seconds

This initial analysis was undertaken using data segments of 100 seconds. Data was also analyzed using longer and shorter segments and the same trends were observed as evidenced in Fig. 11 where data for 100- and 300-second segments are presented. In both cases it can be seen that high-amplitude vertical vibrations are observed when the total wind speed is between 4.5 to 5.5 m/s. This is not unexpected since with a natural frequency of  $\sim 1$  Hz, 100 seconds is capturing a significant number of oscillations, and yet is small enough to not be influenced by wind speed and direction changes.

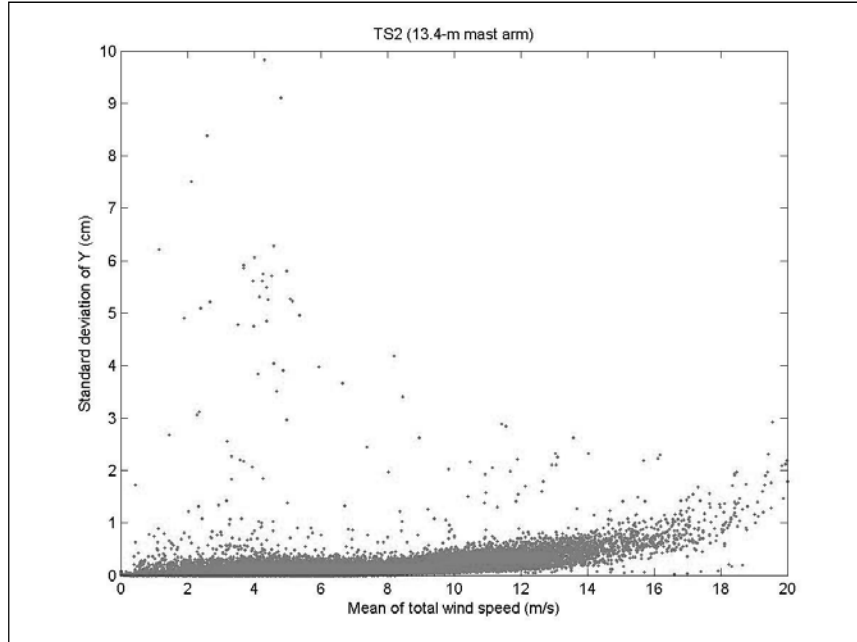
Fig. 13 Effect of mean wind speed on vertical vibrations of TS2 with backplates

Figs. 12 and 13 show the effect of the mean wind speed (the vector sum of  $u$ ,  $v$ , and  $w$ ) on the vertical vibrations of the mast arm of TS1 and TS2, respectively. In both cases, the standard deviation of vertical displacement ( $Y$ ) never exceeds 5 cm when the mean wind speed is over 10 m/s.

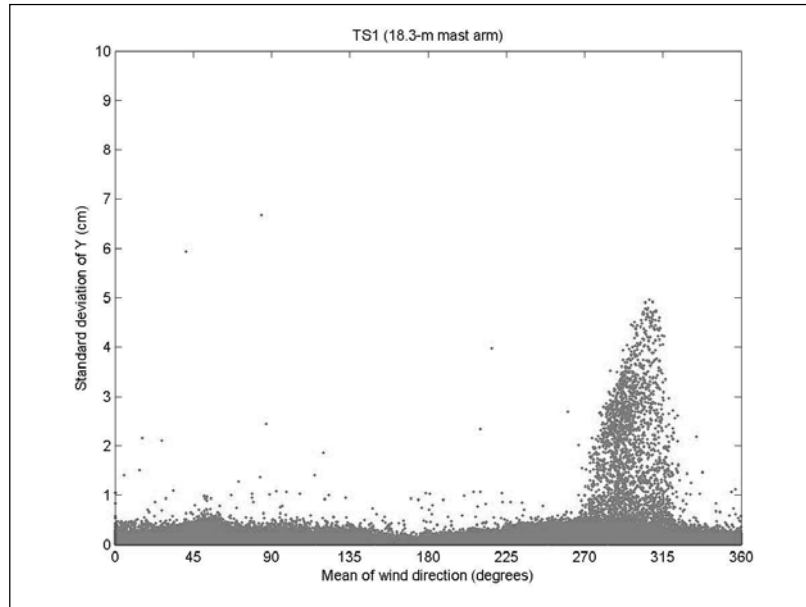
Fig. 20 Effect of wind direction on vertical vibrations of TS1 with vented backplates

Fig. 20 shows the effect of wind direction on the vertical vibrations of TS1. Here higher than average values of the standard deviation of  $Y$  were observed when the mean wind direction was about 300 degrees. For the case of TS2, there was again no discernible relationship of response with wind direction.

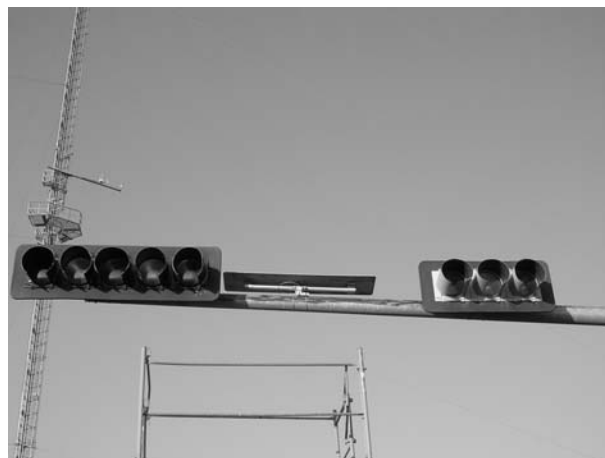
Fig. 21 Mast arm with damping plate

From July to September 2007, data was collected under Mode 1105 with the arms pointing southeast and the signals having regular backplates. In addition, each arm had a plate installed as a damping device, as shown in Fig. 20. Each plate was 1.5 by 0.4 m and was located 140 mm above the top of the mast arm. For TS1, the center of the plate was located 2.2 m from the tip of the arm, while for TS2, the center of the plate was located 2.1 m from the tip of the arm.
