Cumulative damage in RC frame buildings – The 2017 Mexico earthquake case

Abstract. The Puebla-Morelos Earthquake (Mw 7.1) occurred in Mexico in 2017 causing 44 buildings to collapse in Mexico City. This work evaluates the non-linear response of a 6-story reinforced concrete (RC) frame prototype model with masonry infill walls on upper floors. The prototype model was designed using provisions prescribed before 1985 and was subjected to seismic excitations recorded during the earthquakes of 1985 and 2017 in different places in Mexico City. The building response was assessed through a damage index (DI) that considers low-cycle fatigue of the steel reinforcement in columns of the first floor, where the steel was modeled including buckling as was observed in cases after the 2017 earthquake. Isocurves were generated with 72 seismic records in Mexico City representing the level of iso-demand on the structure. These isocurves were compared with the location of 16 collapsed (first-floor column failure) building cases consistent with the prototype model. The isocurves for a value greater than 1 demarcate the location where fatigue failure was expected, which is consistent with the location

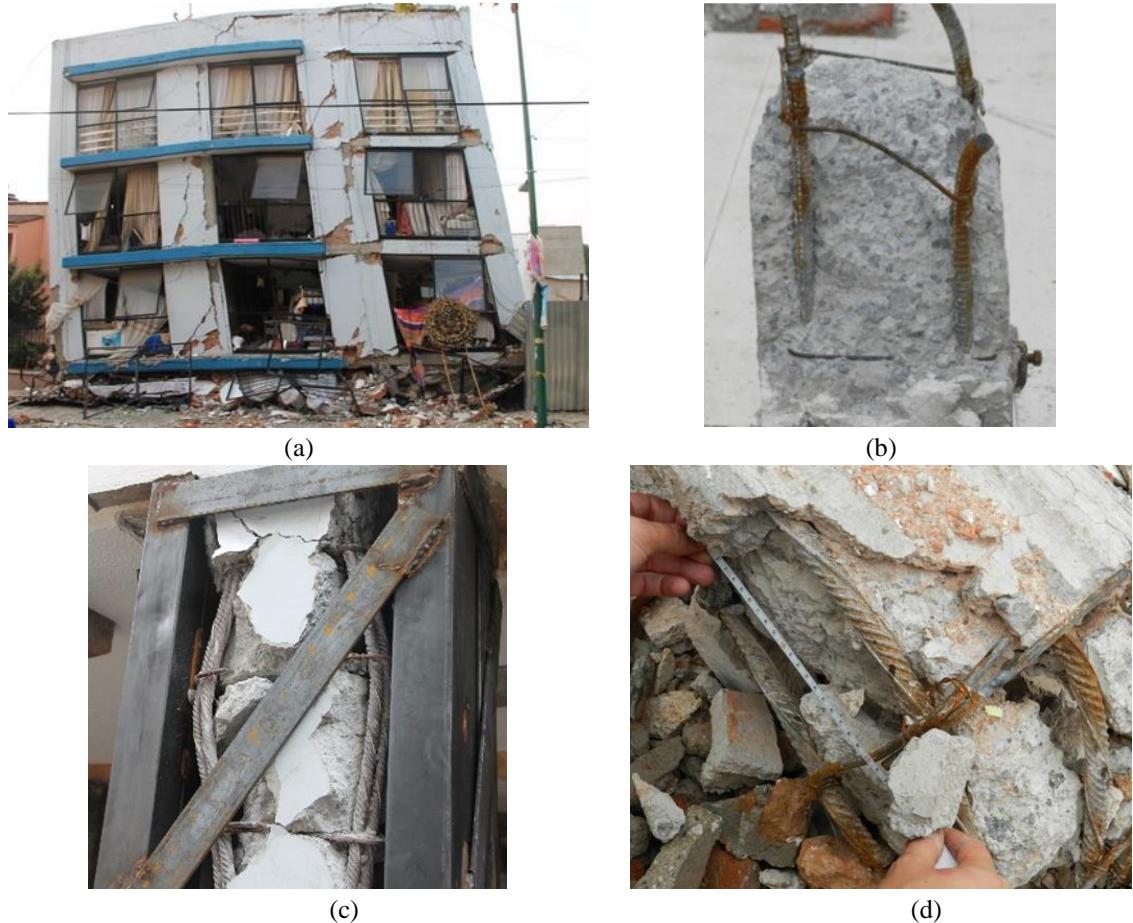
Fig. 1 Typical structural damage - (a) collapsed building, (b-d) damaged columns

buildings. In Fig. 1a, it can be seen examples of buildings that suffered the collapse of all the columns of the first floor after the earthquake, causing the upper levels to descend. It is inferred that the collapse in these cases began and spread in the columns due to numerous observations such as the one in Fig. 1b, which represents other buildings that did not collapse but exhibited severe structural damage in the columns of the first floor, where buckling in the longitudinal reinforcement bars and the loss of the concrete cover and core were observed.

The buckling length of the reinforcement observed after the Puebla-Morelos earthquake is approximately 480 mm for bars with a diameter of about 20 mm (Fig. 1b), which suggests a slenderness factor $L/D \sim 24$ that was commonly observed in Mexico City after the earthquake. The buckling length has been validated in this study using the approach by Dhakal and Maekawa (2002), where the numerical model indicates that global buckling would be achieved by the longitudinal reinforcement under mode 2 (Massone and López, 2014) for 8 longitudinal bars (2 in each corner) equivalent to a reinforcement ratio of 1.2% and stirrups No. 2 (6.4 mm diameter) at 230 mm spacing (0.5d, where d is the distance to the tensile reinforcement), which is the maximum spacing allowed by the 1966 Mexican design code (NCR, 1966). That is, instead of observing longitudinal bar buckling between 2 consecutive stirrups (mode 1 – local buckling, $L/D = 230/20 \sim 12$), buckling would be observed within 2 spacings. This is mainly caused by the small stirrup diameter, which is consistent with Fig. 1b. Thus, the actual buckling length to diameter ratio would be $L/D \sim 24$ for mode 2, which was also inferred from the figure.

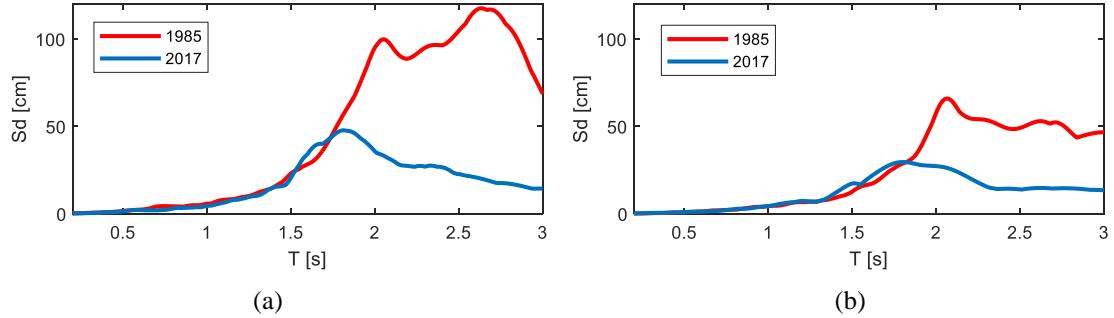
Regarding the seismic records, the only station that recorded both the 1985 and 2017 earthquake events on soft soil in Mexico City was SCT. In Fig. 2, it is observed the elastic displacement spectra, which assume a single degree of freedom linear oscillator response, for the 1985 and 2017 earthquakes in both directions for the SCT station. The response spectra are created using the Newmark-Hall linear acceleration method with $\beta = 0.35$, $\gamma = 0.5$ and a typical damping factor of 5%. Although the moment magnitudes of the 1985 and 2017 earthquakes were vastly different (Mw 8.1 in 1985 vs. Mw 7.1 in 2017), in Fig. 2, it is shown that the elastic displacement demands (S_d), between 0 and 1.5 seconds, were practically identical. This is interesting since that range of periods coincides with that of the buildings most affected by the 2017 earthquake.

Fig. 2 Elastic displacement spectra of SCT station - (a) N90E, (b) N00E

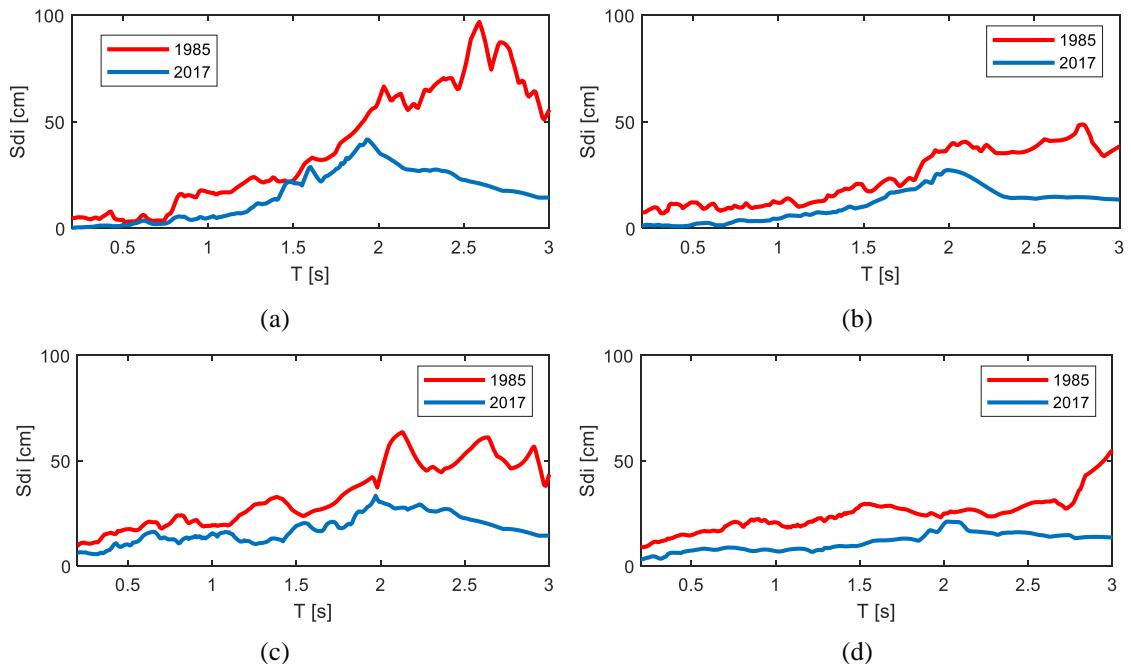
Fig. 3 Inelastic displacement spectra in directions - (a, c) N90E, (b, d) N00E, and (a, b) Q=2, (c, d) Q=4

Since structures can fall into the non-linear range during an earthquake, a better representation of the displacement demand is considering an inelastic oscillator response. To fix the strength of the oscillator, a reduction factor Q is applied to the force obtained with the 1985 earthquake record under a linear response, that is, the oscillator strength depends on the elastic pseudo-acceleration spectra of the record reduced by a factor Q . Two Q factors are selected considering the typical values proposed in Mexican building codes: 2 and 4. A perfectly elastoplastic model with identical loading and unloading stiffness is used. Inelastic displacement spectra for the two Q values are presented in Fig. 3.

It is shown in Fig. 3 that for inelastic behavior, the displacement demand of the 1985 earthquake is markedly higher than that of the 2017 earthquake, even up to a period of 3 s. The trend is the same for both strength reduction factors ($Q = 2$ and $Q = 4$) and in both directions of

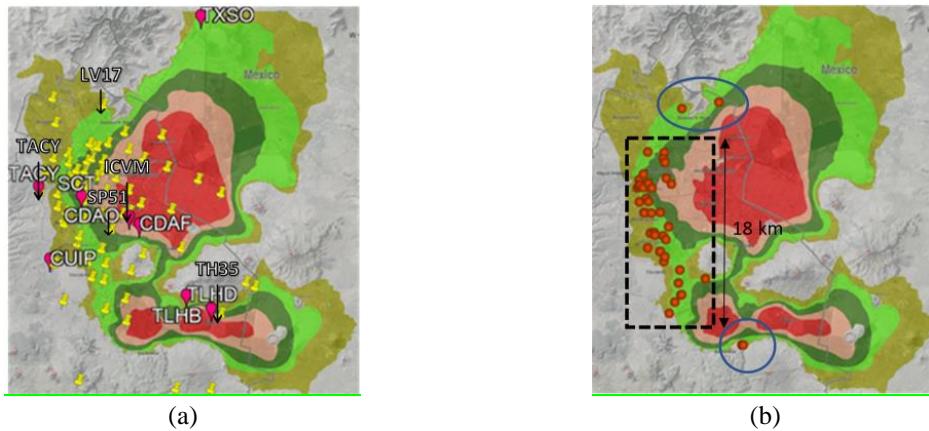
Fig. 4 Mexico City - (a) Seismic records, (b) Location of 44 collapsed buildings (after CDMX gov., 2017)

In Fig. 4a, it is shown, with pink balloons, the location of the 8 seismic stations available in Mexico City that recorded the 1985 earthquake; two of them located on soil type I (CUP5 and TACY stations), one located on soil type IIIa (TXSO station), three on soil type IIIb (CDAF, SCT and TLHD stations), one on soil type IIIc (CDAO station) and one located on soil type IIId (TLHB station). Three of these stations also recorded the 2017 earthquake (SCT, TACY, CUP5), in addition to a series (69) of new stations that have only recorded the 2017 earthquake.

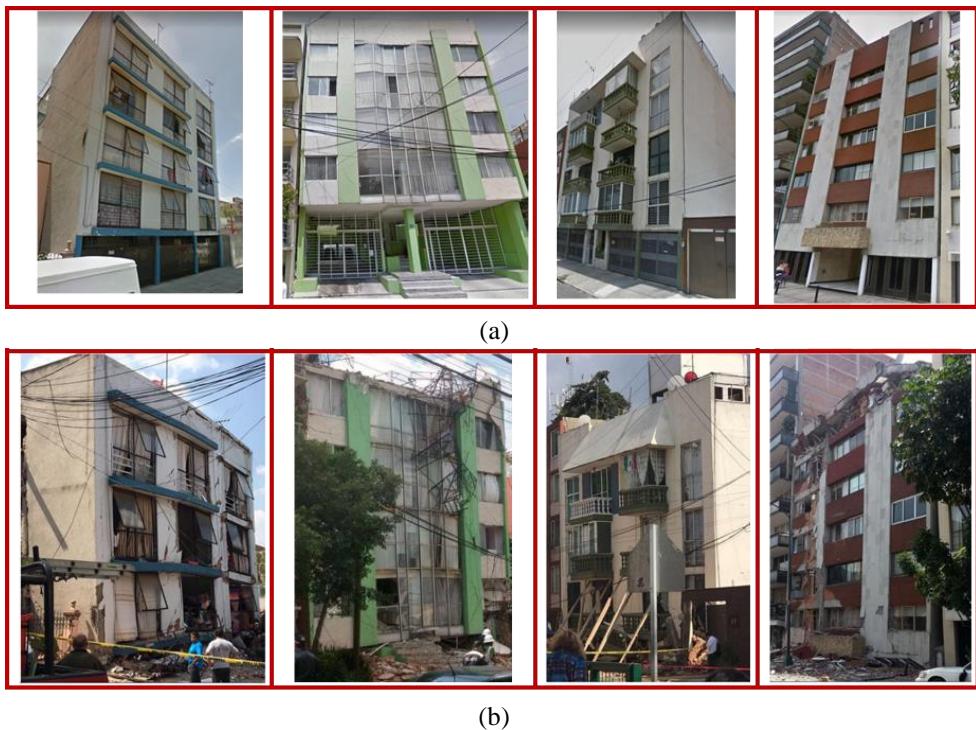
Fig. 5 Collapsed buildings with a soft story - (a) before (Google maps 2017), (b) after (Google maps 2018) the 2017 earthquake

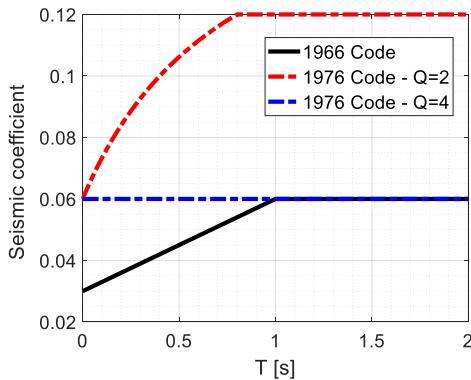
Fig. 6 Design spectrum prescribed in 1966 and 1976 codes

In Fig. 9, it is shown the pushover analysis results for a lateral load pattern with the shape of the first fundamental mode, revealing the overall base shear versus the lateral top displacement of the prototype building. It is shown a strength degradation that starts at a 0.4% drift, which corresponds to 80 mm. The degradation of the strength by 20% is reached at about 0.5% drift, that is 100 mm. The maximum strength is $\sim 0.18W$ (18% of the building weight), indicating that an over-strength of $\Omega = 3$ is expected since the design strength is $0.06W$ for a period of vibration with cracked sections (T_{cr}) of 1.0 s (Fig. 6).

the 1966 design code for frame buildings with flat slabs (Fig. 6), with an over-strength value of $\Omega = 3$, consistent with the over-strength observed in the prototype building. For each of these 5 stations that only recorded the 1985 earthquake, the closest stations with the 2017 record available and located on the same type of soil are identified (TACY for TACY, LV17 for TXSO, SP51 for CDAF, ICVM for CDAO, TH35 for TLHD) to compare their inelastic displacement demands (S_{di}). The inelastic displacement demands are congruent with values lower than 100 mm for the fundamental cracked period of 1 s, with similar displacement demands for the 1985 and 2017 earthquakes, interchanging slightly larger values between them, except for the last case (TLHD station) where the demands exceeded this value, with magnitudes larger on the 2017 records than on the 1985 records. This suggests that the damage to the buildings may have been triggered by a mix between displacement demand and cumulative damage.

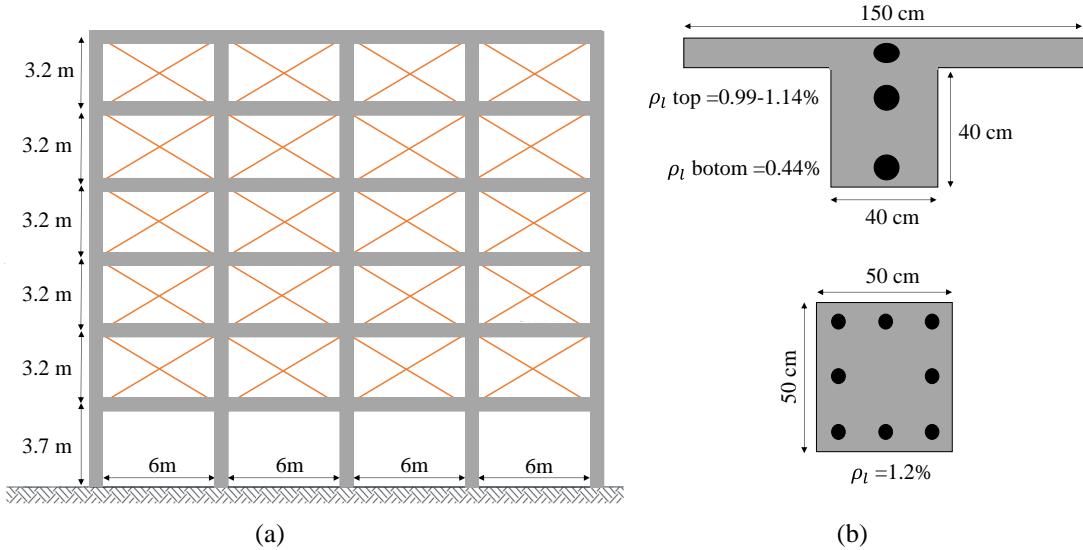
Fig. 7 Prototype model configuration – (a) general elevation, (b) beam-slab and column sections

The height of the first floor of the prototype building (Arteta *et al.* 2019) is 3.7 m and 3.2 m for the upper floors, giving a total height of 19.7 m. There are three (3) and four (4) spans in the short and long directions, respectively, with a length of 6 m each. This gives a total floor area of 432 m². For this work, this prototype is modeled in a 2D space (Fig. 7a) for the long direction (4 spans). The columns have a square section of 500 mm on each side. The beams are also square, but with a section of 400 mm on each side. In this case, the flexural contribution of the slab with a thickness of 100 mm and an effective width of 1.5 m was considered (Fig. 7b). In the case of masonry, it is a 100 mm thick wall and is located on the top 5 floors, composed of solid clay bricks, whose compressive strength is set at 7.0 MPa (Arteta *et al.* 2019).

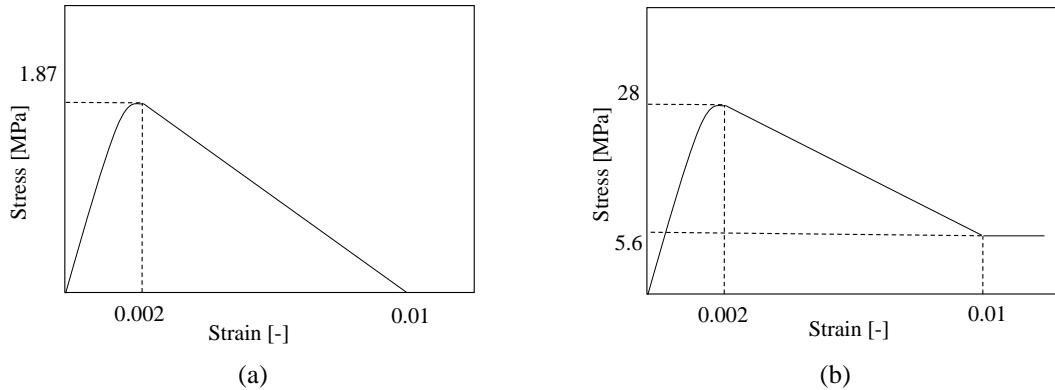
Fig. 8 Stress-strain model of materials - (a) masonry, (b) concrete

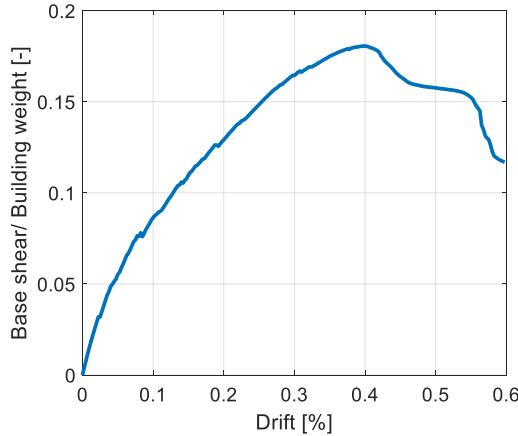
Fig. 9 Prototype pushover analysis – normalized base shear versus lateral displacement

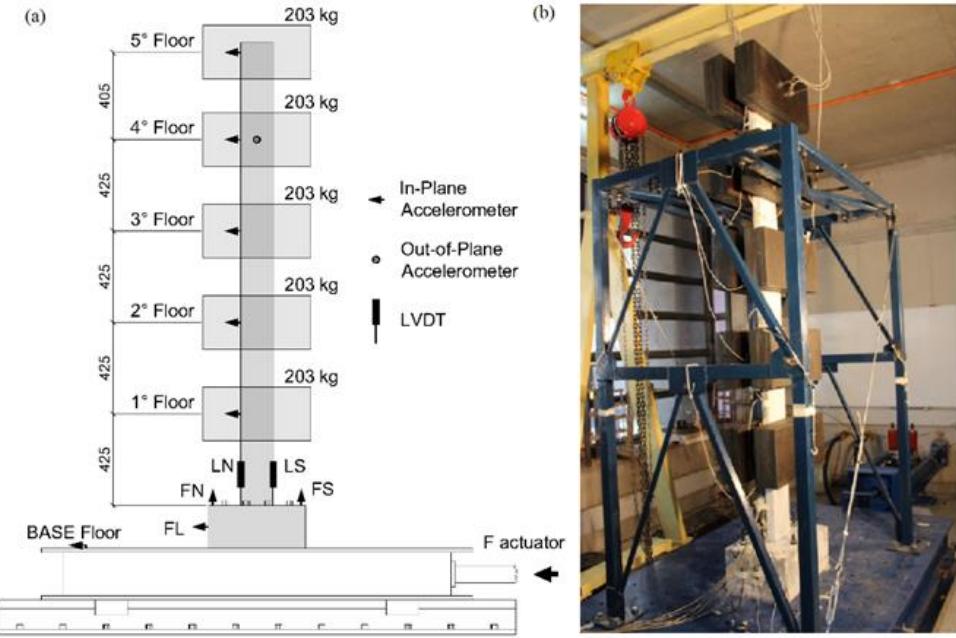
To validate that the modeling scheme, the material model, and the discretization criteria of columns, were good enough to capture the history response of main variables such as moment, shear and lateral displacement with a flexural failure mode, a specimen (M1) from the work by Jiménez and Massone (2018) is studied. As shown in Fig. 10, this work focuses on studying the seismic response of an RC cantilever wall with 5 stories, accounting for 5 vibration modes due to the seismic weight distribution. The weight was consistent with an axial load of $0.07Agf'c$. The wall is 2.15 m high with a cross-section of 150 mm \times 40 mm, and the longitudinal boundary reinforcement is characterized by $2\phi\text{-}6$ mm bonded steel bars on each side. For transverse reinforcement, $\phi 4$ mm stirrups separated at 40 mm were placed at the wall bottom to provide

Fig. 10 Test setup of model validation (Jiménez and Massone 2018)

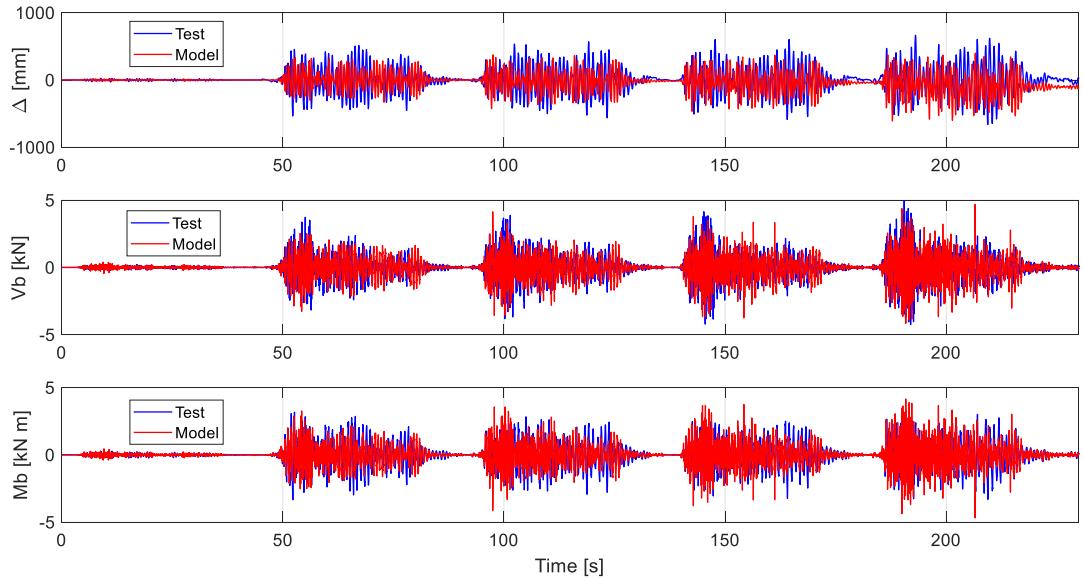
Fig. 11 Test validation - (a) top lateral displacement, (b) base shear and (c) base moment

The damage to the specimen was concentrated at the base of the wall mainly due to bending (Jiménez and Massone 2018). The experimental fundamental period of the wall was 0.37 s, as same as the model accounting for unintended cracking of the specimen due to transportation and shrinkage before testing. The moment, shear and top displacement distribution are relatively similar between the model and the experimental measurement (Fig. 11), with differences of less than 10% for the maximum displacement and shear, validating the modeling scheme used for the prototype.

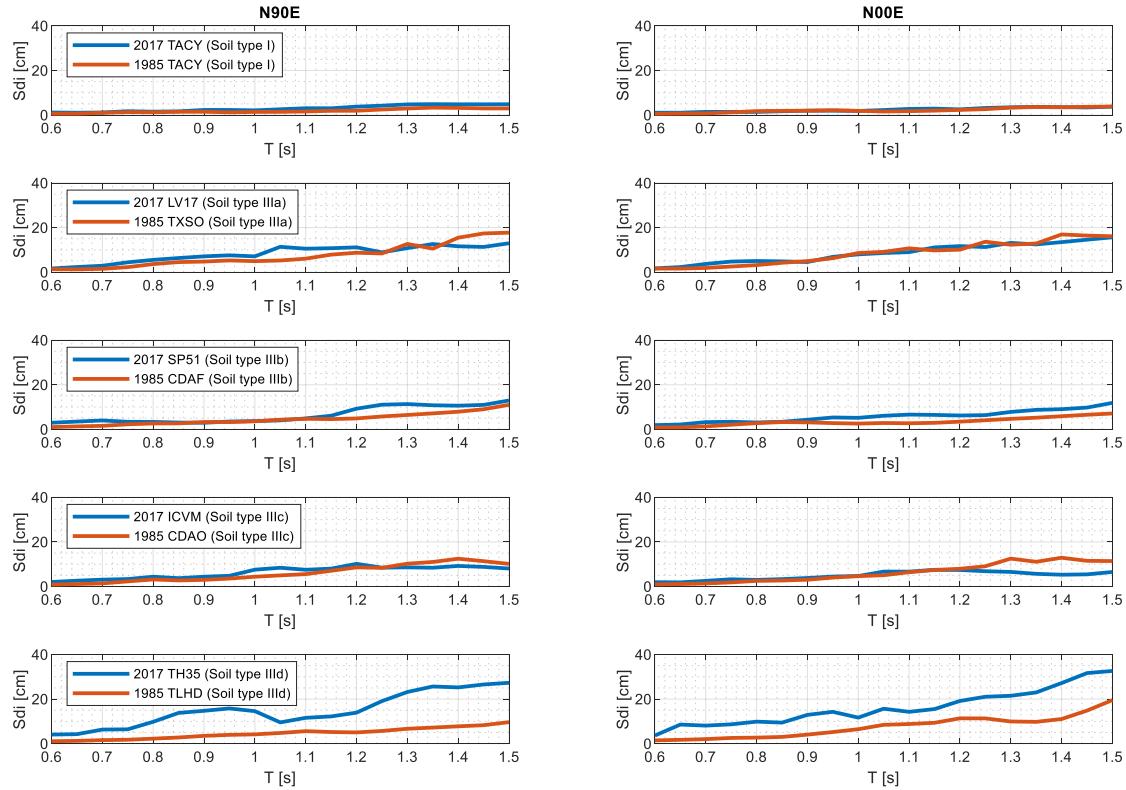
Fig. 12 Comparison of inelastic ($\Omega=3$) displacement demands for close stations for the 1985 and 2017 earthquakes – (a) TACY, (b) TXSO, (c) CDAF, (d) CDAO, (e) TLHD

In Fig. 12, it is shown the inelastic displacement spectra (Sdi) based on the strength design of

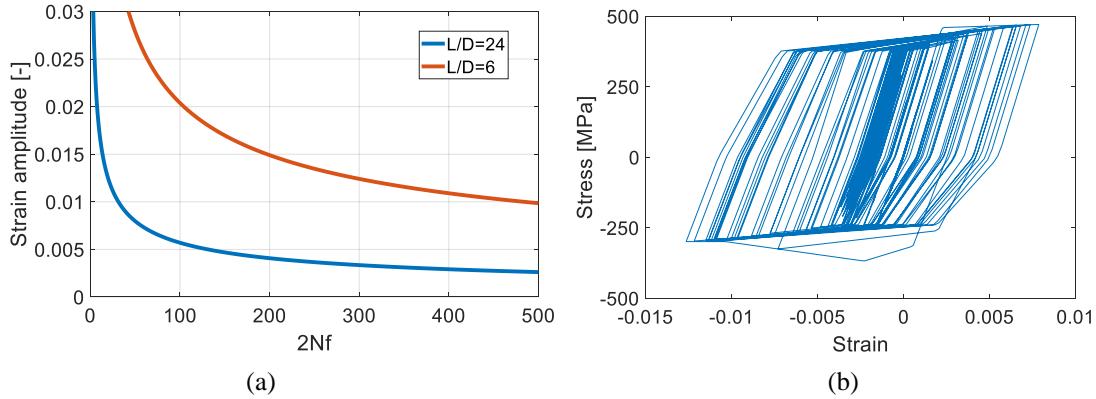
Fig. 13 Reinforcing bars - (a) low-cycle fatigue life, (b) stress-strain response in the prototype building

purposes, Fig. 13a shows the number of half-cycles ($2N_f$) necessary to reach the fatigue failure for different strain amplitude levels and for slenderness ratio $L/D = 6$ and 24 . The $L/D = 6$ curve is also shown to compare with a case where special detailing is provided to columns, constraining the potential buckling length of longitudinal bars as 6 times the bar diameter, as it is required by codes as ACI 318-19 (2019) for Grade 60 steel.

As shown in Fig. 14, a maximum strain value above 0.01 is reached, although several cycles barely reach yielding. The fatigue damage is calculated based on rain-flow counting (Downing and Socie 1982). Thus, peak strains must be identified for the estimation of the total strain amplitude of each half-cycle. Half of every absolute difference between one peak and an adjacent one is named ϵ_a or total strain. The low-cycle fatigue life model proposed by Tripathi *et al.* (2018) is introduced to count damage from each half-cycle (D_i). This quantity is defined in Eq. (2), following Eq. (1) which defines the cyclic capacity of reinforcing bars. The absolute damage index (DI) is calculated as the sum of all terms using Eq. (3). With those considerations, the progression of accumulated damage in time can be also plotted as in Fig. 15. For comparison purposes, the prototype model is also run for a special detailing of transverse reinforcement in columns with slenderness ratio $L/D = 6$ (reinforcing bar without buckling and confined core concrete), showing how the damage is largely reduced given in part due to the larger fatigue life (Fig. 13a).

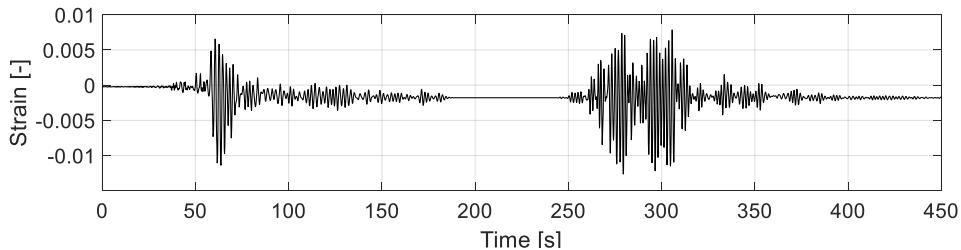
Fig. 14 Cyclic strain-time history of a reinforcing bar (central bottom column) in the prototype building.

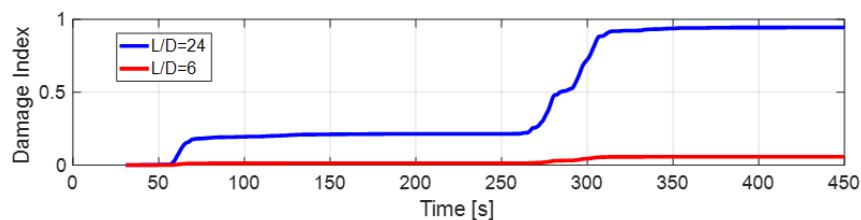
Fig. 15 Time history of damage index progression for a reinforcing bar of the central bottom column

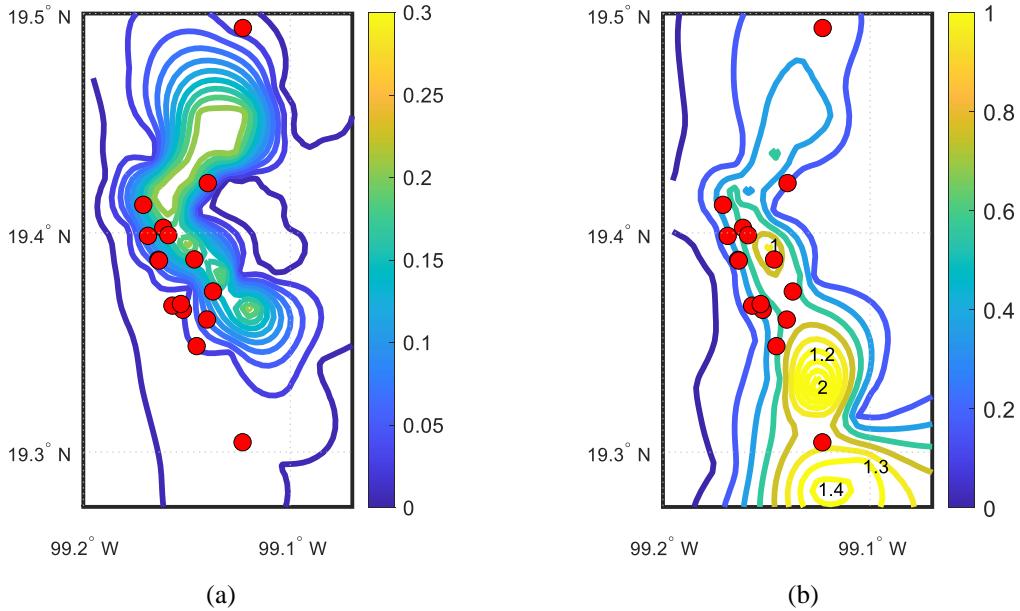
In Fig. 16, it is shown the isocurves of the fatigue damage index (DI), which considers the direction of the largest demand in each station for the 1985 records (Fig. 16a) and the combined 1985 and 2017 records (Fig. 16b). The color scale classifies the intensity of the damage index of each isocurve in the map, limited by geographic coordinates. The red dots are the locations of the 16 collapsed buildings of the study group, whose structure, year of construction and failure mode closely match that of the prototype model. Stations with $DI > 1$ are marked with their corresponding value. The action of the 1985 earthquake generated an accumulation of damage of about 20% with respect to the total required damage to reach the fracture of the steel reinforcement (Fig. 16a). This accumulation of damage is concentrated in the northern part of the city, and

Fig. 16 Prototype iso-damage index curves (low-cycle fatigue model) - (a) 1985, (b) 1985+2017

represents mainly the demand from the SCT station in the N90E direction. In the southern zone, the accumulation of damage from this earthquake is less than 5%. When the joint action of the 1985 and 2017 earthquakes is considered (Fig. 16b), 5 stations reach $DI > 1$, which means that practically all the accumulation of fatigue damage occurs in the 2017 earthquake. On the northern side of the city, only the SCT station achieves a $DI > 1$ ($DI = 1.01$). It is observed that only 2 cases marked in red fall within an isocurve with damage $DI > 1$, and 13 of the 16 cases fall within the isocurve associated with a $DI = 0.4$, thus the sensitivity of the damage to variations in the structural parameters is evaluated.

plastic hinge, for both beams and columns (considering the 1985 and 2017 records). In this case, the concrete core is confined and the transversal reinforcement constrains the buckling of the longitudinal bars, such the reinforcing bar does not lose compressive strength. This restricts the slenderness ratio L/D to a value of 6. In the case of the confined concrete model, given its ductile behavior, the ultimate strain is increased from 0.01 (Fig. 8b) for unconfined concrete to 0.075 for the columns. This case represents those buildings built between the 70s and 80s, which were not damaged in the 2017 or the 1985 events, which were designed with the 1976 design code. This regulation required special detailing on this type of structure. The results are shown in Fig. 19, where the average DI over the collapsed buildings is 0.01, and the most demanding station has a $DI = 0.06$. The reduction in slenderness increases considerably the fatigue life, reducing largely the DI values, compared to the observed response with poor detailing in older buildings (Fig. 16b).

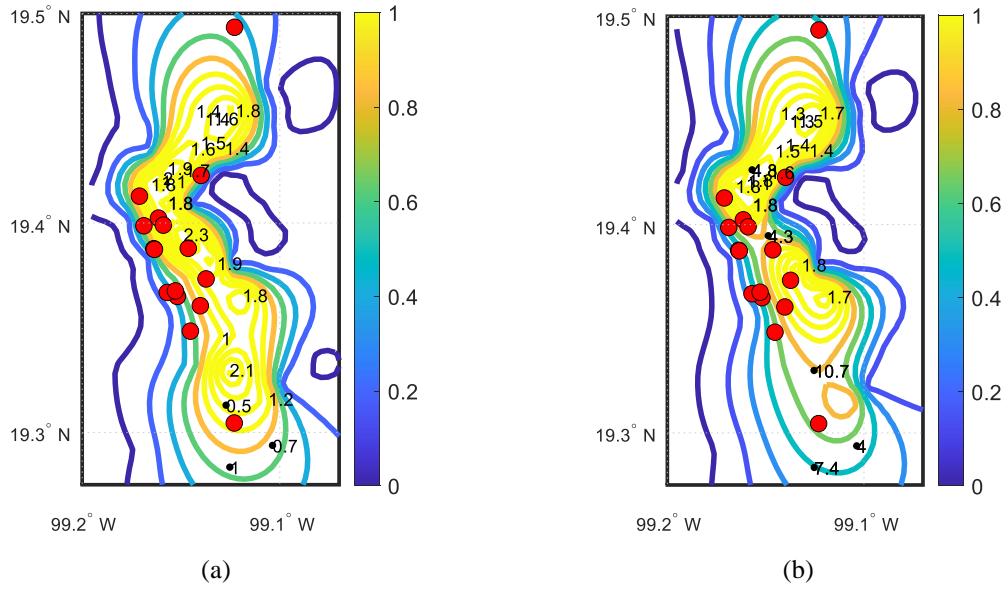
First, the axial load is increased by only 5% in the prototype, and the analysis is performed once again (Fig. 17a). On the other hand, the effect of reducing the cross-section of the columns by 5% is evaluated, that is, changing the section width from 500 mm to 475 mm throughout the height of the columns (Fig. 17b). In these analyzes, the black points indicate the stations in which the dynamic analysis (including the 1985 and 2017 records) was not completed due to the lack of convergence in one of the steps. These values are excluded from the analysis. For these cases, the average DI over the 16 collapsed buildings increases from 0.28 for the original model (Fig. 16b) to 0.56 (Fig. 17a) and 0.48 (Fig. 17b), respectively, giving a better correlation with the observed collapsed buildings. The DI level increases, extending the damage zone towards the northern side of the city. In these cases, most of the collapsed buildings fall within the isocurves associated with $DI = 0.6$. The increase in the intensity of the isocurves provides damage congruence with 9 of the 16 cases, and having the other 7 cases less than 2 km away (Fig. 17a).

Fig. 17 Iso-damage index curves (1985+2017) - (a) +5% axial load, (b) -5% column width

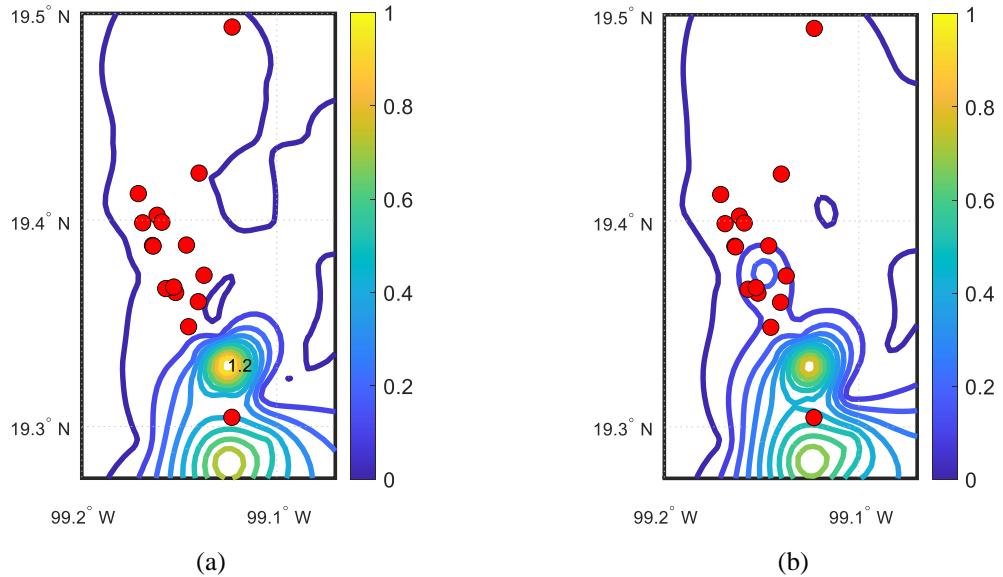
Another relevant comparison is the effect of column strength improvement (considering the 1985 and 2017 records). Thus, increasing the cross-section of all columns in height, from a column width of 500 mm to 600 mm is studied (Fig. 18a). On the other hand, the steel longitudinal ratio of the columns of the first floor is increased, going from 1.2% to 2.0% for another analysis (Fig.

Fig. 18 - Iso-damage index curves (1985+2017) - (a) +20% columns size, (b) 2% steel reinforcing ratio

18b). The average DI for these cases on the collapsed buildings is 0.06 and 0.08, respectively. The northern part of the city does not evidence accumulation of fatigue damage, and only one station imposes the fracture of the reinforcement (Fig. 18a). The distribution and reduced magnitude of the DI isolines are consistent with Mexican buildings that had more robust columns and were exempt from severe damage after the 2017 earthquake (Albornoz *et al.* 2022).

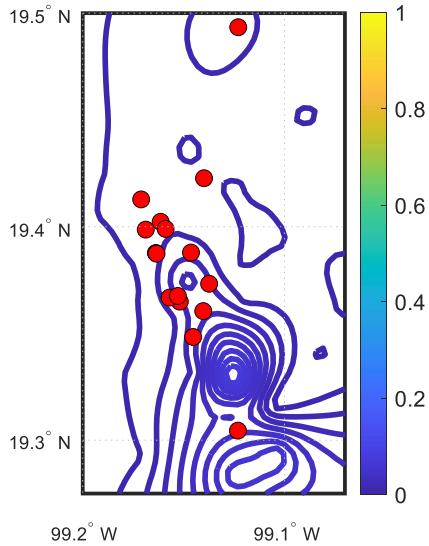
Fig. 19 Iso-damage index curves for a frame with special detailing (1985+2017)

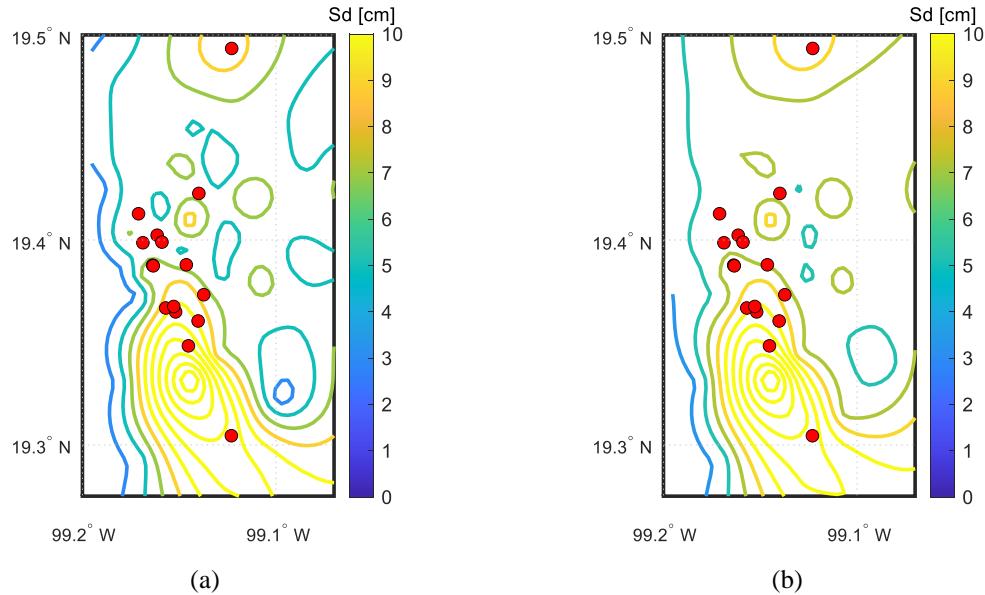
Fig. 20 Elastic displacement demand (S_d) - (a) only 2017, (b) 1985+2017

methodology, isolines are generated that represent the same displacement demand level. First, the elastic (S_d , Fig. 20) displacement spectra, considering only the 2017 earthquake and the combination of the 1985 and 2017 earthquakes, are created. The inelastic response (S_{di} , Fig. 21) is calculated by fixing the SDOF oscillator strength according to the 1966 design spectrum, for an over-strength $\Omega = 3$ (Fig. 21a), that is, 3 times the strength of the 1966 code, which is consistent

In Fig. 20, it is shown that the elastic demands exceed the capacity of the structure (~ 80 mm) on the southern side of the city, even when only the 2017 records are considered (Fig. 20a). In general, the northern part of the city does not reach the displacement capacity of the structure for either earthquake, suggesting that other considerations are required, such as damage accumulation. It should be mentioned that, for the elastic spectrum, the consideration of both records (Fig. 20b) results in the envelop spectrum of them.

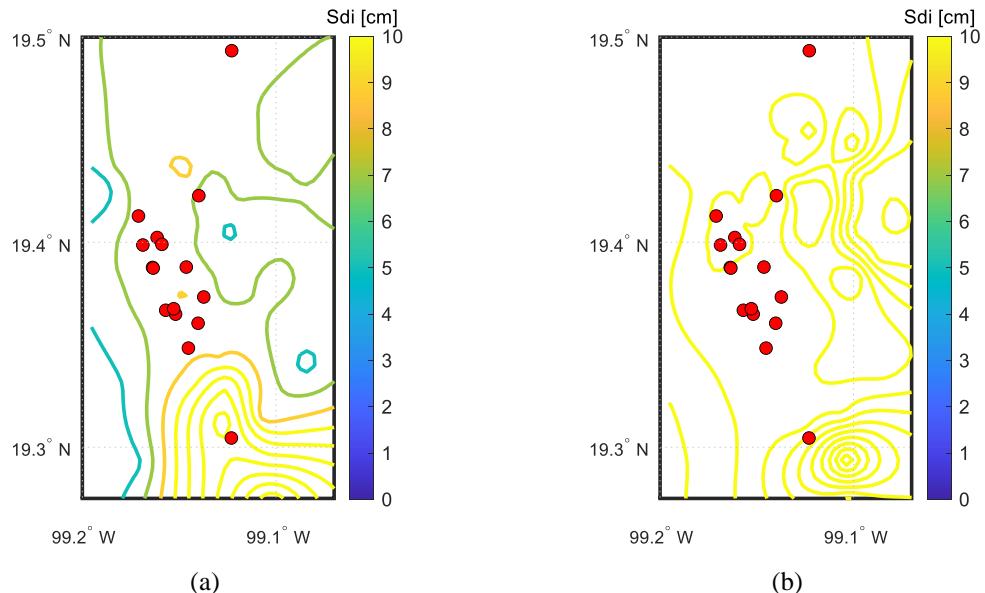
Fig. 21 Inelastic displacement demand (S_{di}) for both earthquakes (1985+2017) - (a) $\Omega=3$, (b) $\Omega=1$

with the prototype over-strength. An over-strength $\Omega = 1$ (Fig. 21b) is also included for comparison purposes.

The inelastic response for the case $\Omega = 3$ (Fig. 21a), reinforces the previous finding. Higher displacement demands are concentrated in the southern part of the city, while the demands in the northern zone decrease in magnitude, remaining below the capacity of the structure. On the other hand, the inelastic displacement demands for $\Omega = 1$ exceed the capacity of the structure, covering an area of damage broader than that observed when both records are used (Fig. 21b). Thus, it is unlikely that an over-strength value of $\Omega = 1$ would have been observed in buildings with the characteristics of the prototype (with reduced strength) in the area.

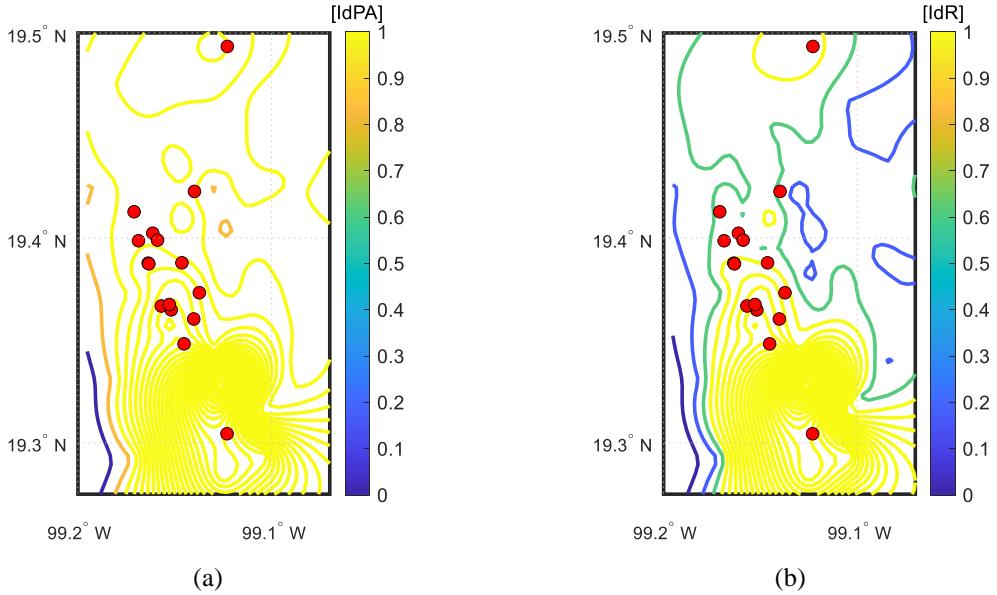
Fig. 22 Damage index (1985+2017) - (a) Park and Ang (1985), (b) Rodriguez (2018) for H/T=20

Similar to the spectral displacement, the damage index (D_{PA}) is computed for inelastic behavior with a fixed strength according to the 1966 design code with $\Omega = 3$ (Fig. 22a). In Fig. 22a, it is shown that the index provides a good correlation with the collapsed building locations, although covering a broader area of potential collapsed buildings.

In this study, the damage index (I_d) is computed with $H/T_{cr} = 19.7m/1.0s \sim 20 m/s$ and a strength set according to the 1966 design code with $\Omega = 3$ (Fig. 22b). Similar to the displacement indexes, for $\Omega = 3$ (Fig. 22b), a good correlation with the collapsed building locations is observed, especially in the southern area, with practically all red points close to an isocurve with $I_d \sim 0.7$. Taking into consideration that Eq. (5) is highly dependent on H/T_{cr} and D_{rc} , an increase in such factors reduces rapidly the index value. A value of $H/T_{cr} = 40 m/s$ represents rigid buildings such as structures based on RC walls that mostly did not present damage after the 2010 Chile earthquake (Massone *et al.* 2012, Lagos *et al.* 2021). Moreover, proper detailing would also increase the $D_{rc}=0.5\%$ value, reducing the likelihood of collapse.
